September 29, 2020

Urban Catalyst  
99 S. Almaden Blvd Suite 840  
San Jose, CA 95113

20-185

Subject: Structural Evaluation of Josefa Tankhouse  
491-499 W. San Carlos St. and 270-280 Josefa St.  
San Jose, California

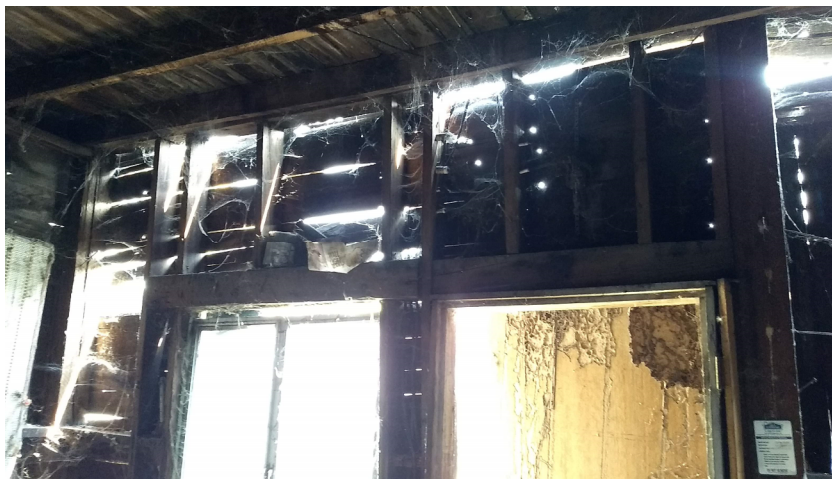
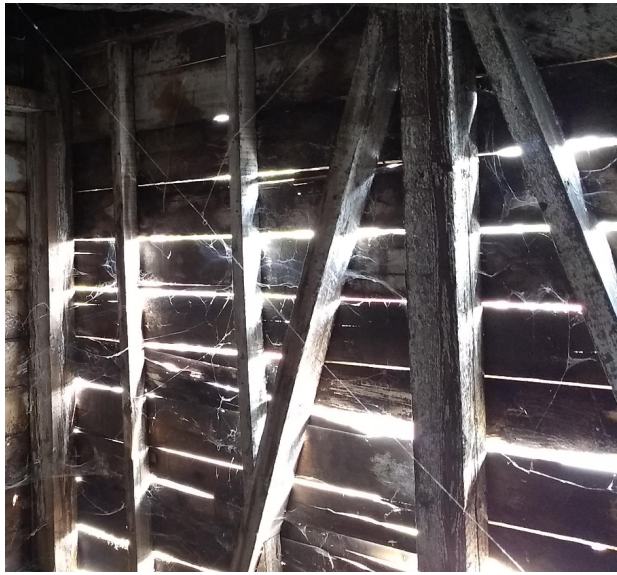
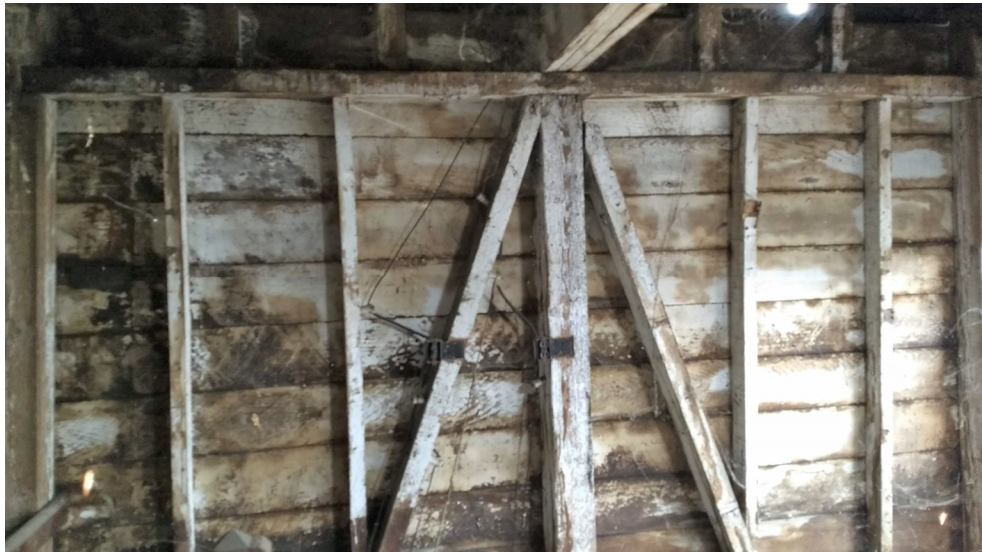
- 1.1. The exterior horizontal sheathing/siding is peeling from the structure. Many holes and gaps were observed. Other walls appear to have sustained significant water damage. Images below are taken from inside the structure.

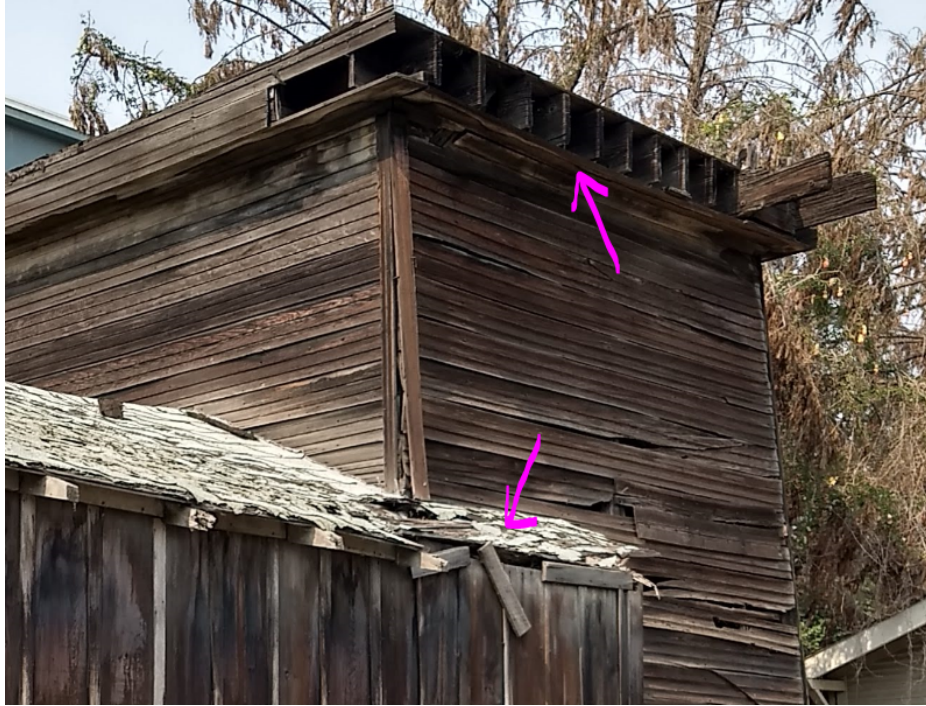
- 1.2. At the south façade, exterior fascia at the water tower was missing and several rafter tails at the garage were already broken. This is a strong indication that the framing is severely deteriorating.

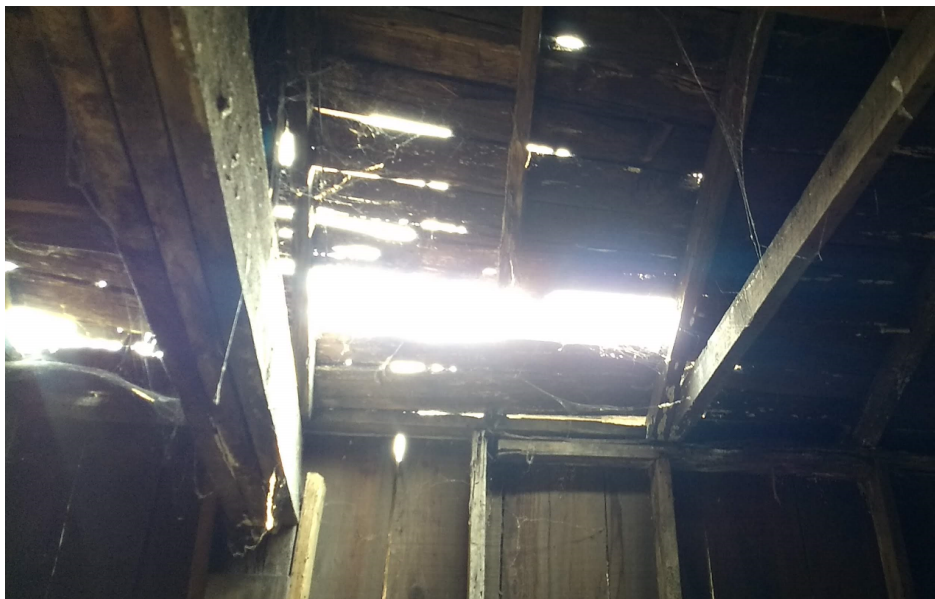
- 1.3. The southern portion of the roof shows serious signs of deterioration and sustained damage. Horizontal lumber roof sheathing was missing and supporting rafter was broken.

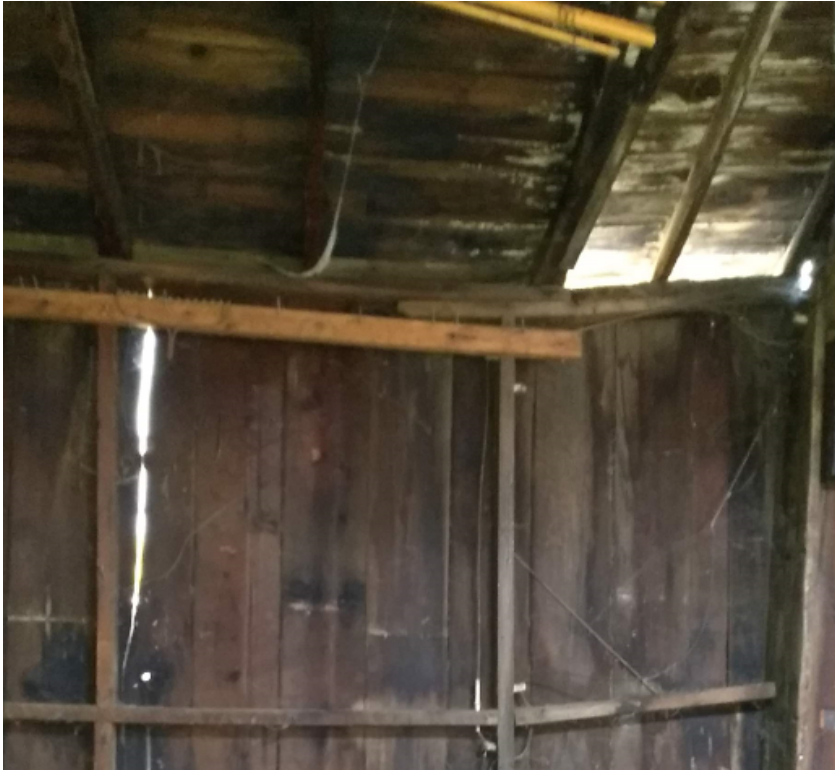
- 1.4. Significant bowing in the roof framing was observed in the northeastern corner of the garage.

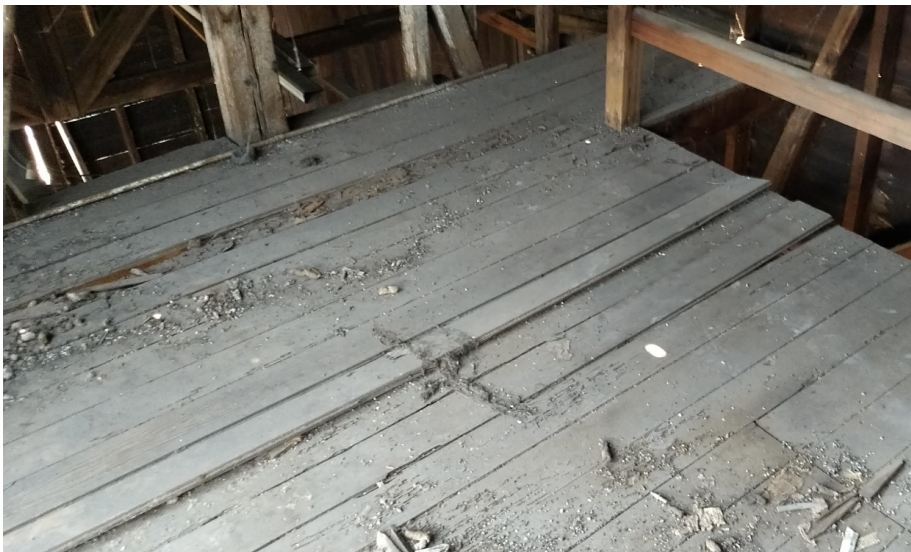
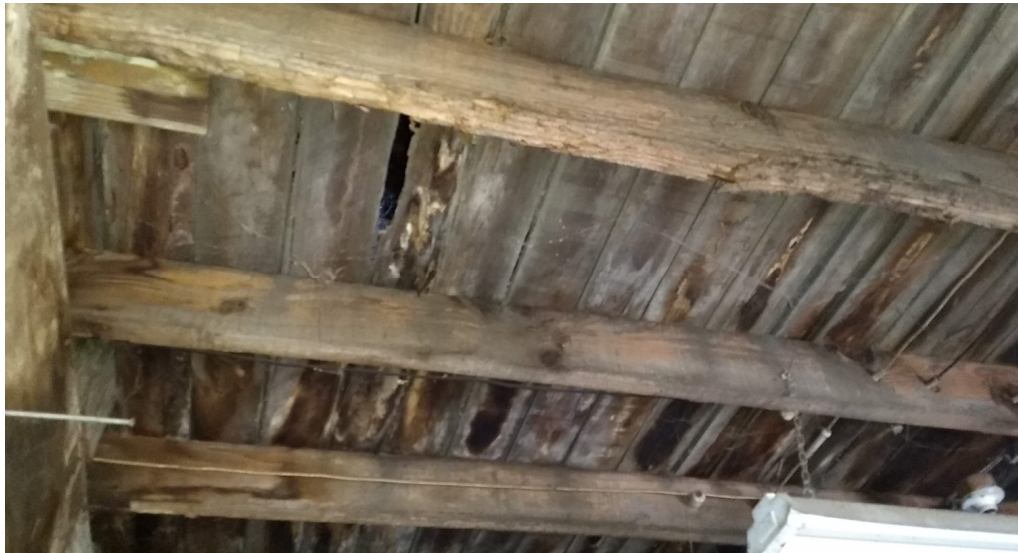
- 1.5. Attic floor framing in the tower felt spongy with many floorboards loose or broken. Looking at the framing from the bottom, it appears that the framing has previously sustained some water damage.

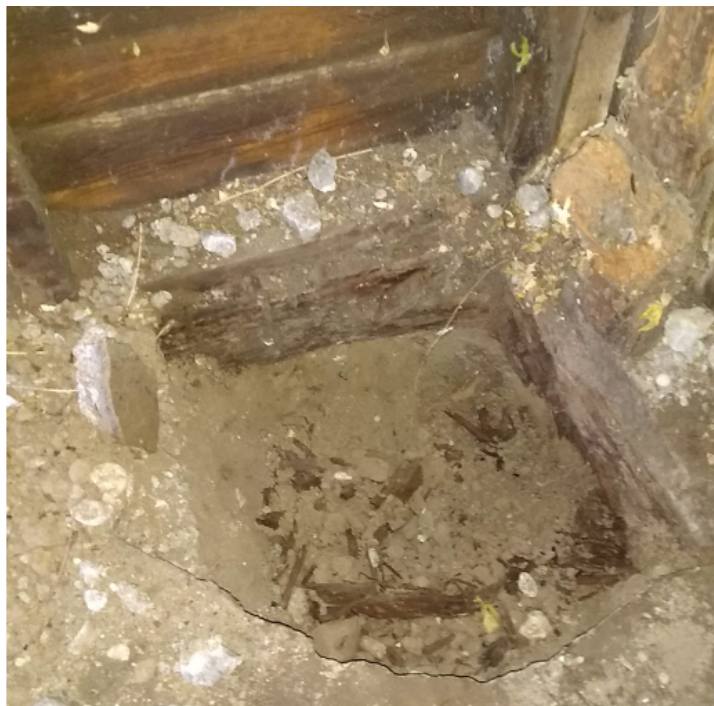
- 1.6. Per contractor exploratory work, the north and west walls of the garage structure do not have a concrete footing while the south and east walls bear on a concrete footing. Structures with no footing will experience differential settlement and this is aggravated by the presence of footing at select location that will magnify the difference in soil pressure underneath. Differential settlement can lead to unlevel building, cracking of the concrete slab and foundations, doors and windows getting out of plumb, skewed wood framing, cracking of wall finishes, etc. See items 1.7 and 1.8 below for some of these observed symptoms.

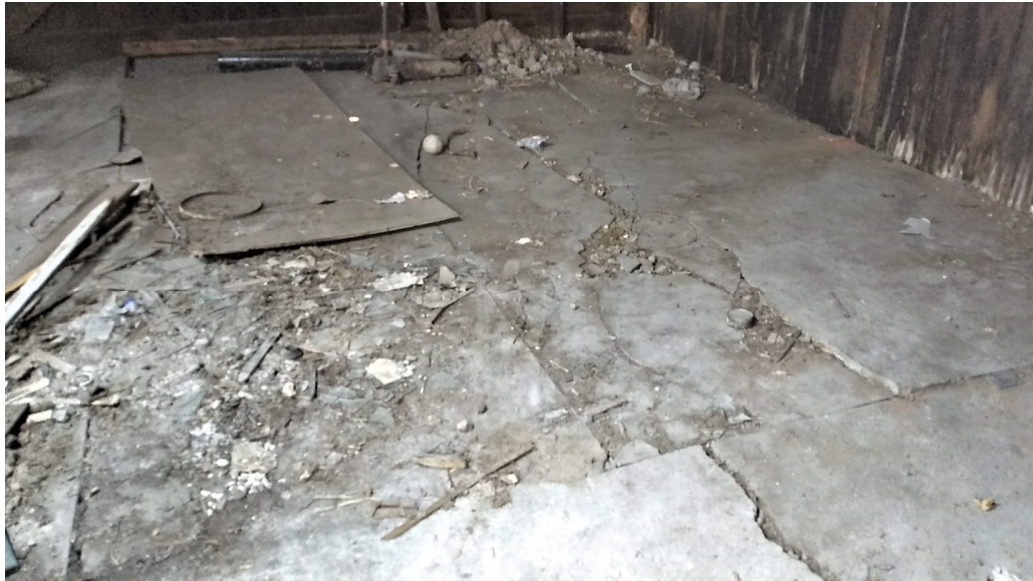
- 1.7. The floor slab inside the building was not level and badly cracked throughout suggesting significant differential settlement has occurred over the years. Should this building be rehabilitated, continued differential settlement can result in additional unwanted slab steps and possible tripping hazards to future users.

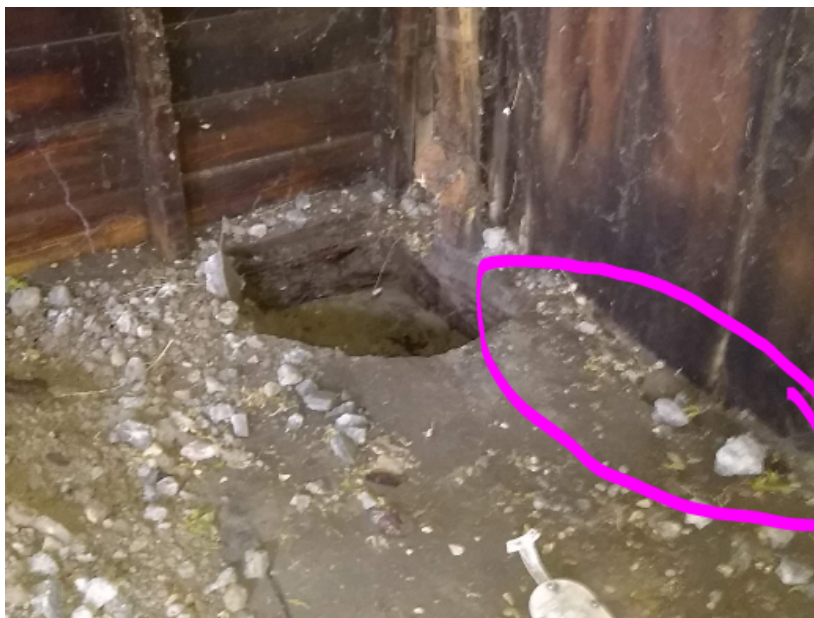
- 1.8. The north wall of the garage (side with no concrete footing) appears to have settled and the wall sill plate is now sitting lower than the garage slab. See photo from item 1.4 above. This appears to be a pronounced effect of differential settlement between the garage and water tower.

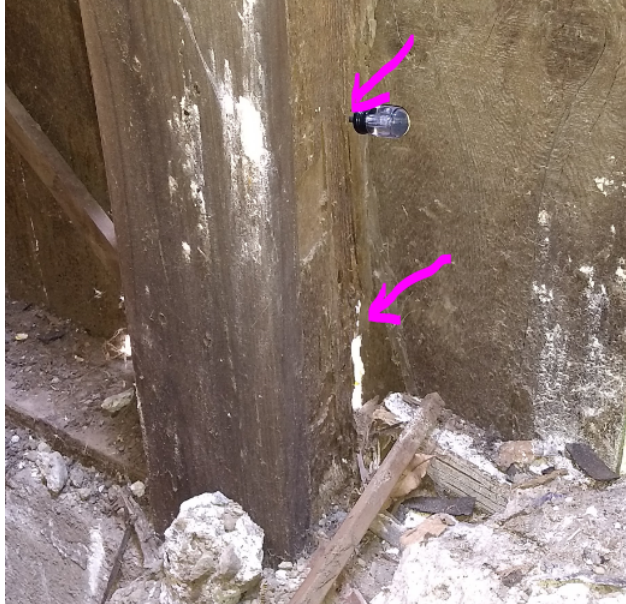
- 1.9. Wall framing on south side of garage shows significant signs of deterioration. Photo below shows a main building post with rot. When tested with a scratch awl, the 3" long scratch awl went in completely with relative ease.

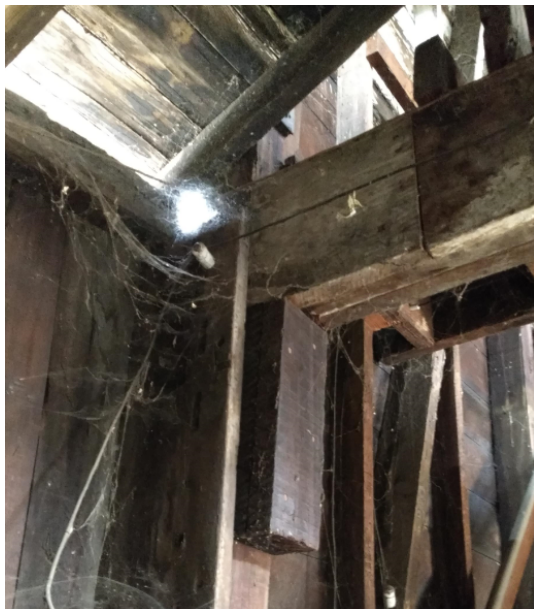
- 1.10. The main structural beam supporting the west wall of the water tower and attic framing is supported by a wood corbel. From this photo, the corbel is a double 2x face nailed to the post. In the photo we can see (4) face nails installed on the outer member. If we assume the inner 2x is fastened with a total of (8) 16d nails to the post, this connection will be inadequate. There would need to be roughly two times as many nails, or utilize different connectors, to adequately support the full code level design loading.

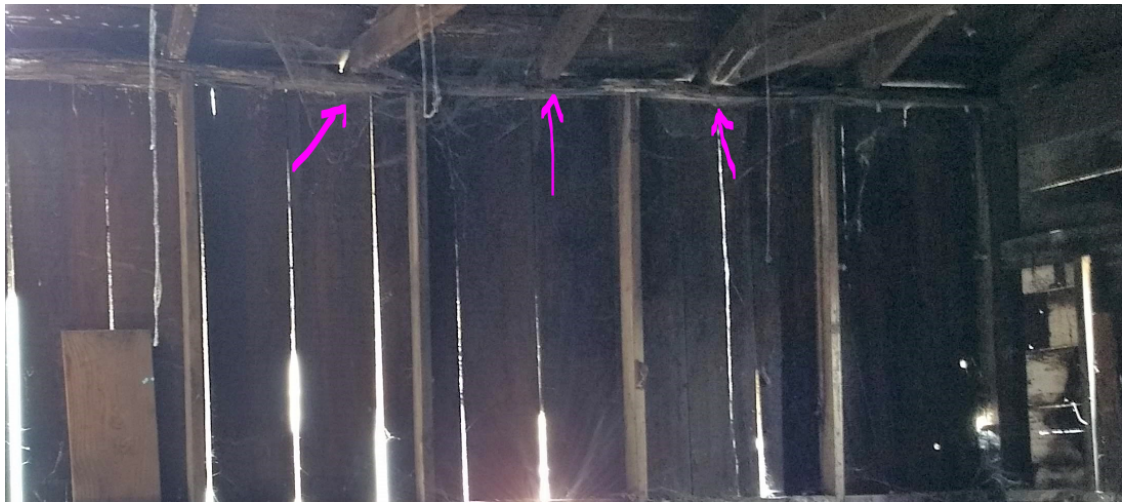
- 1.11. The north bearing wall at the garage is comprised of 2x4 at about 52" o.c. aligned with the roof trusses. Intermediate roof rafters are supported on a single top plate spanning the 52". The south bearing wall appears to have had the studs replaced at some point in time. However, these studs are 2x4 @ 32" o.c. and are not aligned directly under the roof trusses or rafters. See item 1.12 below.
- 1.12. Typical structural wood bearing walls utilize double 2x top plates to support the joists above, but only single 2x top plates were provided at the garage. Since the trusses and rafters were not aligned with the studs and the single top plate is having to span such a far distance between studs (see item 1.11 above), structural analysis shows that these top plates are not adequate ( $d/c = 1.21$ , 21% overstressed). Existing wall top plates appear to be bowing as a result.

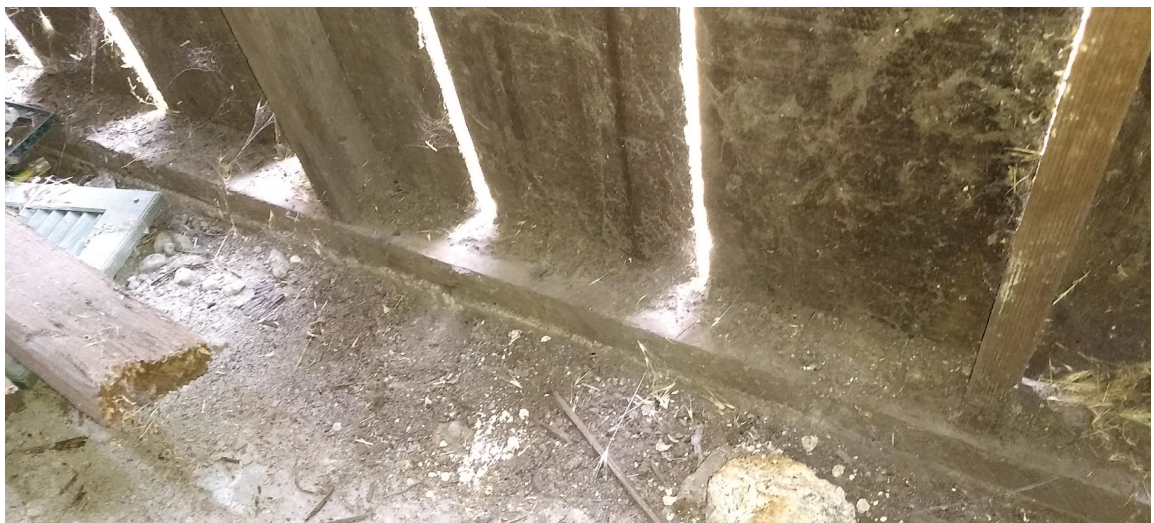
- 1.13. Wall sill plates do not have anchor bolts to the concrete foundation as required by CBC section 2308.3.1.

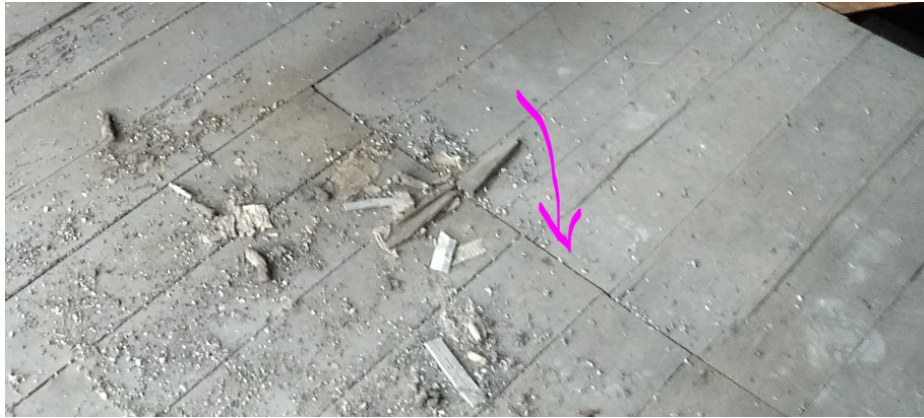
- 1.17. Diaphragm at water tower attic level consist of horizontally sheathed single layer of lumber. Although this system is allowed per current code, end joints of boards are required to be staggered, but this was not the case. Additionally, there was no clear lateral load path to the surrounding shearwalls.

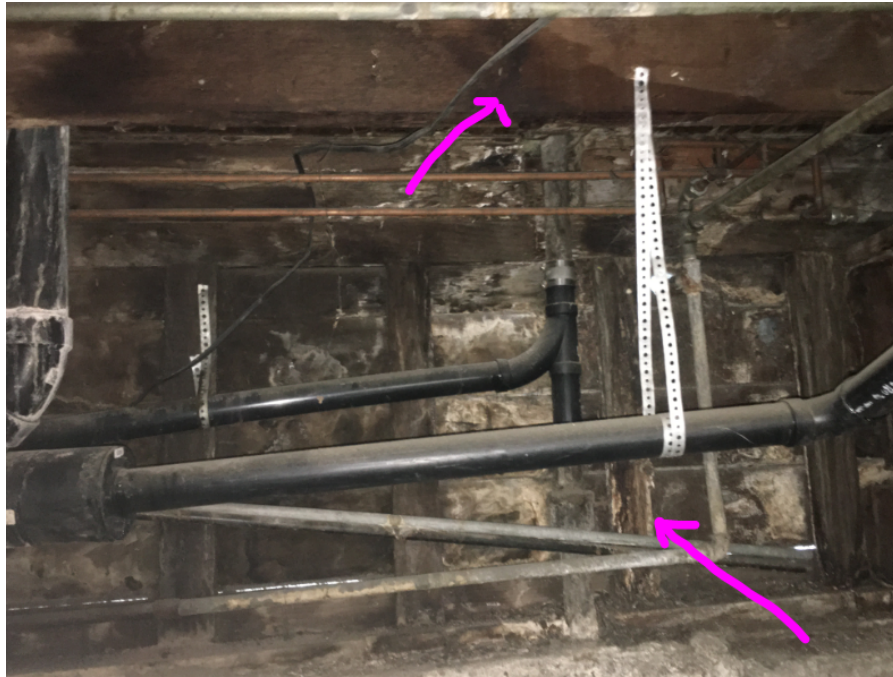
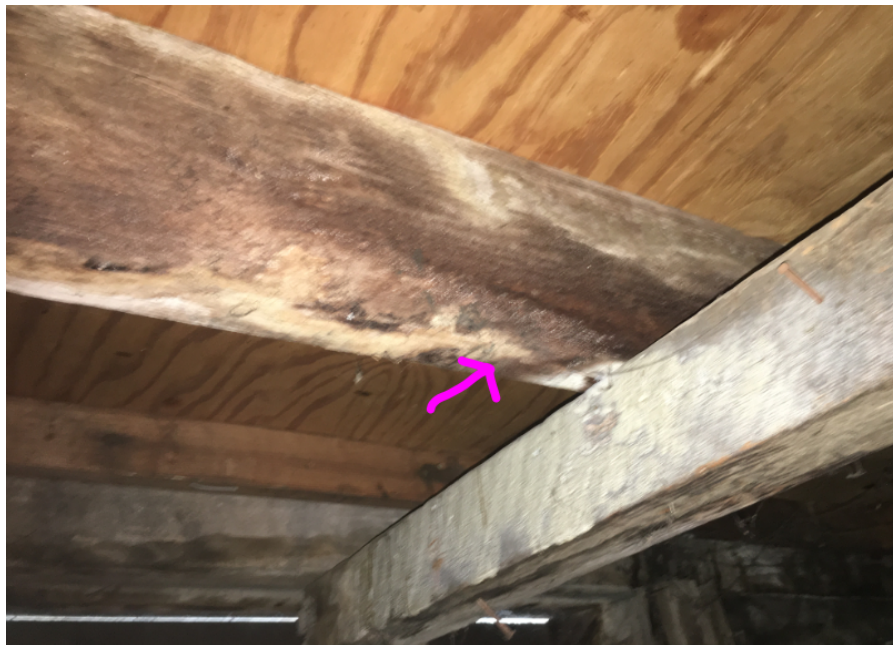
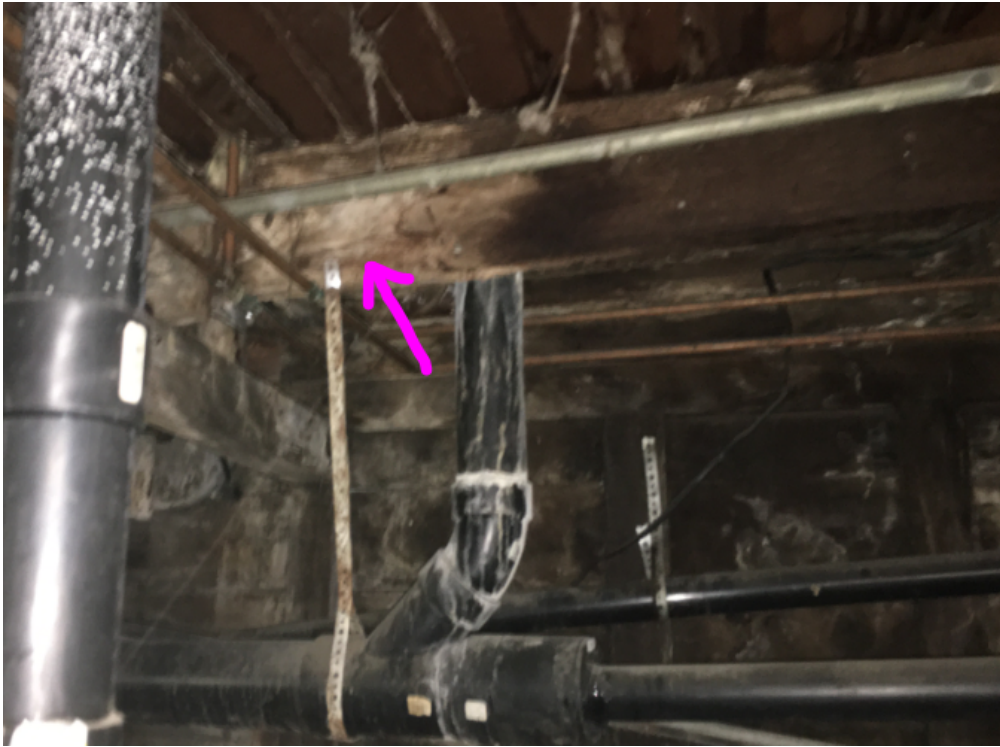
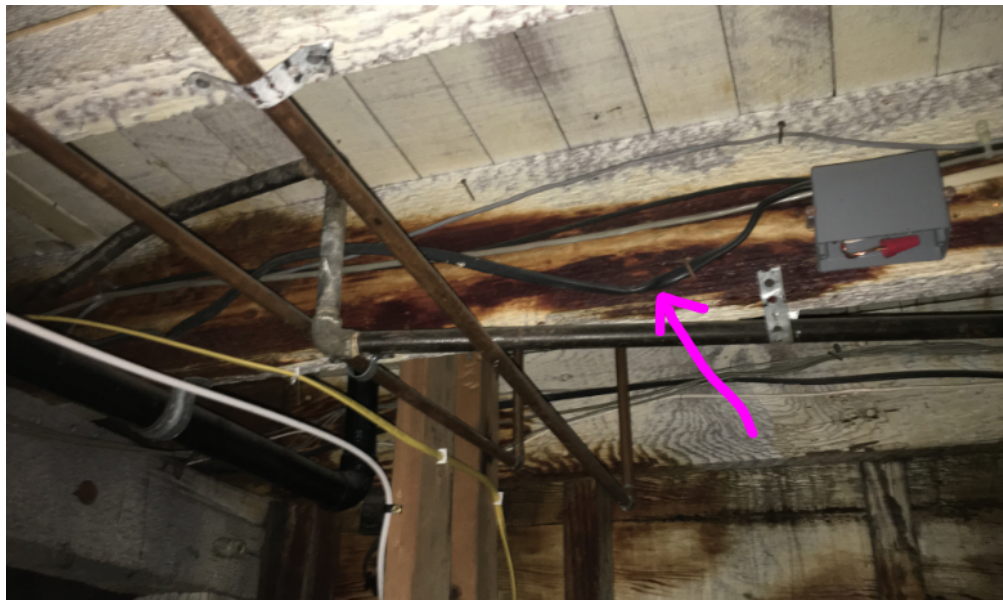
- 1.3. Floor joists and sill plates are showing signs of water exposure and deterioration.

Based on the items noted in our site observation, the building shows previous prolonged exposure to water at several location in the basement and that some of the joist, beam and stud show signs of deterioration. The front deck of unit 497 shows broken floor decking that may indicate some damage to the floor framing underneath. We recommend fixing the broken floor decking at unit 497. We also recommend repairing the deteriorated framing members in the basement.

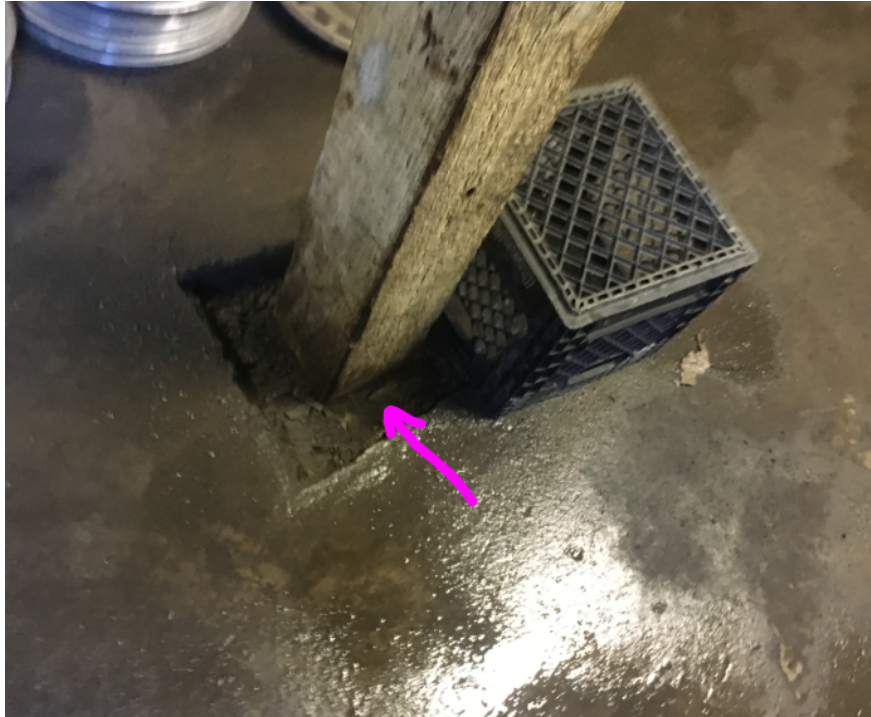
- 1.4. All posts are not protected from water that accumulate in the basement. The photo below shows standing water from pipe leak above. Bottom of post shows deterioration likely from previous exposure to moisture.

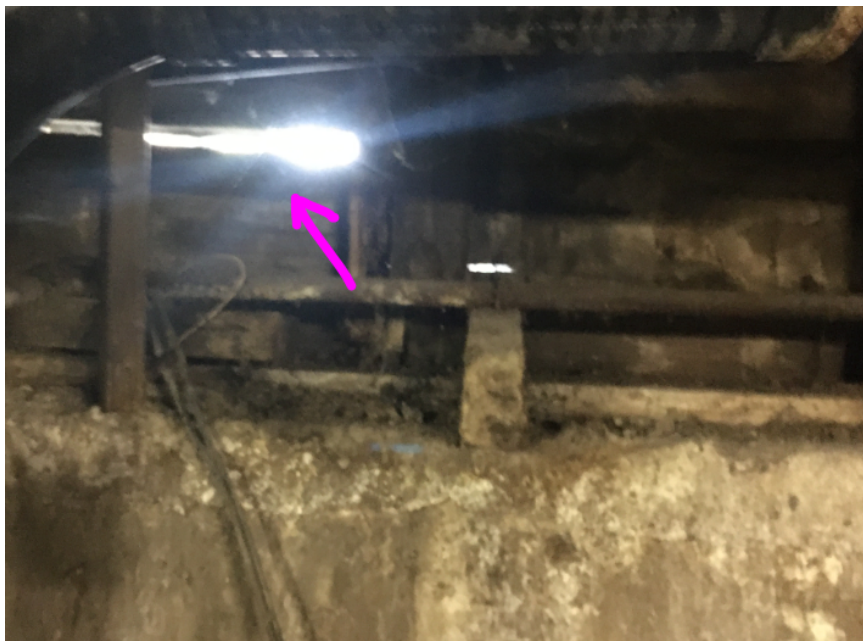
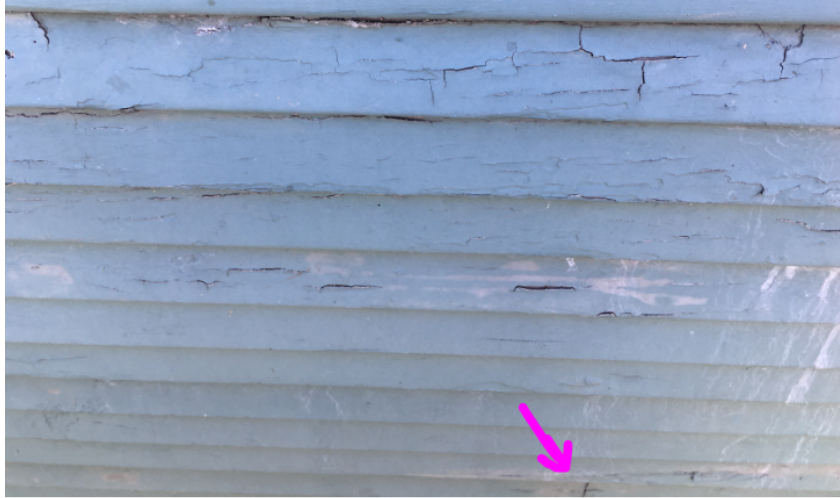
- 1.5. At the back wall, sidings are deteriorating showing warping and bigger gaps.

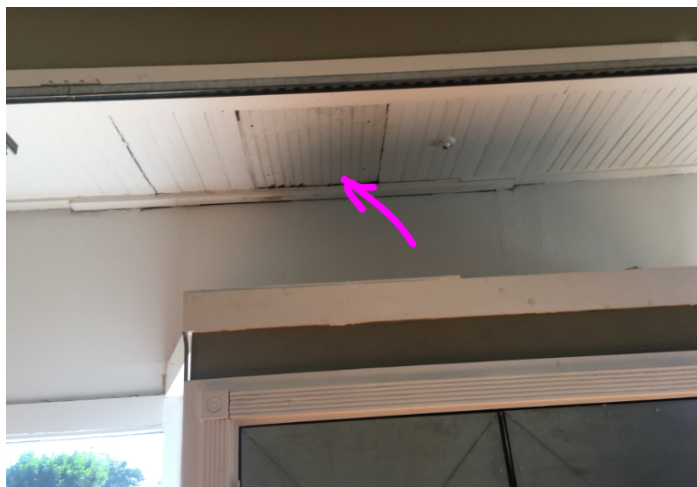
- 1.6. Portion of the Ceiling at the front shows some water stain and bumpiness that might indicate possible water intrusion that may also affect the roof framing above.

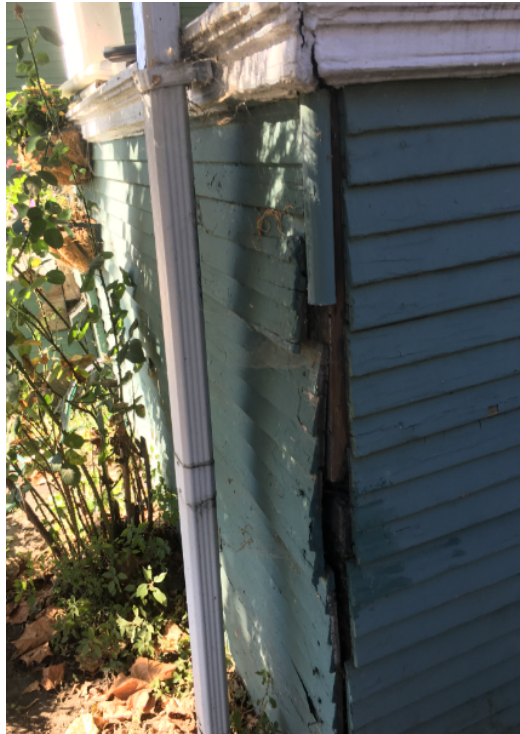
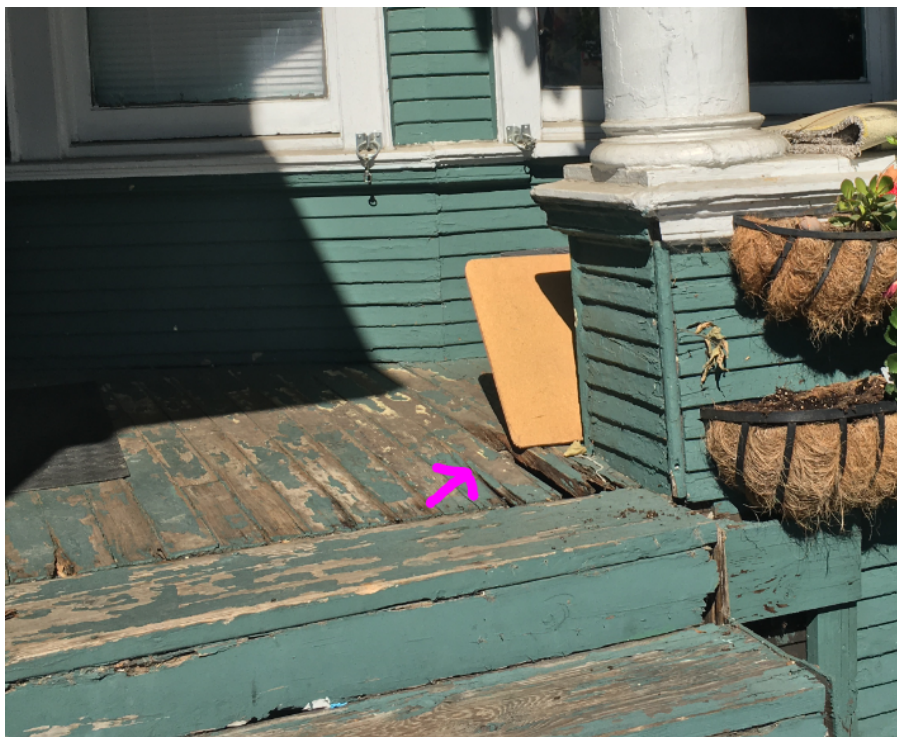
- 1.7. Unit 499 front deck is in poor condition. The trimmer shows some crack and the siding shows big corner gap that indicate swelling or warping of wood underneath. Some flooring are not level and broken

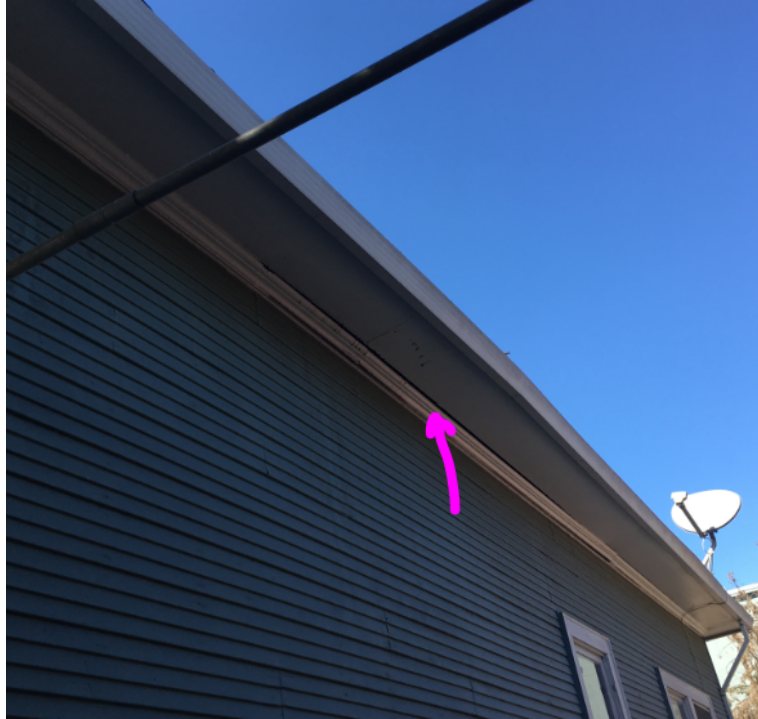
- 1.8. Exterior molding at the roof overhang underside is separating from the ceiling.

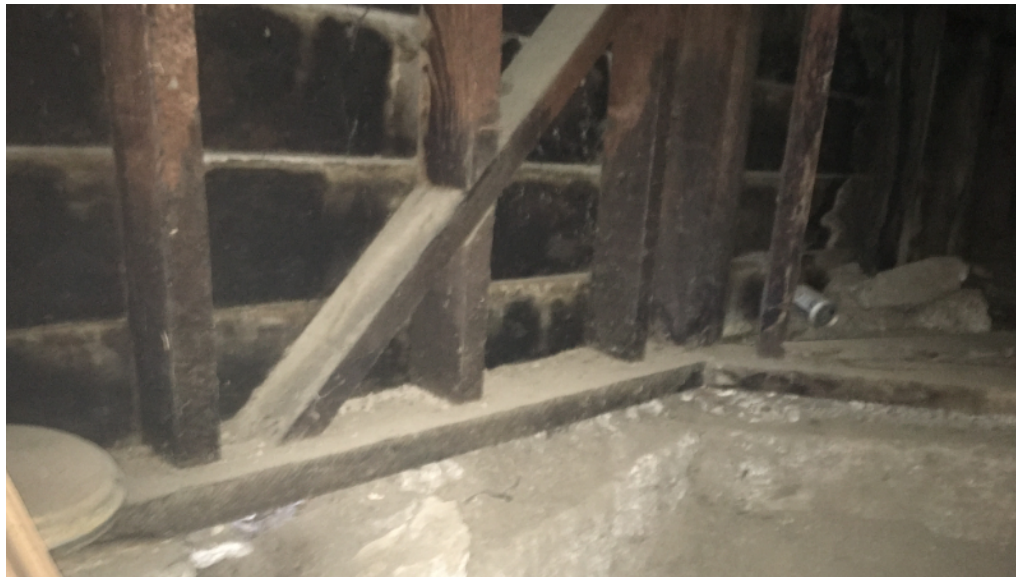
- 1.9. Wall sill plates do not have anchor bolts to the concrete foundation as required by CBC section 2308.3.1.
