### A.44 Chollas Creek – 54th Street (No. 5-04-280)

#### Summary of Recommended Maintenance

## Attachment A: Hydrology and Hydraulics Fact Sheets

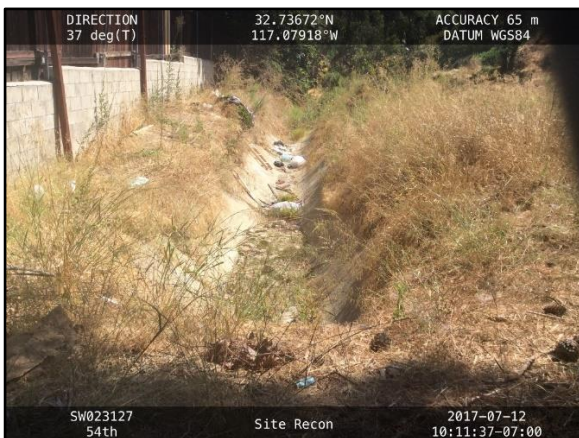
1. 54th St 1: Looking upstream.

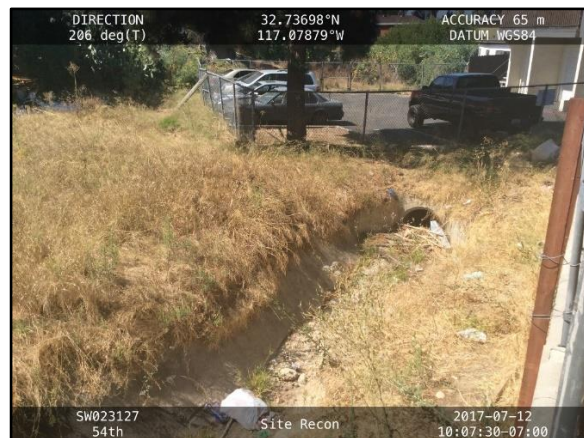
The HEC-RAS modeling indicated that in both the baseline and recommended maintained condition the overall facility level of service was restricted by the capacity of the culvert that conveys flows beneath a parking lot (Station 217) that replaced the ditch that was shown in the as-built drawing. In

2. 54th St 1: Looking downstream towards the culvert; conveys flows beneath parking lot, then discharges back into ditch.

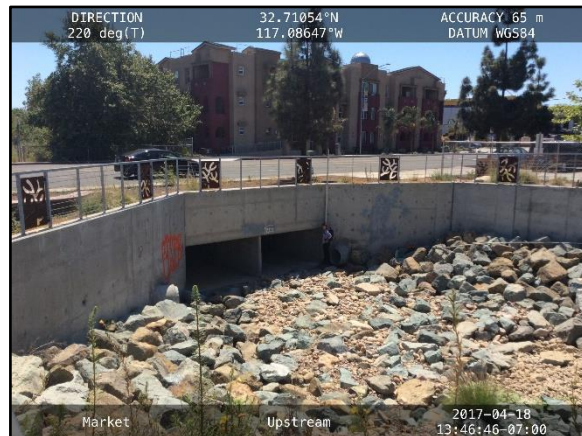
4. Euclid 1: Double box culvert inlet at Market Street.

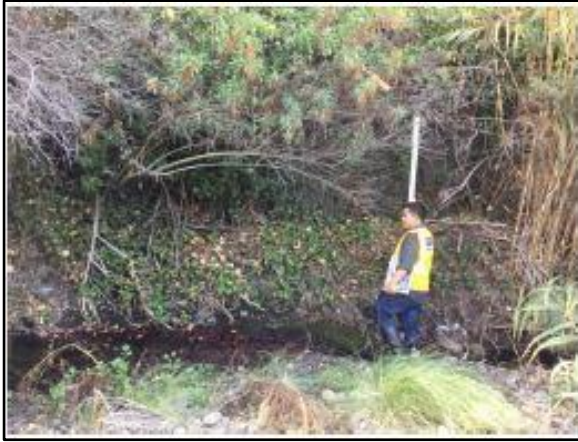
IHHA 8. Federal 1: Downstream portion of Reach 2 looking south at the vegetation left bank (looking downstream).

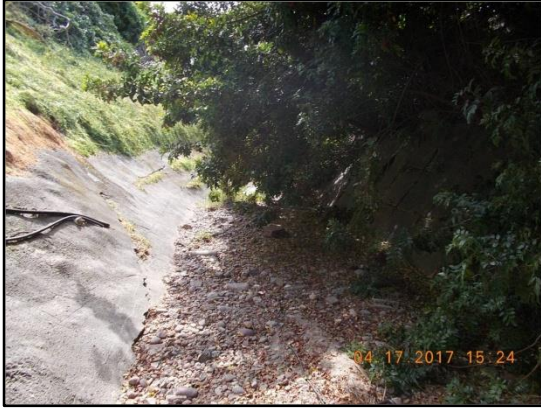
7. Solola 2 (Reach 1): Looking downstream at broken concrete.

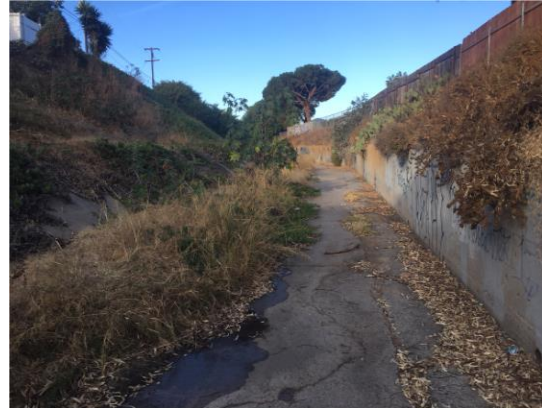
8. Solola 1: Looking downstream at accumulated sediment/debris in concrete channel. (November 2017)

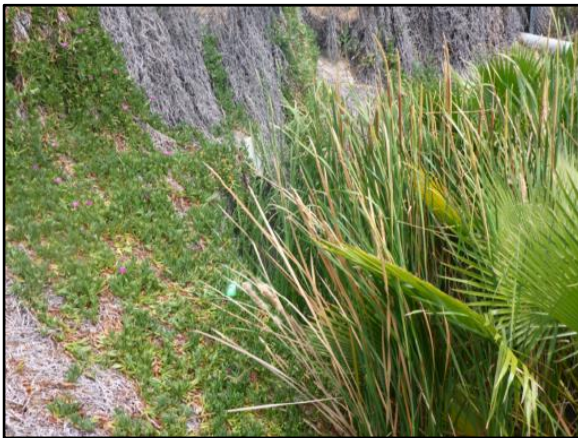
1. Parkside 1: Looking downstream from the inlet of the channel.

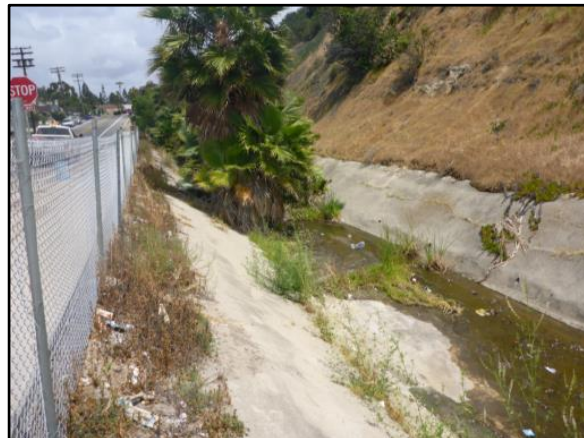
2. Parkside 1: Representative of channel (with moderate vegetation), looking upstream.

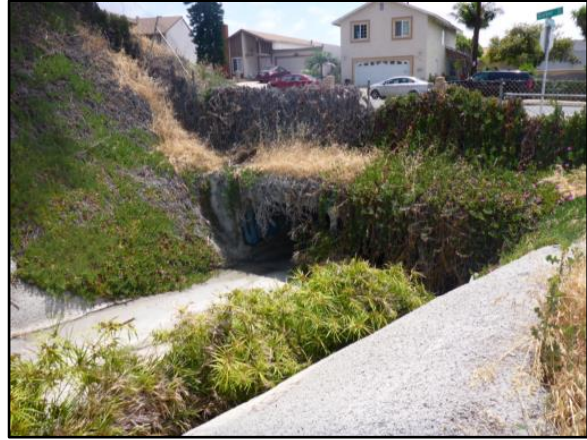
4. Parkside 1: Double box culvert at downstream end of channel, looking southwest.

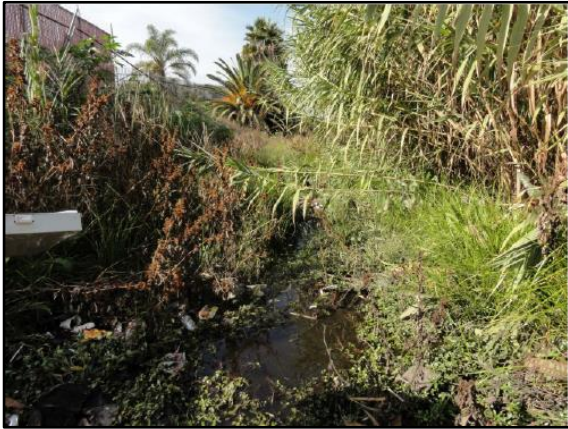
IHHA 2. Cedar 1: Looking downstream from the upstream end of the segment (November 2016).

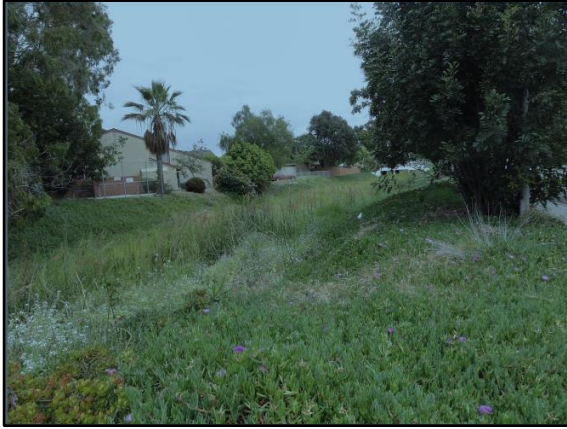
IHHA 7. Cerrissa 1: Looking upstream (April 2015).

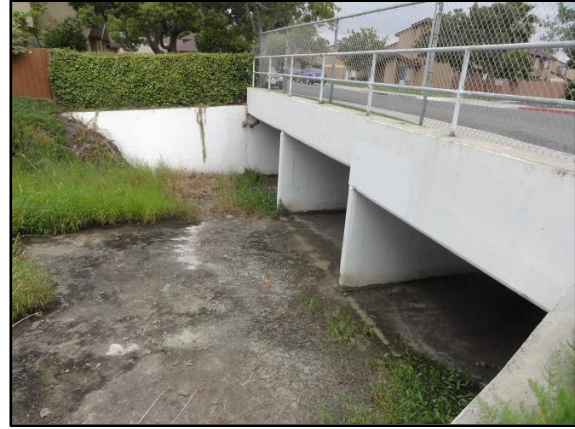
IHHA 8. Cerrissa 1: Looking downstream at the Cerrissa Court triple RCB culvert (April 2015).

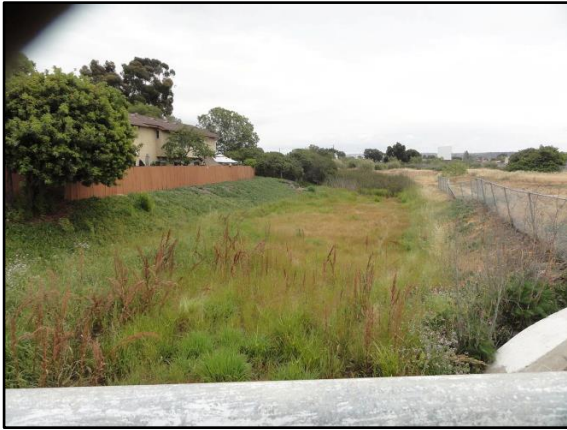
IHHA 9. Cerrissa 1: Looking upstream at the downstream end of the segment (April 2015).

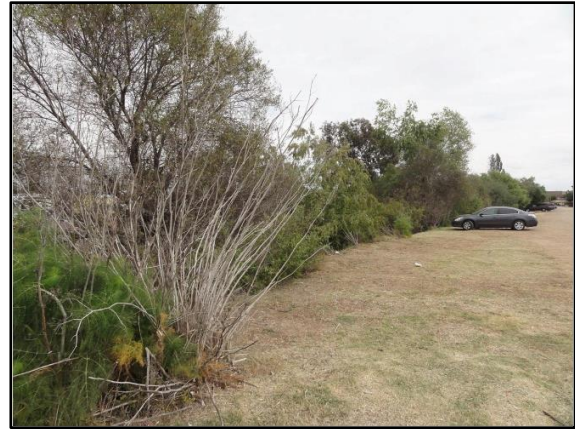
IHHA 11. Cerrissa 1: Looking upstream (April 2015).

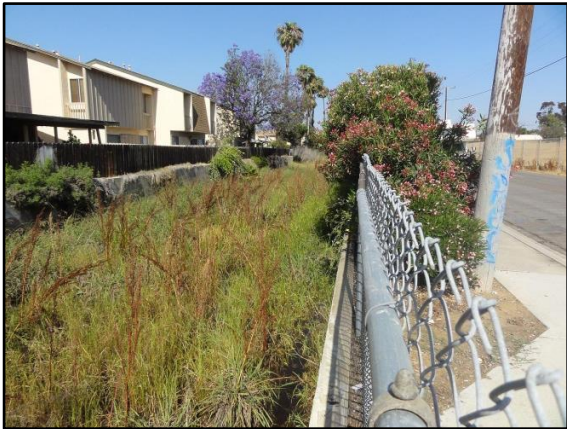
IHHA 21. Grove 1: Looking upstream at the downstream portion of the segment (May 2015).

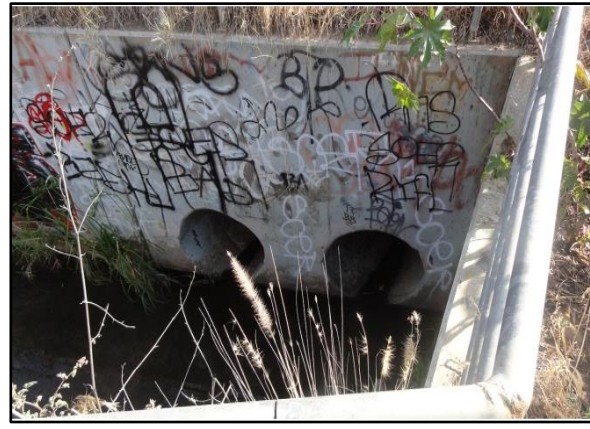
IHHA 24. 30<sup>th</sup> St 1: Looking downstream at the double-barrel 36-inch-diameter RCP culvert at the San Diego Railroad crossing (May 2015).

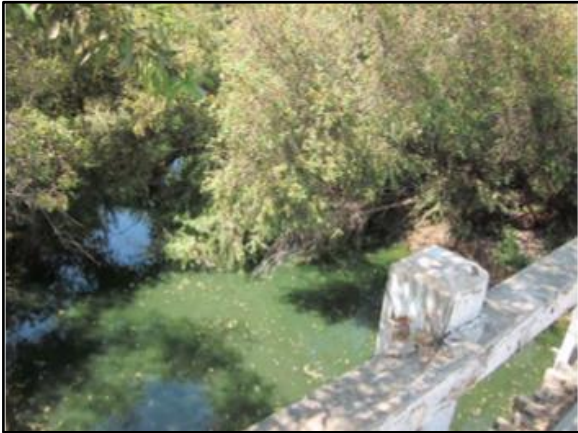
6. Pilot Channel 1: Immediately downstream of the Hollister Street Bridge.

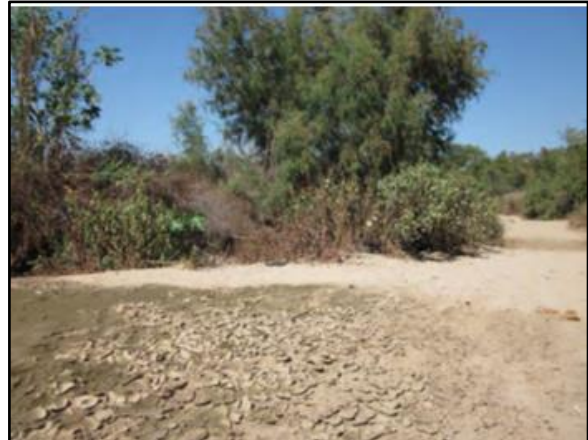
8. Pilot Channel 1: Looking north at the confluence point with the Smuggler's Gulch.

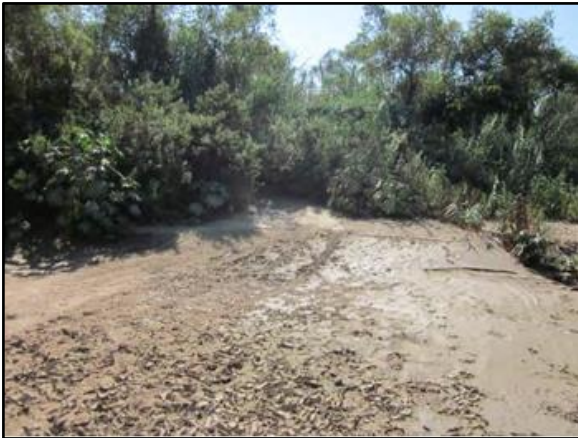
11. Pilot Channel 1: Looking south at the confluence point with the Smuggler's Gulch.

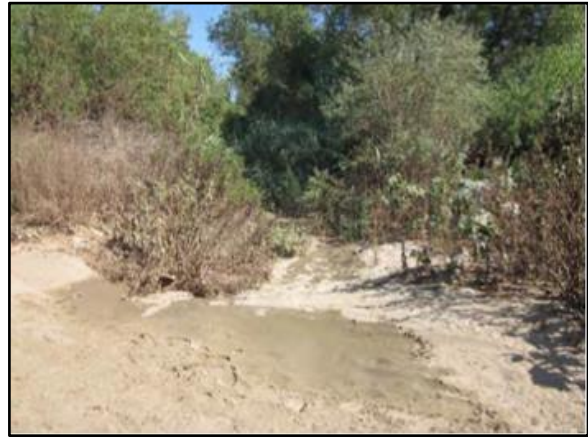
13. Pilot Channel 1: Looking east at the confluence point with the Smuggler's Gulch.

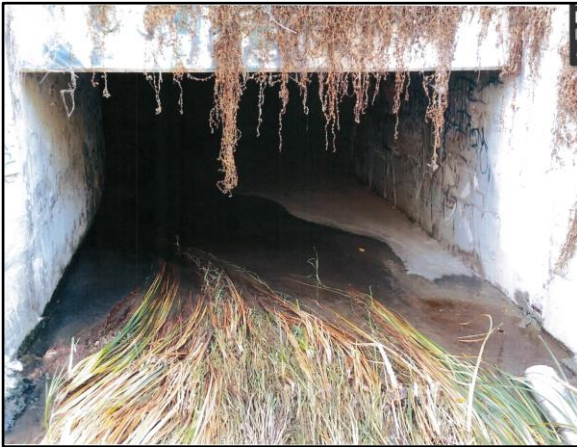
4. Via de La Bandola 11, Map 1: 8-foot-wide by 4-foot-high RCB culvert at downstream end of channel (Station 1418); no observed sediment or vegetation in culvert.

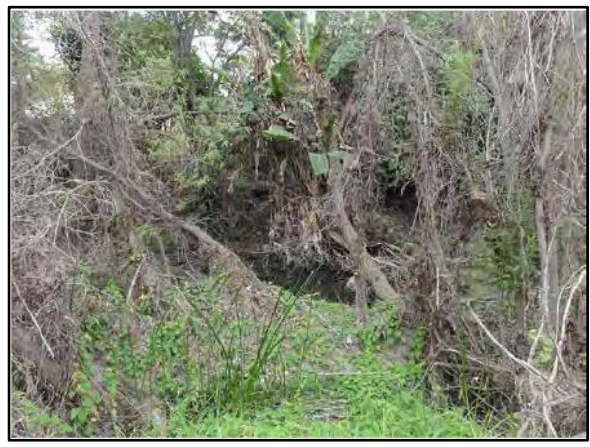
IHHA 1. Smythe 1, Map 2 (Reach 3): Looking upstream toward outlet of triple barrel 8-foot wide by 5-foot high RCB culvert (Station 4127.051).

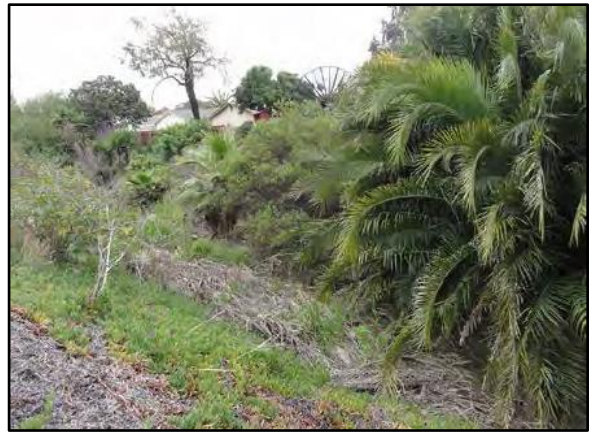
IHHA 5. Smythe 1, Map 2 (Reach 3): Looking upstream near HEC-RAS cross-section 4313.02.

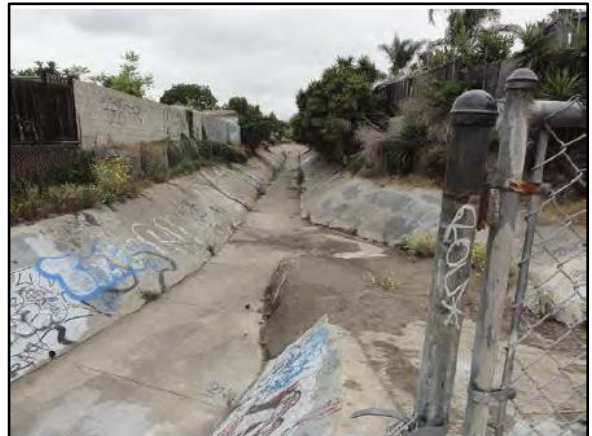
IHHA 8. Via Encantadoras 3, Map 2 (Reach 2): Looking upstream from double 72-inch-diameter RCP culvert.

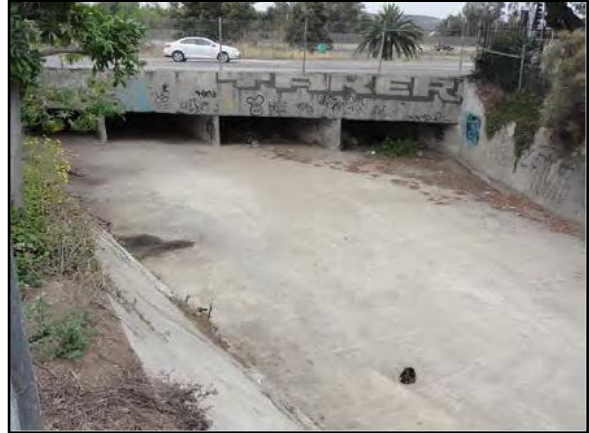
IHHA 11. Via Encantadoras 2, Map 2 (Reach 1): Looking downstream at entrance to quadruple 12-foot-wide by 4-foot-high RCB culvert beneath West San Ysidro Boulevard.

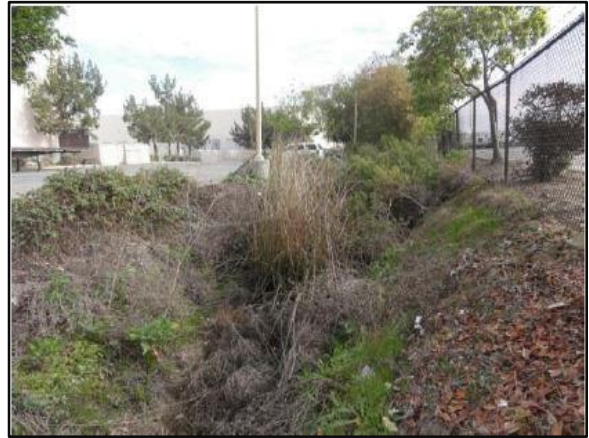
IHHA 3. Siempre Viva 1, Reach 1 (Bristow Channel): looking east towards upstream end of dense vegetation.

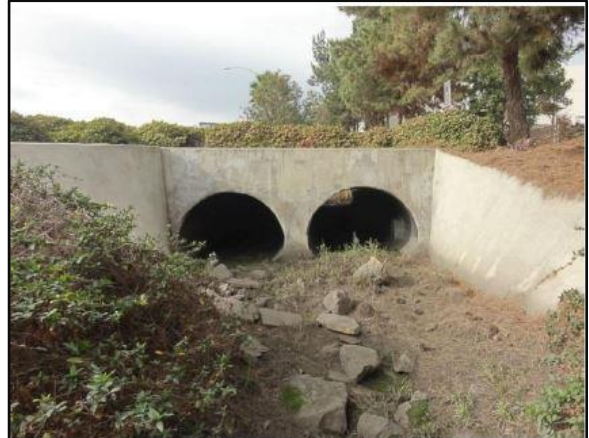
IHHA 8. Siempre Viva 1, Reach 2 (Bristow Channel): Looking west towards the outlet of the upstream pair of culverts.

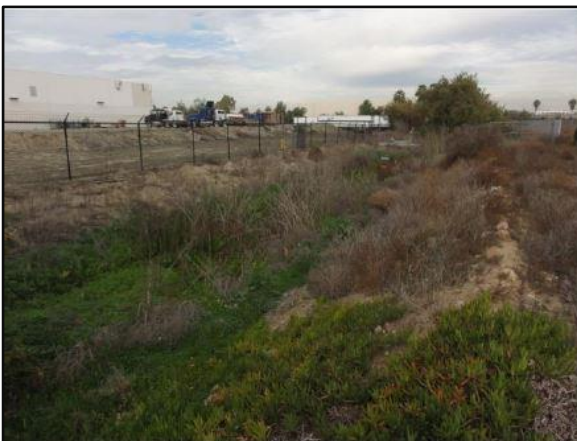
IHHA 21. Siempre Viva 1, Reach 3 (Siempre Viva Channel): Downstream portion of Reach 3 looking south towards the shared detention facility.
