Appendix F2 Geologic Evaluation Report Open Space

26 October 2018 (Revised 20 September, 2019)

**Subject: Preliminary Geologic Evaluation Report
Agua Mansa Open Space
City of Jurupa Valley, California
Langan Project No.: 721013502**

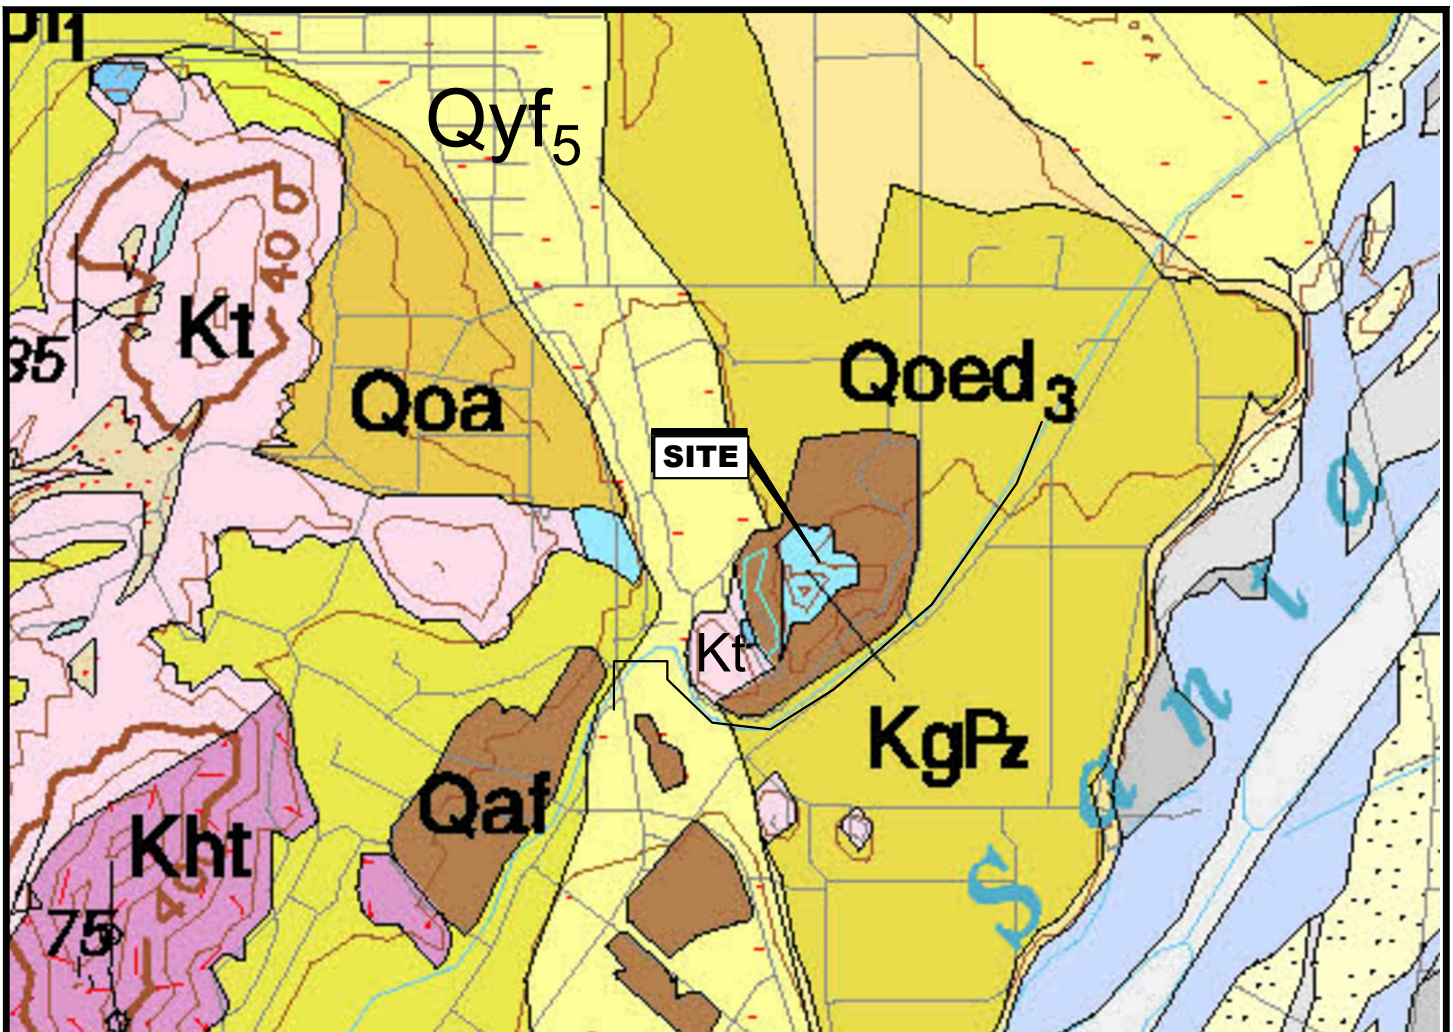
200 feet of dunal sands, alluvial fan deposits, and fill, infilling bedrock swales and creating topographic highs throughout the Site (Woodford et. al., 1941). The regional geology is depicted on Figure 4 (Regional Geologic Map).

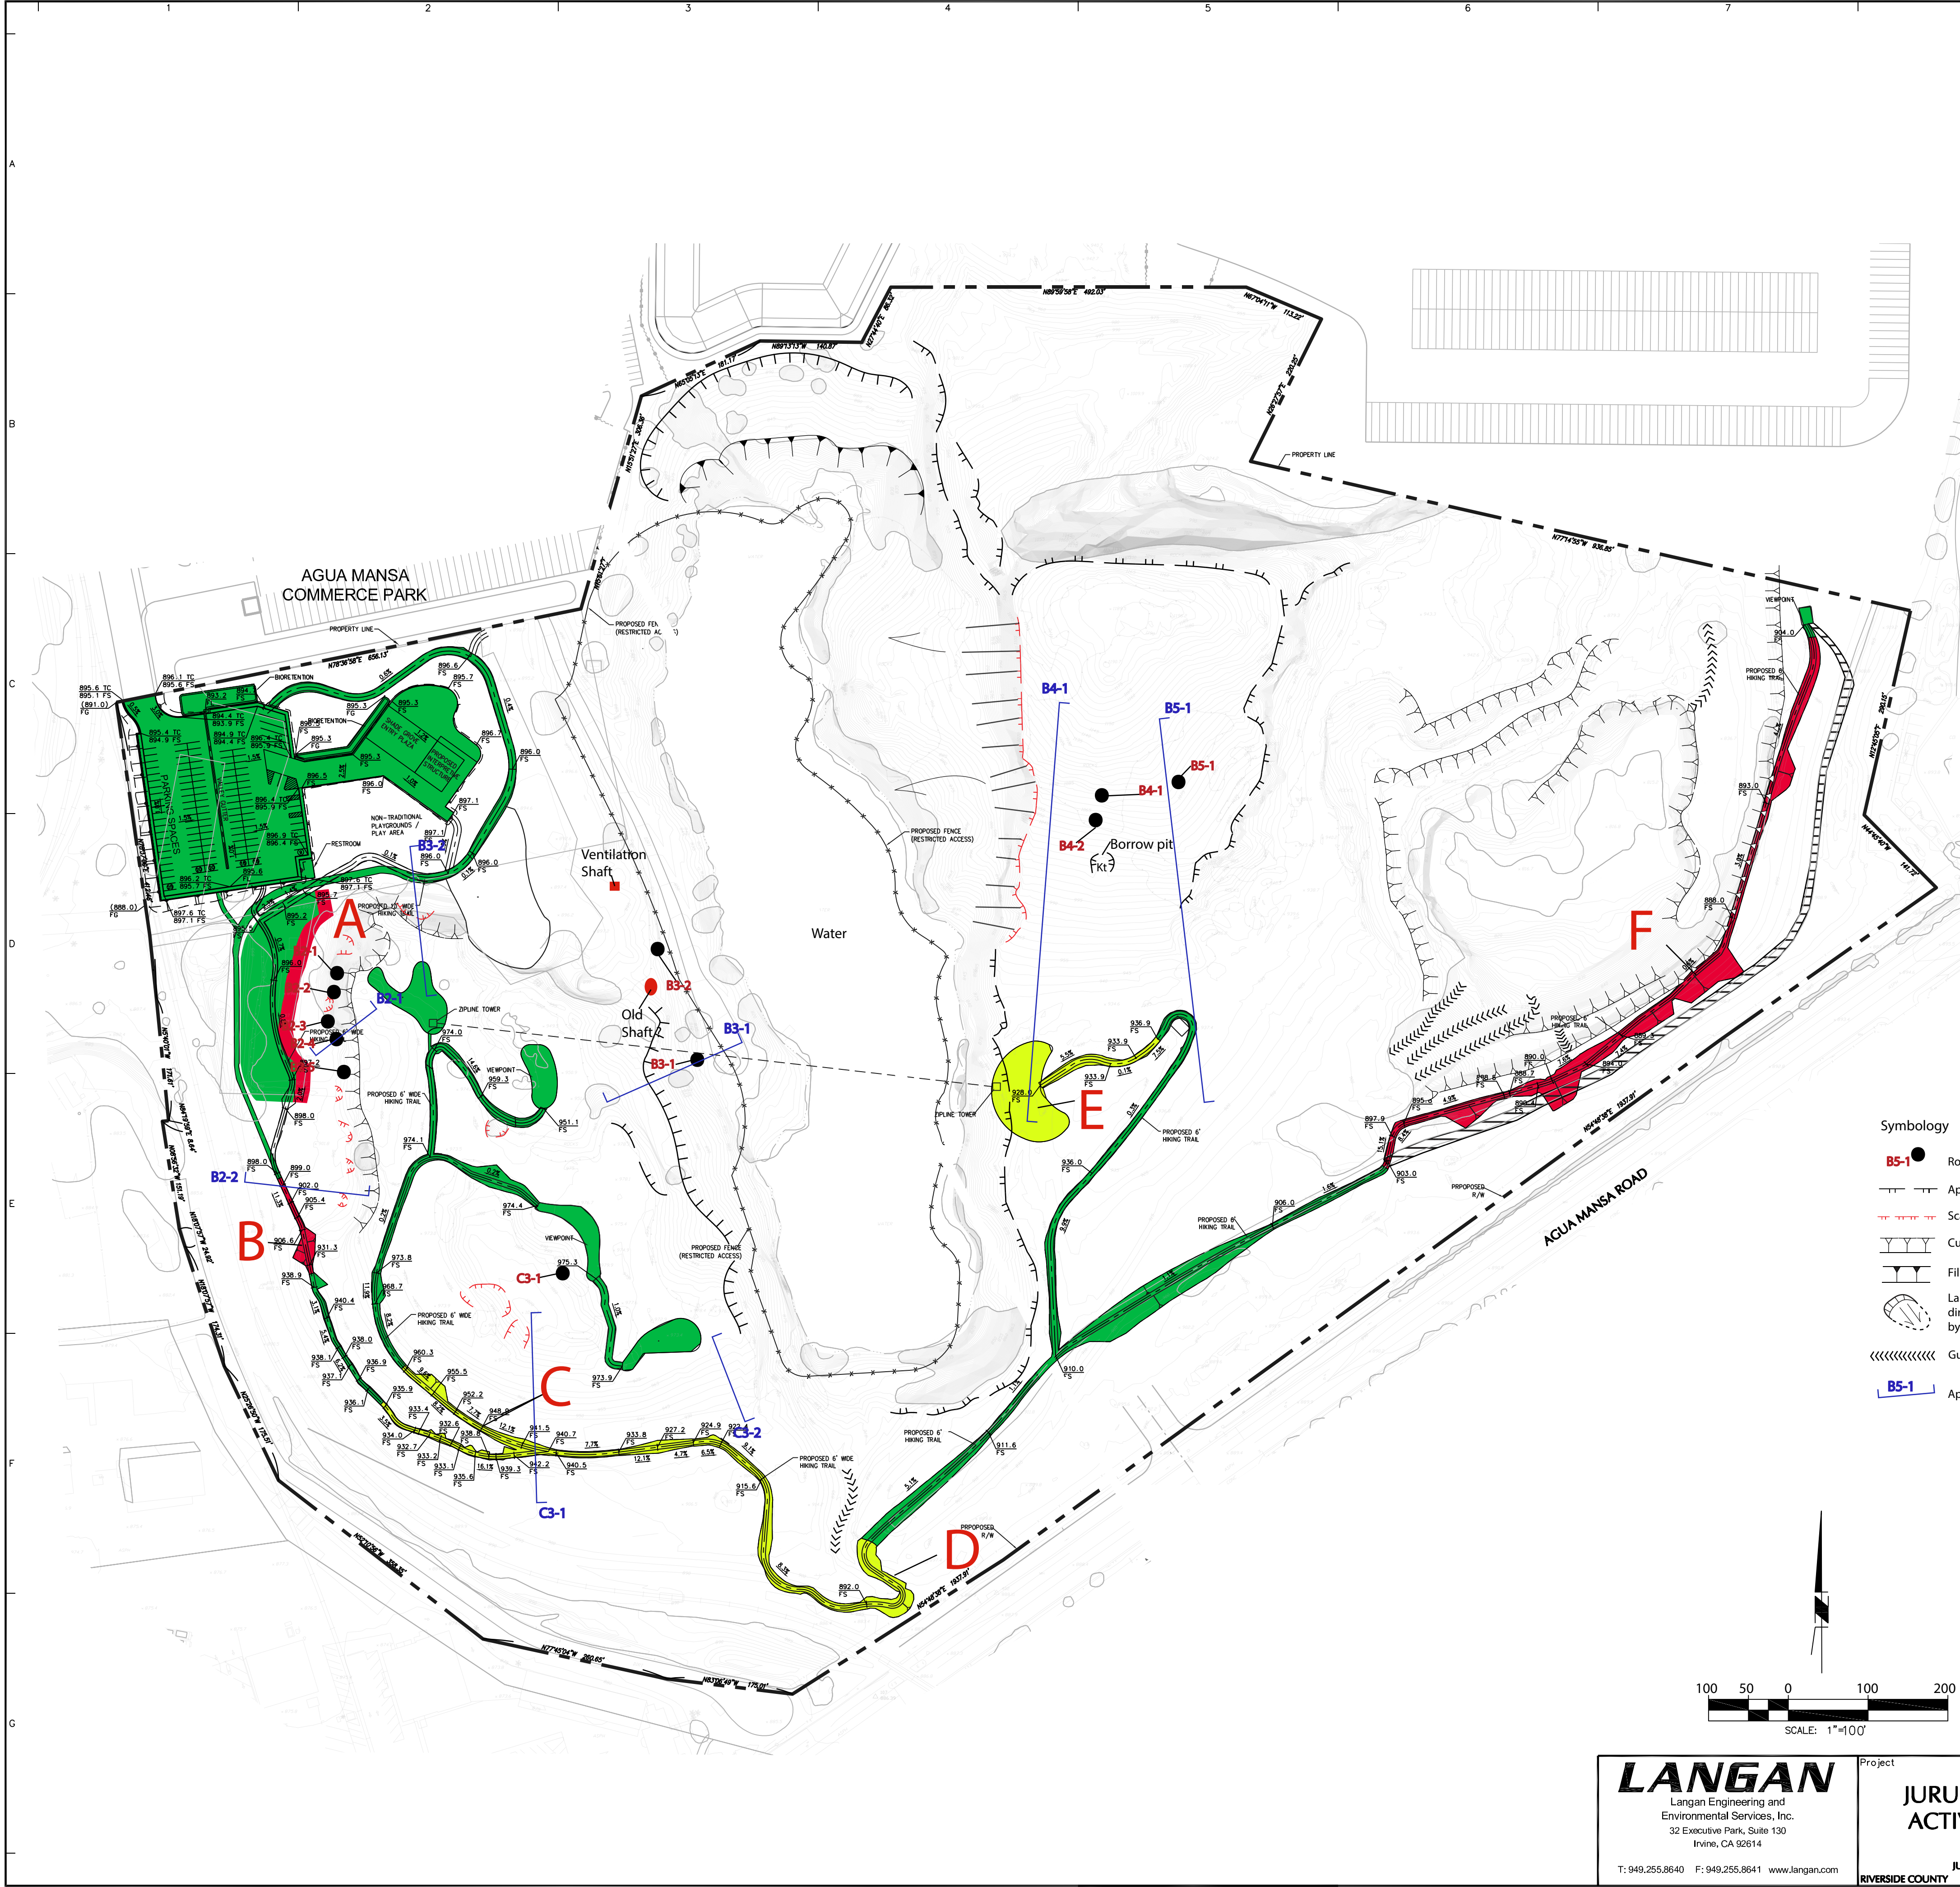
The proposed improvements were color-coded based on the potential to be impacted by geologic hazards (Planned Facility Mitigation Zone Map, Figure 5). Identified constraints potentially impacting the proposed facilities include limited rockfall areas and erosion of weak surficial materials. Red designates the areas at highest risk for rockfall or erosion, yellow designates areas with moderate impact risk, and green designates the lowest risk areas. The designations and ranking criteria are explained in Table 1. Additionally, Table 1 provides potential mitigating alternatives.

Transect B2-1 was determined to have a rockfall hazard impacting up to 15 feet beyond the toe of slope; this would impact the eastern perimeter of the proposed Dog Park. This area is designated as Area A on Figure 5. Transect B-2 was determined to be susceptible to rockfall, with transect B2-2 showing rockfall runout up to 14 feet beyond the limits of the proposed trail in the CRSP run. This transect was also determined to have an abundant number of rocks impacting the trail. The stretch of trail is depicted as extending along the toe of a steep cut face with talus deposits; the trail climbs steeply to the top of the cut. The CRSP results for this transect appear to reflect the conditions observed in the field. This area is designated as Area B on Figure 5.

Transect C3-1 was given a moderate risk for rockfall. Although the CRSP run showed rockfall runout up to five feet beyond the trail alignment, field observations indicated that this area would have a moderate potential for rockfall. The CRSP run also indicated a small boulder field reaching and extending beyond the trail alignment. While in the field, we observed occasional boulders two to three feet in diameter on the slope surface. This area is designated as Area C on Figure 5.

An area designated as Area D was observed to be within an area susceptible to erosion, with the trail extending down in and out of a drainage swale that is underlain by highly erodible earth materials.

Area E was not determined to have rockfall runout impacting the trail or lookout during the CRSP analyses, but observations during mapping documented boulders within surficial materials on the slope. Boulders within the surficial materials were noted to be up to six feet in diameter. However, it is unclear if source of the boulders is a result of previous haul road activity upslope, or are detached from upslope outcrops. The rockfall analysis determined that any rockfall would not encroach on the trail or overlook.

The proposed trail alignment is proposed along a narrow bench between the crest of a slope and an oversteepened slope above a quarry pit, designated as Area F. The materials exposed in the slope are composed of erodible surficial materials. In our opinion, this area has a high susceptibility to slumping of weak surficial materials toward the quarry pit, which can undermine and damage the proposed trail.

In order to avoid rockfall impacts to the Dog Park, we recommend either establishing a minimum 15 foot setback from the toe of slope, or placing a rockfall fence along the perimeter of the proposed Dog Park. Rockfall fence parameters can be provided during the design-level phase of the project.

We recommend fill be placed to elevate the trail, providing a continuous and gradual rise from the flat area at the bottom of the hill to the top of the cut. The fill would provide a rockfall catchment, and elevate trail patrons above the rockfall hazard. Grading quantities for the fill berm can be established during final design.

If a moderate rockfall risk is unacceptable, then we recommend light scaling to remove larger boulders that may loosen and roll downslope. A mid-slope bench could also be graded further to provide a more substantial bench to intercept rocks rolling from the top of slope.

We understand this area will receive fill in the future, resulting in more even Project Site grades. This may mitigate future potential erosion issues in this section of trail. Otherwise, on-going maintenance will be likely to repair washed-out portions of trail. This is not regarded as a hazard, more of a maintenance issue.

We recommend that signage be posted to encourage trail patrons to remain on the designated trails, and not venture toward the slope where a moderate rockfall potential exists.

We recommend that the trail be relocated to the existing haul truck access road alignment. The exact location, dimensions and extent of the above recommended mitigations should be assessed in the final design analysis for the Project Site.
