The Junipers Project
Environmental Impact Report
SCH No. 2018041032 - Project No. 586670

Former Carmel Highlands Golf Course
Built Environment Assessment

Subject: The Junipers Project: Former Carmel Highlands Golf Course Built Environment Assessment

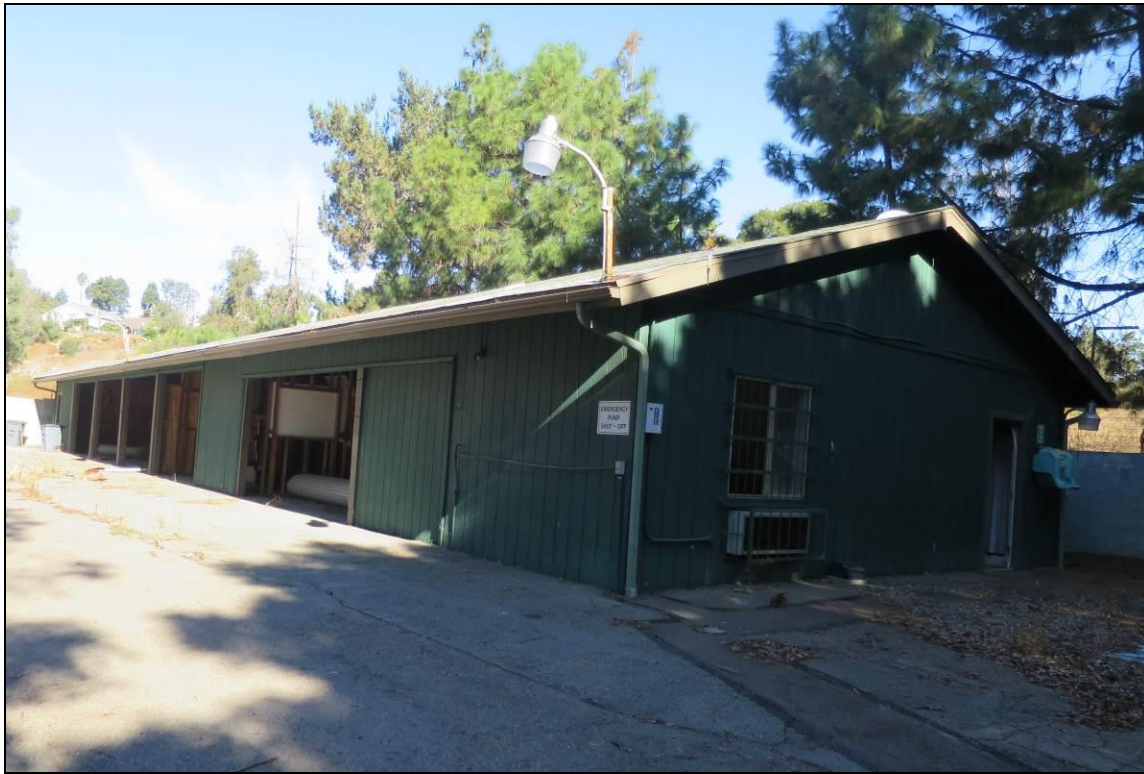
Figure 1: View of structure facing north. (photograph by IS Architecture 2017)

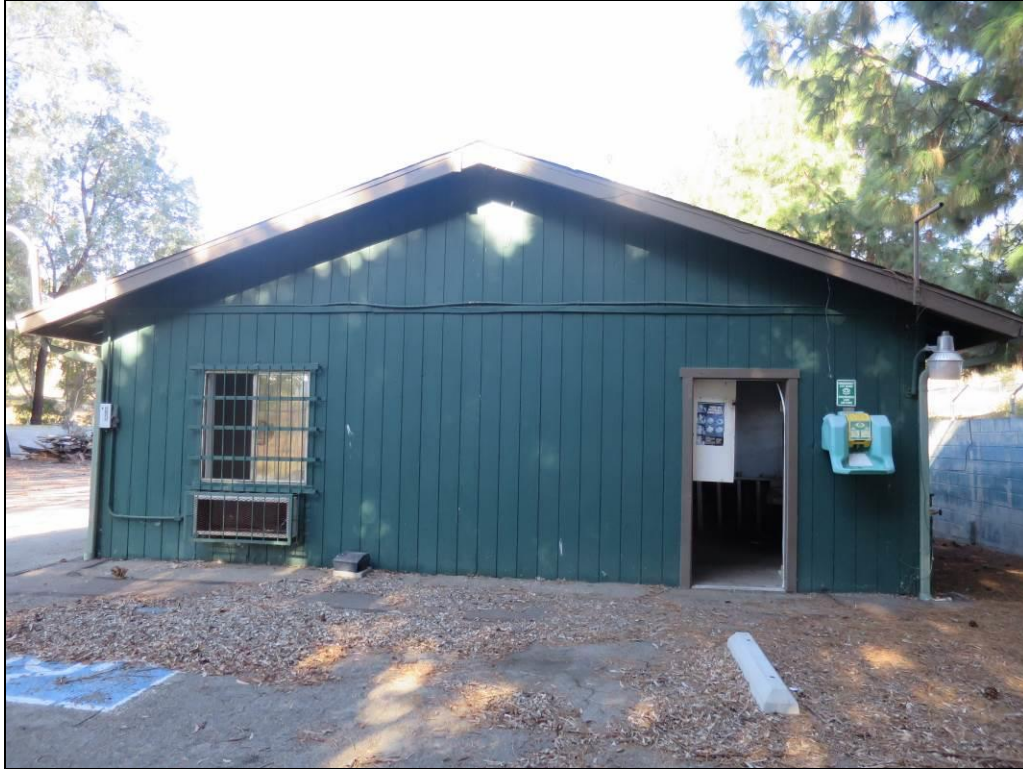
Figure 2: Southeast elevation of structure facing northwest. (photograph by IS Architecture 2017)

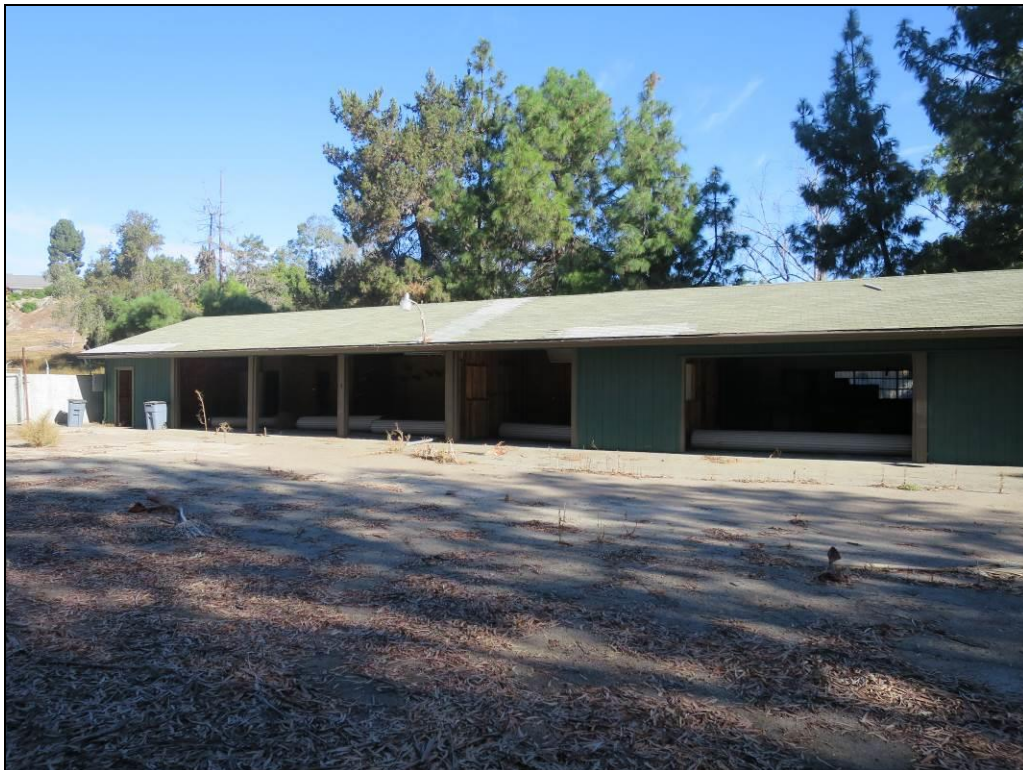
Figure 3: Southwest elevation of structure facing northeast. (photograph by IS Architecture 2017)

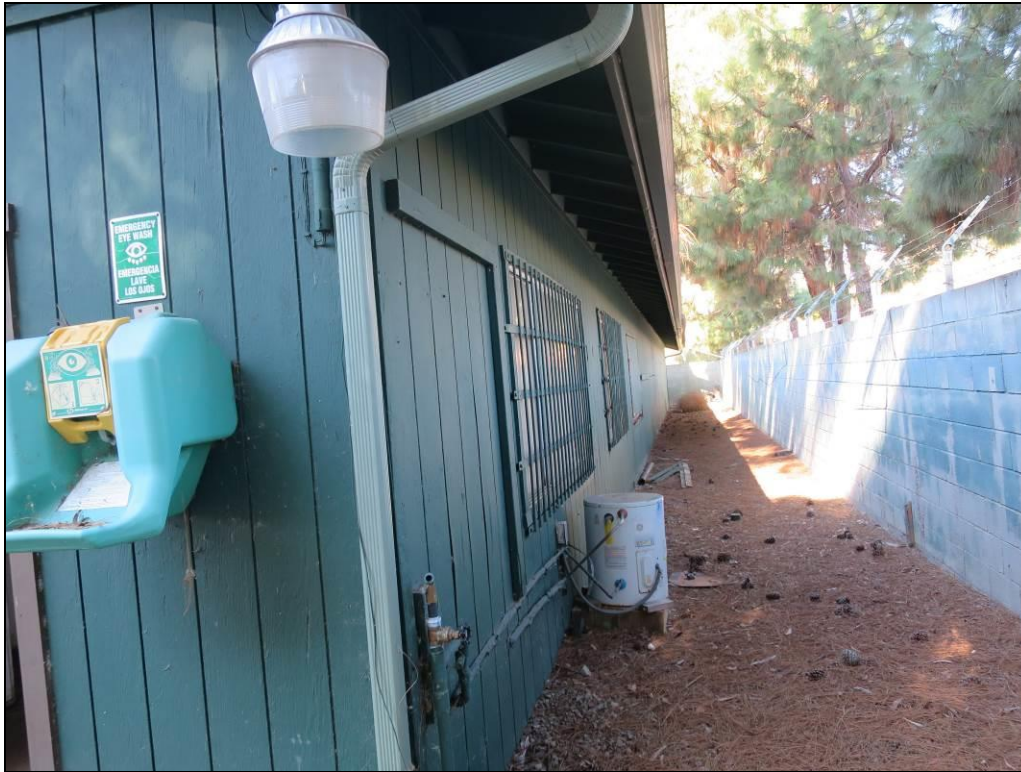
Figure 4: Northeast elevation of structure facing northwest. (photograph by IS Architecture 2017)

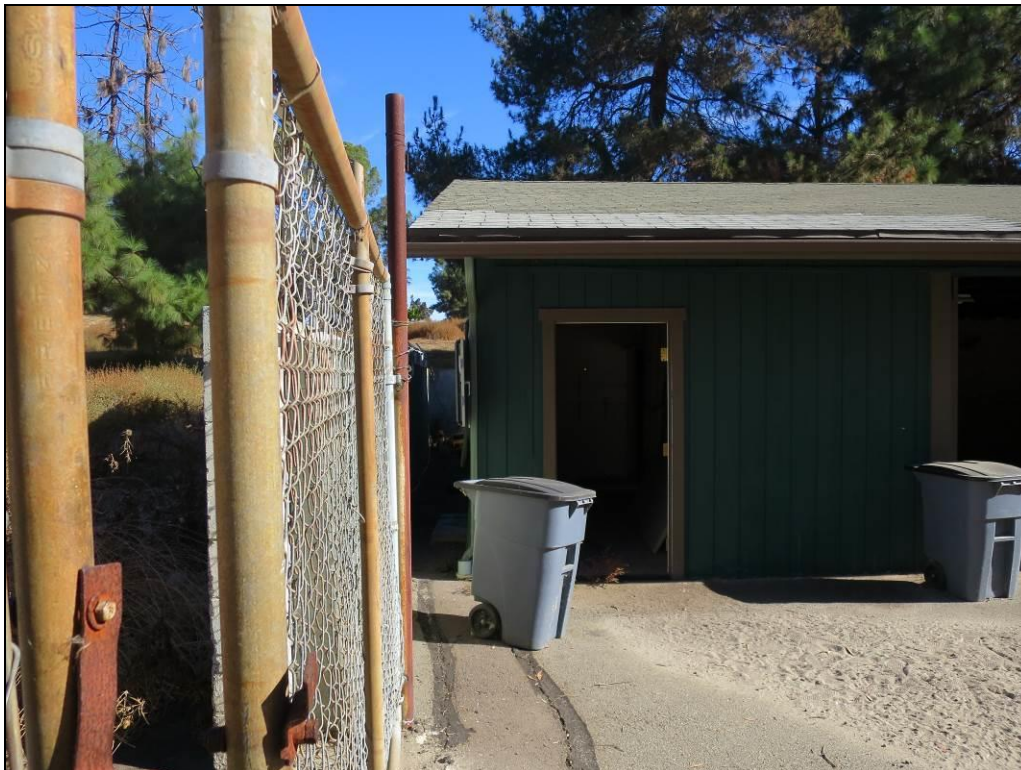
Figure 5: Northwest elevation of structure facing northeast. (photograph by IS Architecture 2017)
