PROTECTED TREE REPORT

1111 Sunset Blvd. Los Angeles, CA 90012

January 05, 2021

LISA SMITH, **THE TREE RESOURCE** REGISTERED CONSULTING ARBORIST #464 ISA BOARD CERTIFIED MASTER ARBORIST #WE3782 ISA TREE RISK ASSESSOR QUALIFIED - INSTRUCTOR MEMBER OF AMERICAN SOCIETY OF CONSULTING ARBORISTS P.O. BOX 49314, LOS ANGELES, CA 90049 **T** 310-663-2290 **E** lisa@thetreeresource.com

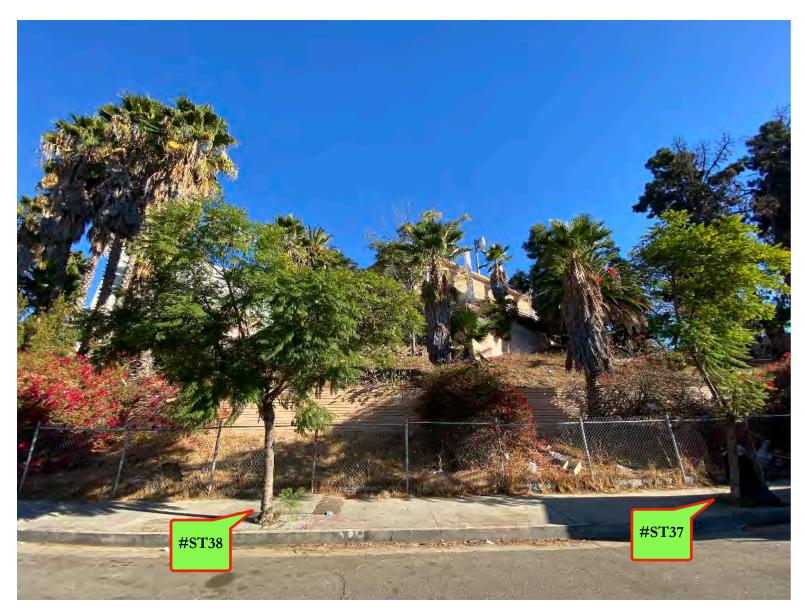
PHOTO 2 - Shows Street Tree #38 - To be removed

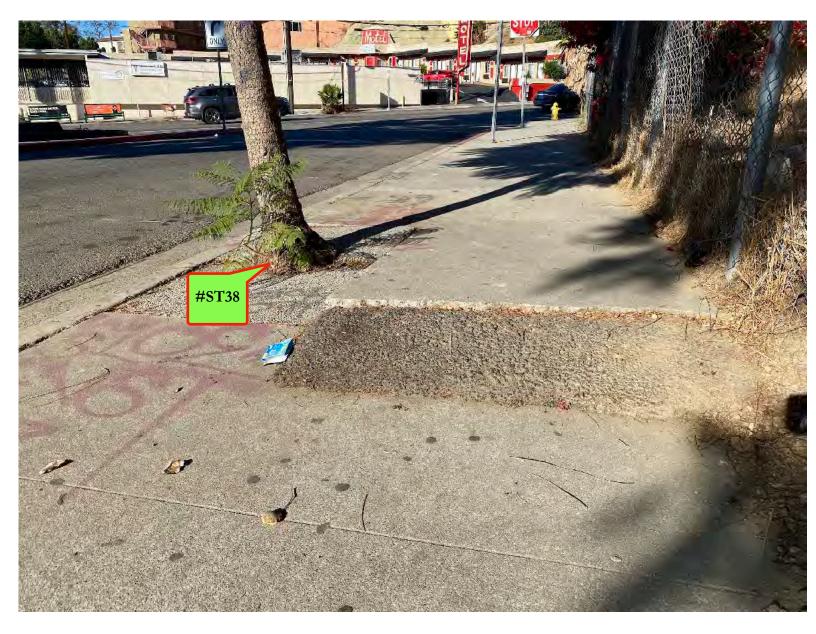
PHOTO 3 - Street Tree #38 (left) and #37 (right) - These 2 Jacaranda trees will be impacted by the updated road, which will close off this through-way. These trees are in poor condition due to the restricted tree wells which the trees have grown into, restricting their trunks, and causing them to be embedded in the concrete and asphalt. These trees are not able to mature and structurally maintain their root plate.

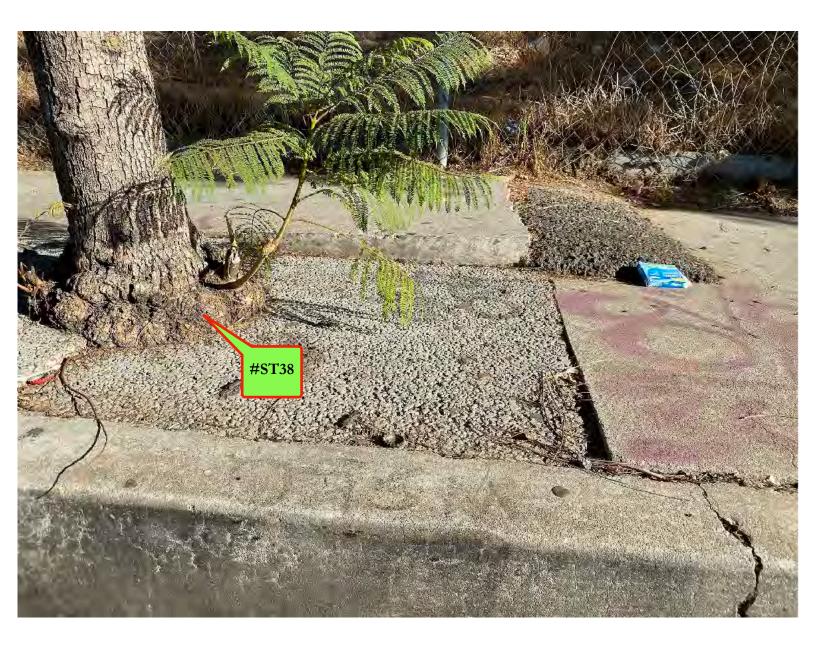
PHOTO 4 - Jacaranda Street Tree #38 - To be removed.

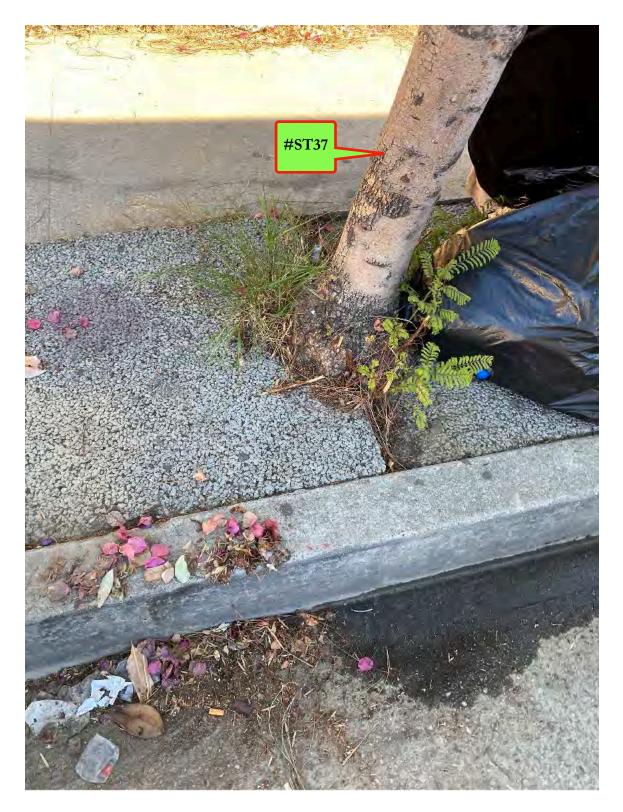
PHOTO 6 - Jacaranda Street Tree #37 - To be Removed.

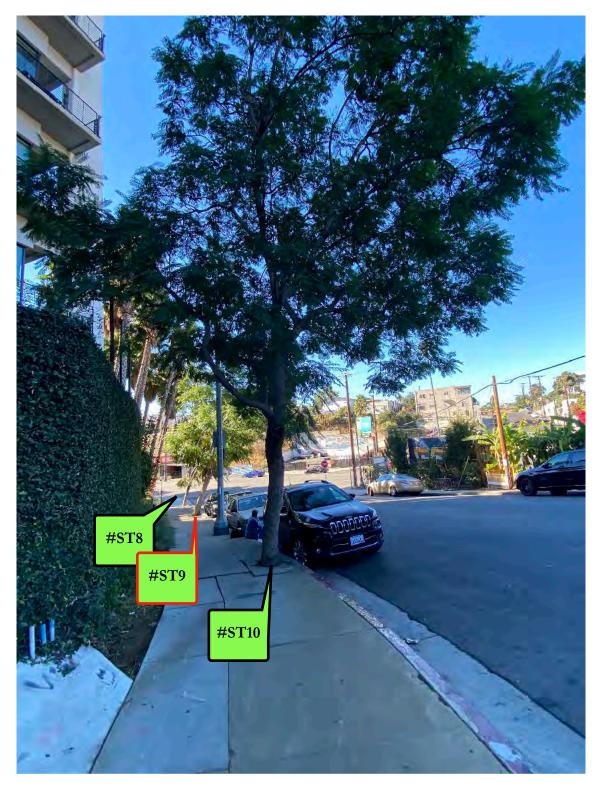
PHOTO 15 - Street Tree Jacarandas #ST8, ST9 and ST10 (front) - Street Tree #9 will be removed for the installation of the new required road work.

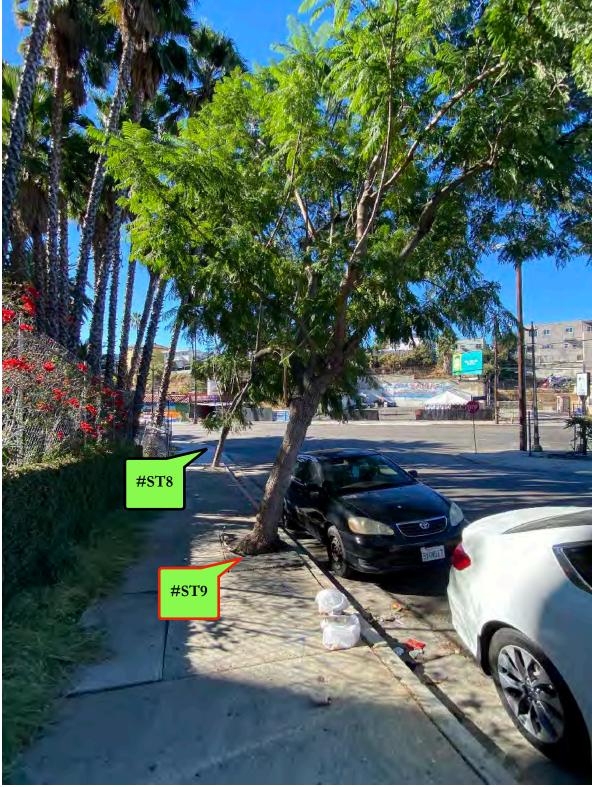
PHOTO 16 - Street Tree Jacarandas #ST8 (rear) to be retained and ST9 (front) to be REMOVED for the required driveway access to the DWP Transformer Pad. This DWP pad General Requirements establish a more than 2,000 square foot transformer yard and staging area, which must be located entirely on private property, and limit the maximum slope for a required access driveway leading thereto.

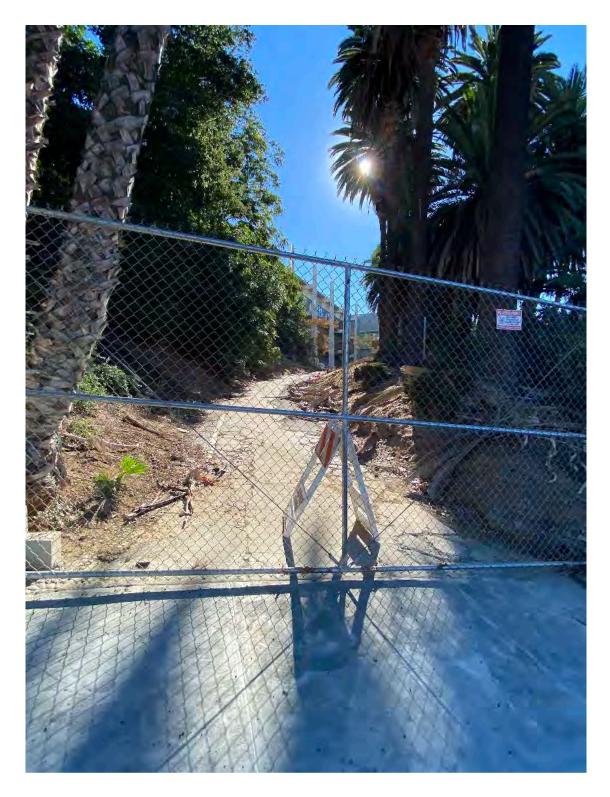
PHOTO 17 - Palm Trees #84 - #106 - These palms will be removed due to the grading that is required for this sloping site.

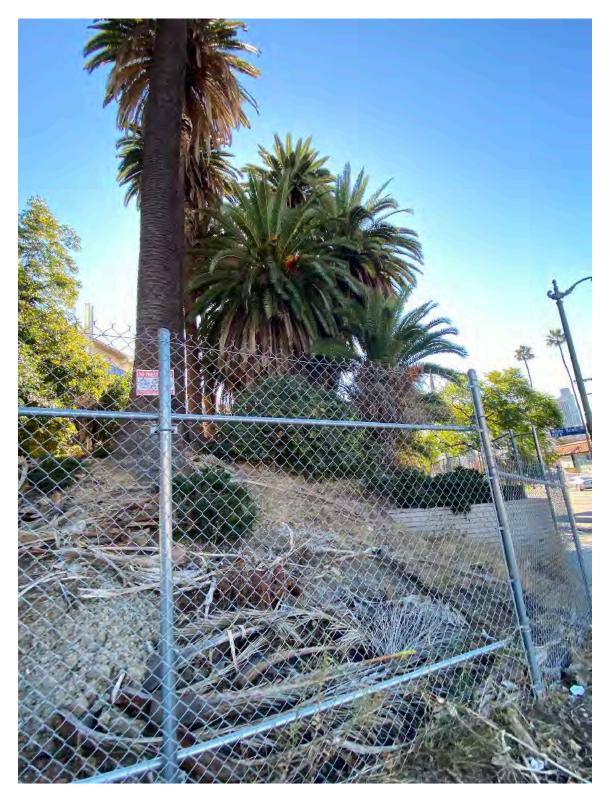
PHOTO 18 - Palms at corner of White Knoll and Sunset Blvd - These palms will be removed due to the required grading.

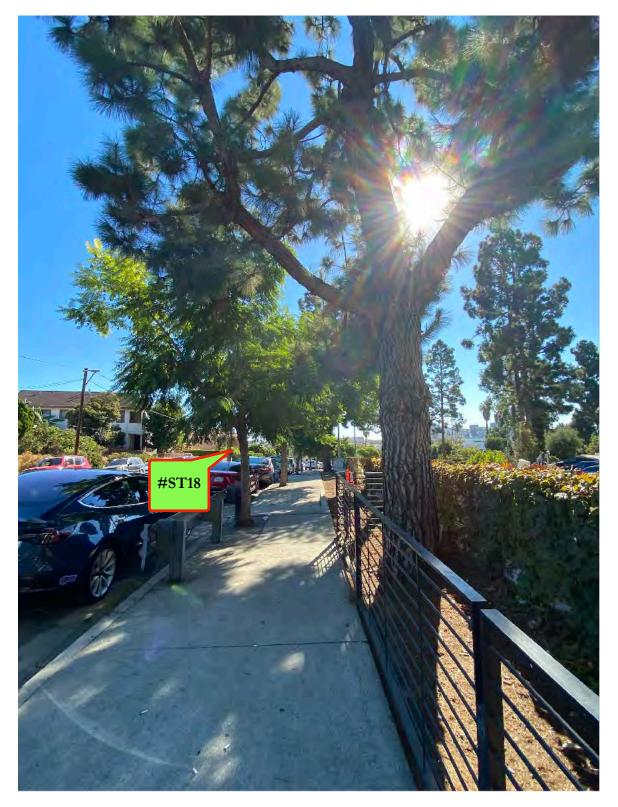
PHOTO 27 - Street Tree Jacaranda #ST18 - next to railing - to be removed and replaced at a 2:1 ratio.

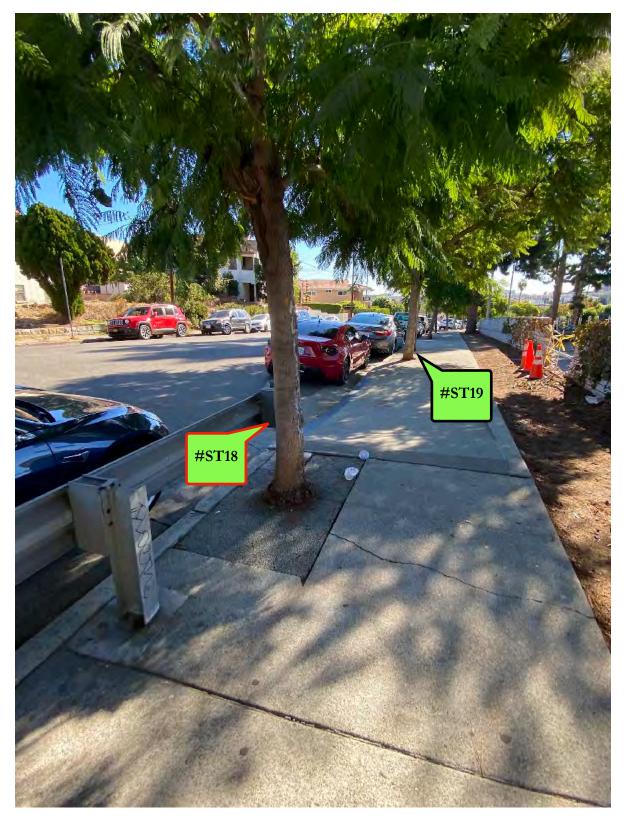
PHOTO 28 - Street Tree #ST18 (front) - to be removed and #ST19 - (back) to be retained and protected in place. 1111 Sunset Blvd.

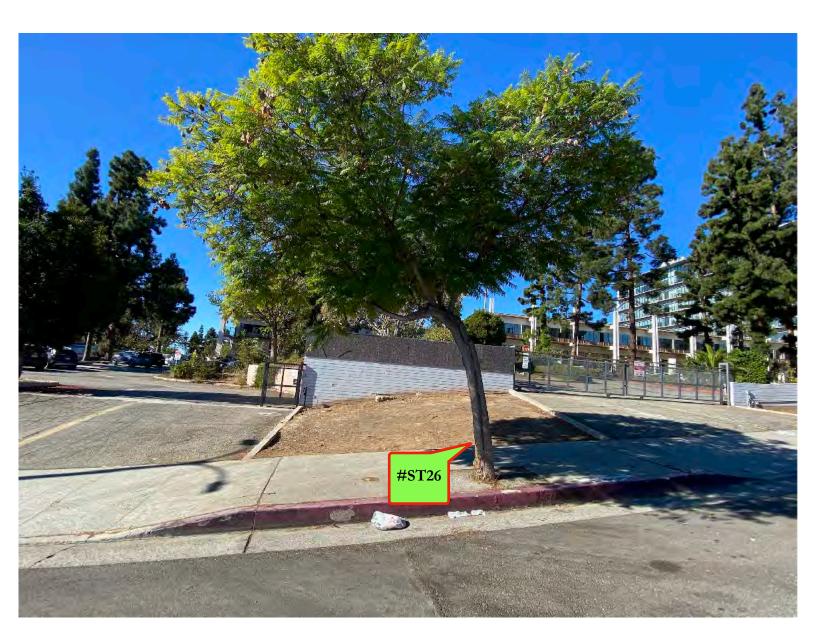
PHOTO 37 - Street Tree #ST26 - to be REMOVED and replaced to the satisfaction of UFD

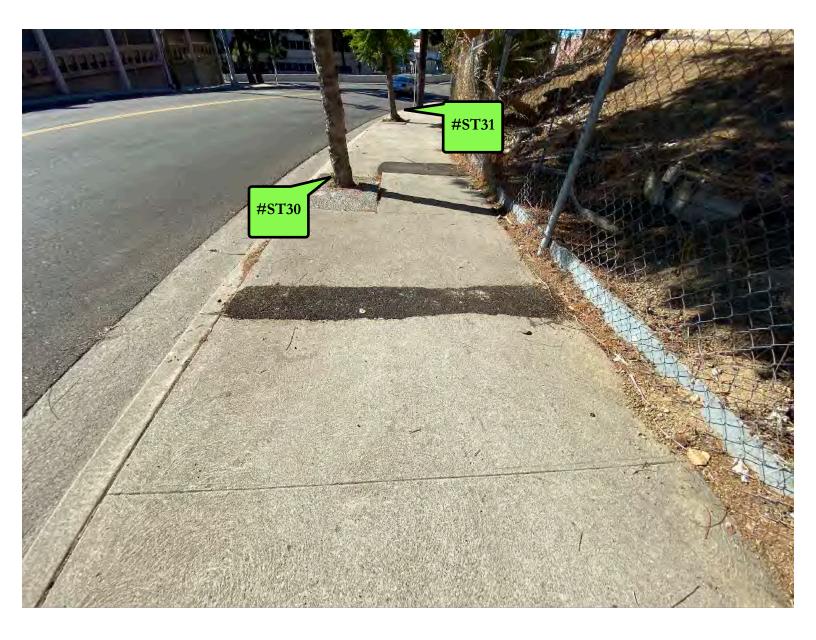
PHOTO 41 - Street Trees #ST30 (front w/ sidewalk lifting) and #ST31 (rear) - both trees to be retained and protected in place.

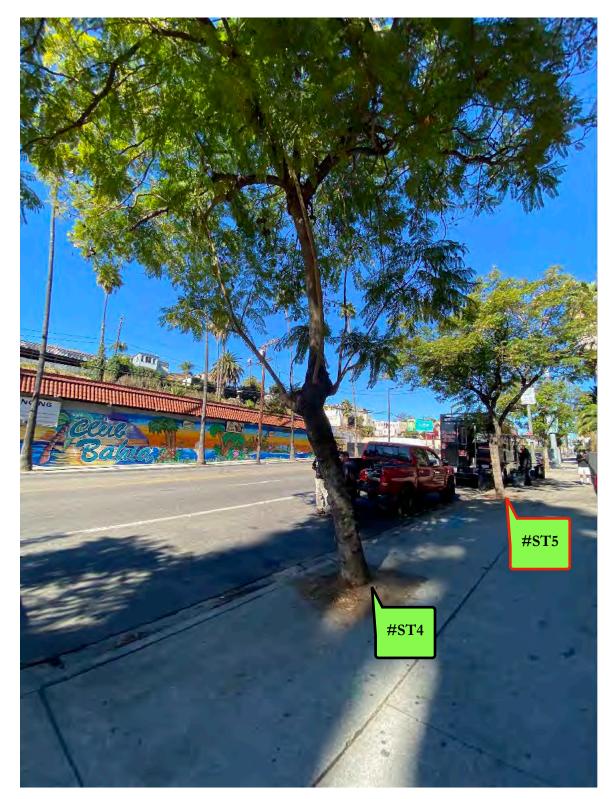
PHOTO 48 - ST4 - to be retained and protected in place. ST5 located between truck and food truck to be removed for new driveway.

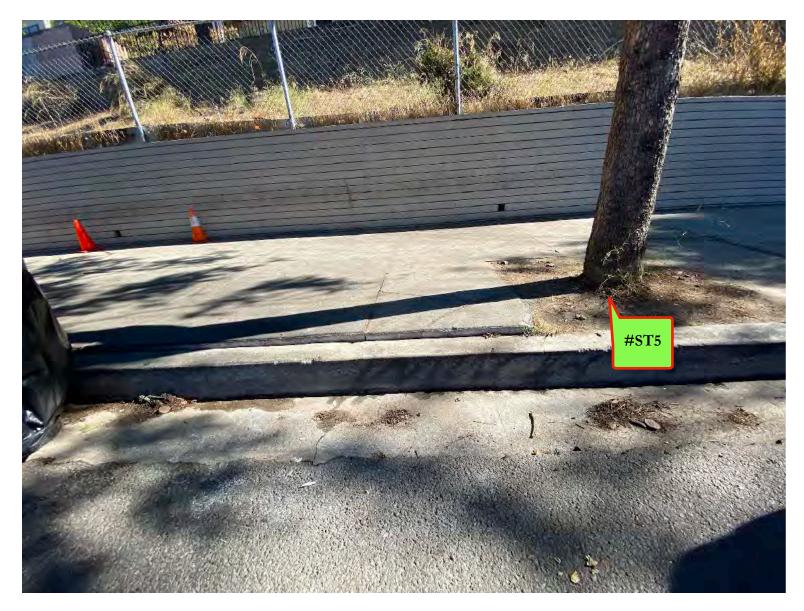
PHOTO 50 - ST5 is slightly buried, lifting the adjacent sidewalk. This tree is slated for removal for the new driveway access. It will be replaced at a 2:1 ratio.

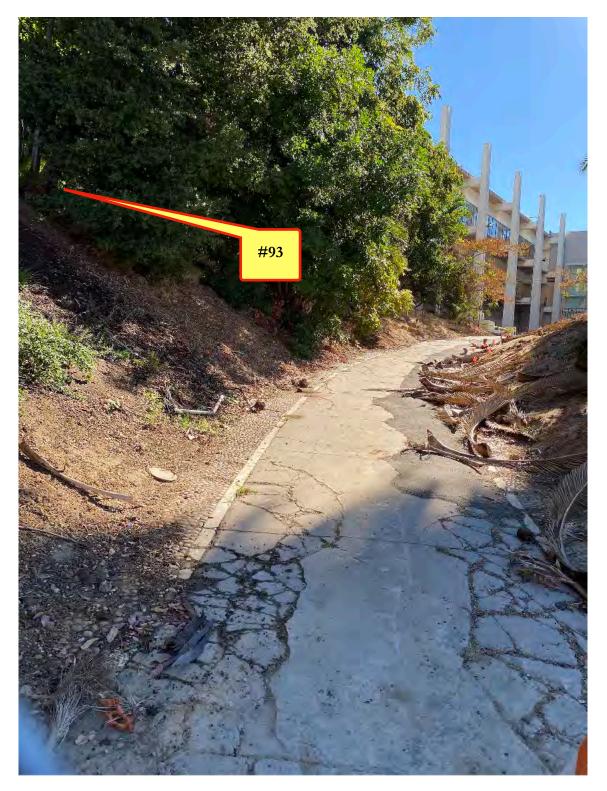
One (1) coast live oak *(Quercus agrifolia)* tree #93 will be impacted by required grading and a DWP installation. This tree is recommend for removal and replacement to the satisfaction of the Urban Forestry Division, at a four-to-one (4:1) ratio, 24" box minimum size, in the Native Oak species.

PHOTO 52 - Coast Live Oak tree in upper left - to be removed due to required grading on this site. This tree will be removed and replaced at a 4:1 ratio.

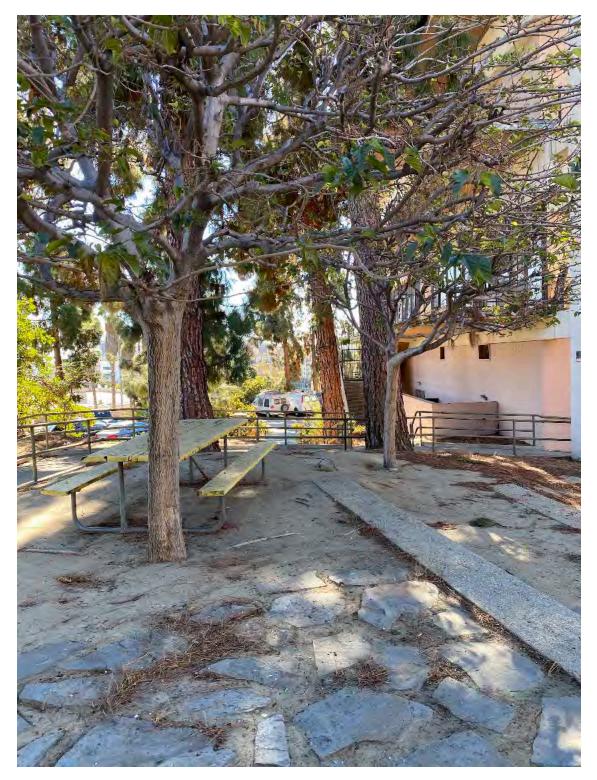
PHOTO 53 - Fig Trees in one of the interior courtyards - these trees are in poor condition and will be removed due to the required grading.

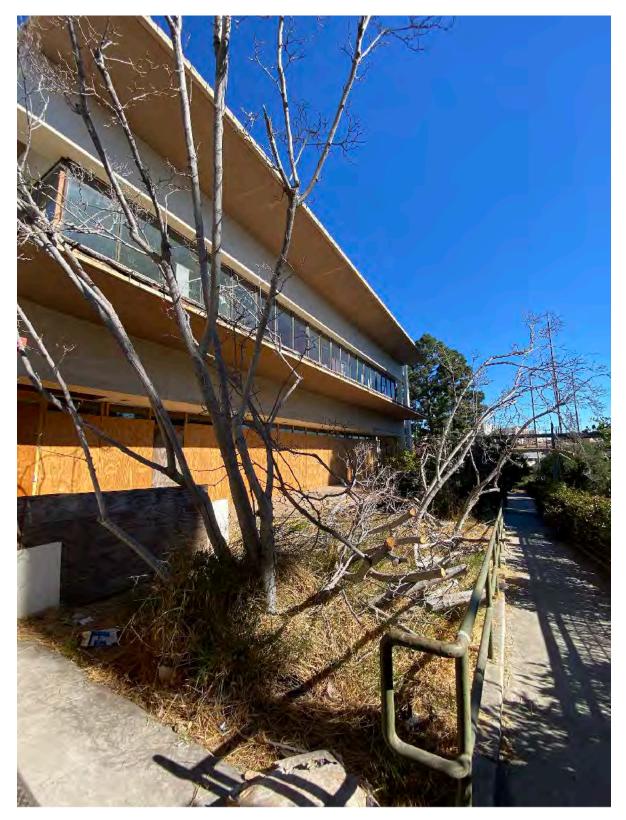
PHOTO 54 - Dead Trees #52, 53, 54 and #55 in the center courtyard

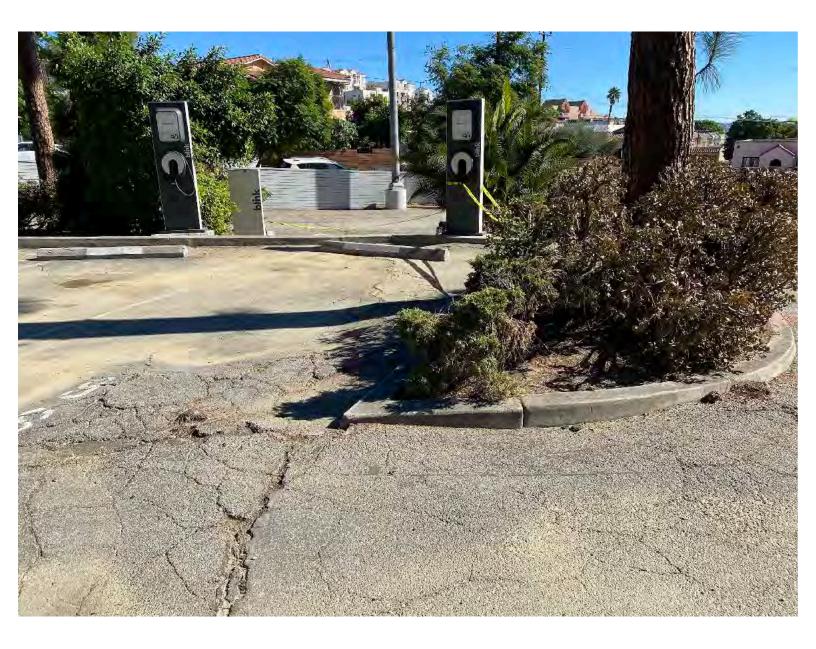
Canary Island Pine (*Pinus canariensis*) consist of 43 of the 104 trees. Lack of dedicated irrigation has caused drought stress on many of these pine trees. They are crowded, over-grown, and in competition for light, soil space, water, soil nutrients and growing space. The majority was densely installed in small dedicated parking lot planters which are now heaving and cracking.

PHOTO 55 - Canary Pines in the parking lots will be impacted by the required grading and be removed. Many have outgrown their small planter spaces and are impacting the existing asphalt.

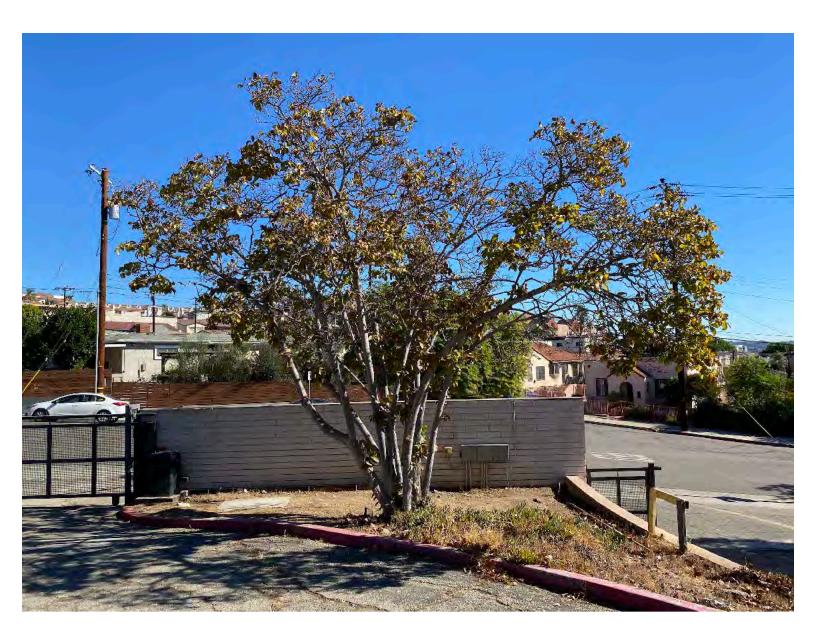
PHOTO 56 - Tree in front - in decline due to age, drought stress, climate change, etc. To be removed due to grading

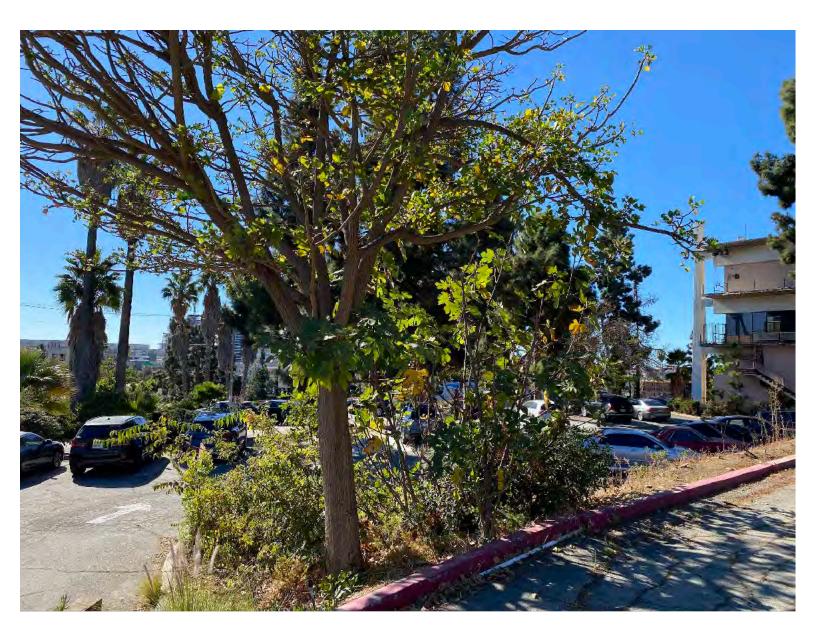
PHOTO 57 - Coral Tree in decline - this tree is stressed due to age, drought, climate change. This tree is in poor condition and will be removed due to the required grading.

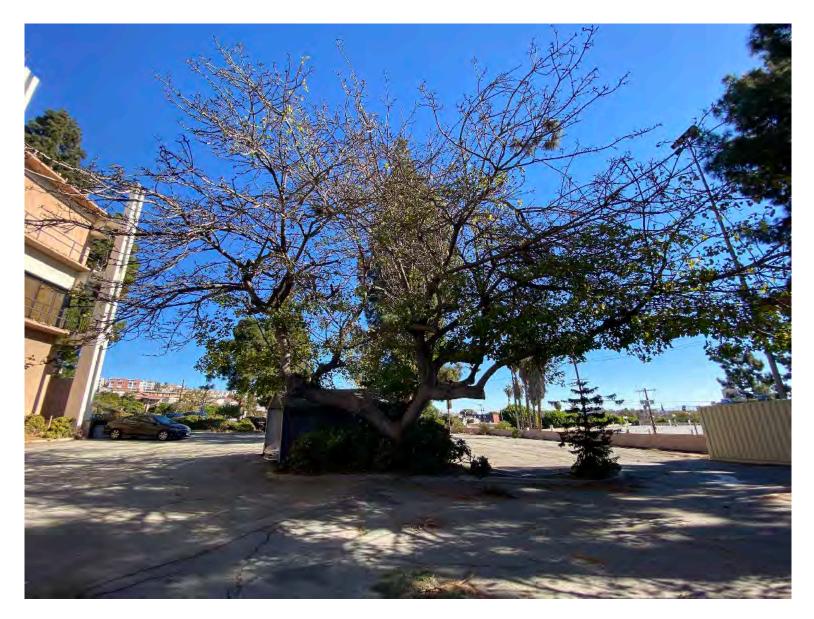
PHOTO 58 - Coral tree in decline. This tree is in poor condition and will be removed due to the required grading.

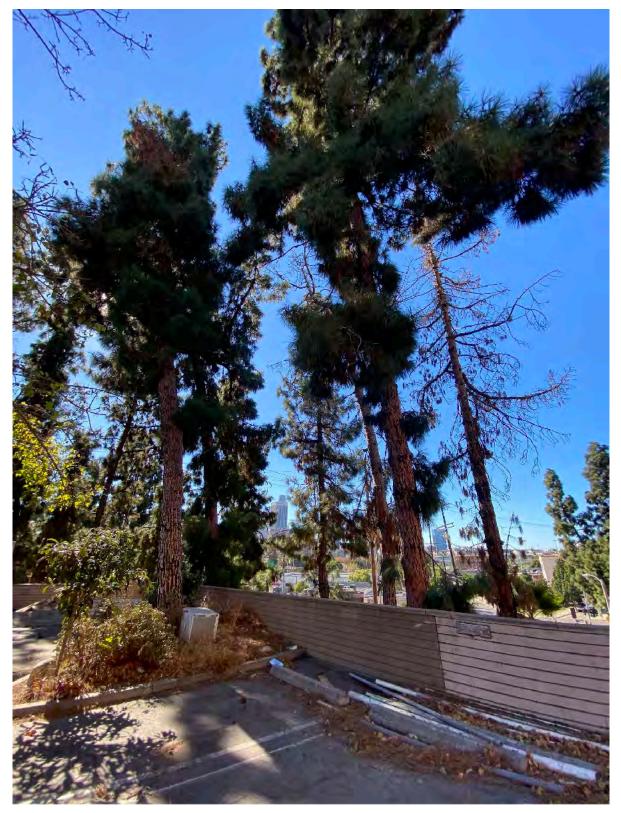
PHOTO 59 - These trees are in poor condition and will be removed due to the required grading.

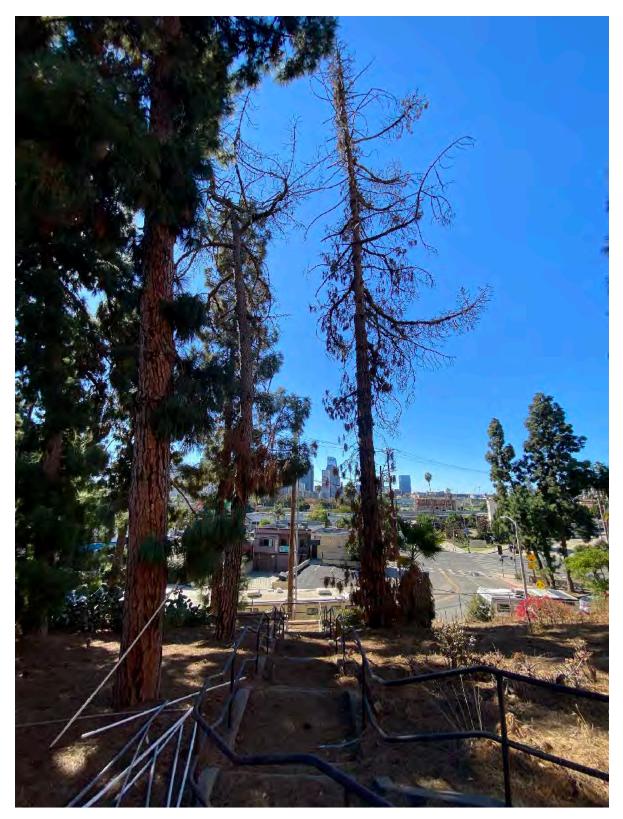
PHOTO 60 - These trees are in poor condition and will be removed due to the required grading.

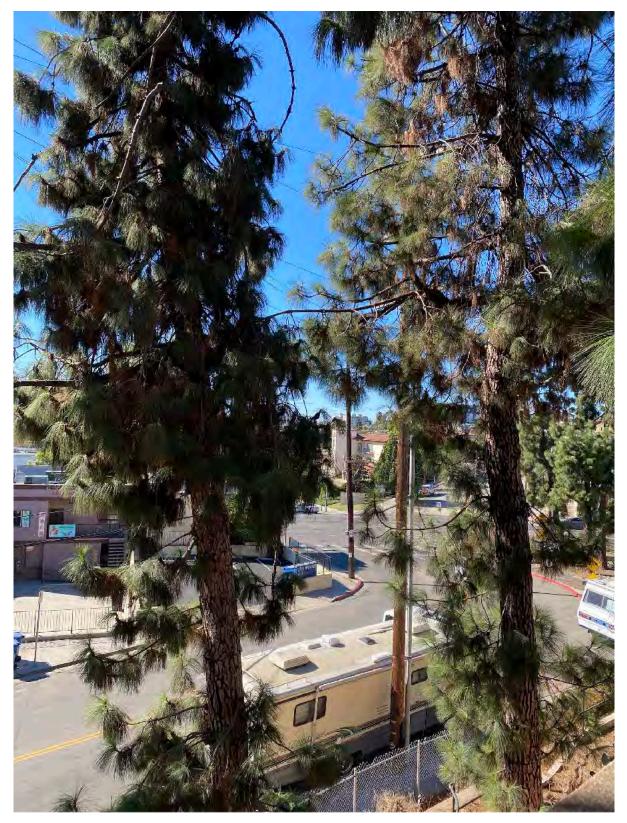
PHOTO 61 - These trees are in poor condition and will be removed due to the required grading.

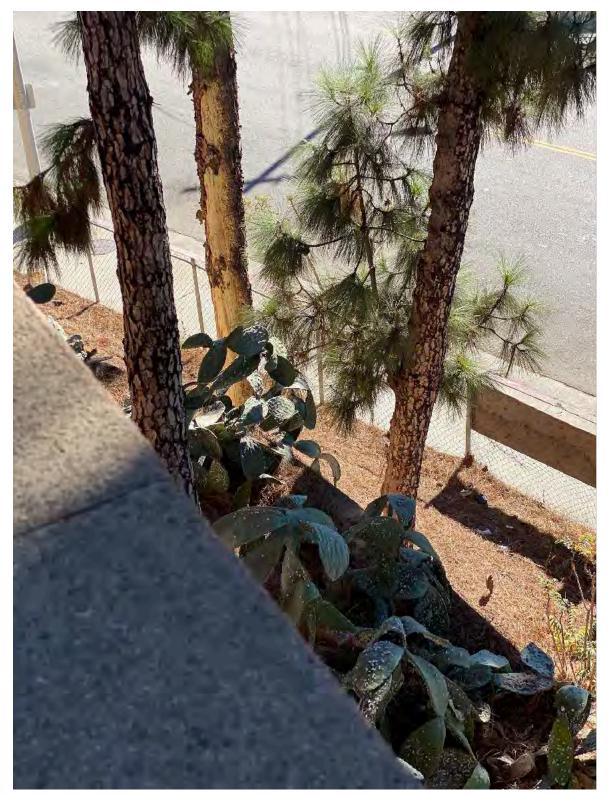
PHOTO 62 - These trees are in poor condition and will be removed due to the required grading. - Notice the bark is gone from some of these pines. They may have been impacted by a fire that torched their bark.

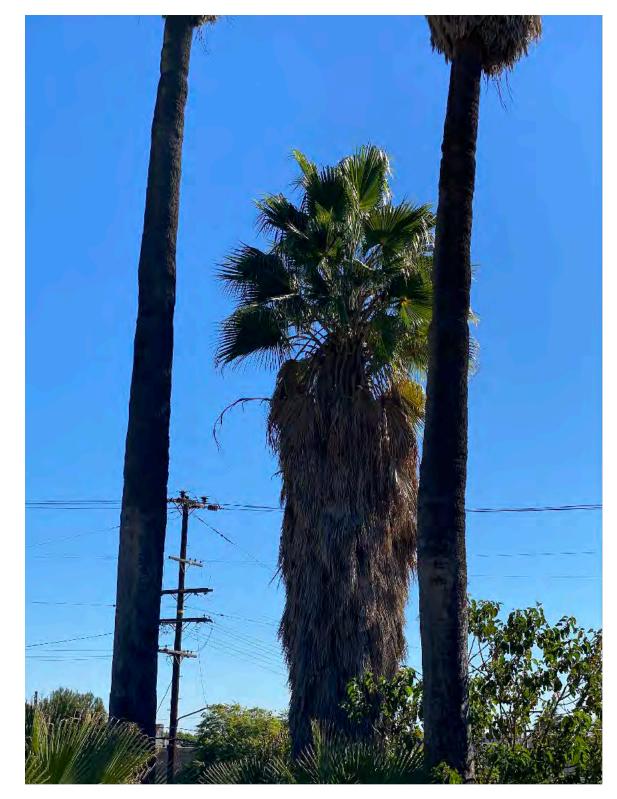
PHOTO 63 - Fan Palms throughout the site have had no maintenance for years, resulting in dead fronds/ beards that can become a "fire candle" if ignited.

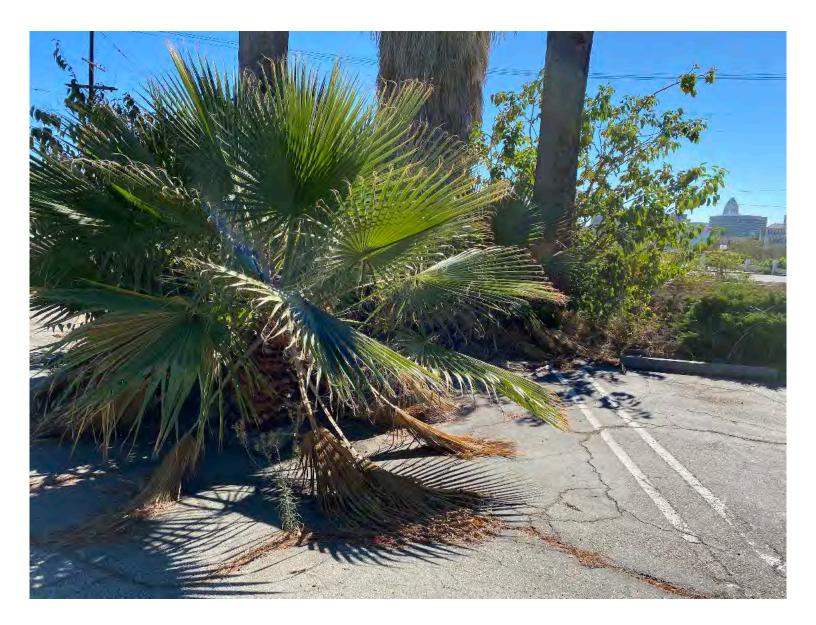
PHOTO 64 - Example of these palms and their prolific potential for seeding throughout the site. This has been the main source of their growth on site. Not intentionally planted.
