## Tree Impact Analysis

### Sunnyvale Town Center Block 3 Landscape and Parking Lot Plan Set Iteration 12/19/2016

Report:

1/9/2017

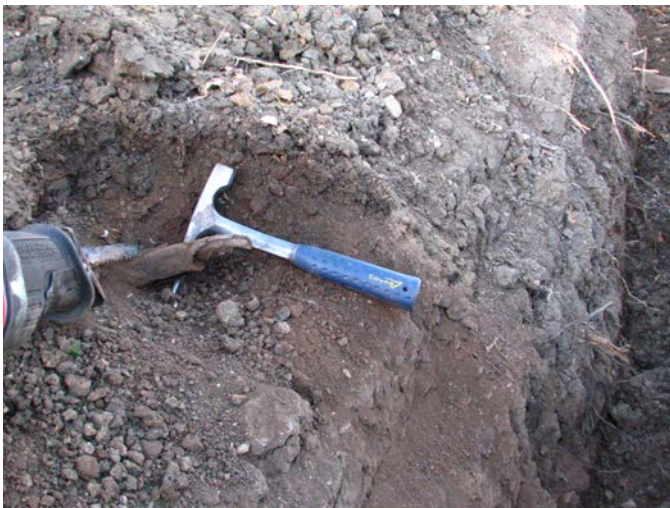
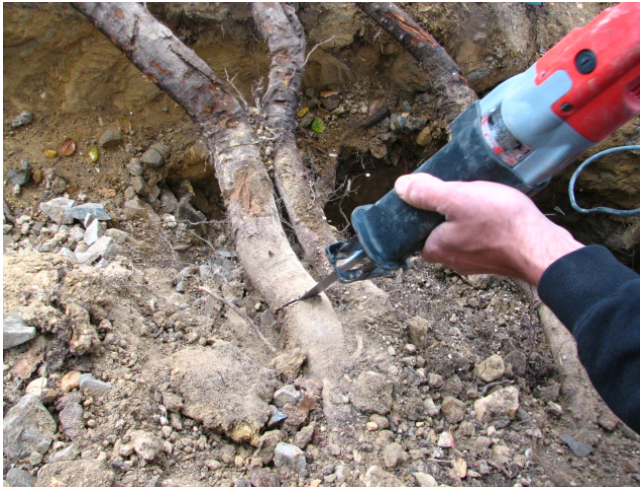
If a root is shattered or broken, then back-dig around the root using a small hand tool until a clean unbroken section of root is visible, and prune the root at that location to remove all shattered material (see images below).

Prune all roots at right angle to the root growth direction (i.e. cut "square" per the images below).

Backfill immediately (same day) with parent soil and water thoroughly to saturate the uppermost 24-inches of the soil profile.

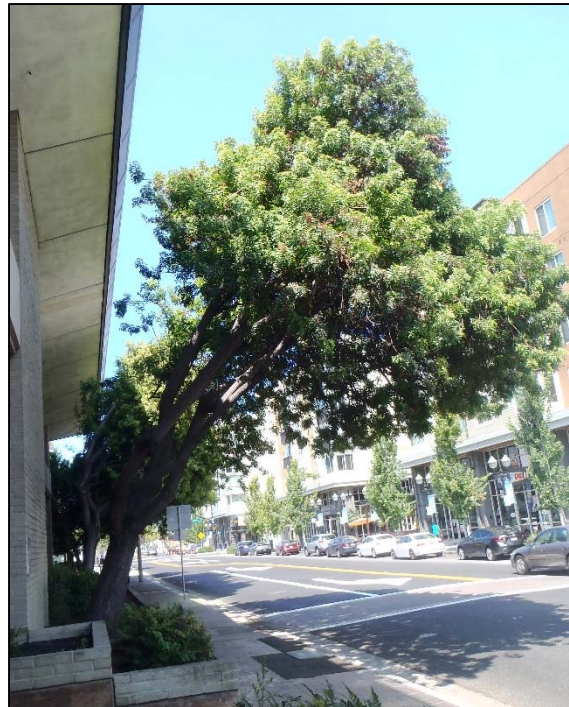
**Photo 1:** Looking west at Brazilian pepper #286. The tree was typical of the Brazilian peppers growing along the north side of the Macy's building. It leaned and had a one-sided crown to the north as a result of pruning/topping for building clearance and phototropism.
