Smith Basin Improvement Project

**PRELIMINARY GEOTECHNICAL EVALUATION
SMITH BASIN SCOUR ASSESSMENT
ORANGE COUNTY WATER DISTRICT
VILLA PARK, CALIFORNIA**

November 20, 2015
Project No. 209509001

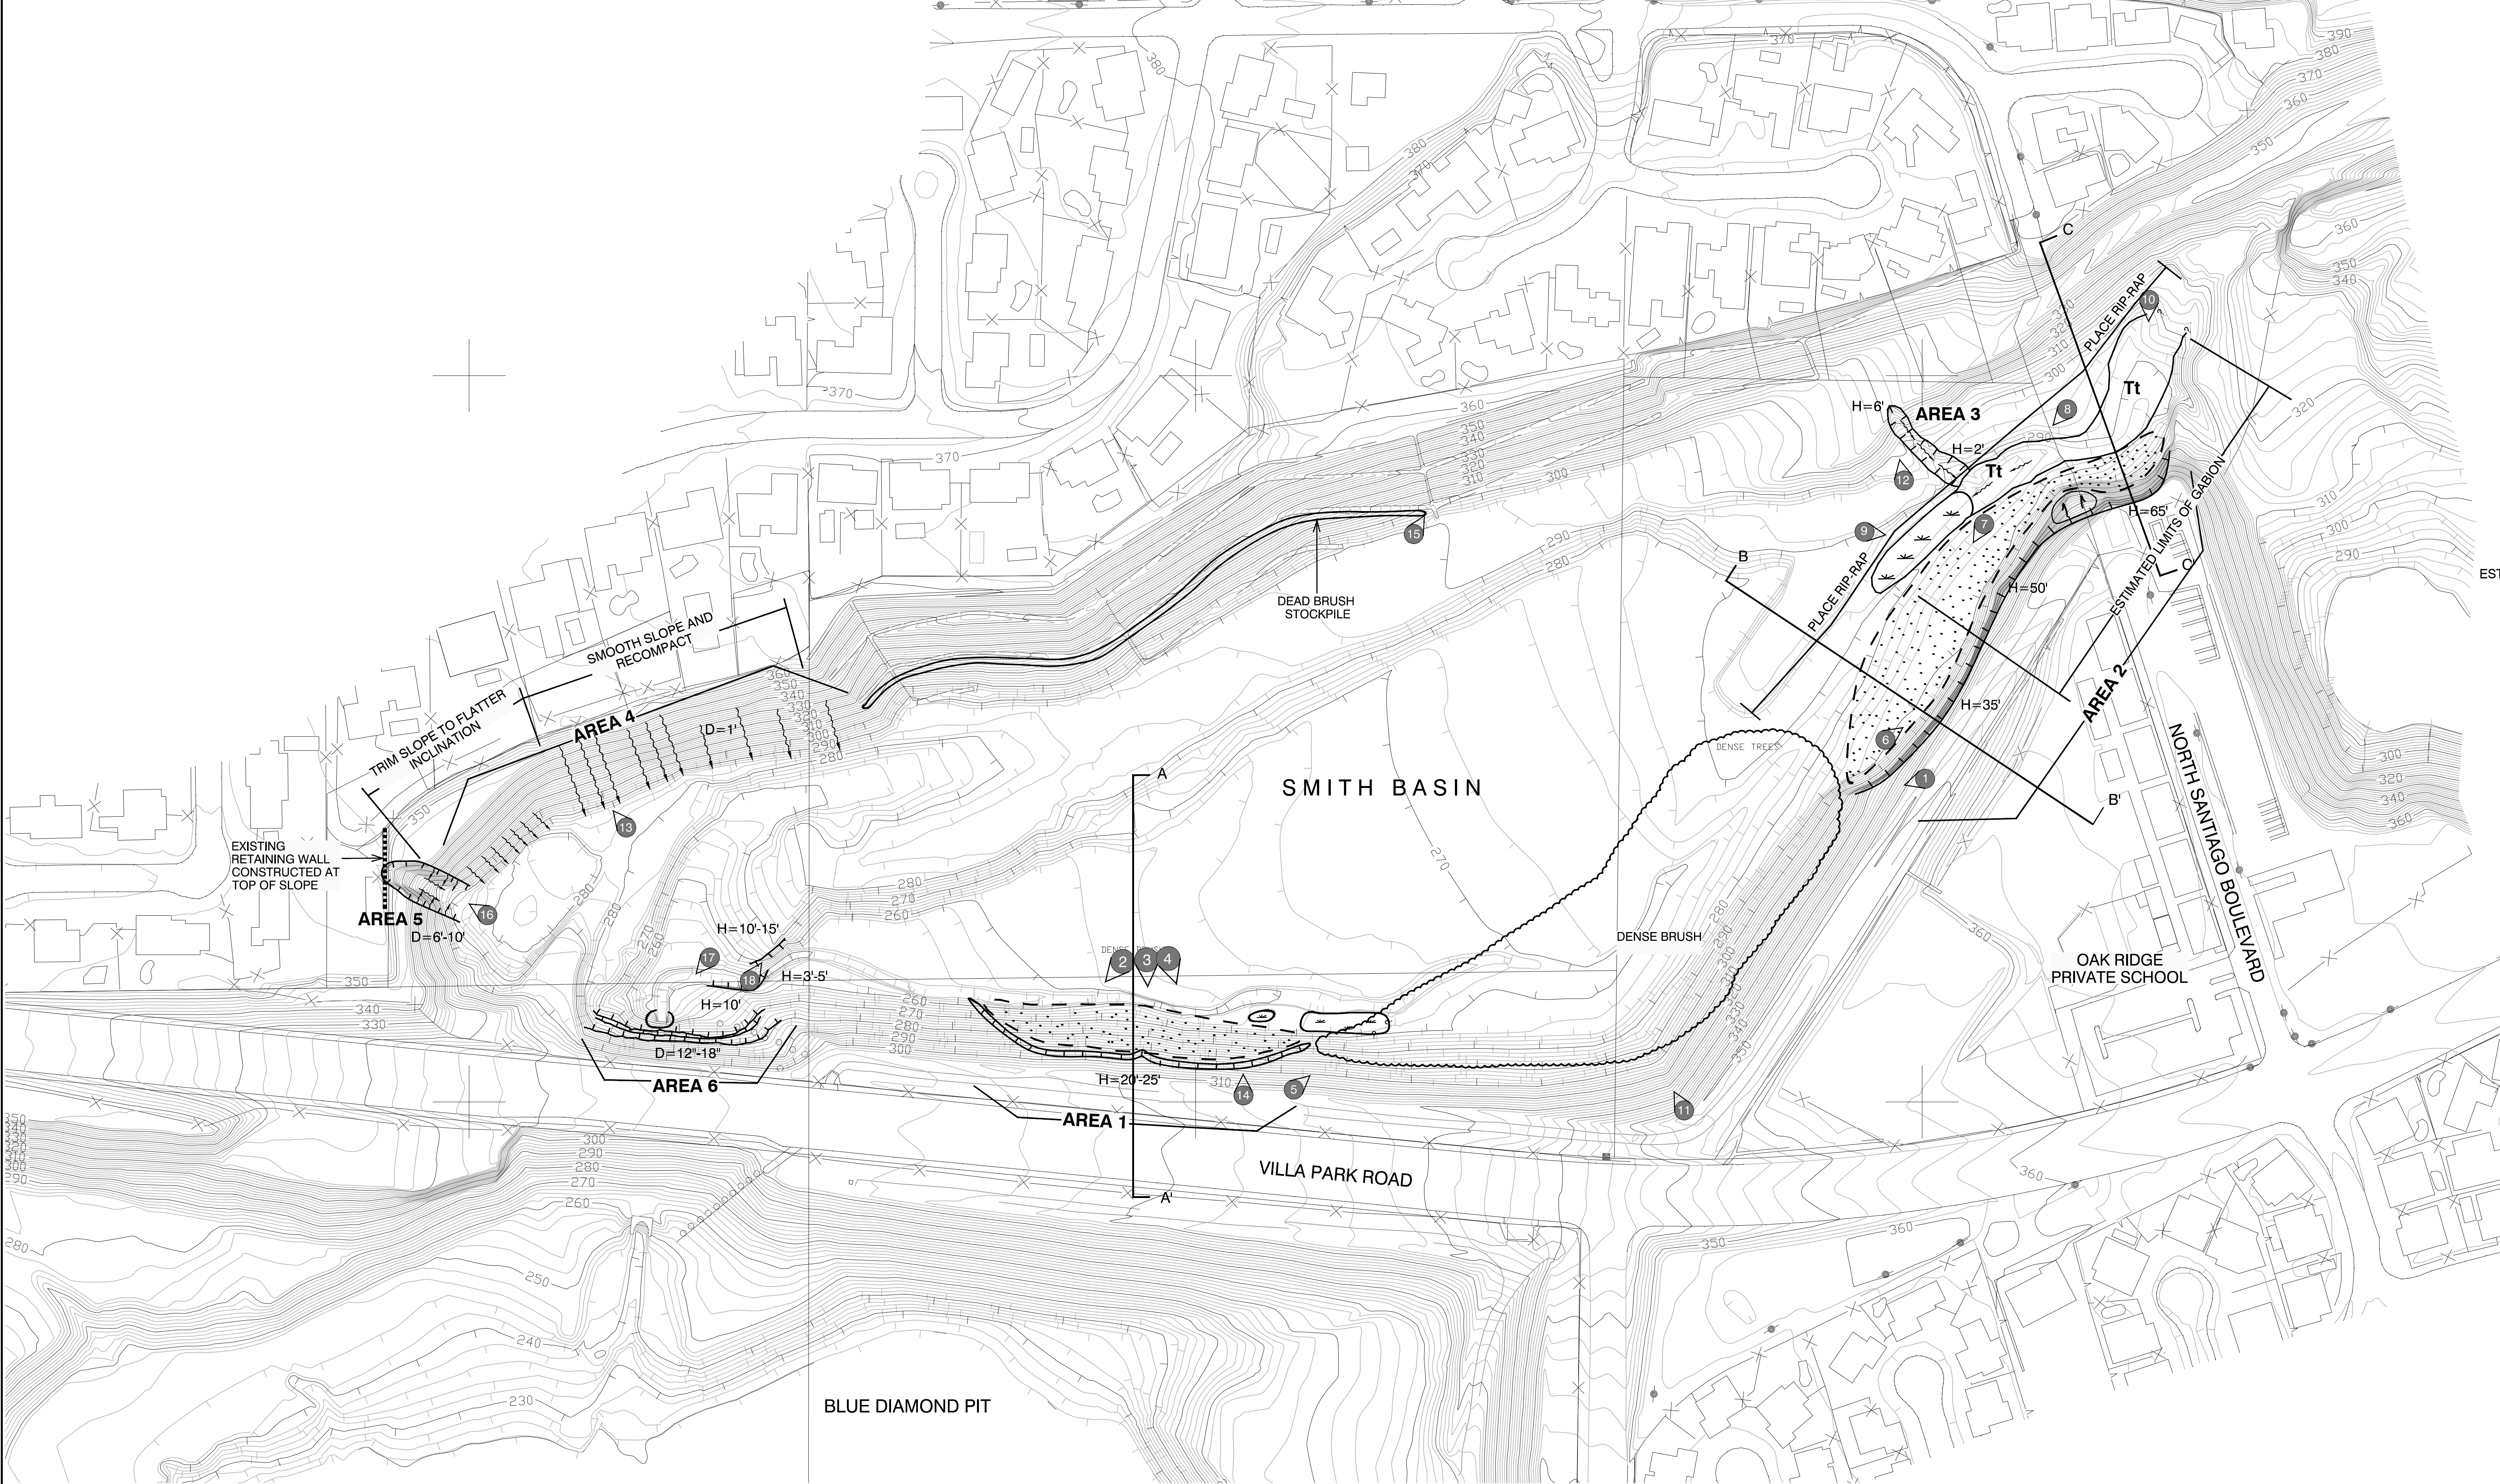
Ninyo & Moore		EROSION MAP	FIGURE 2
PROJECT NO.	DATE		
209509001	11/15	SMITH BASIN SCOUR ASSESSMENT ORANGE COUNTY WATER DISTRICT VILLA PARK, CALIFORNIA

General descriptions of each area of significant erosion are provided in the following sections. Figure 2 presents the locations of the erosion areas, the approximate lateral extent and scarp heights of the erosion features, and the locations of where the photographs were taken. Representative photographs of the erosion areas are included in Appendix A.

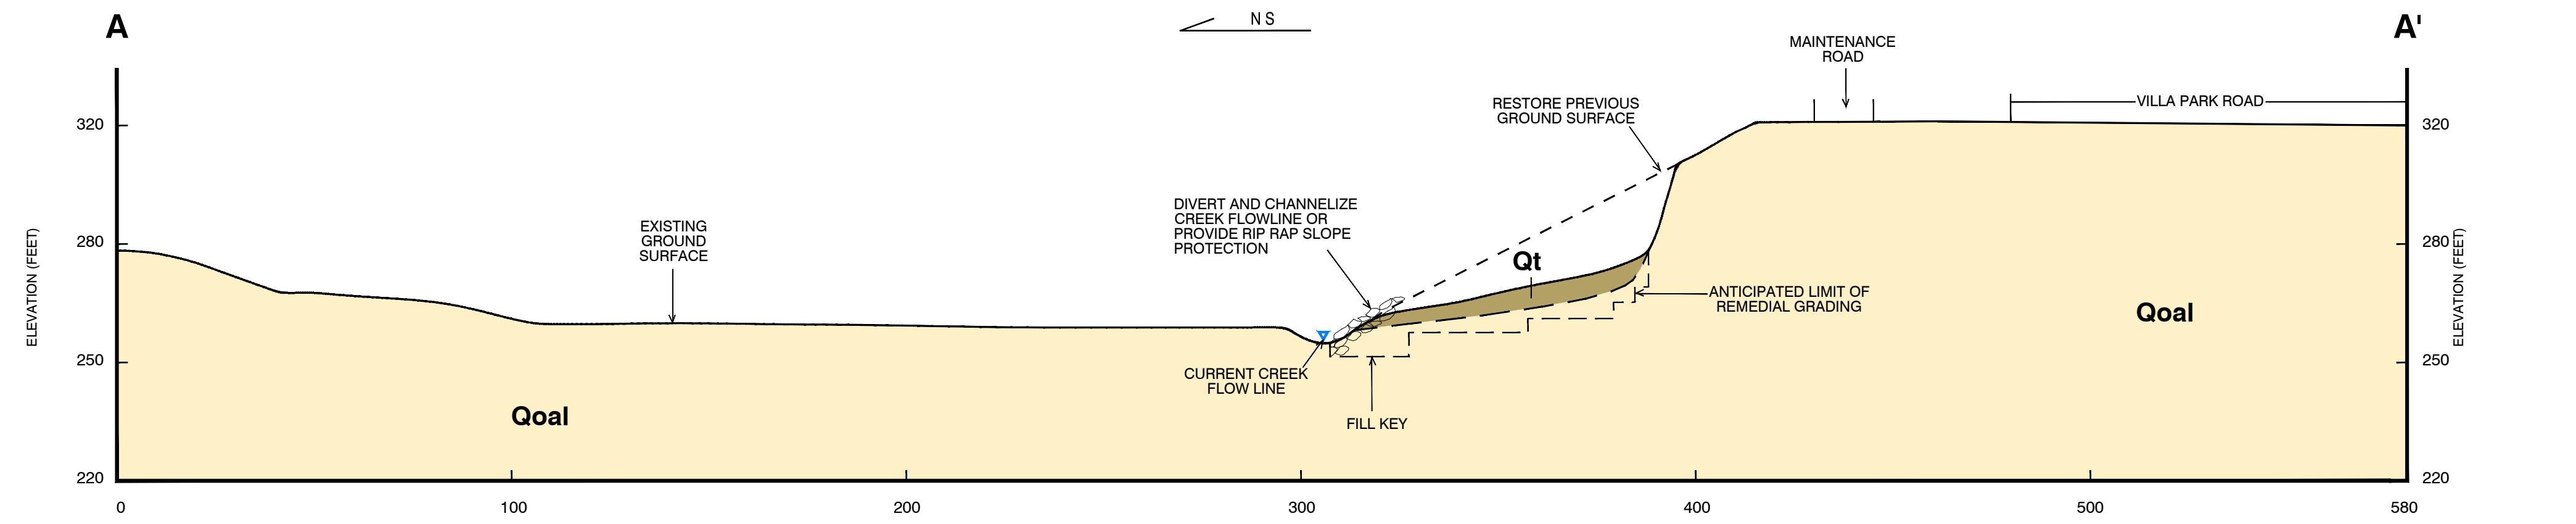
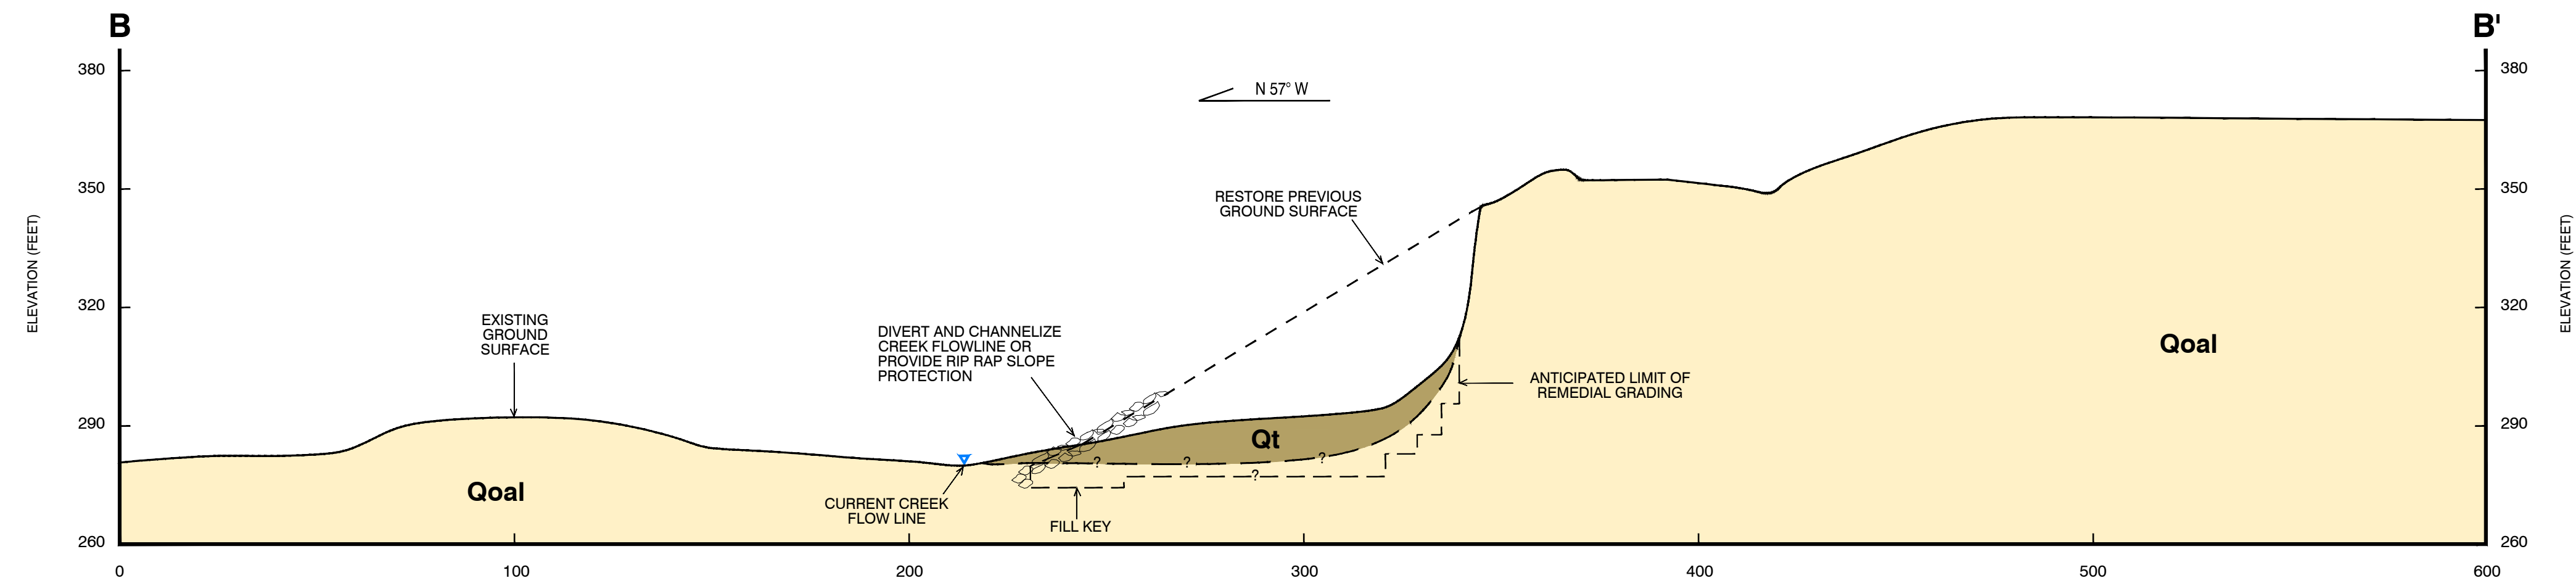
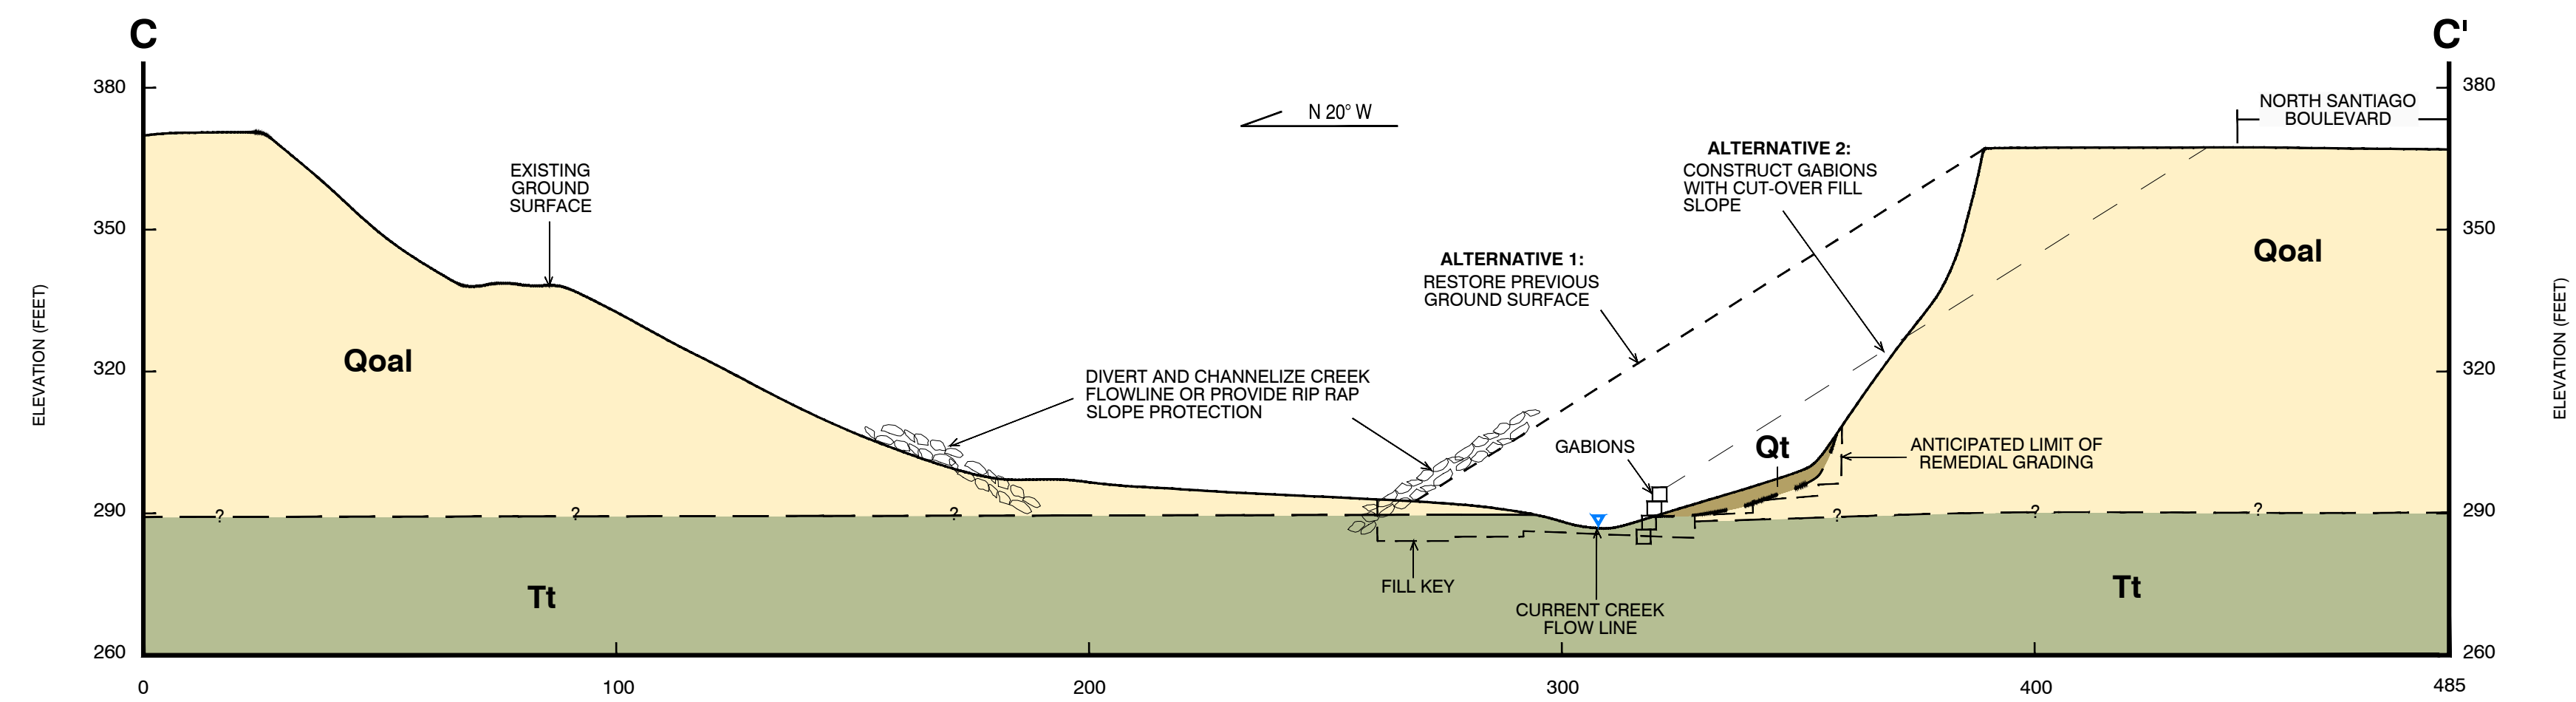
<i>Ninyo & Moore</i>		CROSS SECTIONS	FIGURE
PROJECT NO.	DATE	SMITH BASIN SCOUR ASSESSMENT ORANGE COUNTY WATER DISTRICT VILLA PARK, CALIFORNIA	3
209509001	11/15

Area 1 is located on the southern embankment slope adjacent to Villa Park Road (Appendix A, Photograph 1). The topographic expression of the erosion is not reflected in the topographic map provided by OCWD. The southern embankment slope was constructed at an approximate slope ratio of 1.7:1 (horizontal to vertical) based on the pre-erosion topography. An approximately 450-foot-long area along the toe of the embankment slope has been progressively eroding during high water flow events since approximately 1981. The erosion has created a near-vertical scarp that is estimated to be up to approximately 25 feet high (Appendix A, Photographs 2 through 4). Some eroded talus is present near the base of the scarp, but the majority of the eroded material has presumably been transported downstream. Our interpretations of the subsurface conditions are shown in Cross Section A-A' (Figure 3).

Similar to the southern embankment slope, the eastern embankment slope was constructed at an approximate slope ratio of 1.7:1 (horizontal to vertical) based on the topography in the non-eroded area to the south. The approximately 700-foot-long area along the toe of the embankment slope has been progressively eroding during high water flow events since approximately 1973, or may have begun during the flood event that destroyed the bridge in 1969. The erosion has created a near-vertical scarp that ranges in height from approximately 35 feet at the southwest end (Appendix A, Photographs 6 through 8) up to approximately 65 feet at the northeast end (Appendix A, Photographs 9 and 10). Some eroded talus is present near the base of the scarp, but the majority of the eroded material has also been transported downstream. A relatively large soil slump is present at the OCWD/County of Orange property boundary (Appendix A, Photograph 9). Our interpretations of the subsurface conditions are shown in Cross Sections B-B' and C-C' (Figure 3).

Restoring the slopes to the previous configuration of approximately 1.7:1 (horizontal to vertical) is recommended to stabilize the near-vertical erosion scarps. If the slope is restored to approximately 1.7:1 (horizontal to vertical), the toe of the slope will bury the current flow line of Santiago Creek and the creek will need to be diverted to the north. Remedial grading to remove eroded talus material to expose competent material suitable for support of compacted fill and construction of a fill key should be performed. The anticipated remedial grading and fill key construction for the slope repair in Area 1 and the southwestern portion of Area 2 are shown on Cross Sections A-A' and B-B', respectively (Figure 3). This repair alternative is shown on Cross Section C-C' as Alternative 1.

- If the flow line of Santiago Creek cannot be diverted, utilization of gabions may be considered to provide erosion protection along the creek flow line. Remedial grading to remove loose soil below and behind the gabions is anticipated. Filling behind the gabions may involve placement of Geogrid to increase the stability of the gabions and slope repair. A fill slope may be constructed behind the gabions up to the existing scarp. From this point, a cut slope may be constructed up to the existing street elevation. However, construction of the cut slope will result in losing some of the maintenance road at the northeast end and removing some of the old asphalt concrete from the old bridge approach area. The adjacent area on the North side of the road that is being used by a landscape supply company may also be lost. Approximately 500 lineal feet of gabions for the south side of the creek is estimated (Figure 2). This repair alternative is shown on Cross Section C-C' as Alternative 2.

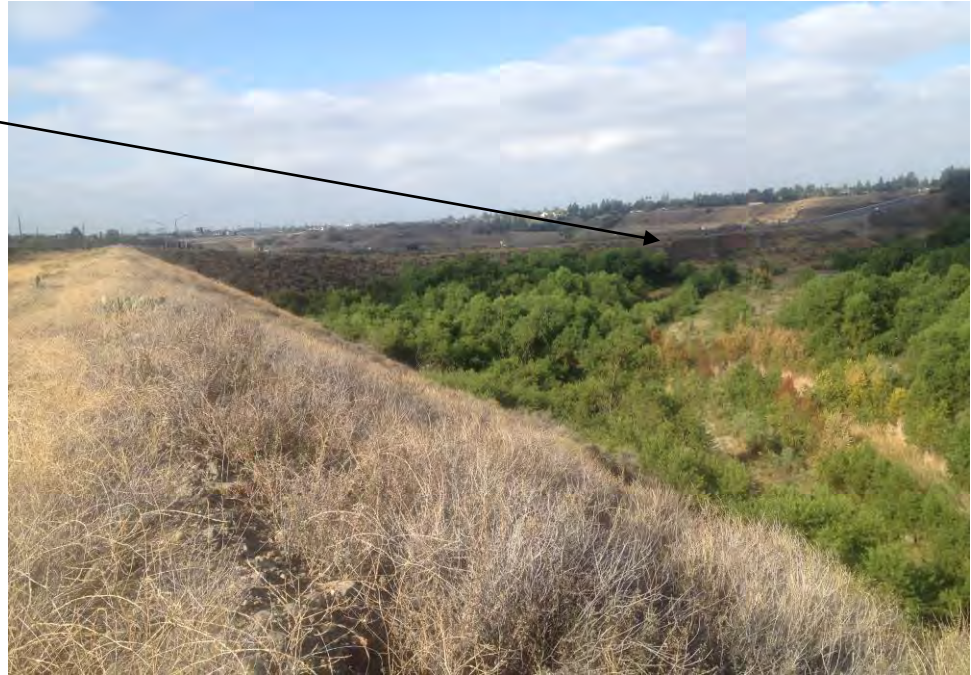
The primary cause of erosion in Areas 1 and 2 is undercutting of the toe of the embankment slopes from the southerly migration of Santiago Creek. Since approximately 1978, the flow line of Santiago Creek has been progressively migrating to the south resulting in erosive waters flowing along the base on the easterly and southerly embankment slopes during high flow events.

Photograph 1: Looking southwest toward Area 1 slope failure. Photograph also shows thick vegetation growth in the basin bottom.

- Re-establishing and channelizing the flow line of Santiago Creek northward, away from the southern and eastern embankment slopes, toward the center of Smith Basin, is recommended to divert water flow away from the toe of slope areas and reduce the potential for additional erosion and undermining. Placement of rip rap to enhance the surficial stability of the new channelized creek is recommended.

- If diverting and channelizing Santiago Creek is not allowed, placement of rip rap on the lower portions of the southern and eastern embankment slopes is recommended after the erosion scarps are repaired. The rip rap should extend along the entire eastern and southern embankment slopes to the discharge pipeline to Blue Diamond Pit beneath Villa Park Road.
- Rip rap should be placed on the north side of the creek where the creek is narrow as it enters Smith Basin.

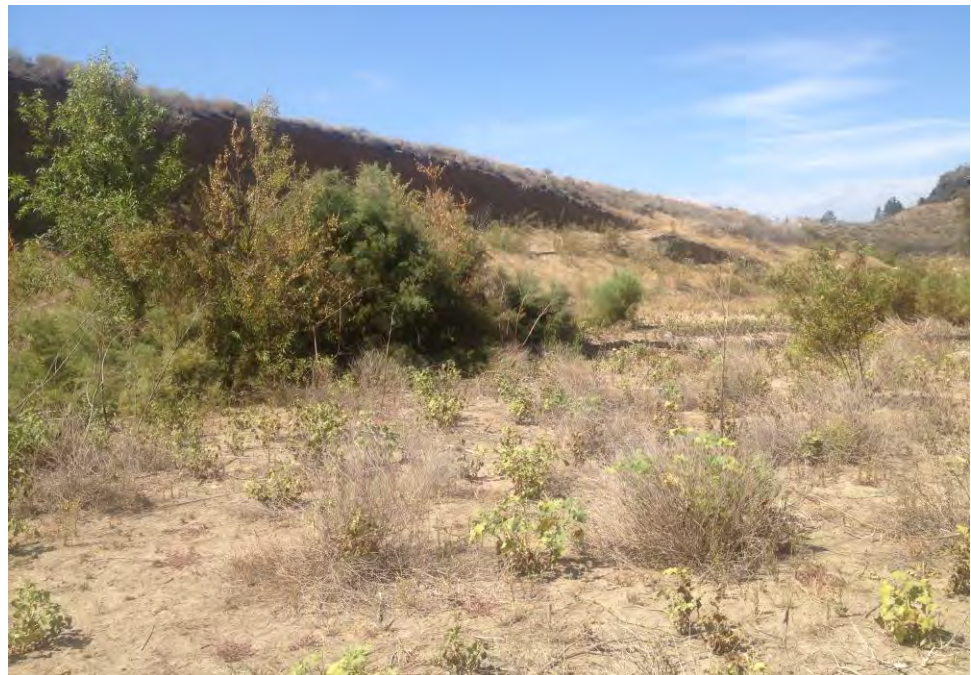
Photograph 2: Western portion of slope failure in Area 1 adjacent to Villa Park Road.

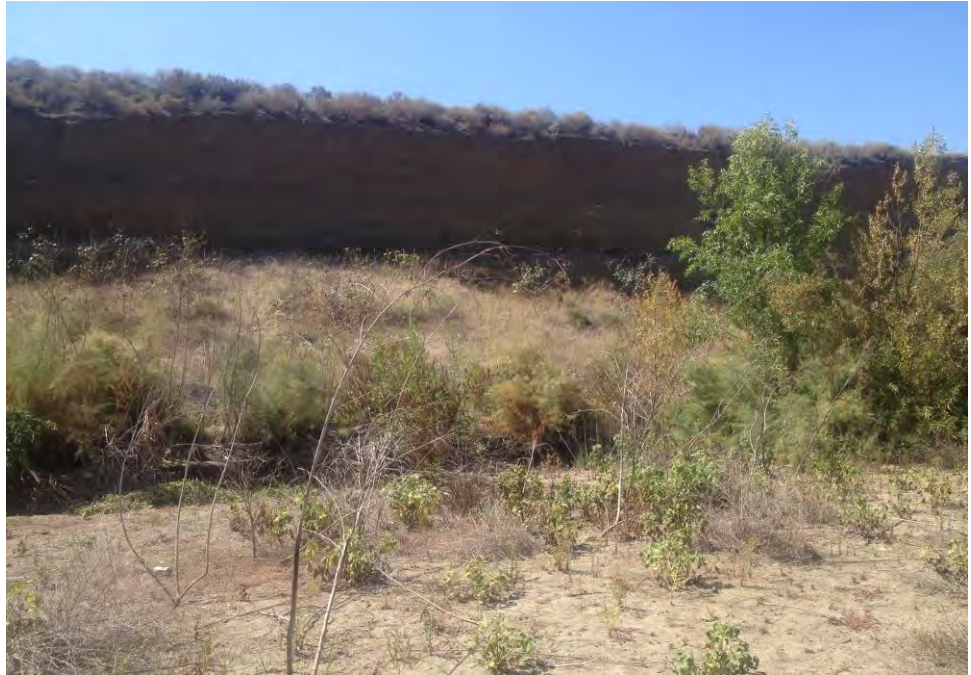
Photograph 3: Central portion of slope failure in Area 1 adjacent to Villa Park Road.

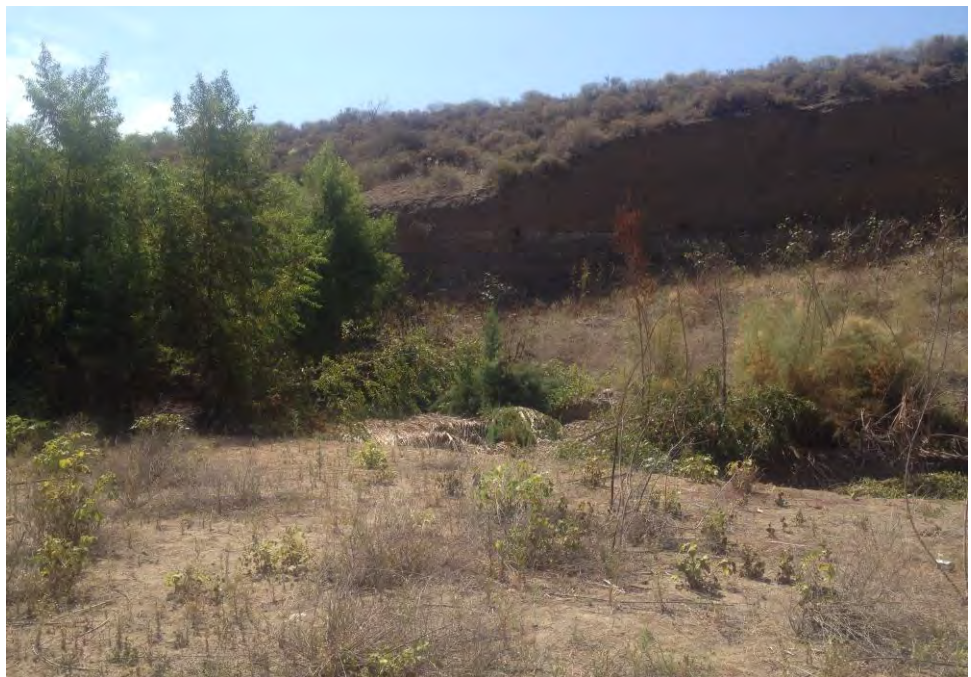
Photograph 4: Easter portion of slope failure in Area 1 adjacent to Villa Park Road.

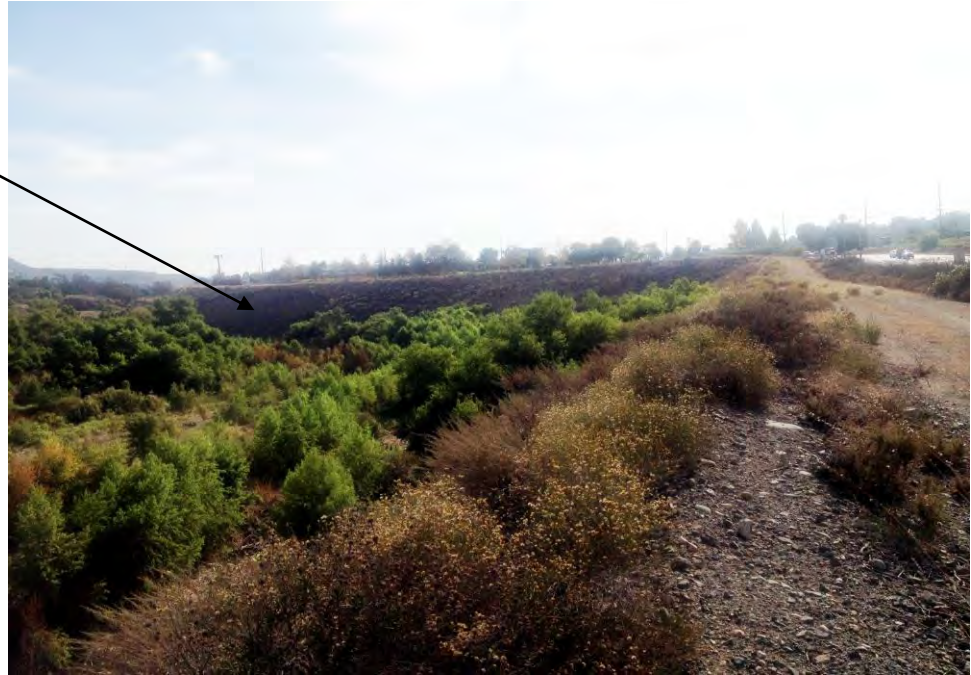
Area 2 is located on the eastern embankment slope which is adjacent to Oak Ridge Private School and the northern end of North Santiago Boulevard (Appendix A, Photograph 5). The topographic expression of the erosion is generally reflected in the topographic map provided by OCWD. The area of erosion is approximately 700 feet in length, however, the northeastern approximately 200 feet of the erosion area is located outside OCWD property. It is our understanding that this portion of the eroded area is within property owned by the County of Orange.

Photograph 5: Looking northeast toward Area 2 slope failure. Photograph also shows thick vegetation growth in the basin bottom.

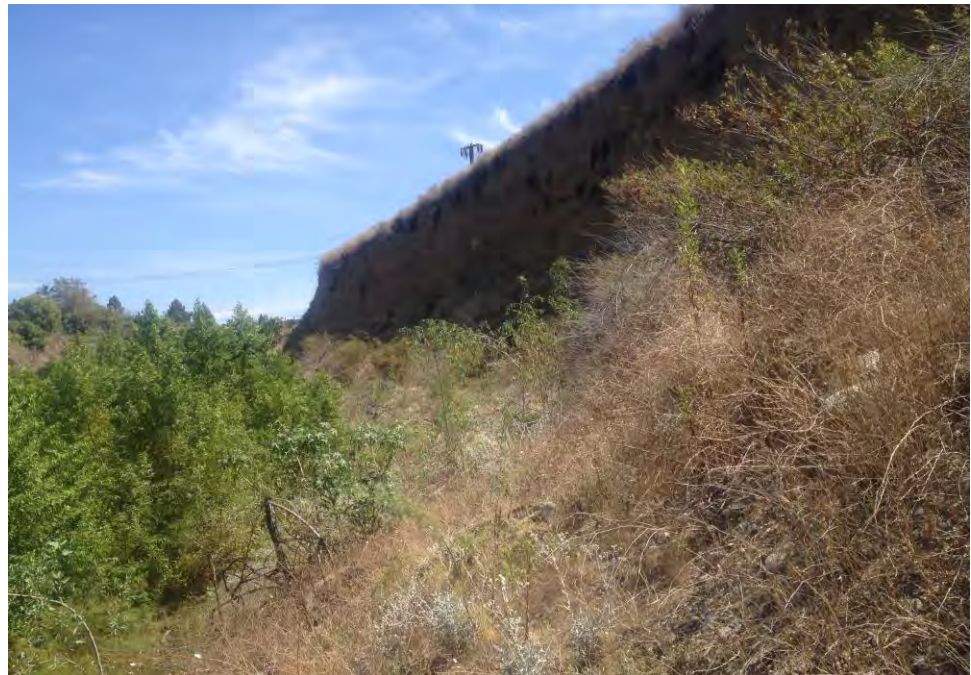
Photograph 6: Southwest portion of slope failure in Area 2 adjacent to Oakridge Private School.

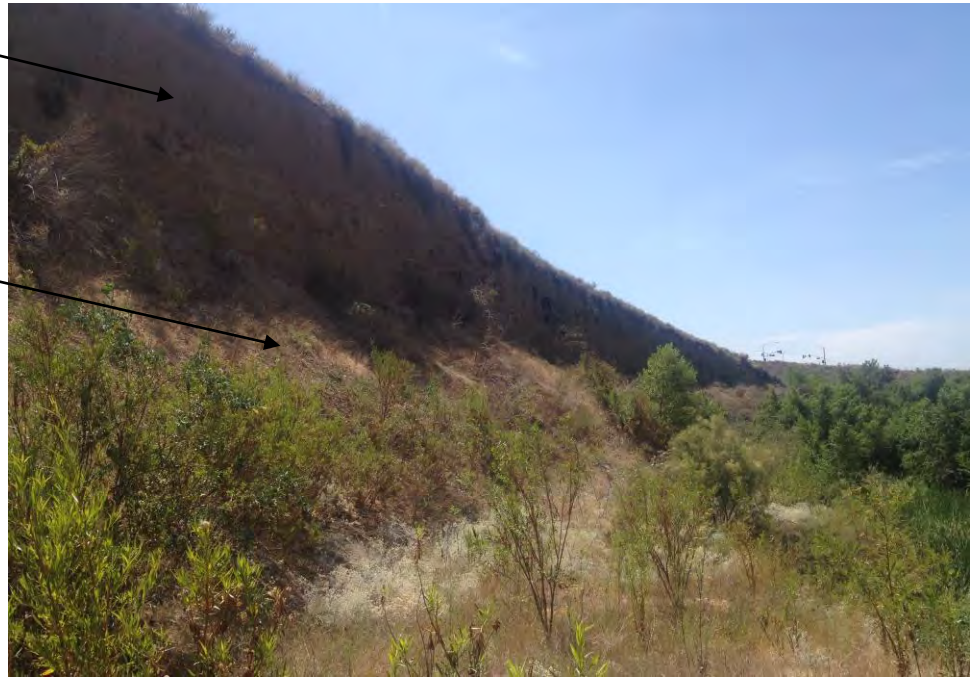
**Area 2 - approximately
35-foot-high near-
vertical erosion**

Eroded soil debris

Photograph 7: Central and southwest portions of slope failure in Area 2 adjacent to Oakridge Private School.

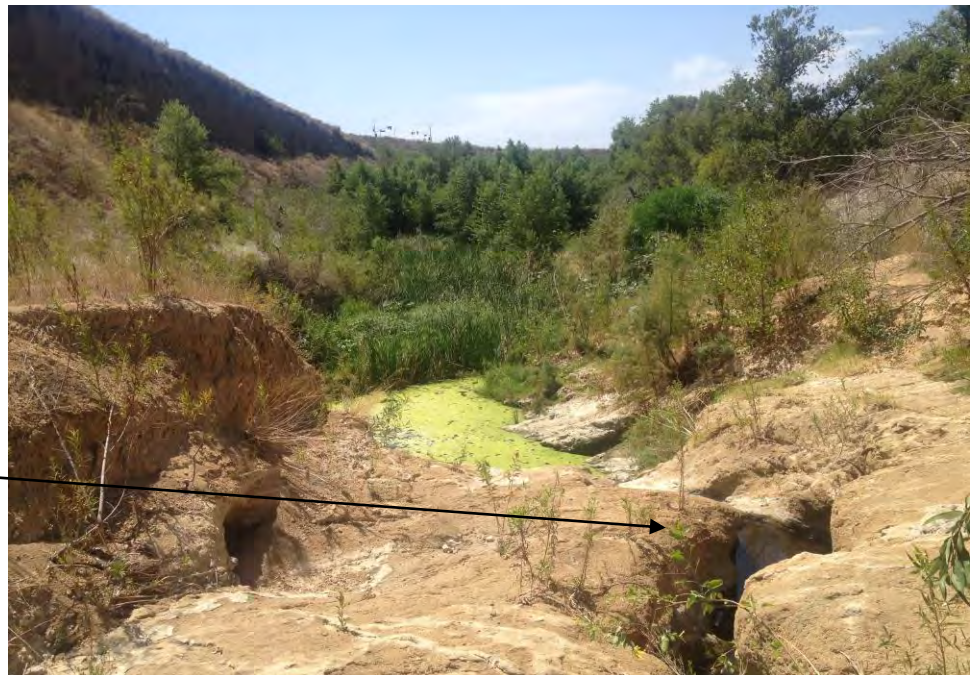
**Incised sandstone
bedrock near the
base of Area 2**

Photograph 8: Current flow line of Santiago Creek incising into bedrock and ponding of surface water adjacent to base of Area 2.

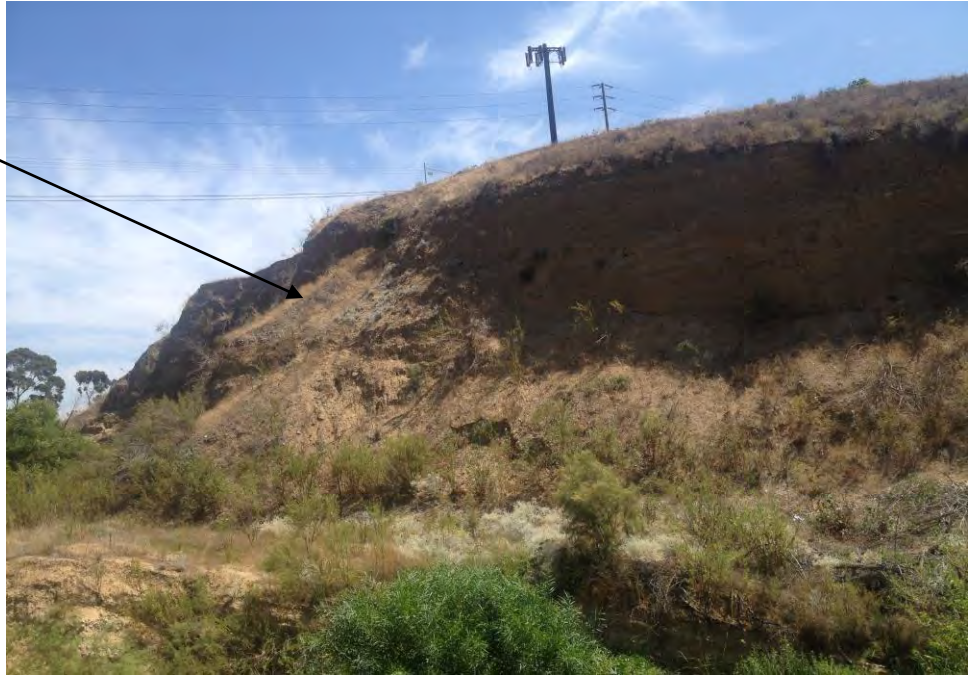
Soil Slump

Photograph 9: Relatively large soil slump near north end of Area 2.

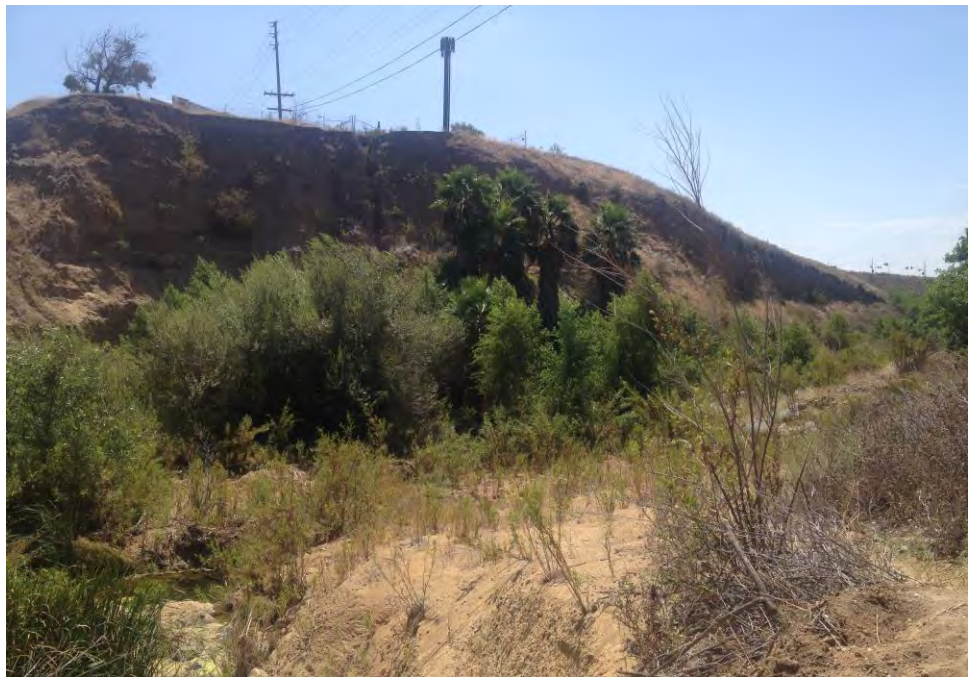
Photograph 10: Northeast end of Area 2 below North Santiago Boulevard cul-de-sac where a bridge was destroyed in the 1969 flood event.

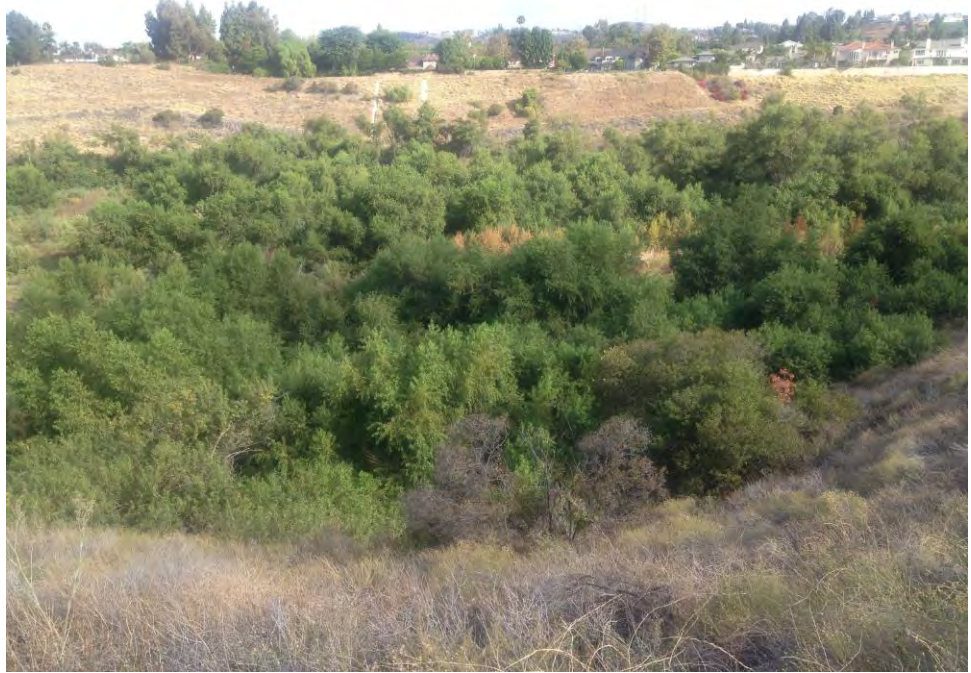
Photograph 11: Looking northwest across basin, photograph shows thick vegetation growth on the lower portions of the slope and basin bottom.

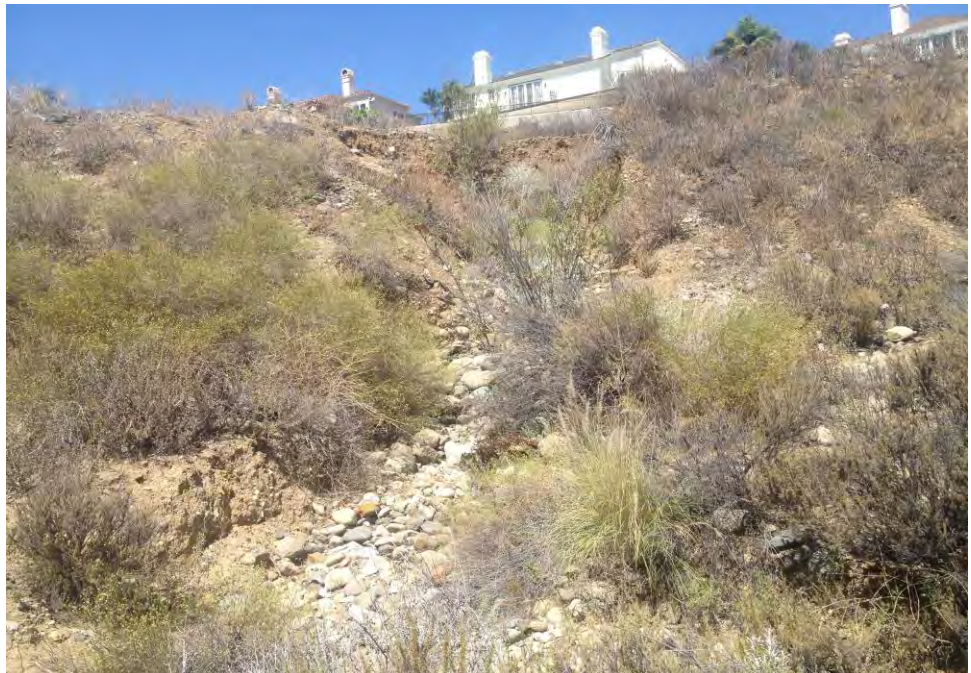
Area 3 is located near the northeast corner of the basin, northwest of Area 2 (Figure 2). The erosion is within the basin interior and begins at the top of a relatively flat area between the creek flow line and the northern embankment slope. The erosion consists of a relatively narrow erosion gully that has side scarps on the order of 2 to 6 feet deep (Appendix A, Photograph 12).

The primary cause of erosion in Area 3 is uncontrolled surface water flow from the relatively level area between the creek and the northern embankment slope. Water flowing over the top of the slope is resulting in incising, or down-cutting, of the soil material comprising the slope. The erosion gully may continue to widen and retreat toward the northern embankment slope if not mitigated. Eroded debris may also contribute to the ponding condition that has occurred between Areas 2 and 3.

Photograph 12: Approximately 2- to 6-feet-deep erosion in slope area within the basin, Area 3.

- Repair of the erosion gully may be accomplished by removing the loose debris from the bottom and filling the void with compacted fill.

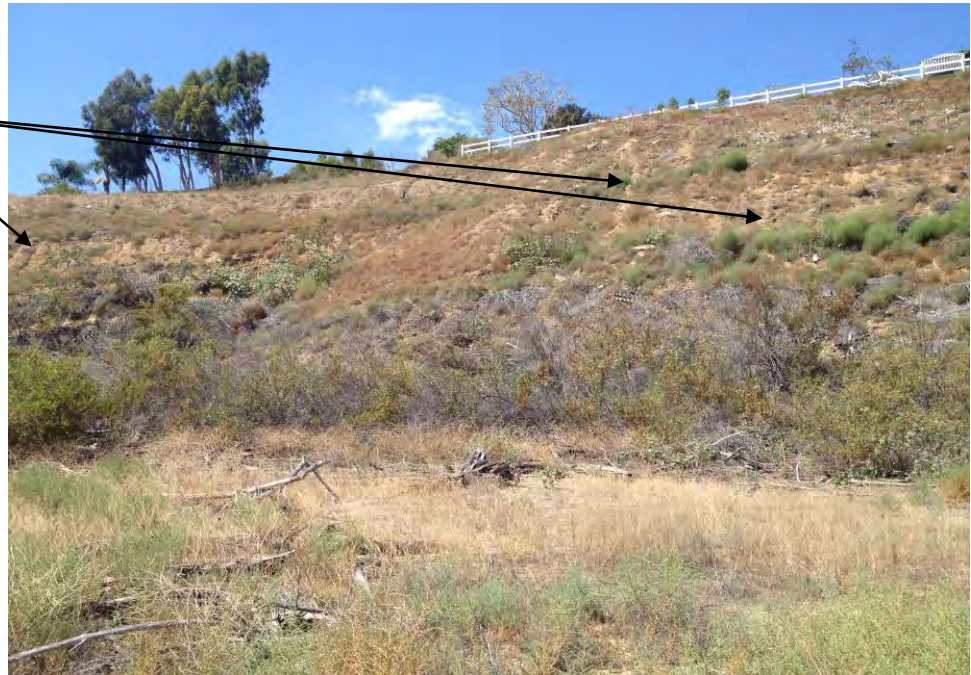
The primary cause of erosion in Area 4 is uncontrolled surface water flow on the embankment slope and the steepness of the slope. The absence of concrete v-ditch terrace drains and downdrains allow water flowing downslope to reach velocities that result in erosion of the granular soils that comprise the slope. The erosion rills in Area 4 may continue to deepen and widen during heavy and/or prolonged rainfall. The northern embankment slope areas that have drainage improvements were performing relatively well at the time of our site reconnaissance; however, the existing v-ditches on the eastern portion of the northern embankment slope should be cleared of obstructions, including maintaining rip rap energy dissipaters at the base of the downdrains.

**Typical
Erosion
Rills**

Photograph 13: Area 4 - Erosion rills on south-facing slope that does not have concrete v-ditch drainage improvements.

- Periodic maintenance to repair erosion rills in Area 4 is anticipated. To reduce the rate of erosion in the portions of the slope that are approximately 1.4:1 (horizontal to vertical) or flatter, the slope surface could be smoothed with a small dozer to fill-in the shallow erosion rills and the surface of the slope recompact. Following recompaction, re-vegetating the slope face is recommended and straw wattles may be placed on the slope face at approximately 15-foot vertical intervals to reduce water flow velocities down the slope face.

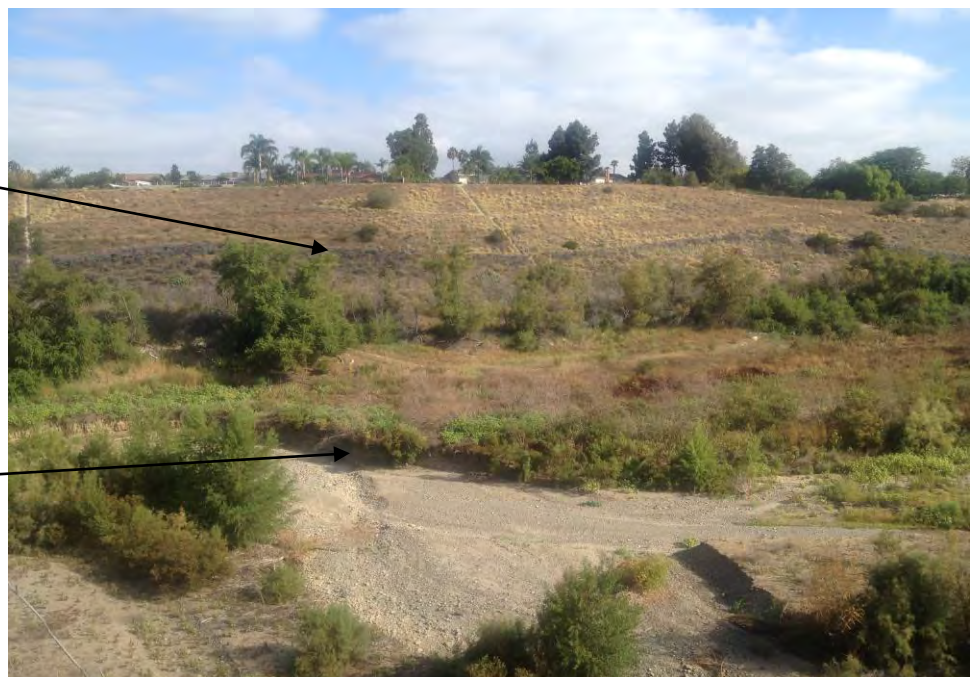
**Line of dead brush
stockpiled on the north
basin slope**

**Near-vertical
flood bank in
the interior of
the basin**

Photograph 14: South-facing slope constructed with concrete v-ditches do not show signs of significant erosion. Dead brush has been stockpiled adjacent to the lower v-ditch. Photograph also shows a near-vertical interior flood bank.

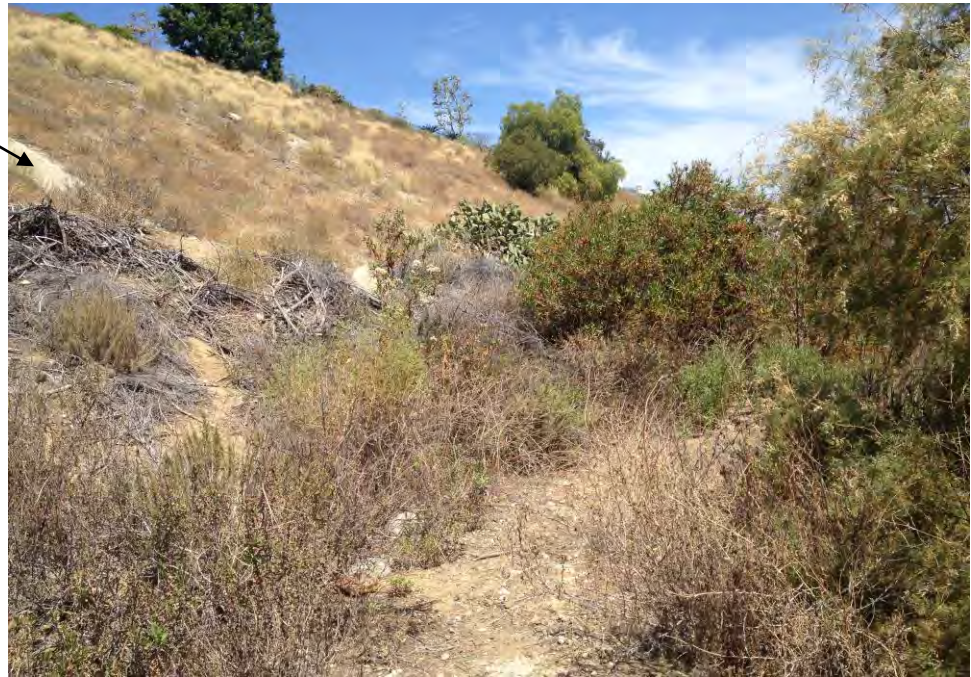
**Obstructed
Down drain**

Photograph 15: Concrete v-ditch down drain obstructed by vegetation.

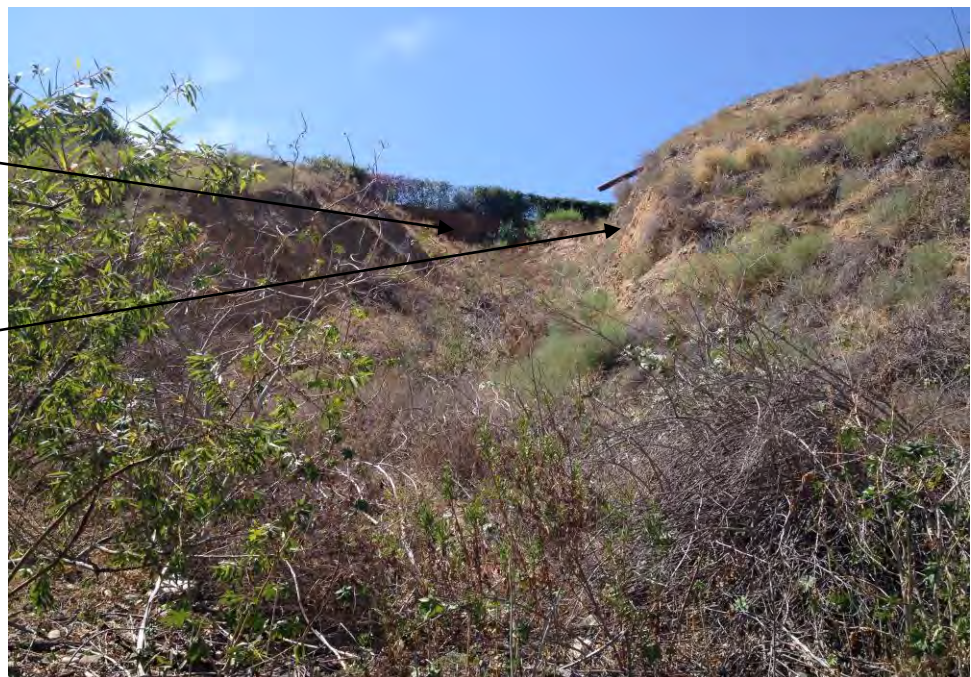
Area 5 is located near the top of the embankment slope near the west corner of the basin (Figure 2). The embankment slope in this area is relatively steep, up to approximately 1:1 (horizontal to vertical). The erosion in this area was first observed in the 1970 aerial photographs at about the same time that the grading for the residential property to the west and north was being performed. Over the years, the erosion gulley has widened and retreated to the west toward the adjacent residential property. Based on our aerial photograph review, a retaining wall was constructed near the rear property line of the residential property between 2006 and 2007. The topography in Figure 2 shows the erosion prior to the retaining wall being constructed. The approximate location of the retaining wall was added based on our visual reconnaissance from below the gulley and our aerial photograph review. Access to the slope area is restricted due to the steepness and vegetation. The erosion gulley has relatively steep side slope that are estimated to be about 6 to 10 feet in height (Appendix A, Photograph 16).

The primary cause of erosion in Area 5 is uncontrolled surface water flow on the relatively steep, approximately 1:1 (horizontal to vertical) embankment slope. The primary concern in Area 5 is continued widening of the erosion gully and the possible continued westward retreat of the gully.

**Retaining Wall
constructed at top
of slope**

**Steeply-eroded side
slopes**

Photograph 16: Area 5 - Erosion from beneath residential property extending down basin slope with approximately 6 to 10-foot-high near-vertical side slopes. A retaining wall has been constructed at the top of the slope that is not depicted on Figure 2.

- To reduce the potential for further erosion of the gulley and the adjacent portions of the approximately 1:1 slope, placement of fill against the slope to reduce the slope ratio to approximately 2:1 (horizontal to vertical) may be considered. This would involve remedial grading to remove loose soil below the toe of the new fill slope to construct a fill key and to remove loose soil accumulated in the gulley. Typical benching into the existing slope as fill placement progressed should be performed.
