Smith Basin Improvement Project

**PRELIMINARY GEOTECHNICAL EVALUATION
SMITH BASIN SCOUR ASSESSMENT
ORANGE COUNTY WATER DISTRICT
VILLA PARK, CALIFORNIA**

November 20, 2015
Project No. 209509001

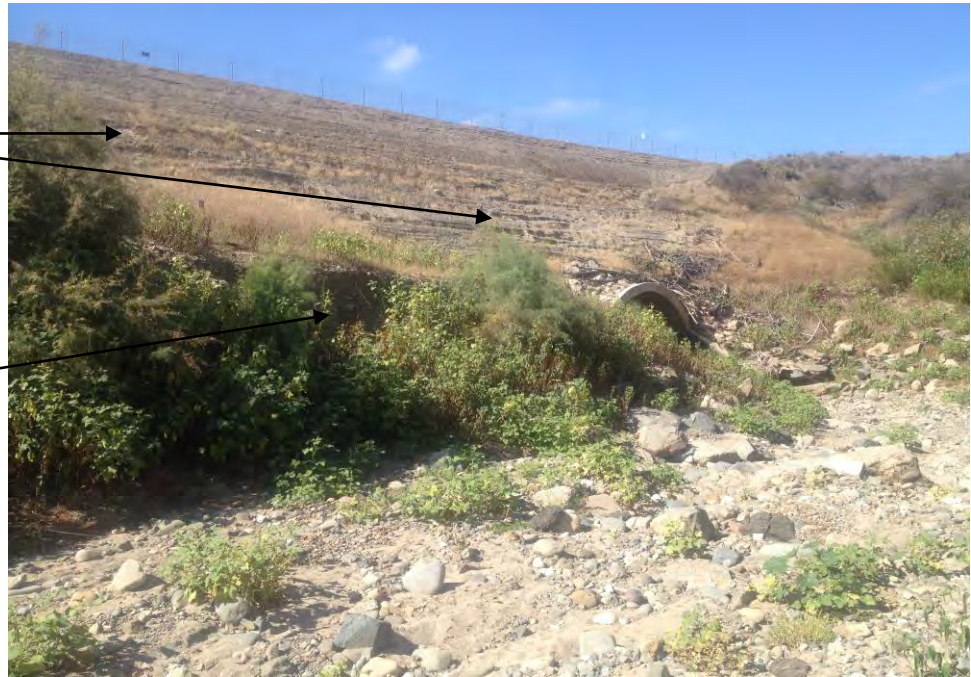
The primary cause of erosion in Area 6 below Villa Park Road is wave action during windy conditions when the basin is impounding water. A lack of vegetation on the slope is causing more erosion in Area 6 in comparison to the other slopes that are also impacted by wave action. The erosion on the slope above the outlet structure may continue to expand and new wave-cut benches may form if not mitigated.

**Wave-cut erosion
benches**

**Near-vertical erosion
bank near basin outlet
structure**

Photograph 17: Area 6 - Fill slope above culvert with wave-cut erosion benches up to approximately 18 inches high and near-vertical erosion near basin outlet structure.

- Similar repair methods that are recommended for Area 4 may be used in this area. The slope surface could be smoothed with a small dozer to fill-in the shallow erosion rills, the surface of the slope recompacted, and the slope re-vegetated with placement of straw wattles, as described in our recommendations for Area 4.
- Establishing a new channelized flow line of Santiago Creek and re-grading to widen the “bottle-neck” area just upstream of the outlet structure could be performed to mitigate the near-vertical erosion scarps in this area. Placement of rip rap in front of the outlet structure and along the sides will also help to reduce erosion.

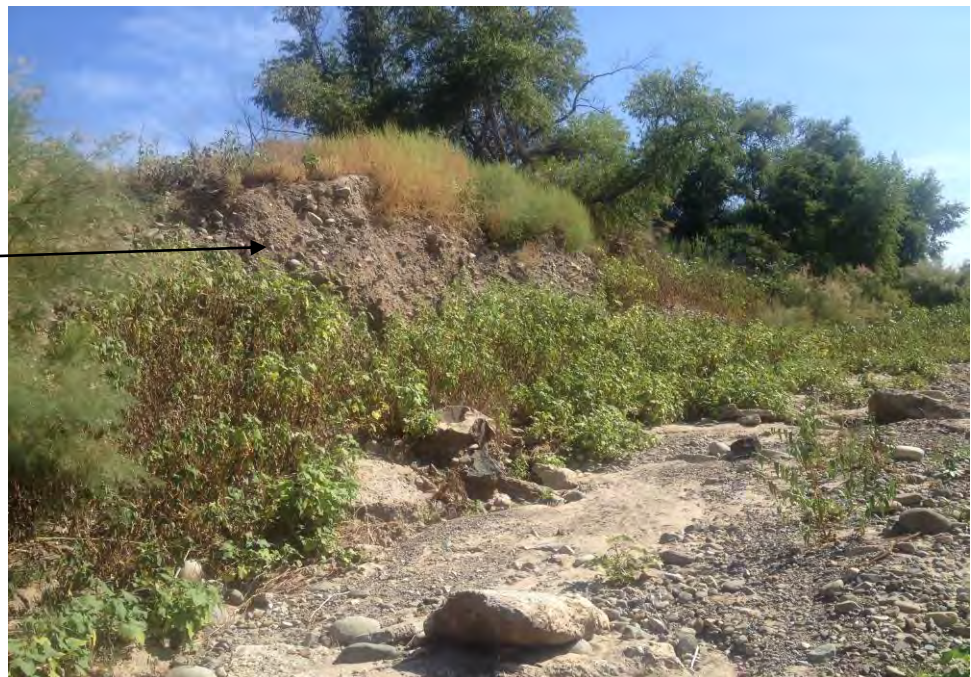
**Near-vertical erosion
bank near basin outlet
structure**

Photograph 18: Area 6 – Near-vertical erosion scarp upstream of outlet structure.
