Tree Survey Report

NAPA CREEKSIDE HOUSING PROJECT NAPA, NAPA COUNTY, CALIFORNIA

Revised July 2019 May 2019

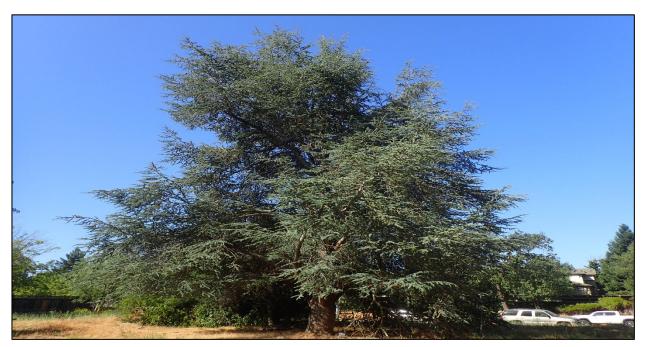
Photograph #1. Tree #765. 34" DBH Deodar cedar (*Cedrus deodara*) in the western portion of the Study Area proposed for removal.

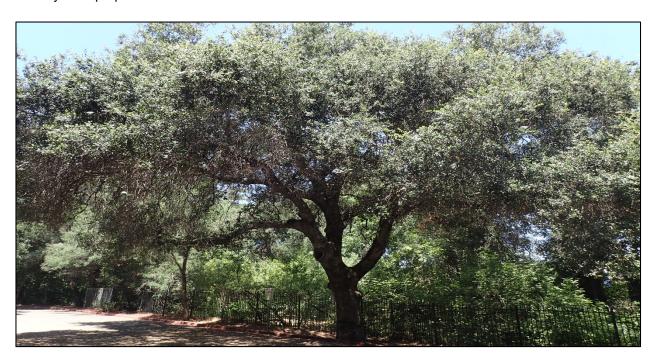
The largest protected native tree surveyed was a 69.1-inch multi-trunk valley oak (tree #761). The largest single-trunk protected native tree surveyed was a 33.0-inch coast live oak (tree #816).

Photograph #2. Tree #816. 33" DBH coast live oak (*Quercus agrifolia*) protected tree in the eastern portion of the Study Area that will be retained.

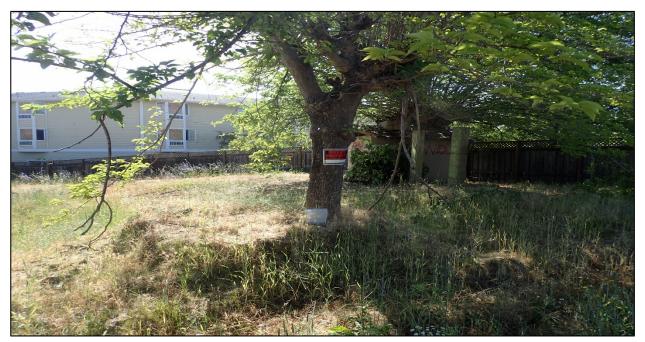
Photograph #3. Tree #769. 13.9" DBH white mulberry (*Morus alba*) in the center of the Study Area proposed for removal.

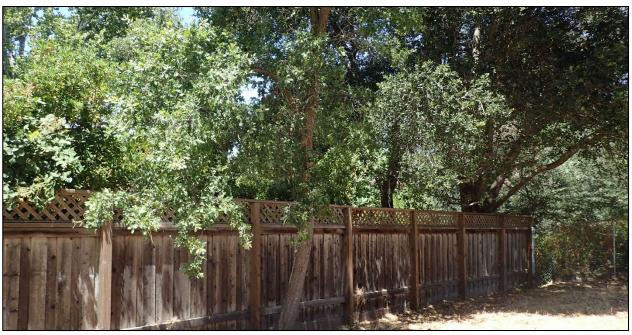
Photograph #4. Tree #836. 7.5" DBH valley oak (*Quercus lobata*) in the southern portion of the Study Area adjacent to an existing fence that will be retained.

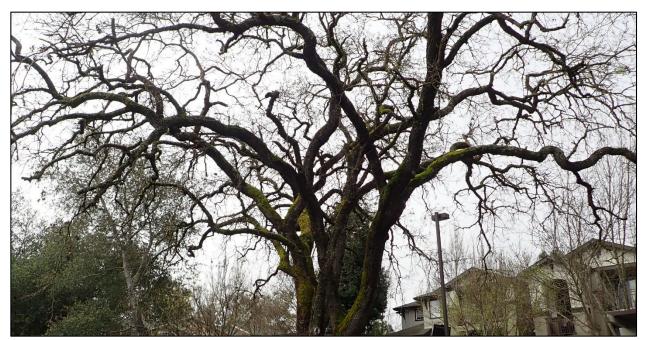
Photograph #5. Tree #367. 51.5" DBH valley oak (*Quercus lobata*) protected tree in the western portion of the Study Area proposed for removal.

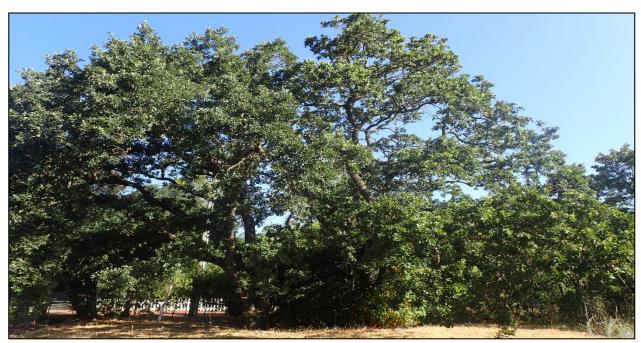
Photograph #6. Tree #761. 69.1" DBH valley oak (*Quercus lobata*) protected tree in the northern portion of the Study Area that will be retained.
