RE: Salvador Channel Stability Assessment at the Proposed Valle Verde and Heritag House Continuum of Housing Project, 3700 Valle Verde Drive, Napa, CA

Field Inspection, Channel Cross-Section Survey and Hydrogeomorphic Conditions Assessment: Salvador Channel

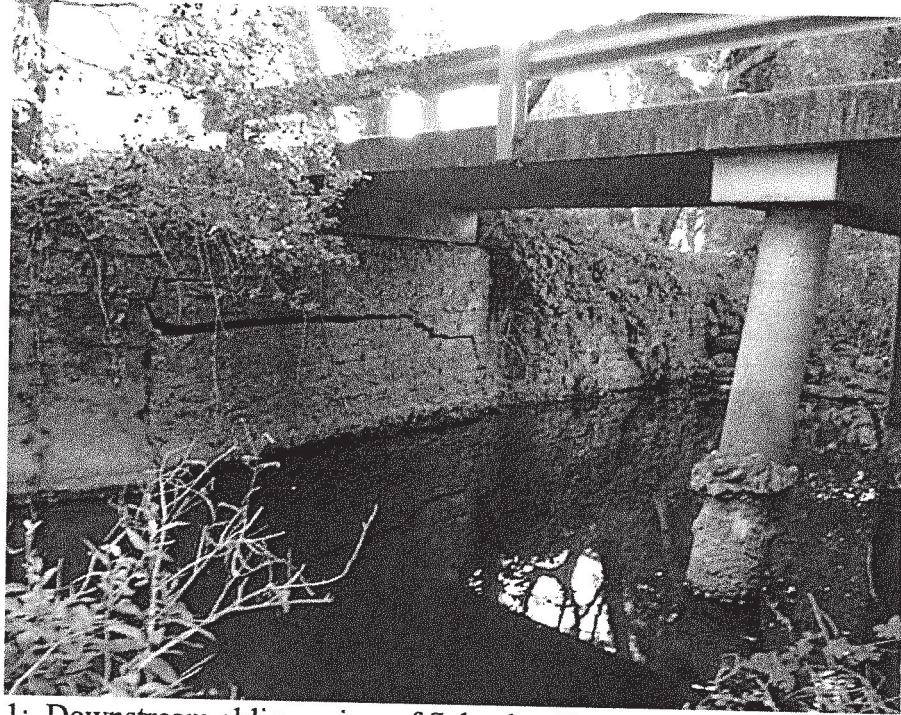
CH inspected the reach of the Salvador Channel extending from the old bridge upstream of the project site to just downstream of the vacant Sunrise assisted living facility building. The existing bridge lies just upstream of the Project boundary, although it has been proposed for partial removal in association with Project implementation. Concrete bridge abutments support the existing bridge, and a 2-3 ft. high grouted rock wall constructed just downstream of the bridge serves as a local grade control to protect the bridge piers and east abutment from excessive channel scour (Photo 1, see attached Photo Log). As can be inferred from Photo 1, the rim of rough grout visible around the piers coincided with the original level of the bridge undercrossing, which probably consisted of a grouted concrete lining that deteriorated and failed at some point in the past. The photo also depicts the severity of the cracking of the east abutment. *Vandivere's Sept. 2019 re-inspection of the channel reach revealed that a portion of the cracked east sidewall below and immediately upstream of the abutment has now broken away from the downstream portion that underlies the east bridge abutment. Once this failed portion of the mortared sidewall fails completely, it will collapse into the channel and will expose the remainder of the downstream portion of the wall to backcutting, which will accelerate the failure of the remaining side wall.*

Photo 1: Downstream oblique view of Salvador Channel at the existing bridge crossing and the severely cracked east abutment. Note the remnant ring of grouted rock on the bridge pier, approximately two feet above the ponded water level.

- Removal of the Zerba Bridge, which will improve local flood conditions overall, will likely need to include removal of the failing west bank wall that supports the current bridge foundation. Its removal will require provisions for streambank stabilization using biotechnical means and acquisition of regulatory and resource agency permits.

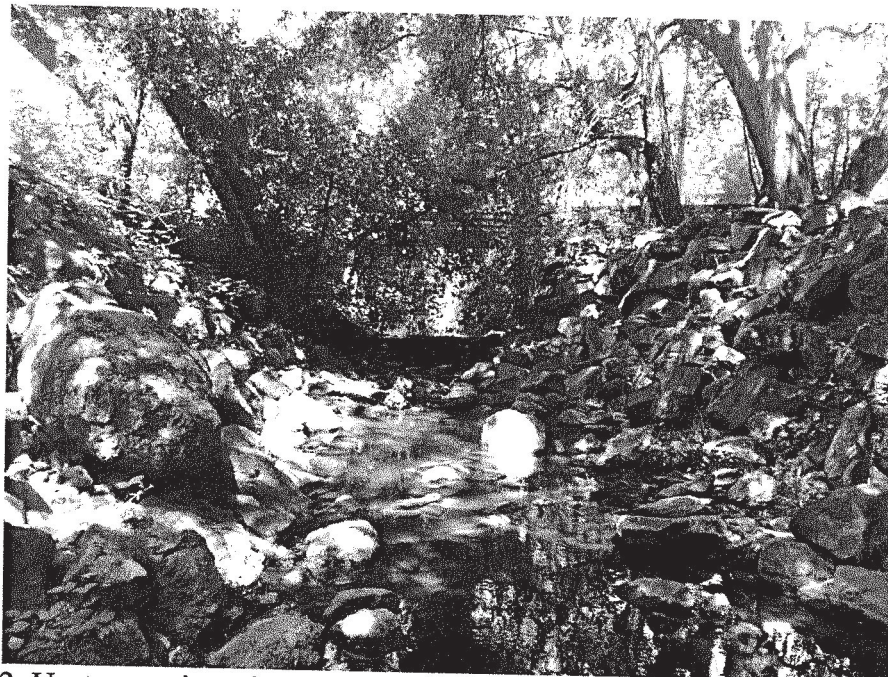
Downstream of the grade control, both the east and west banks are lined with large 1-3 ft. diameter rip-rap (Photo 2), the placement of which may have been concurrent with the bridge construction, or it was necessitated by increased scour downstream of the concrete armored bridge crossing.

Photo 2: Upstream view along the Channel reach immediately downstream of the existing bridge, which is visible behind the tree foliage. The 2-3 ft. high grouted rock wall/grade control structure crosses the channel at the shaded center of the photo.

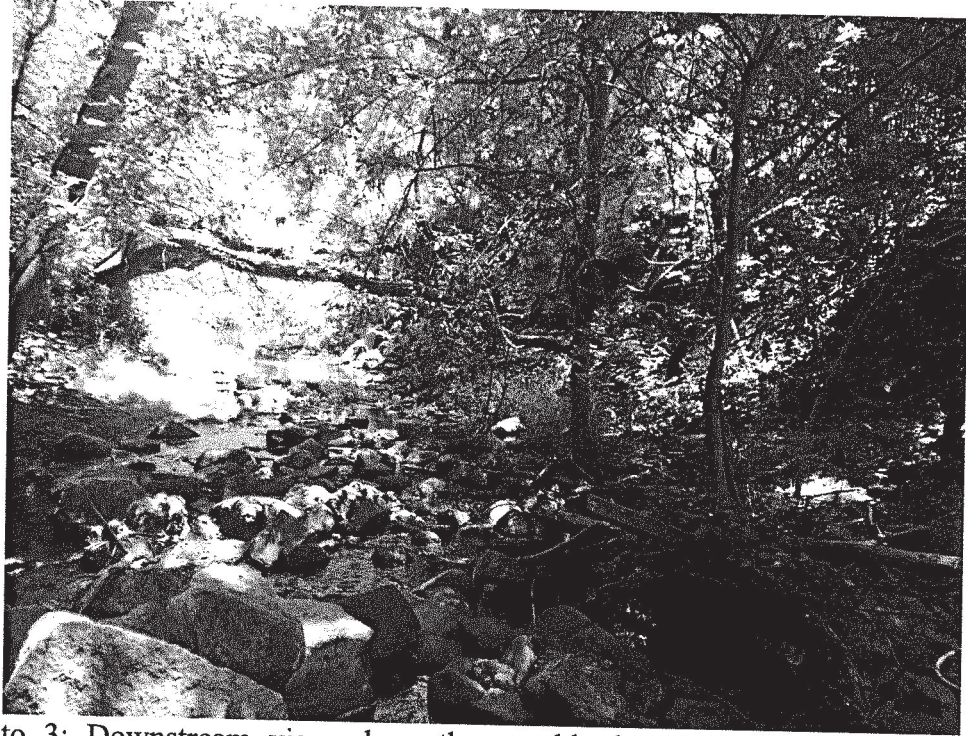
It appears that a portion of the rip-rap placed downstream of the bridge has dislodged and fallen into the center of the channel. Some of this dislodged rock was subsequently transported downstream during major floods and has formed the skeletal elements of a roughly longitudinal and discontinuous mid-channel bar that extends downstream past the northern boundary of the abandoned assisted living building parcel (Photo 3). The larger boulder-sized elements have forced low flows to bi-furcate to either side of the bar.

Photo 3: Downstream view along the roughly longitudinal and discontinuous mid-channel bar formed by collapsed boulders transported a short distance downstream from the upstream riprap revetments.

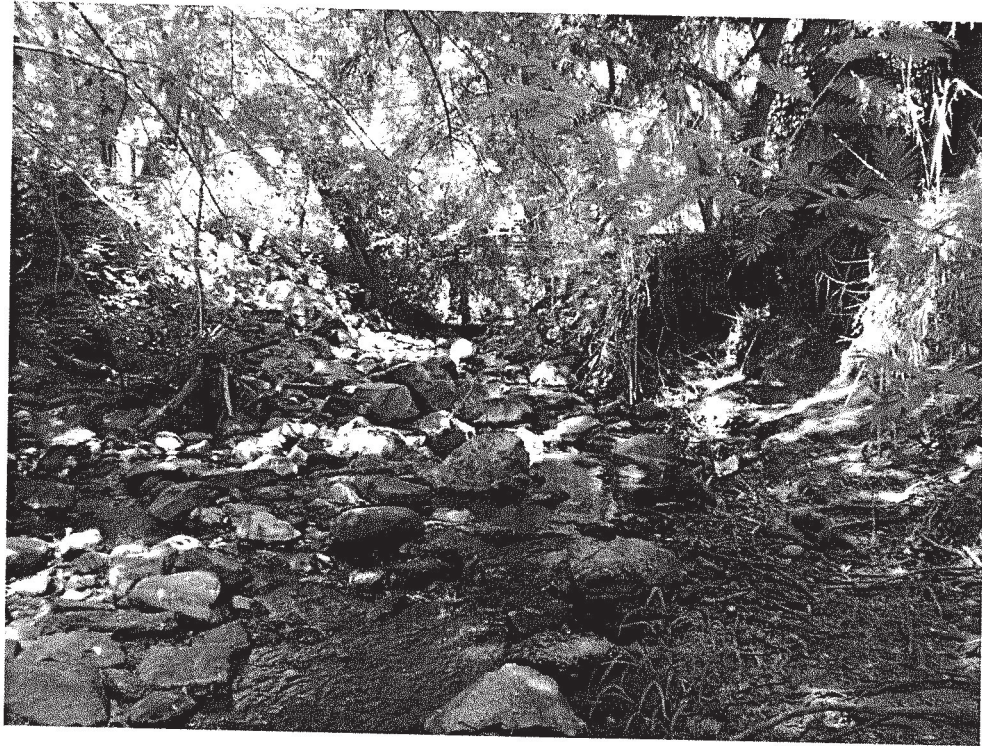
Immediately downstream of the main riprap installation, portions of the east bank have been severely eroded (Photo 4). West bank erosion is also evident in this reach, which extends onto

Photo 4: View looking upstream from the analyzed cross-section. Note the severe erosion along the east bank (at right), immediately downstream of the riprapped banks.

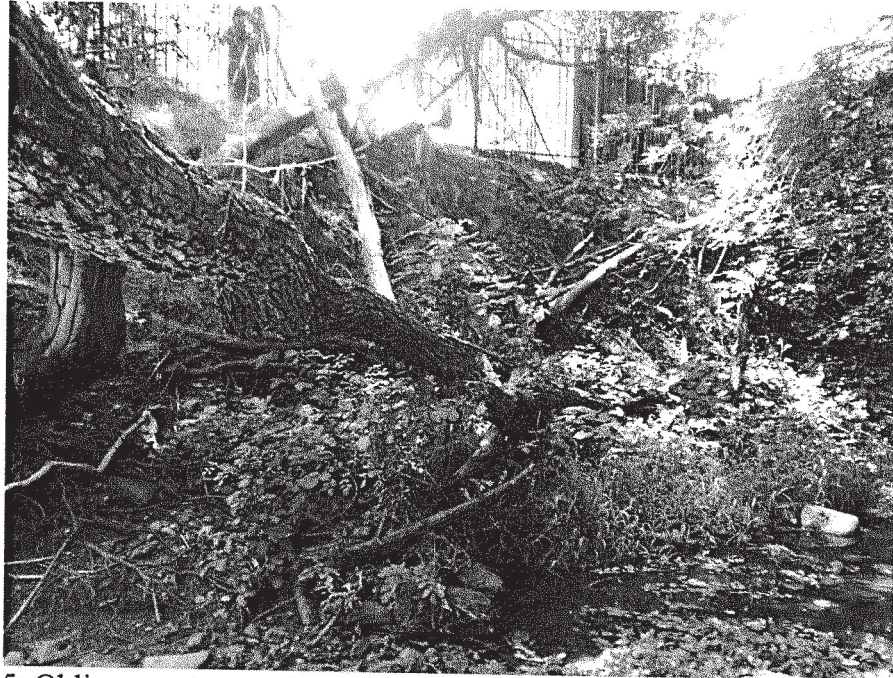
The channel cross-section selected for the 2014 stability analysis was taken through this short reach, as shown in Figure 2. Photos 5 and 6 show the local west bank condition. Photo 5 is an oblique view of the west bank that depicts the steep local slope (approx. 0.5:1 H:V) and the proximity of the top of bank to the asphalt parking area. The total station visible at the upper left of the photo was set atop the asphalt adjacent to the curb, about five feet from the fence. The cross-section extended directly across the channel from the set-up position. Photo 6 is a close-up of the bank immediately downstream of the analyzed cross-section, which was unvegetated, but of similar composition to the bank at the section location. The photo shows the low and mid-bank region, including a lens of fine grained sediment infused with gravel and cobble. This lens likely represents a low terrace deposit of alluvium that with incision has been eroded, along with the finer-grained material that overlies it further upslope. The thickness of this lens is approximately 3-4 feet and is underlain by a more resistant claystone. The claystone layer was also observed further downstream where the local west bank is vertical and overlain by similar fine-grained material, as well as across the channel where it forms stable low terraces. The tree rooting evident in Photo 6 is an extension of one of the dead trees visible in Photo 5, and has been lending some stability to the low bank zone. However, as these trees are sufficiently undermined and collapse during significant flood events, the root systems can also be upended and create local obstructions to flow and diversion of these flows onto the exposed banks, resulting in substantial bank erosion and/or slump failures.

Photo 5: Oblique upstream view of the west bank- the analyzed cross-section extended as a straight line along the line-of-sight of the total station at top left.

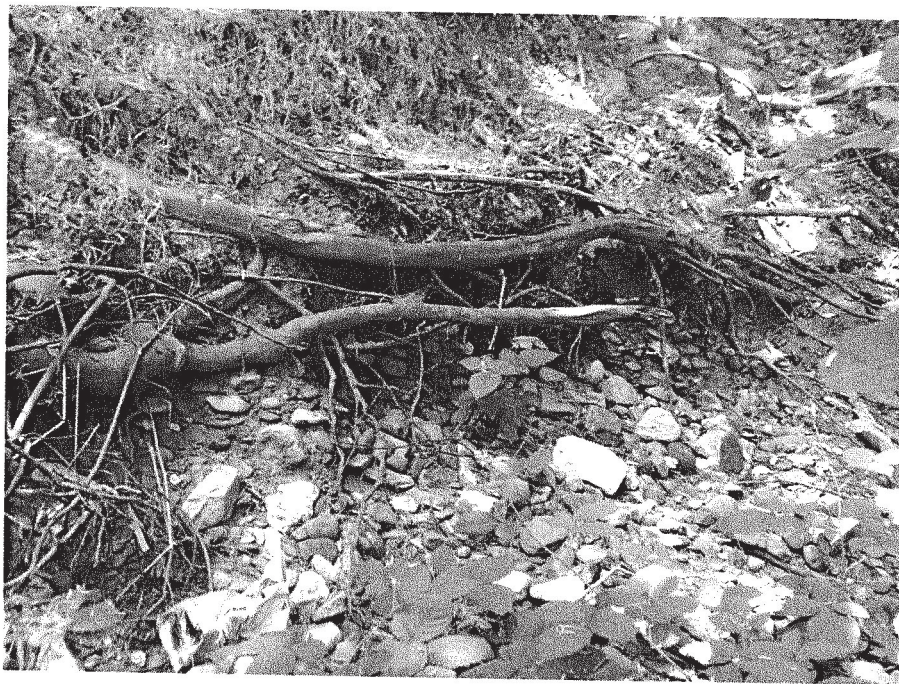
Photo 6: A close-up of the low to mid-bank zone of the west bank, immediately downstream of the analyzed channel cross-section location. Note the patch of still-intact bank soil infused with large gravel and cobble at mid-left under the tree root. Erosion of this lens of material produced the loose gravel and cobble on the lower terrace. The larger gravel-cobble component is absent in the mid-bank soils.

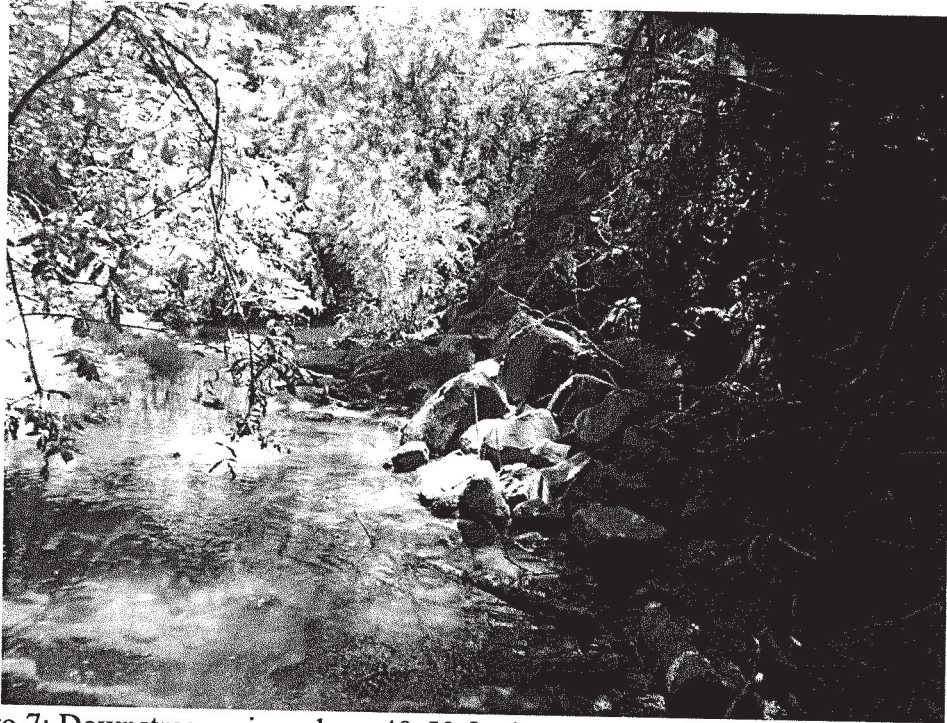
Rip-rap has been placed along a 40-50 ft. long section of the right bank, adjacent to and just downstream from the unrocked section that encompasses the analyzed cross-section (Photo 7). It appears that this rock was haphazardly dumped in response to localized bank erosion. Whereas the west bank riprap installed downstream of the bridge was placed with some attention to three-point bearing, a more stable method of placement, this downstream rock revetment is more uneven and no subgrade keying of the revetment is evident. Both lobes of the dumped rock extend out into the low flow channel.

Photo 7: Downstream view along 40-50 ft. riprap treatment of the west bank adjoining the vacant Project building's rear parking area. Note the boulders encroaching on the active flow zone of the channel.

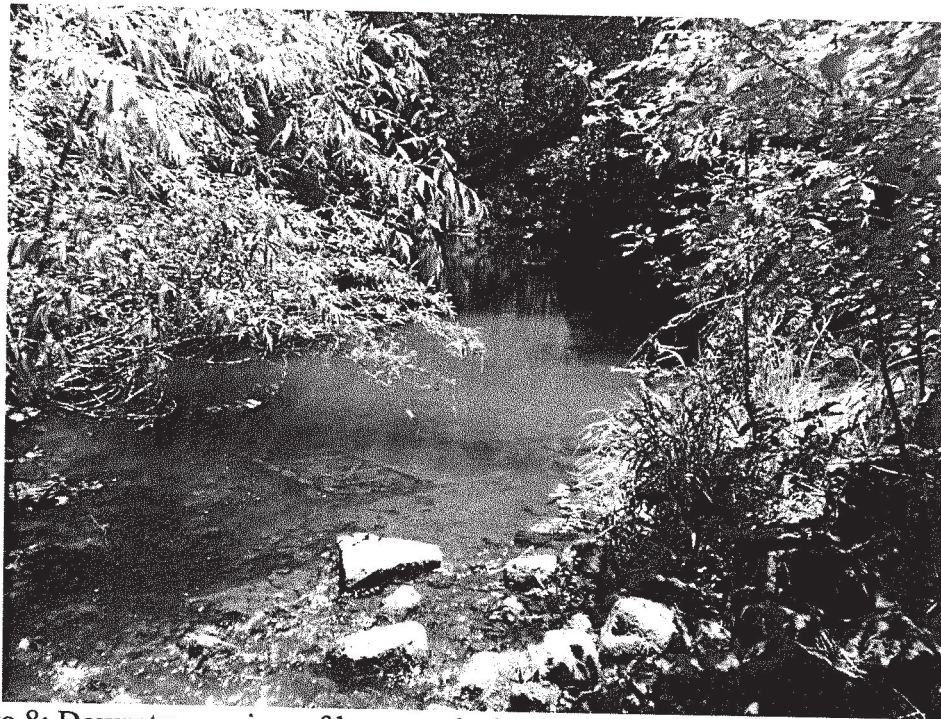
Immediately downstream of the west bank riprap shown in Photo 7, the channel bed form transitions from a very roughened riffle, with a local slope of 2.4 percent, to a long pool (Photo 8) with a milder slope. The pool extends downstream for a distance of 150-200 ft. before the channel enters a bend toward the southern property boundary. Within the pooled reach, the west bank is unarmored and vertical to nearly vertical. Non-native, invasive vines (e.g. ivy) are the dominant vegetal cover, where such cover exists. Some smaller concrete rubble was observed along the channel bottom through the pool reach. The second west bank soil sample was taken in a bare area toward the head of this reach.

Photo 8: Downstream view of lower end of the long riffle and the transition to the long pool that extends downstream from the lower end of the riprap zone in Photo 7 to roughly the southern property boundary.

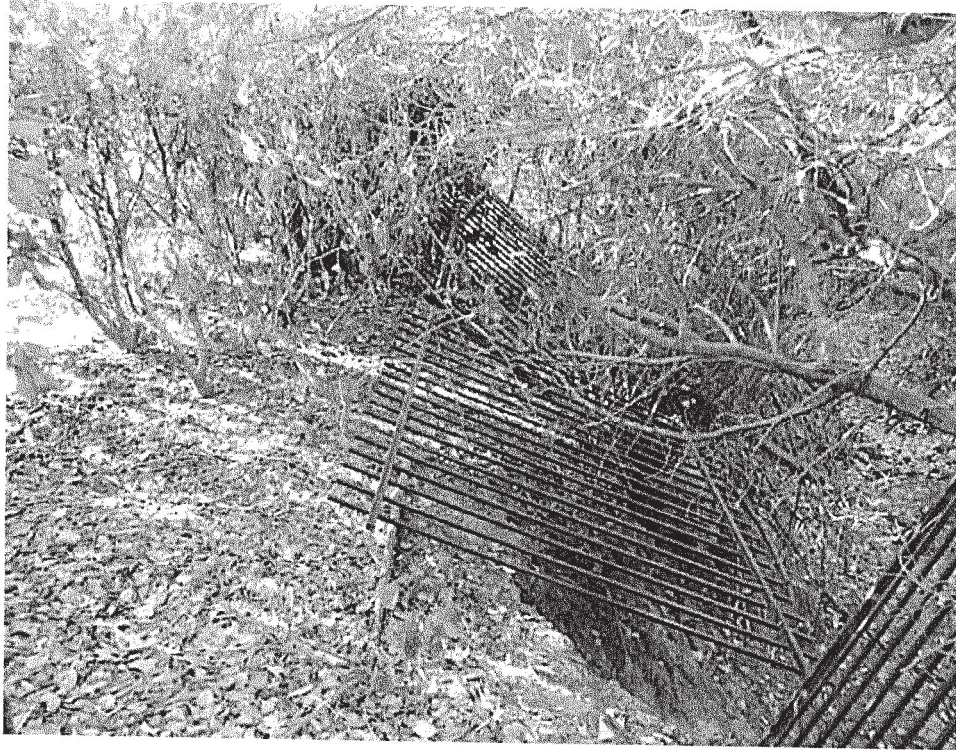
Downstream of the pool reach, the west bank forms the outer radius of a channel bend, which is typically more prone to bank erosion. The local west bank has experienced significant erosion through this bend and has undermined the iron property fence, as shown in Photo 9.

Photo 9 (Couresty of W. McGuire): Upstream view of the eroded west bank through a failed section of the existing property fence.
