Tree Protection and Preservation Plan

4265 El Camino Real Hotel Project

October 2018

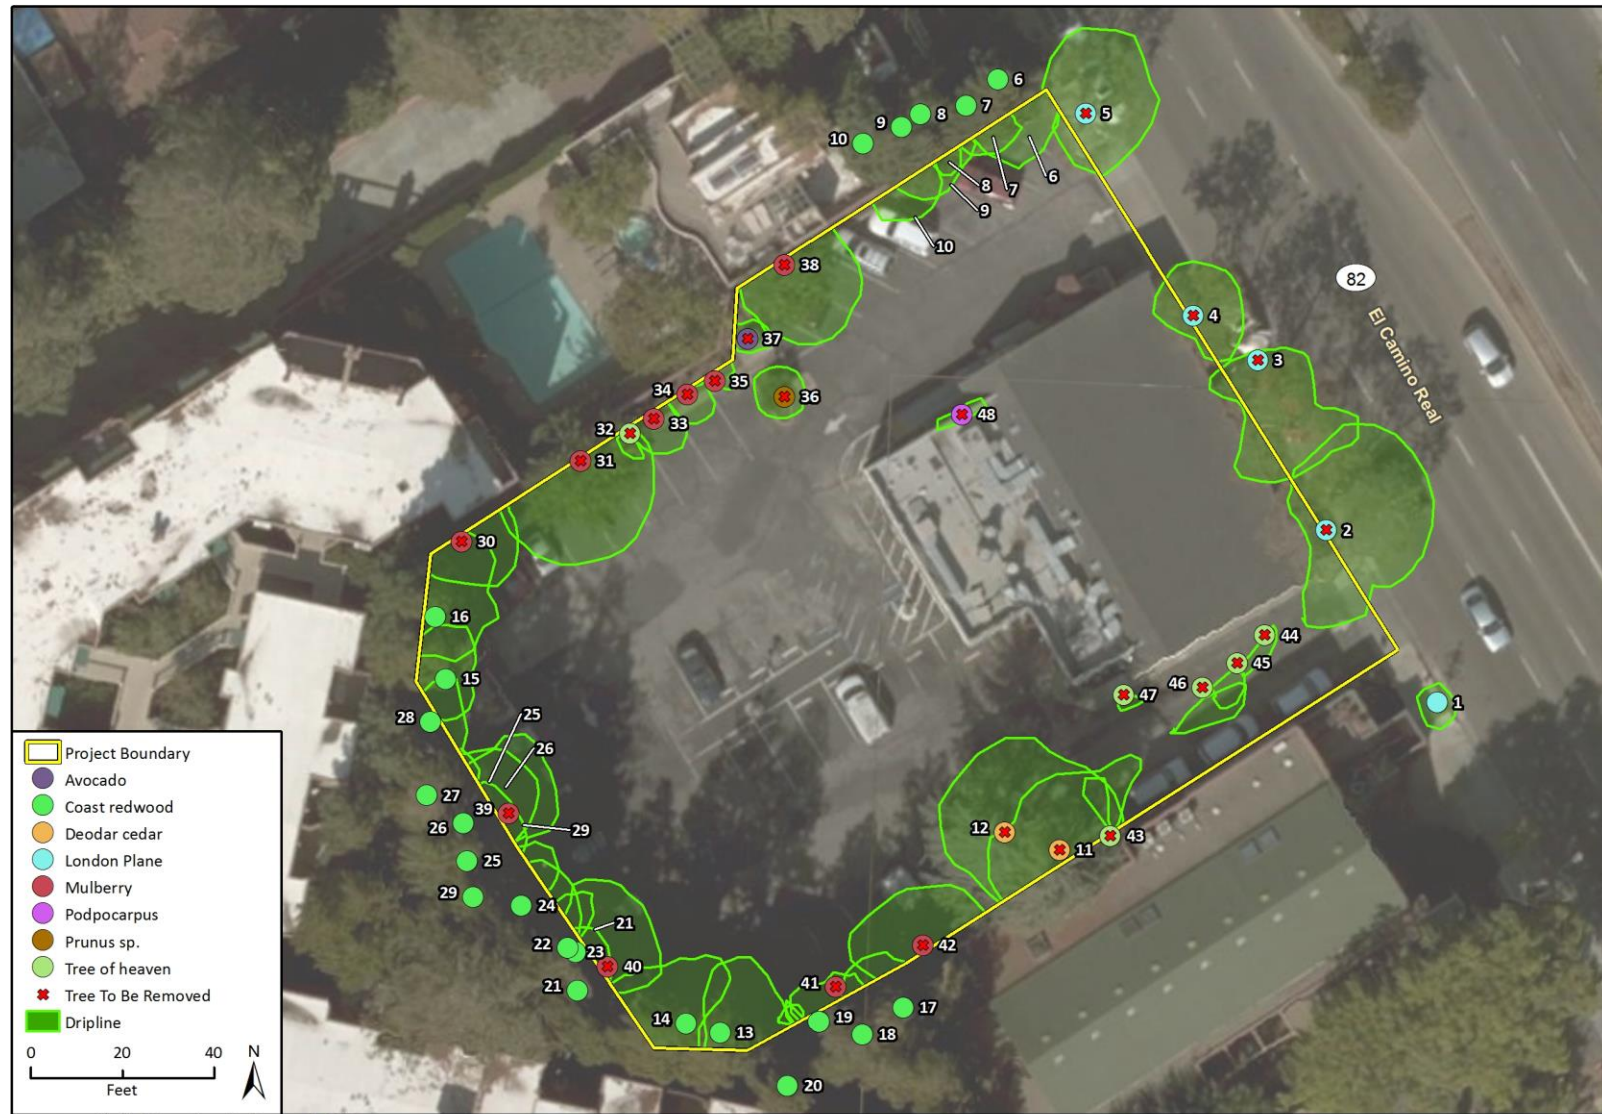
Figure 3 - Tree Locations

Four of the coast redwood trees (trees #13, 14, 15, and 16) are located within the project site in the northwest and southwest corners. The five London plane trees (trees #1, 2, 3, 4, and 5) are City of Palo Alto street trees located along El Camino Real immediately east of the project site. Coast redwood trees and street trees are considered Protected by the City of Palo Alto and are subject to protective measures, outlined in the Section 4 below. Table 2 below provides the updated data collected for all trees. Figure 3 depicts the locations of the surveyed trees.

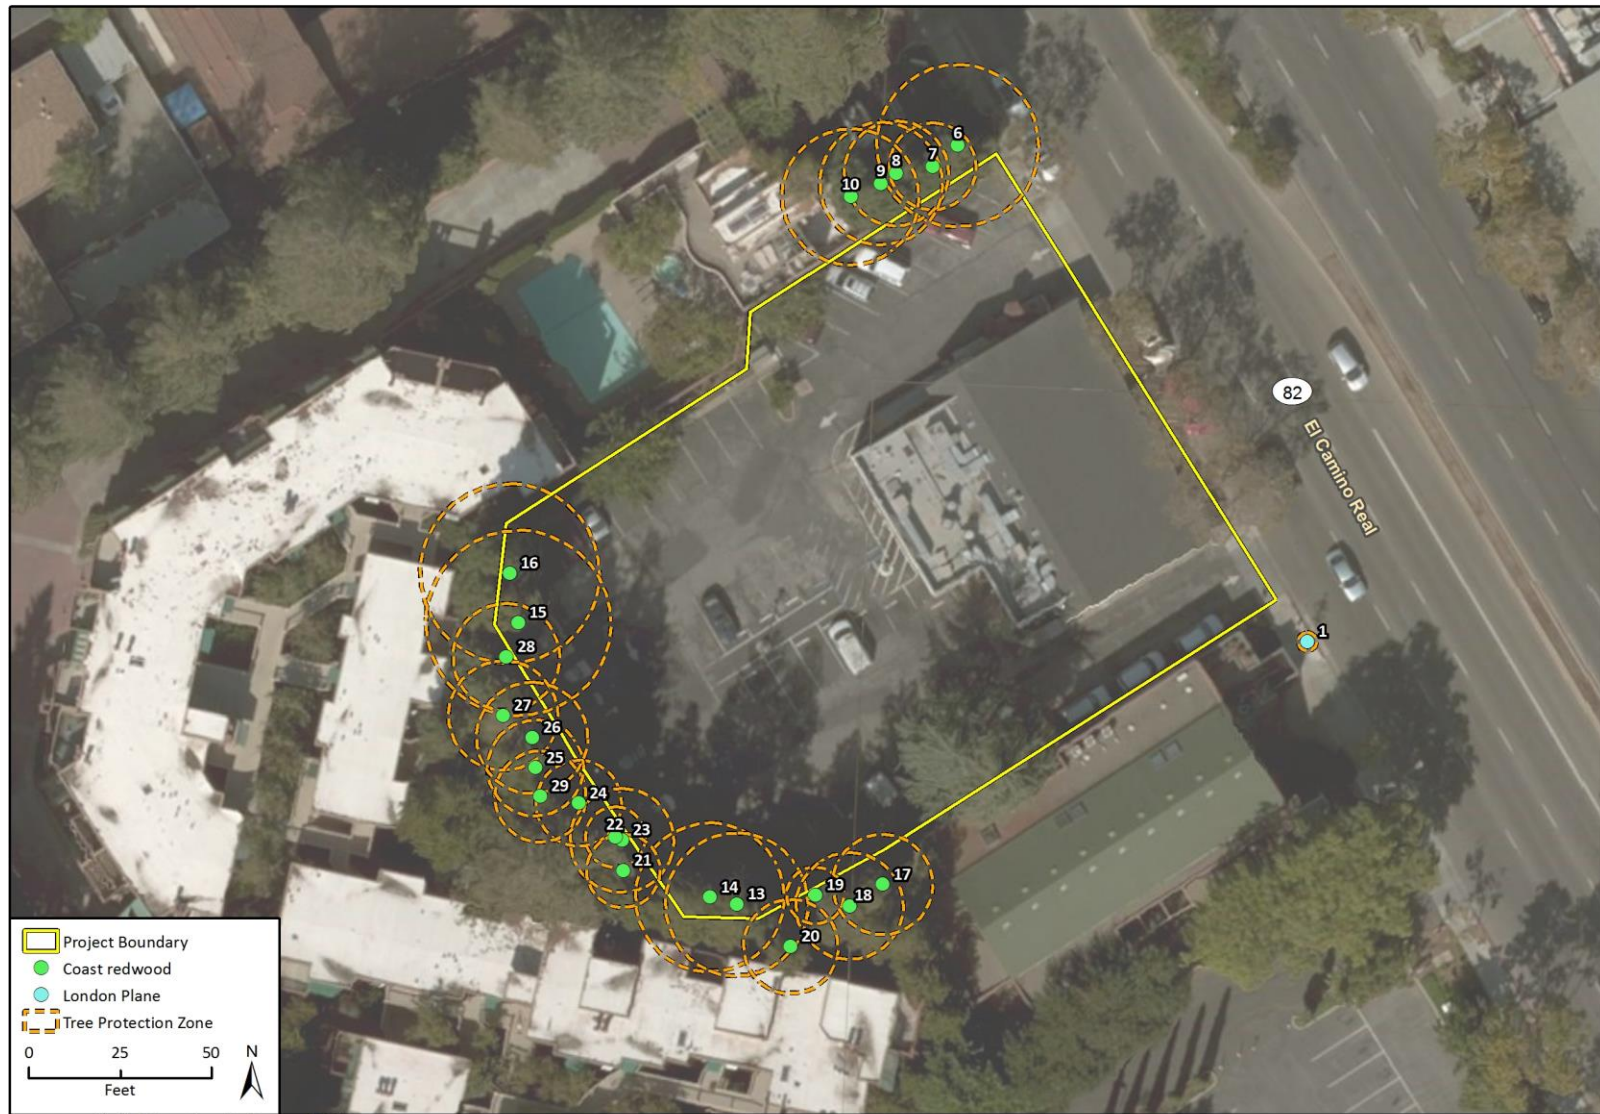
Figure 4 - Tree Protection Zones of Trees to be Protected

The proposed project would result in the removal of all trees located in the project site, with exception of the four protected coast redwood trees (Figure 4). Three London plane trees located immediately in front and north of the existing restaurant (trees #2, 3, and 4) are proposed for removal or relocation to an alternate location along the street along the eastern property boundary or removal entirely to accommodate ingress and egress for the proposed project. One additional London plane tree is proposed for removal (tree #5). One London plane tree located south of the project (tree #1) will be retained.

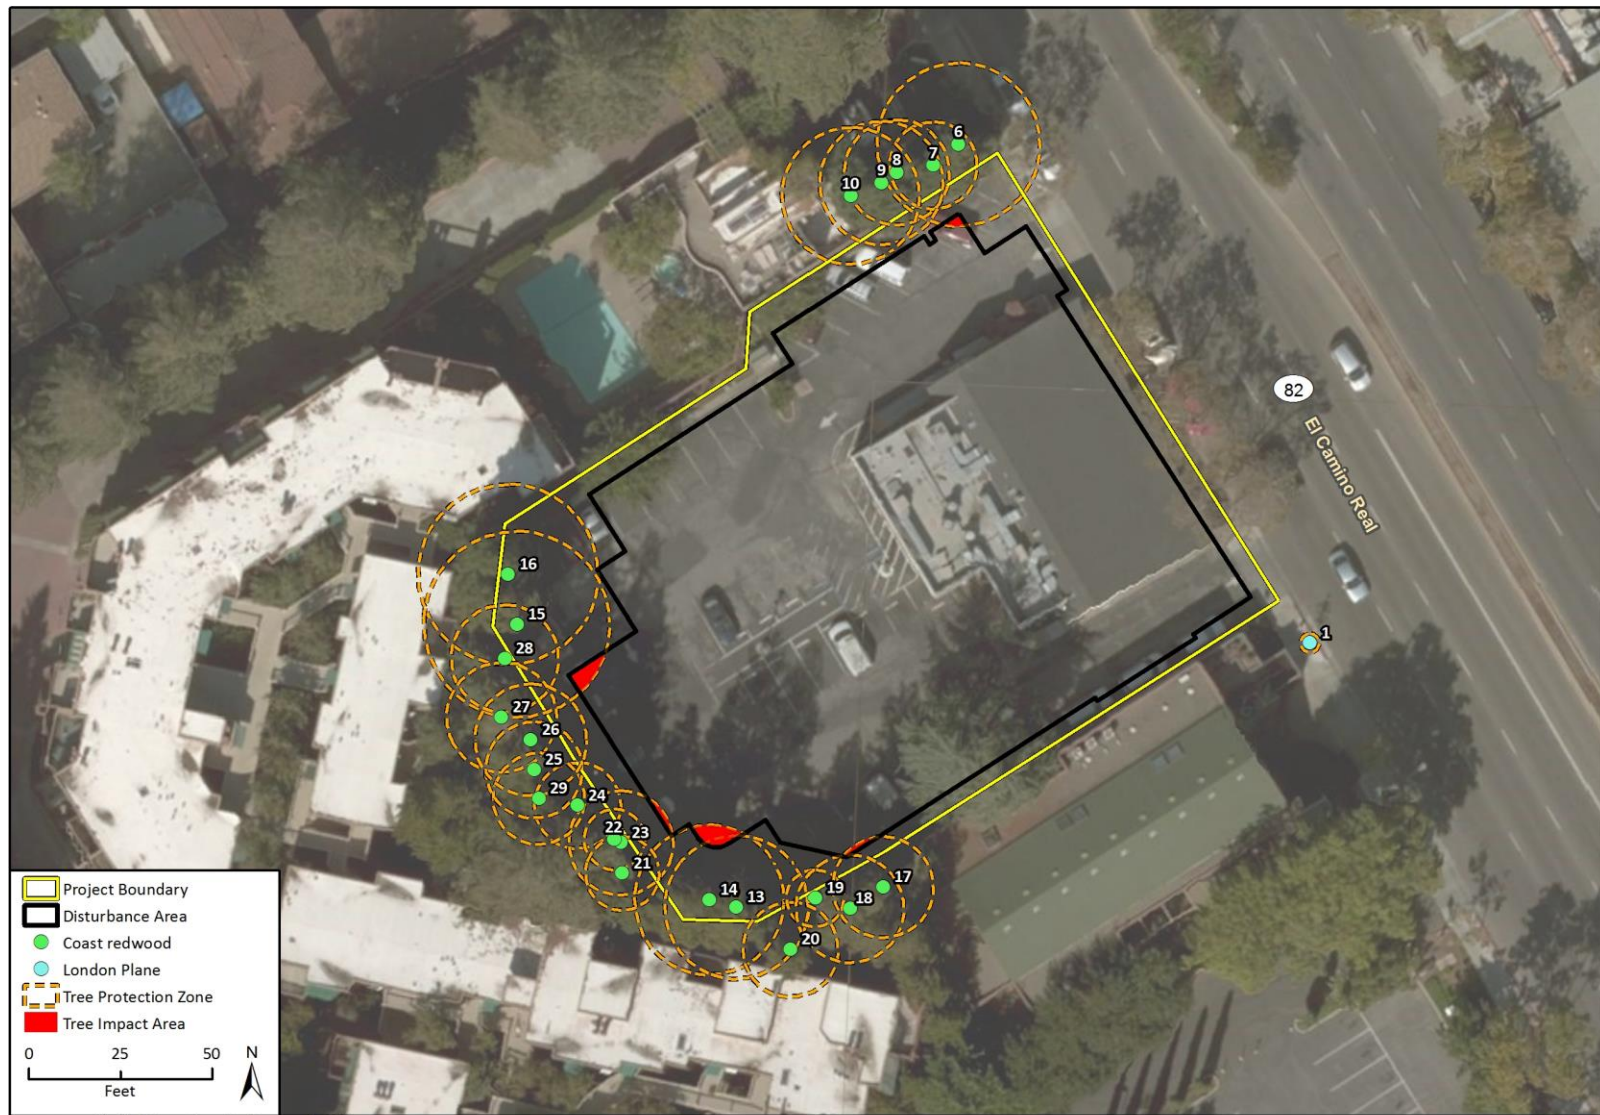
Figure 5 – Impacts to Tree Protection Zones

Based on the project plans dated June 26, 2018, three of the four protected coast redwood trees within the project area (trees #13, 14, and 15) and an additional four protected coast redwood trees on neighboring properties (trees #6, 17, 18, and 23) would be impacted by the proposed project. These trees have a portion of their Tree Protection Zones (TPZ; defined as a radius of ten times the trunk diameter at breast height, measured in feet) within the project Shoring/Disturbed Area Boundary (Figure 5). The percentage of the TPZ impacted ranges between 0.1 percent and 4.30 percent. Table 3 below summarizes these impacts. Project-related excavation is not expected to occur within ten feet of the protected coast redwood trees. As such, structural roots of four inches or greater are not expected to be impacted.

Tree #	TPZ Area (ac)	Impact Area within TPZ (ac)	Percentage of TPZ Impacted
23	0.02	0.0003	2.11%
17	0.01	0.0003	1.98%
18	0.02	0.00002	0.10%
6	0.04	0.0003	0.72%
13	0.03	0.0004	1.42%
14	0.03	0.0013	4.3%
15	0.05	0.0010	2.15%
