**Tree Inventory and Assessment**

**August 26, 2017**

**18081 Saratoga Los Gatos Road  
Monte Sereno, CA 95030**

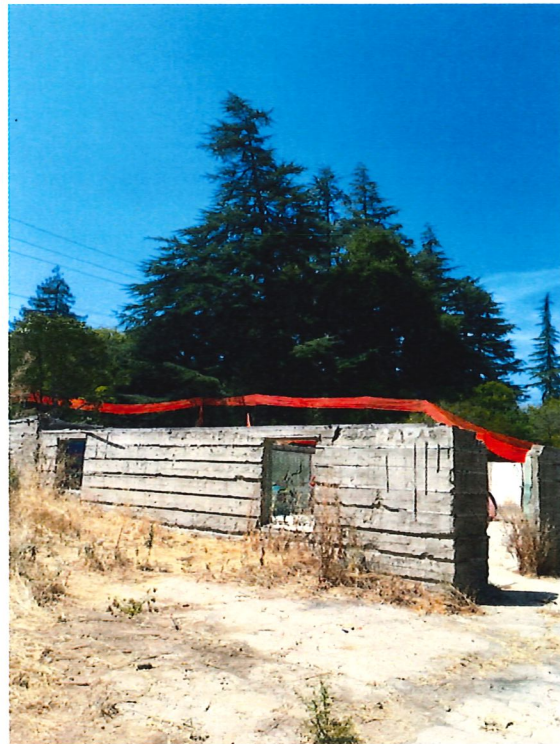
The property is located along the northeast side of Saratoga Los Gatos Road between Rose Avenue and Viewfield Road. The lot is vacant with an old concrete structure and disintegrating shed (Image 1). The entire road frontage consists primarily of volunteer invasive acacias (*Acacia spp.*) with one coast redwood (*Sequoia sempervirens*) #107 and Norfolk Island pine (*Araucaria heterophylla*) #106 on the west end. The frontage trees have to be maintained below the high voltage lines and most have been topped including #106 and #107. The interior of the site contains an array of volunteers and invasive species with most of the trees accounted for being coast live oaks with an average trunk diameter of 12 inches. There are two coast live oaks #109 and #128 at opposite corners of the property which are the best specimens along with deodar cedar (*Cedrus deodara*) #108. Many trees have ivy growing up their trunks and nothing has been maintained for years if ever. Silk oak (*Grevillea robusta*) #134 is another large specimen on the property but contains codominant stems, decay in the trunk, and is also covered in ivy.

Image 1: Interior of the site with deodar cedar #108 in the background

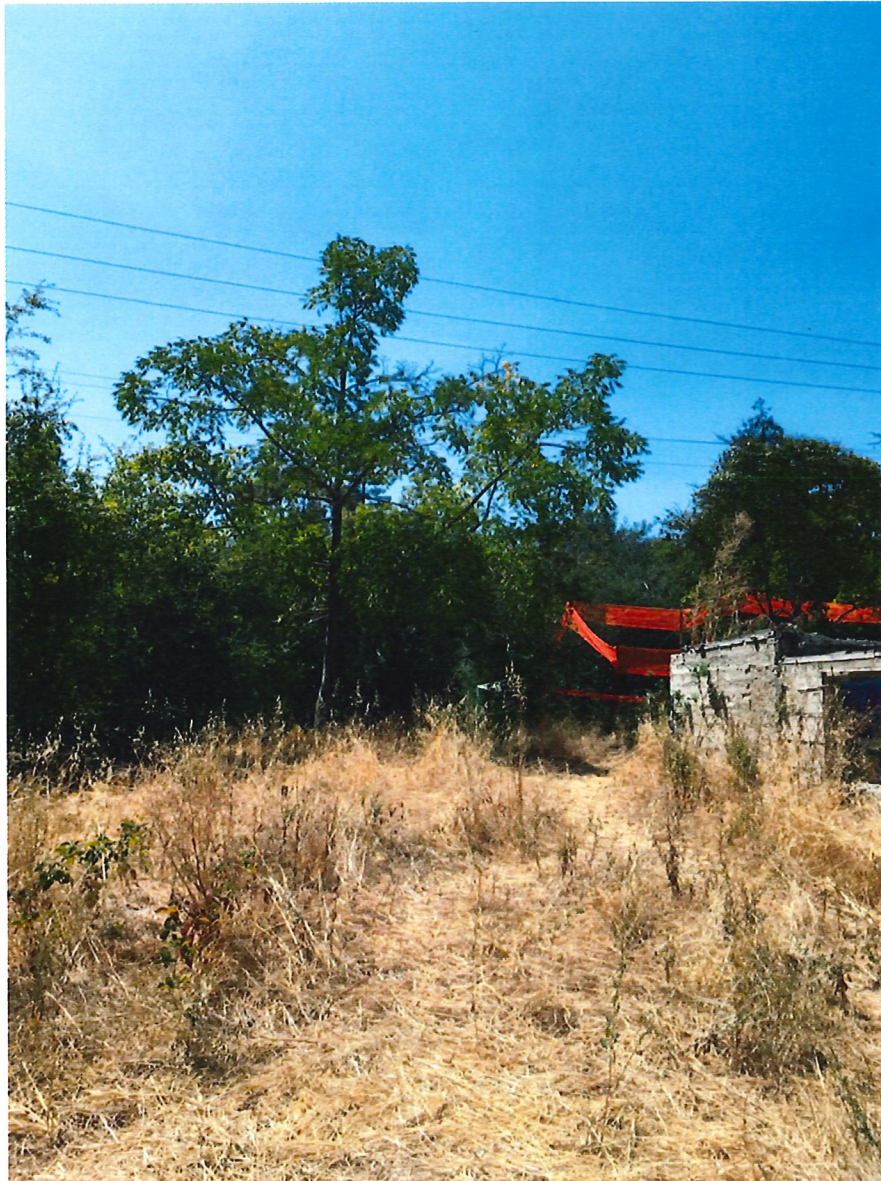
### C1: Ash tree #110

ash ( <i>Fraxinus velutina</i> 'Modesto')	110	11	35	25	Fair	Poor	Poor	Poor	Failed tree
coast live oak ( <i>Quercus agrifolia</i> )	111	14	35	30	Good	Good	Good	Good	
plum ( <i>Prunus cerasifera</i> )	112	20	20	20	Poor	Poor	Poor	Poor	
Peruvian pepper ( <i>Schinus molle</i> )	113	11, 12	25	30	Poor	Poor	Poor	Poor	Tree is not salvageable
London plane ( <i>Platanus x hispanica</i> )	114	9, 9, 9, 9	45	45	Good	Fair	Fair	Fair	
Italian cypress ( <i>Cupressus sempervirens</i> )	115	24	55	20	Good	Fair	Fair	Poor	
Italian cypress ( <i>Cupressus sempervirens</i> )	116	15	55	20	Good	Fair	Fair	Poor	
coast live oak ( <i>Quercus agrifolia</i> )	117	10	35	25	Good	Good	Good	Good	
valley oak ( <i>Quercus lobata</i> )	118	8	30	25	Good	Good	Good	Good	
valley oak ( <i>Quercus lobata</i> )	119	6	25	20	Good	Fair	Fair	Fair	
plum ( <i>Prunus</i> sp.)	120	10	20	20	Poor	Poor	Poor	Poor	
deodar cedar ( <i>Cedrus deodara</i> )	121	12	20	40	Fair	Poor	Poor	Poor	tree has fallen growing parallel to the ground

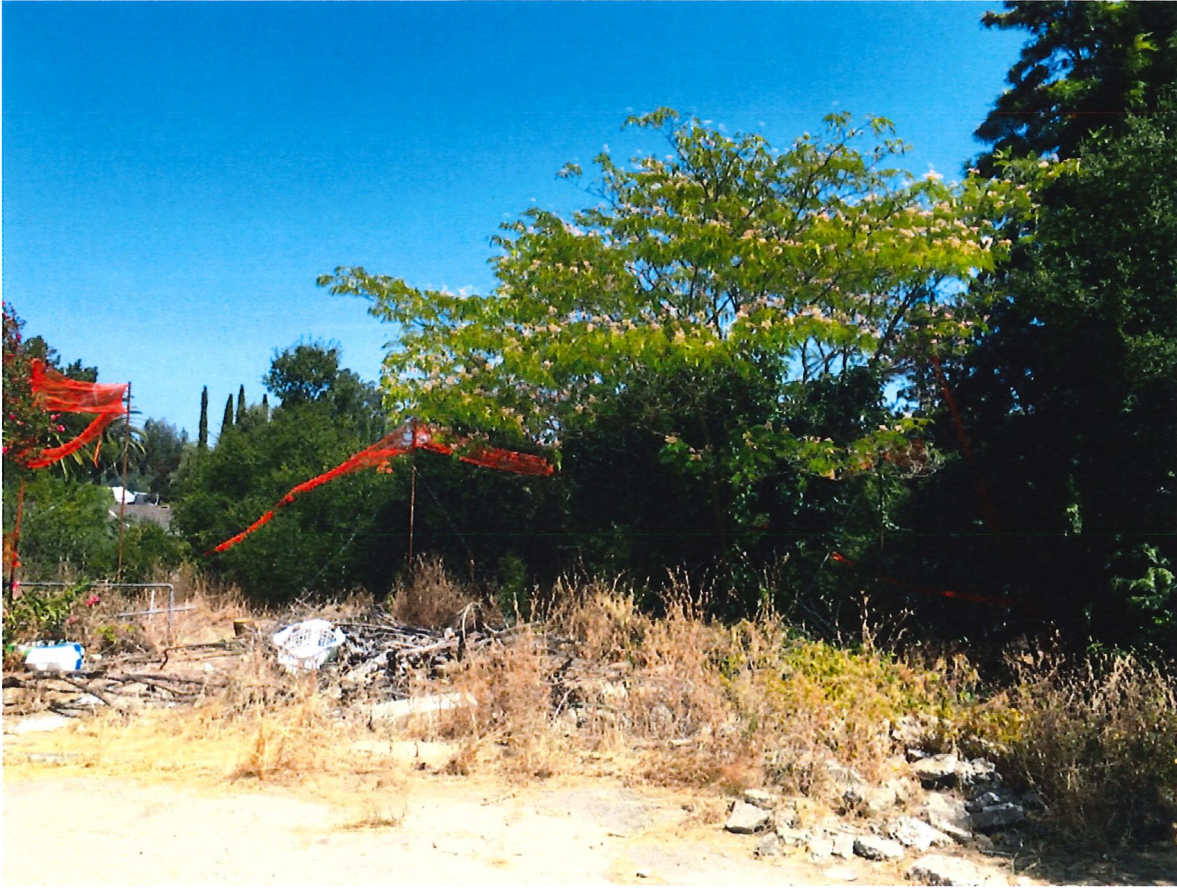
**C3: Silk tree #136**

Tree Species	Number	Trunk Diameter (in.)	Estimated Height (ft.)	Estimated Crown Diameter (ft.)	Health	Structure	Condition	Suitability for Preservation	Notes
plum ( <i>Prunus</i> sp.)	127	12 multi	20	20	Good	Fair	Fair	Fair	
coast live oak ( <i>Quercus agrifolia</i> )	128	12	35	30	Fair	Good	Fair	Good	
coast live oak ( <i>Quercus agrifolia</i> )	129	6	25	20	Good	Fair	Fair	Fair	
coast live oak ( <i>Quercus agrifolia</i> )	130	10	35	30	Good	Good	Good	Good	
coast live oak ( <i>Quercus agrifolia</i> )	131	6	25	20	Good	Good	Good	Good	
coast live oak ( <i>Quercus agrifolia</i> )	132	6	25	20	Good	Good	Good	Good	
coast live oak ( <i>Quercus agrifolia</i> )	133	8	30	20	Good	Poor	Poor	Poor	suppressed under silk oak
silk oak ( <i>Grevillea robusta</i> )	134	20, 14, 10	55	40	Fair	Poor	Poor	Poor	
coast live oak ( <i>Quercus agrifolia</i> )	135	10	40	30	Good	Fair	Fair	Fair	
silk tree ( <i>Albizia julibrissin</i> )	136	6, 6, 6, 4	30	30	Poor	Poor	Poor	Poor

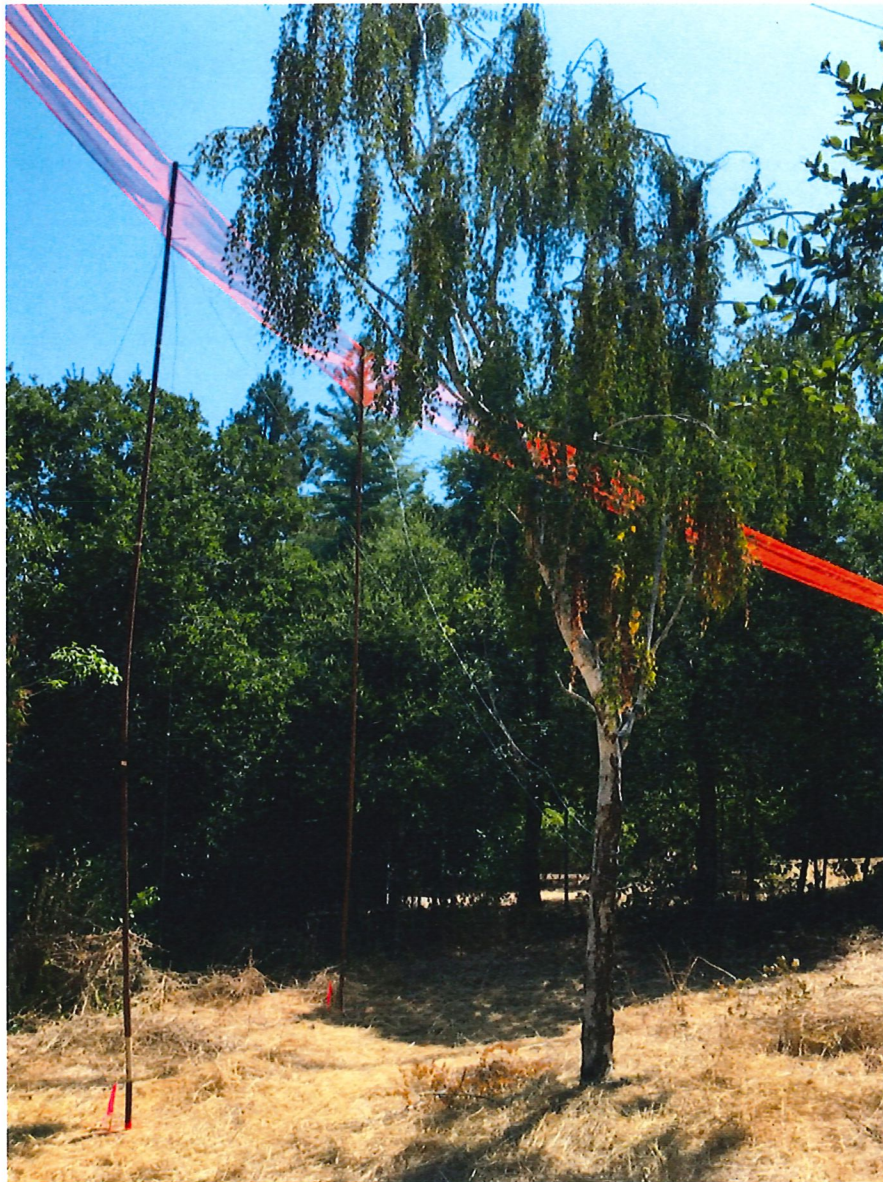
**C4: Birch #139**

coast live oak ( <i>Quercus agrifolia</i> )	137	10 multi	25	20	Fair	Poor	Poor	Poor	
coast live oak ( <i>Quercus agrifolia</i> )	138	6, 6 or 10	30	30	Good	Fair	Fair	Fair	
European birch ( <i>Betula pendula</i> )	139	7	30	20	Poor	Poor	Poor	Poor	
coast live oak ( <i>Quercus agrifolia</i> )	140	5, 7, 8	30	30	Good	Fair	Fair	Fair	
coast live oak ( <i>Quercus agrifolia</i> )	141	6, 6	25	20	Good	Fair	Fair	Fair	
valley oak ( <i>Quercus lobata</i> )	142	7	30	20	Good	Fair	Good	Good	
coast live oak ( <i>Quercus agrifolia</i> )	143	11	40	30	Good	Fair	Fair	Fair	Leans
ash ( <i>Fraxinus velutina</i> 'Modesto')	144	22	45	45	Poor	Poor	Poor	Poor	
European olive ( <i>Olea europaea</i> )	145	8	25	20	Fair	Poor	Poor	Poor	
coast live oak ( <i>Quercus agrifolia</i> )	146	14	45	35	Fair	Fair	Fair	Fair
