## Tree Report Concar property

**Prepared for:**  
California Coastal Properties  
520 Newport Center Dr. Unit 610  
Newport Beach, CA 92660

**Prepared by:**  
HortScience | Bartlett Consulting  
325 Ray Street  
Pleasanton, CA 94566

**August 28, 2018**

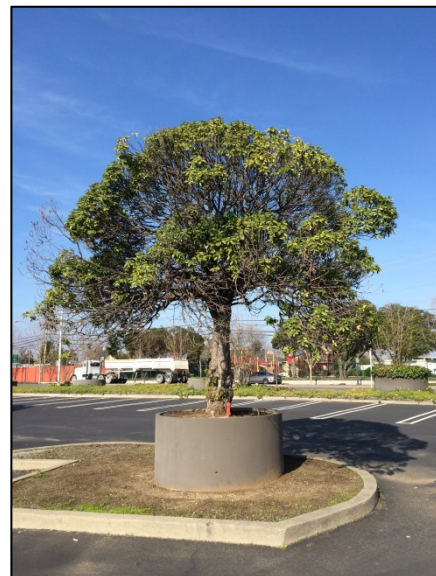
Myoporum was the most frequently occurring species with 16 trees. Myoporums at the Concar site were typical of the species, a large shrub/small tree with rounded form (Photo 1). Trees were mature in development. The largest myoporum #22 was 22-inches in diameter. Almost all trees, however, were between 10- and 12-inches. Overall condition was poor due to heavy infestation of, and damage caused by, thrips, a small sucking insect. Most myoporums had dieback of twigs and branches. Many had decay in the main trunk.

**Photo 1.** Myoporum #9 was 9-inches in diameter and in poor condition. Note the raised planter.

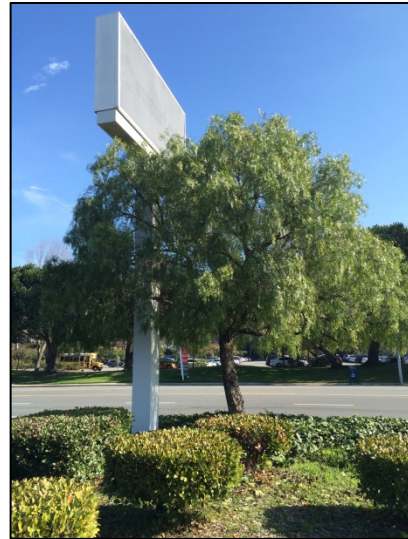
Ten (10) Calif. peppers were located in a landscape area between the parking lot and S. Grant Street (Photo 2). Trees were semi-mature in development with trunk diameters between 9- and 15-inches. Trees were typical of the species. Overall condition was good (6 trees). Calif. peppers #44 and 48 were in excellent condition while #34 and 38 were fair.

**Photo 2.** Calif. pepper #44 was 10-inches and in excellent condition.

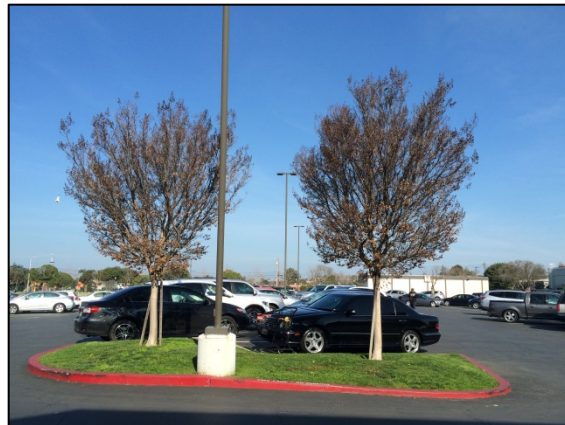
Nine (9) crape myrtles were located in small island planters in the parking area (Photo 3). Trees were young; trunk diameters were either 5- or 6-inches. All 9 trees were in good condition with the form and structure that is typical of the species.

**Photo 3.** Typical crape myrtle trees in island planter.

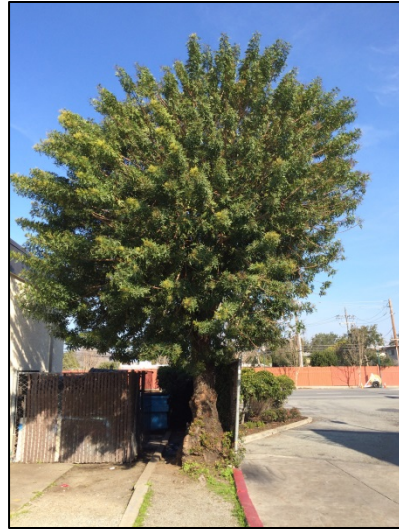
- Jacaranda #62 was 14-inches and in fair condition.
- Pittosporum #63 had trunks of 5- and 3-inches and was in poor condition.
- Southern magnolia #61 was 9-inches and in fair condition.
- Brazilian pepper #23 was 18-inches in diameter and in good condition (Photo 4). It was located near the parking lot in the northeast corner of the site.

**Photo 4.** Brazilian pepper #23.
