Tree Resource Evaluation/Construction Impact Assessment

James P. Allen C Associates Morgan Hill Technology Center & Mixed-Use Project

APN Nos. 728-30-006/009, 728-31-014/015&016 SW Corner of Cochrane Road & DePaul Drive

> Tree Resource Evaluation/ Construction Impact Assessment/ Tree Protection Plan

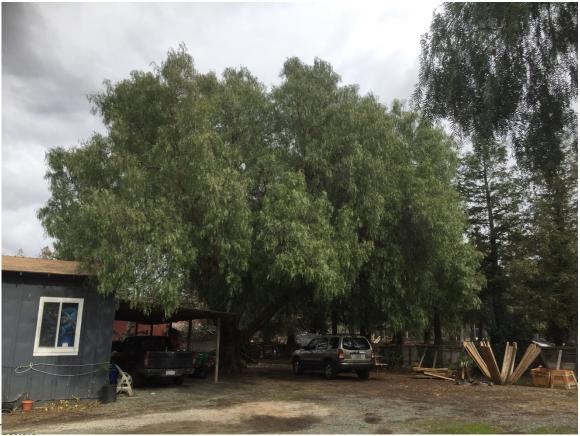
Two California pepper Trees #114 (pictured on the title page), #115 along with one coast live oak, Tree #101 growing on Half Road have good preservation suitability.

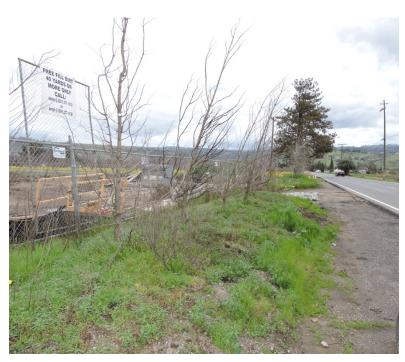
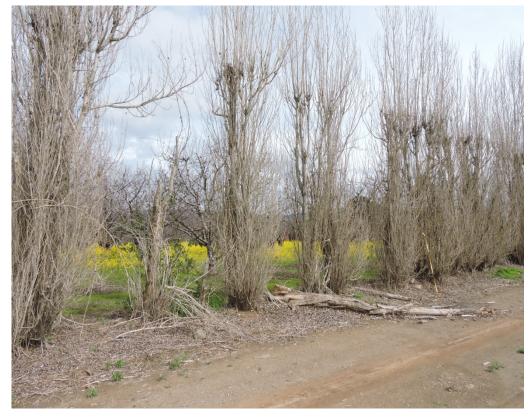
**Tree Groups #102 and 103** are composed of 19 small locust trees that were planted parallel to Half Road on the Southern project boundary. These trees may be considered as "Street Trees".

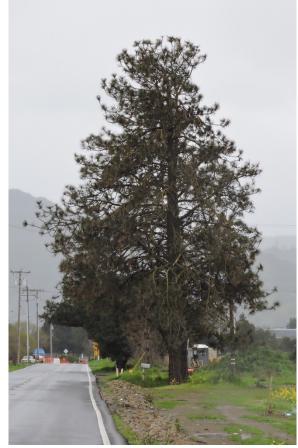
There is a long line of densely planted trees outside the project boundary along the northern edge of the adjacent orchard. The Westernmost edge of Tree Group #128 will need Tree Protection Fencing installed in order to guard against construction damage.
