**Consulting Arborist's Report
December 11, 2017**

Campus Tree Evaluation

For: 92nd Street Elementary School

Prepared by: Arborgate Consulting, Inc.
Greg Applegate, ASCA, ASLA
1131 Lucinda Way
Tustin, CA 92780
714/ 731-6240

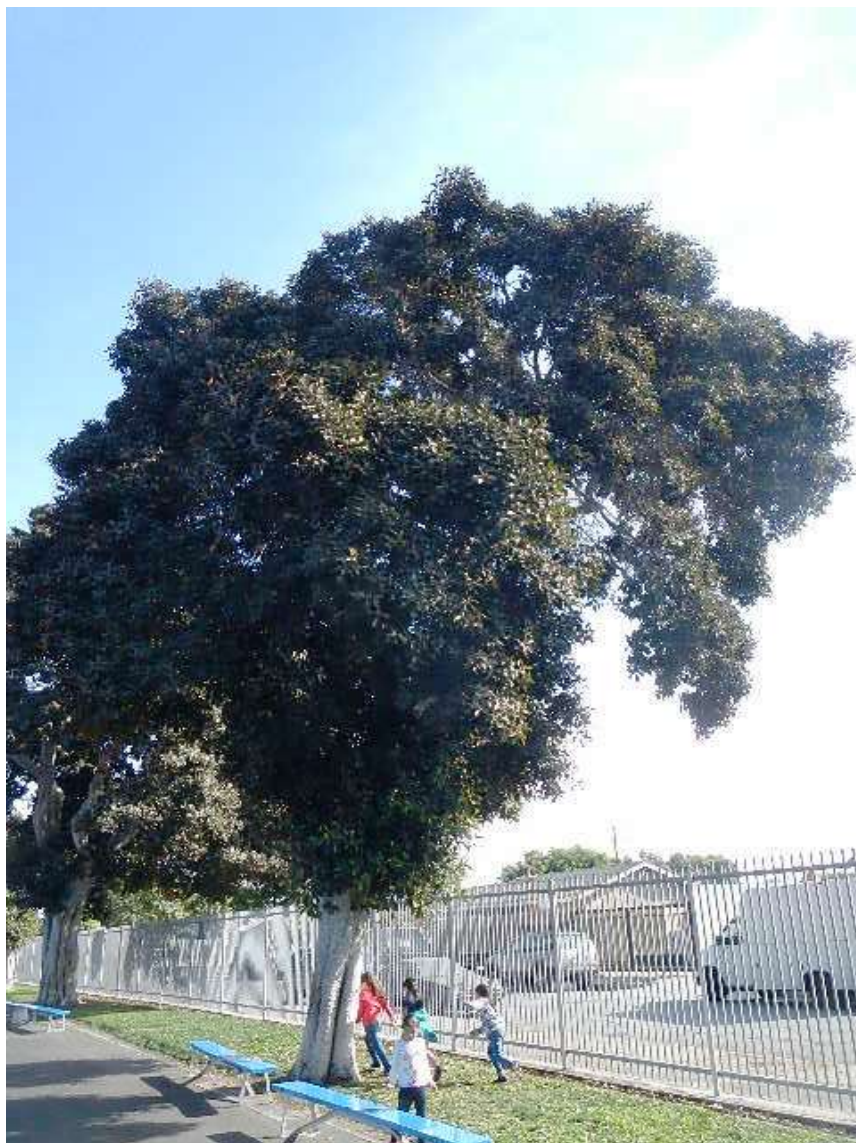
#7 Ficus. Note children do play and sit under these trees.

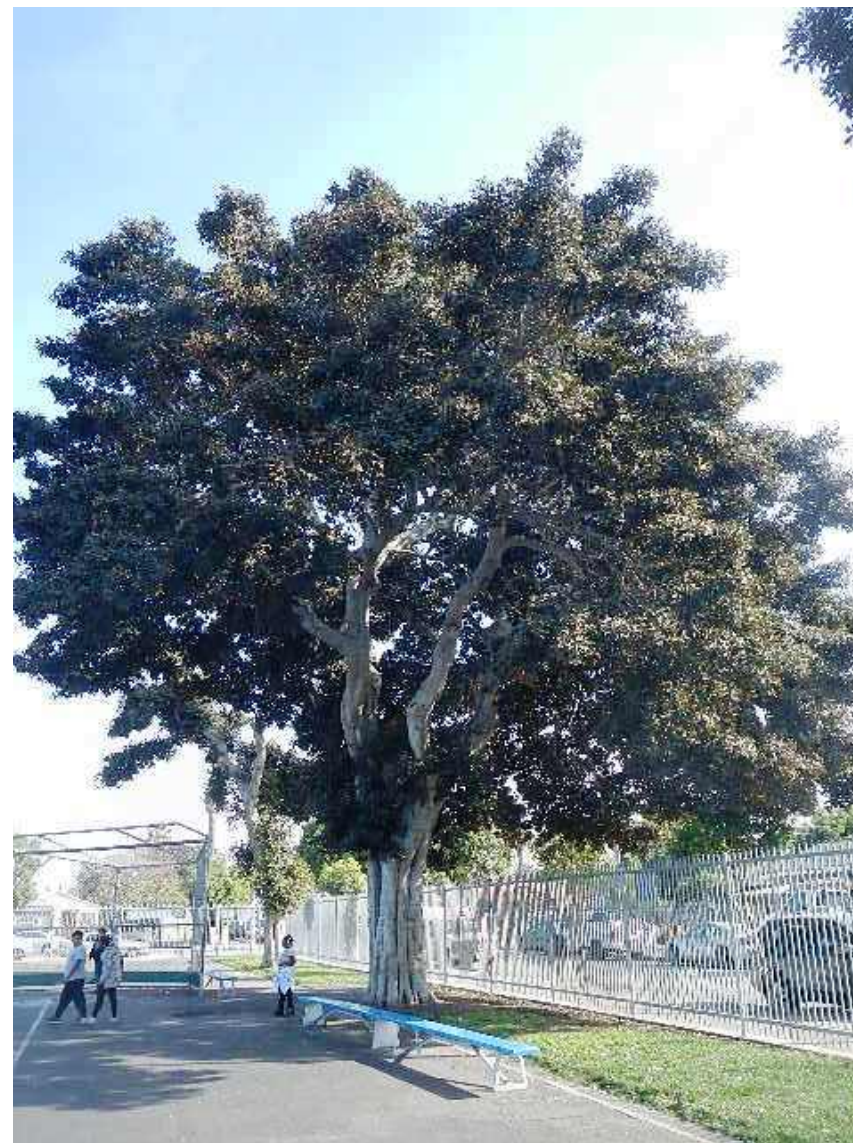
#8 Ficus is quite large

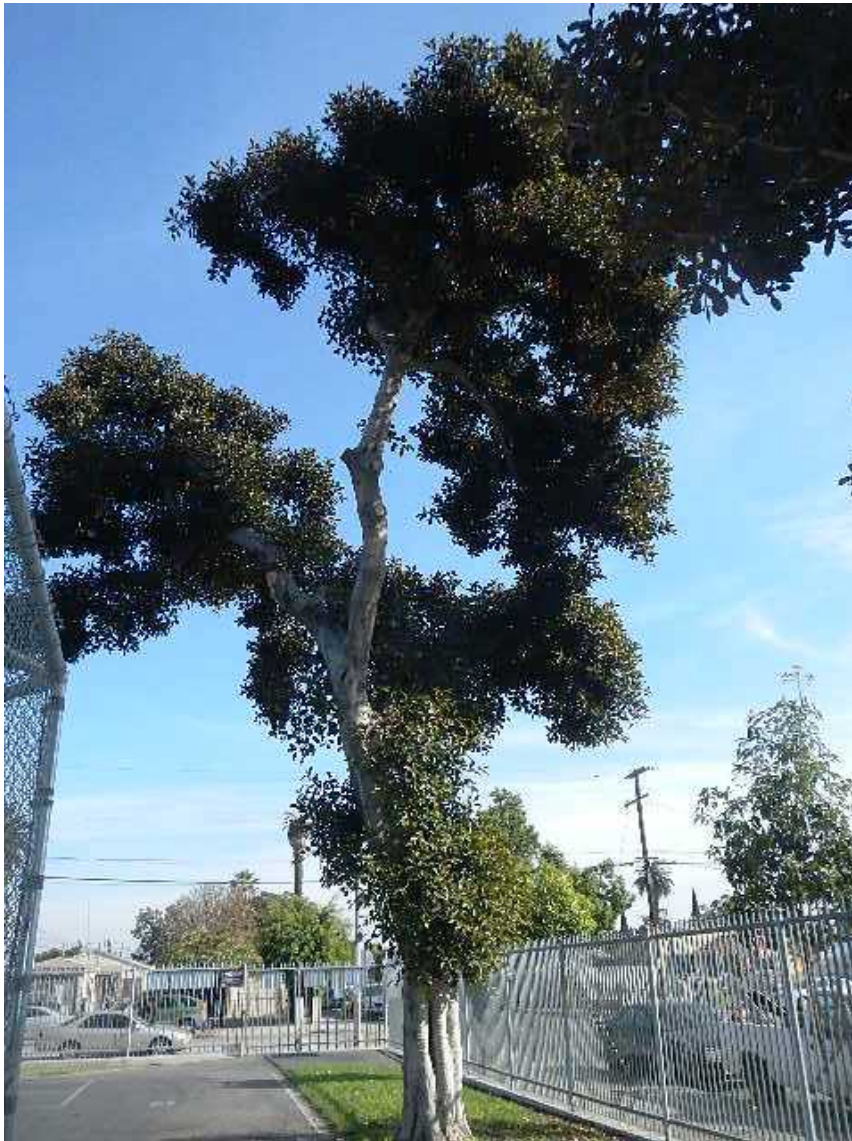
#9 Ficus has dropped limbs before.

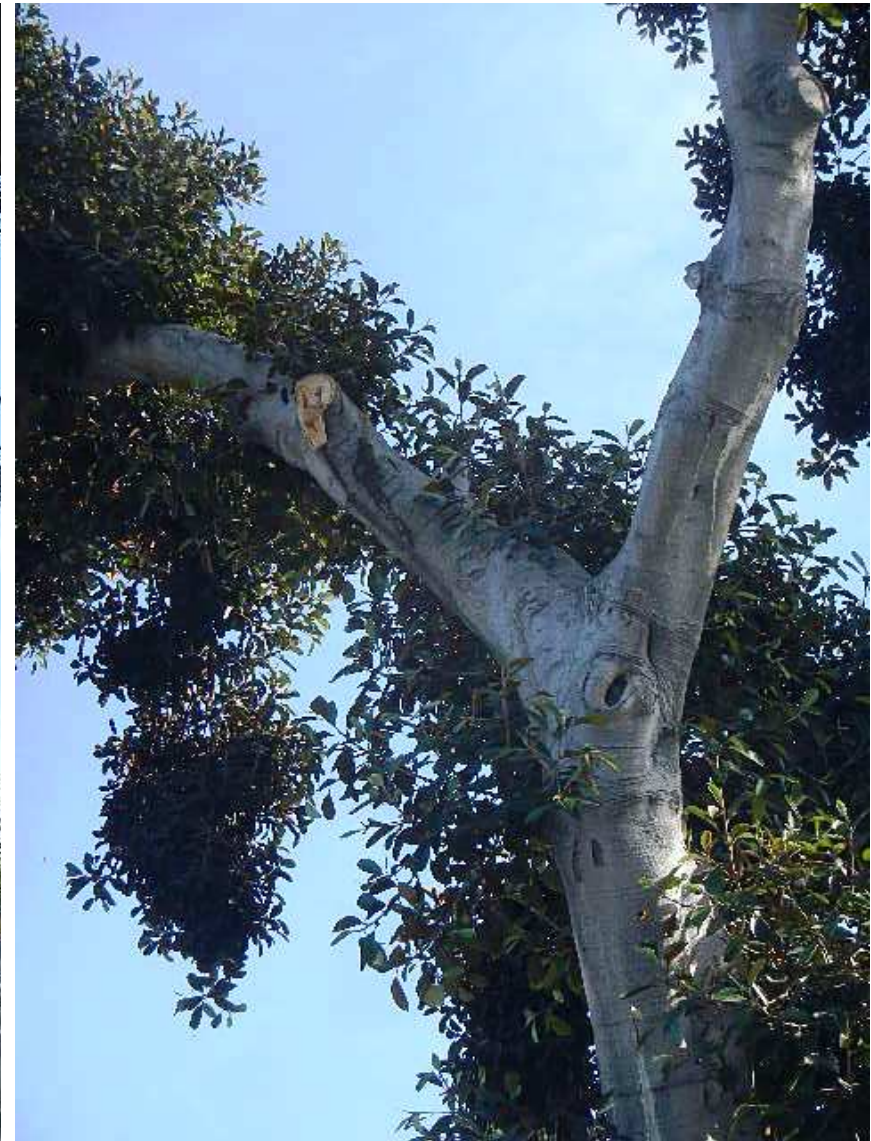
#9 Ficus – note broken limb and past lion-tailing

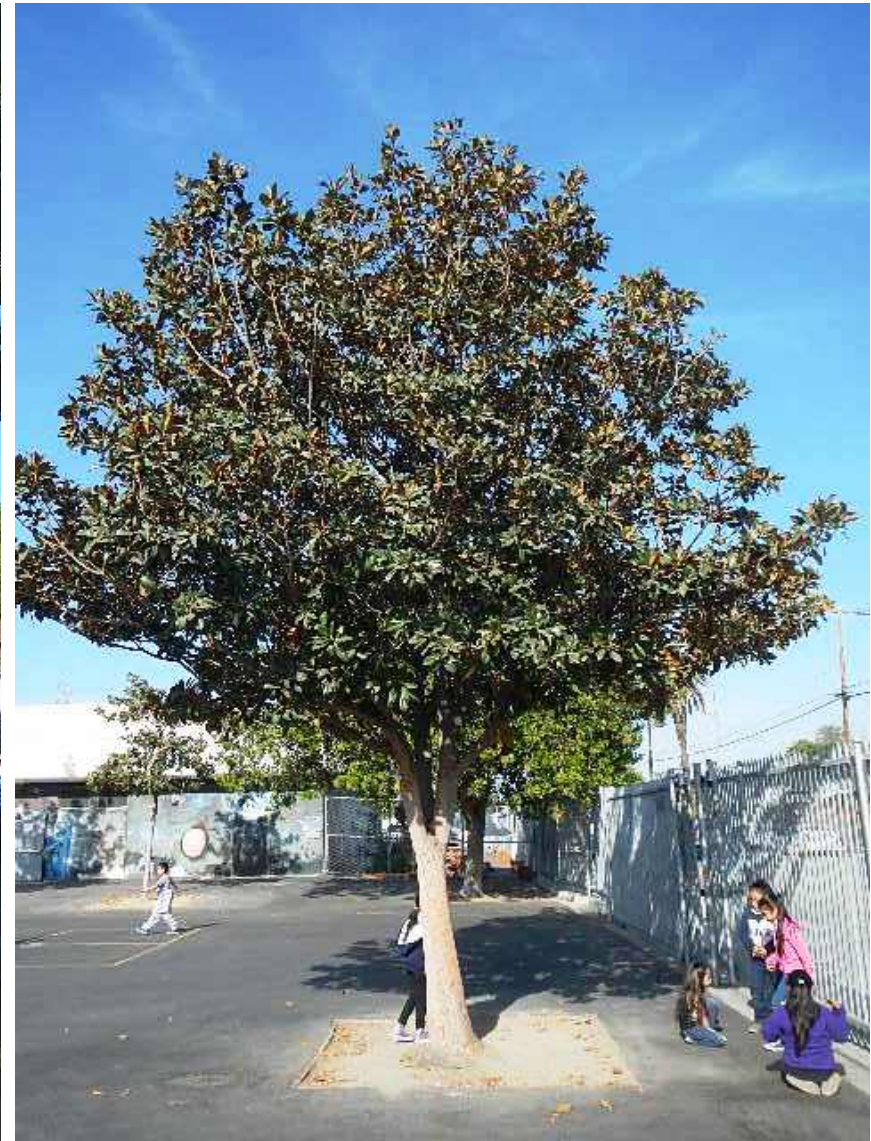
#13 Magnolia – note small cutout.

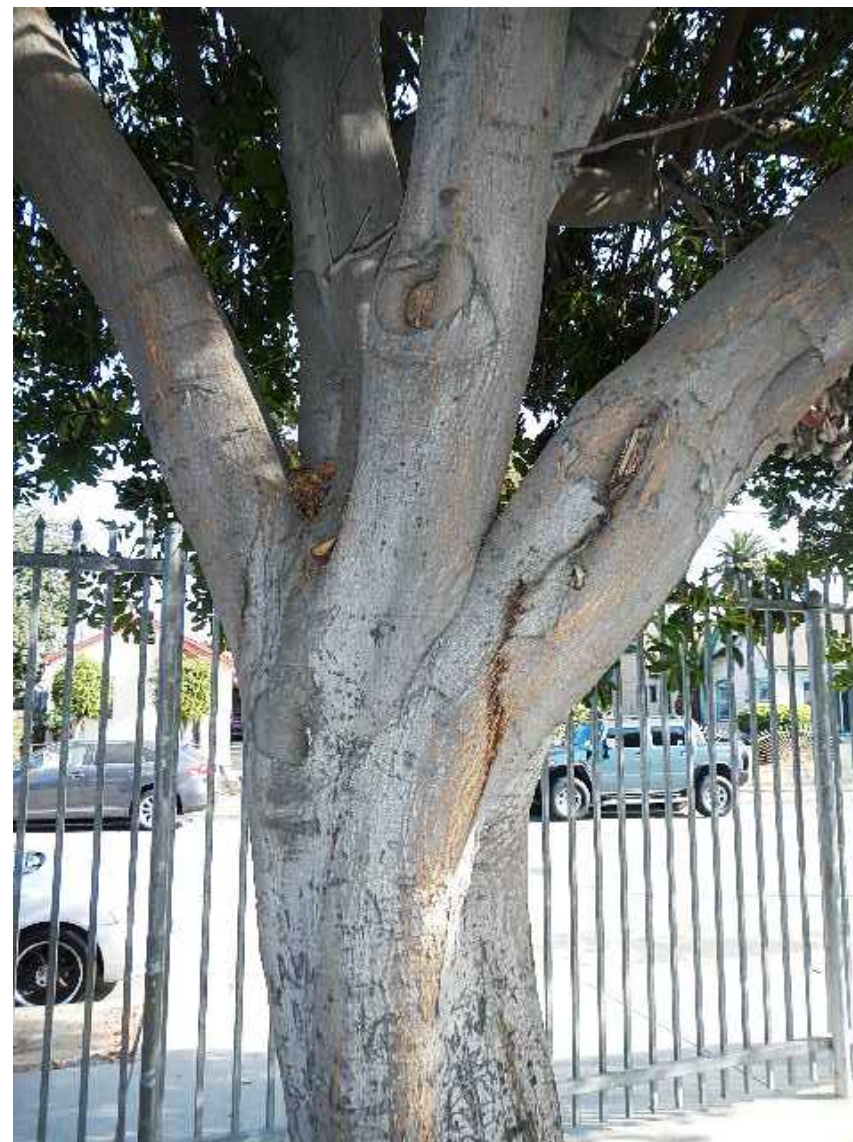
#14 Carrotwood – note included bark and old flush cuts.

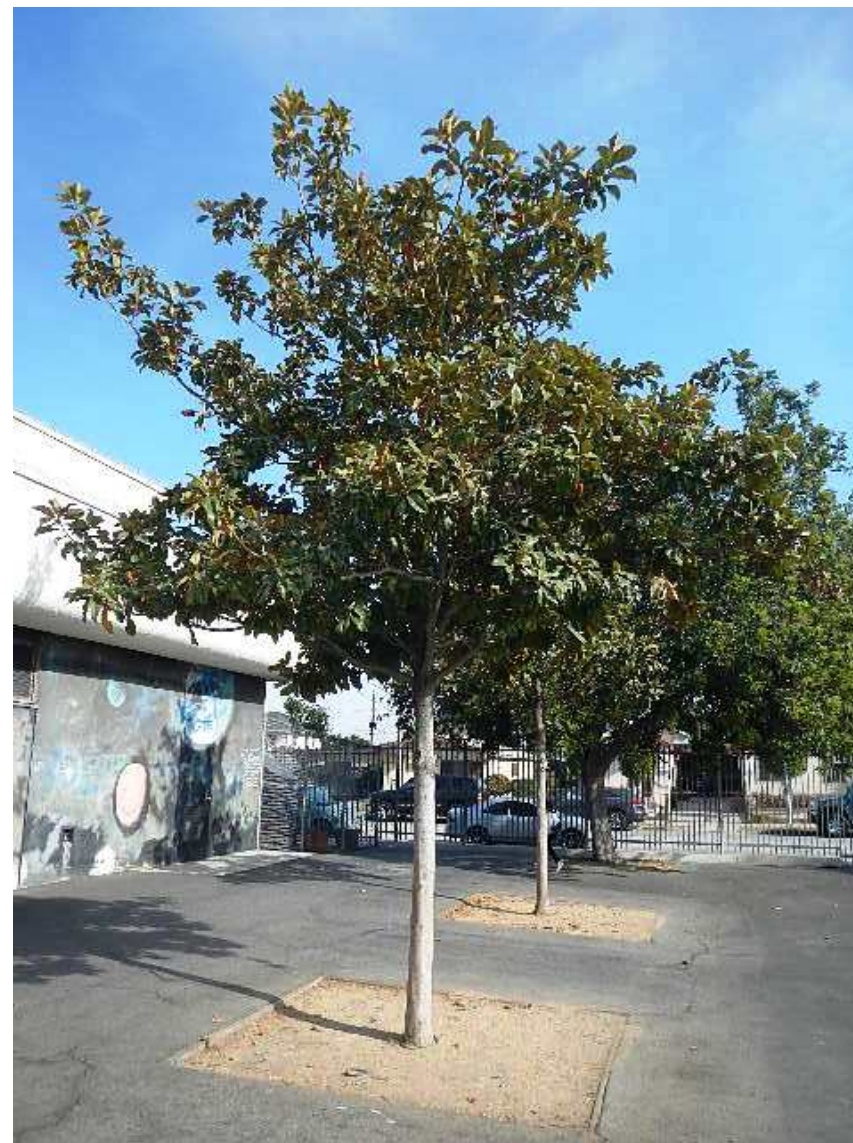
#16 Magnolia

The polyphagous shot-hole borer (PSHB) is spreading quickly and has already killed tens of thousands of trees. One magnolia (#16) appears to be infested and infected. It spreads a Fusarium disease and there is no effective treatment approved so far. The Huntington Botanic Garden said that almost a third of their 900 species are vulnerable. UCI is losing all their sycamores, about 1,600 trees. No preventative treatment is known to be effective, so the best that can be done is to recommend that only trees known to be resistant be planted. Ficus, crape myrtles, deodars and magnolias are thought to be resistant. The elms are considered “non-reproductive hosts”.

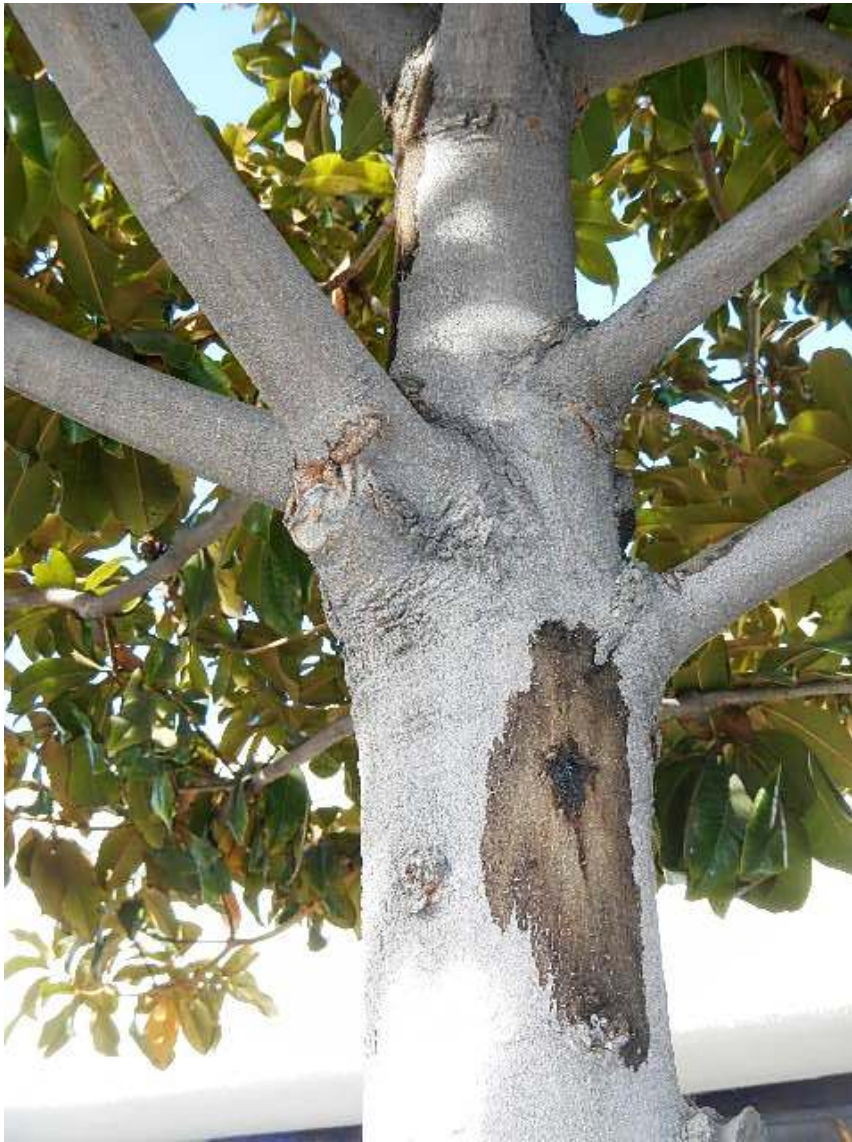
#17 Magnolia – note symptom of polyphagous shot hole borer.

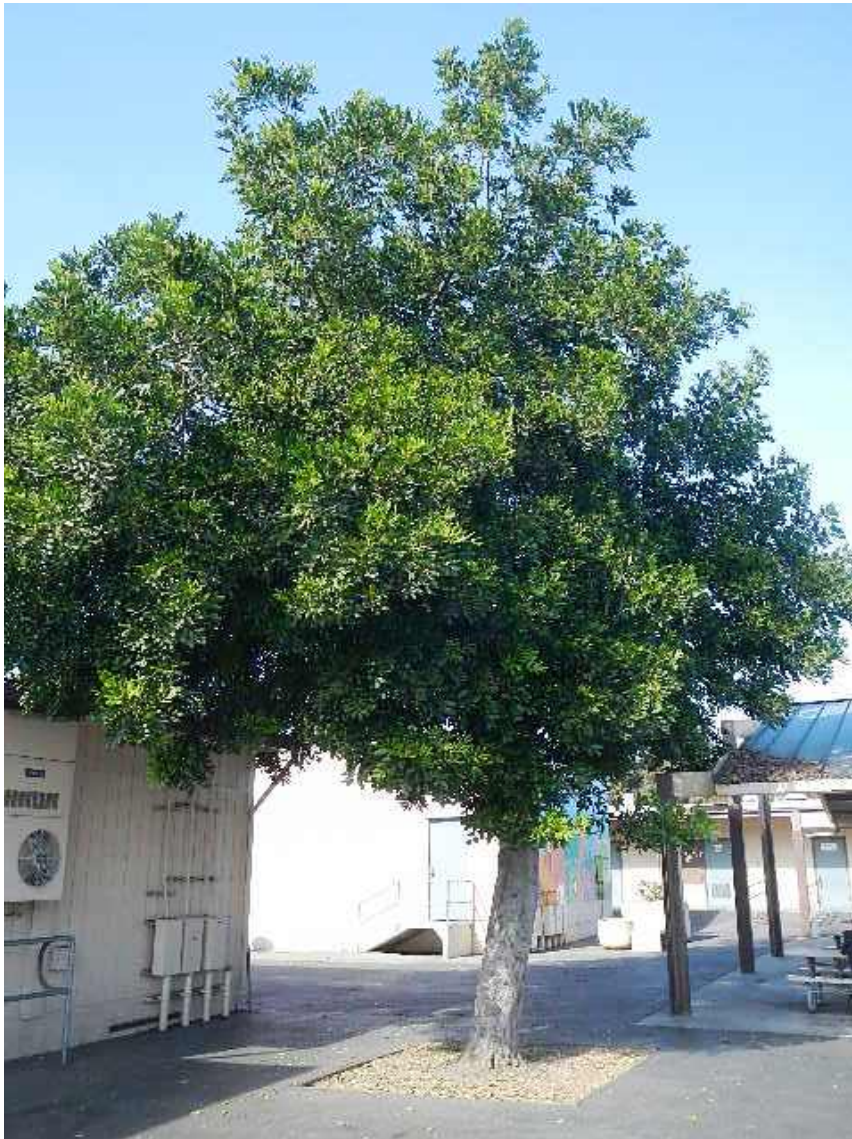
#18 Carrotwood – note scars on trunk and included bark

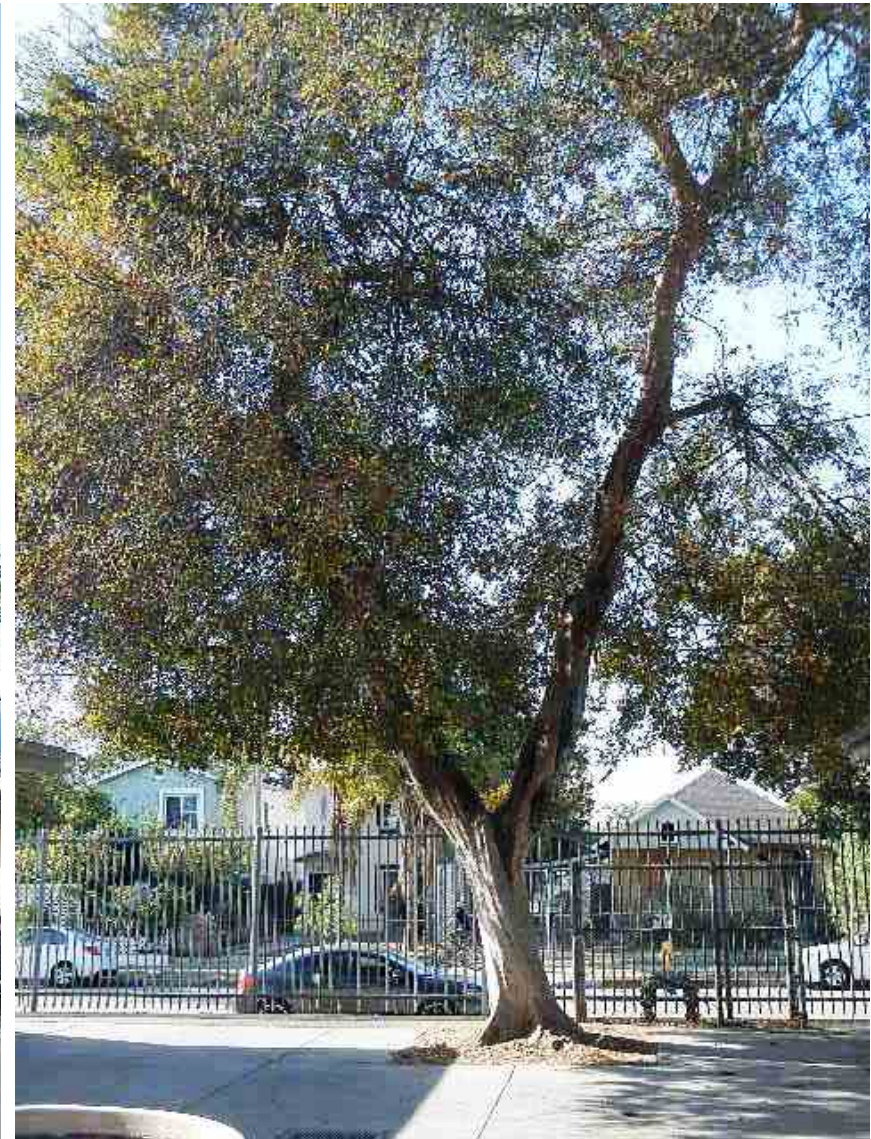
#19 Elm – should be removed, due to large cankers from anthracnose.

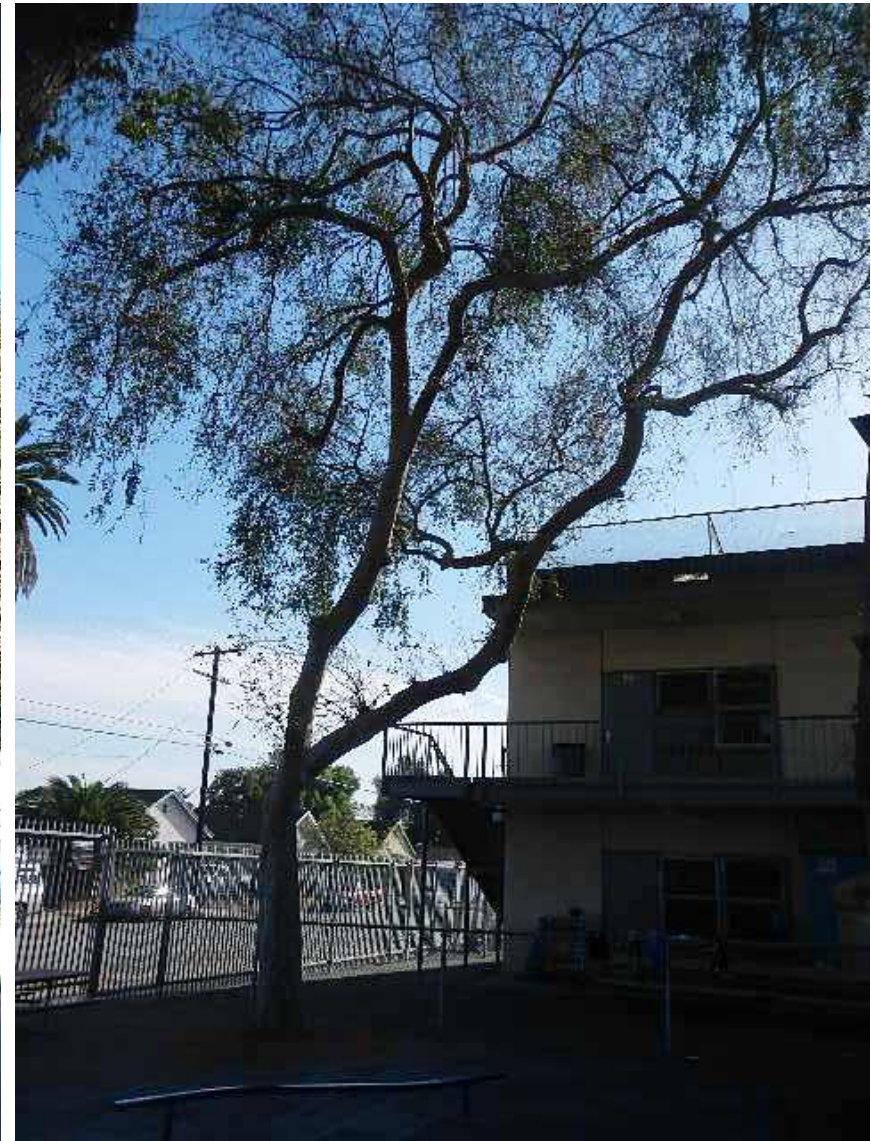
#23 elm is one-sided

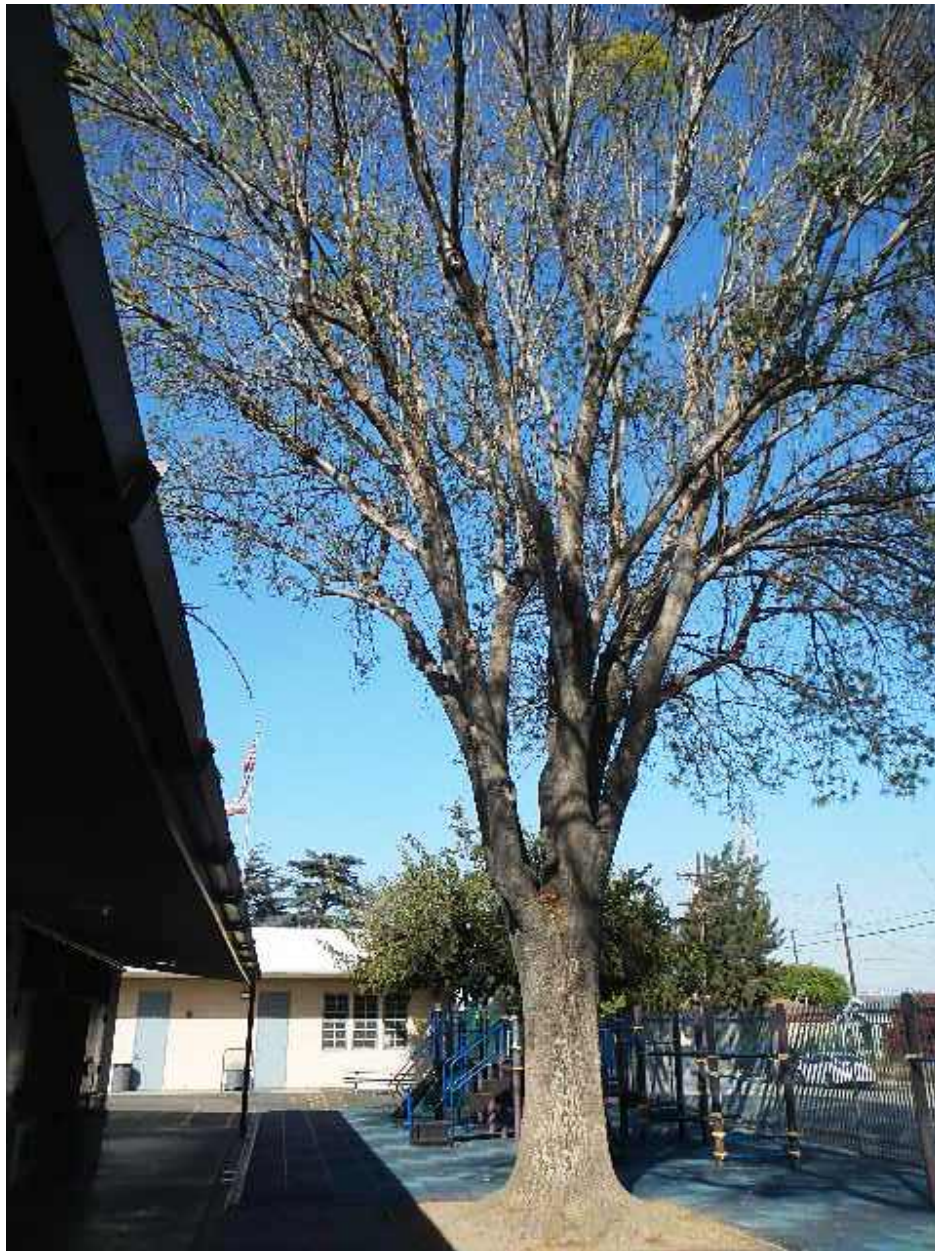
#24 Shamel ash

There is a large healthy Shamel ash, *Fraxinus uhdei*, with 38" trunk diameter. It is growing in a 10 x10 foot cutout east of the kindergarten building. This species is notorious for root damage and even a 10 x 10 foot cutout is not enough root room.

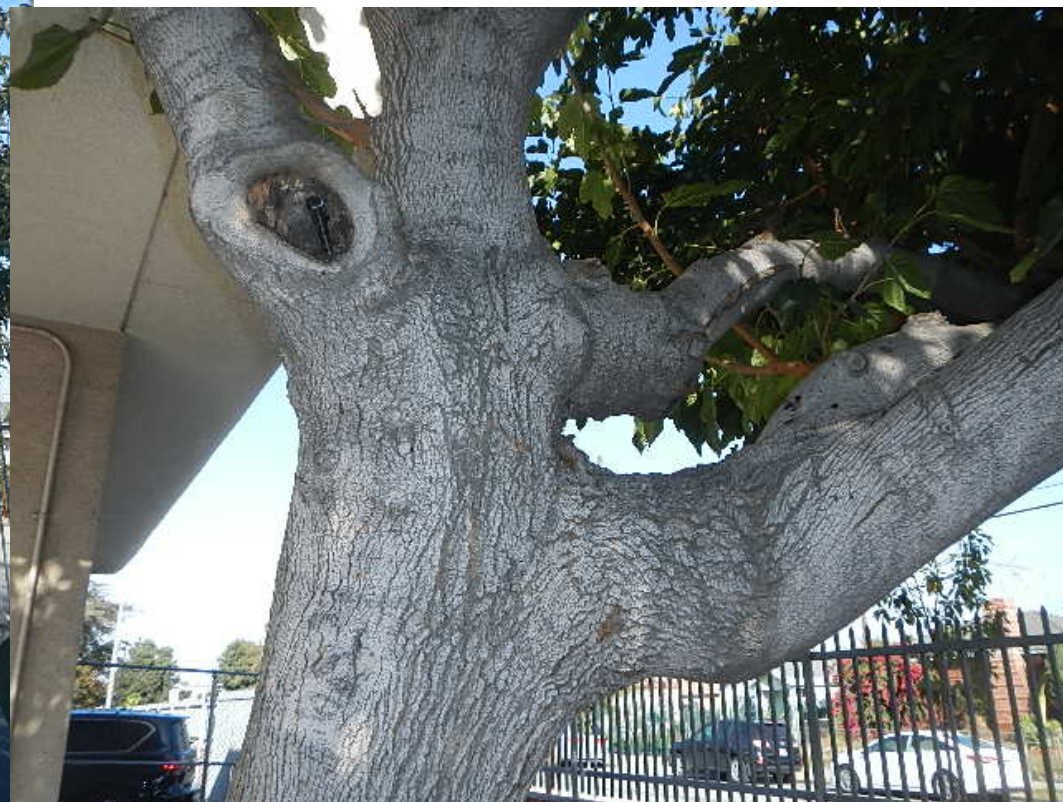
#25 Mulberry – note decay at base of limb at old flush cut and shear crack in back

Decay, e.g. in #25, that may have been held in check can advance when the trees' reserve carbohydrates are reduced or depleted by construction impacts, or just by aging. Large roots cut for irrigation, underground utilities and footings can immediately render trees less stable during storms and strong winds. Large roots cut inside the root plate are also more likely to decay back into the base of the trunk.

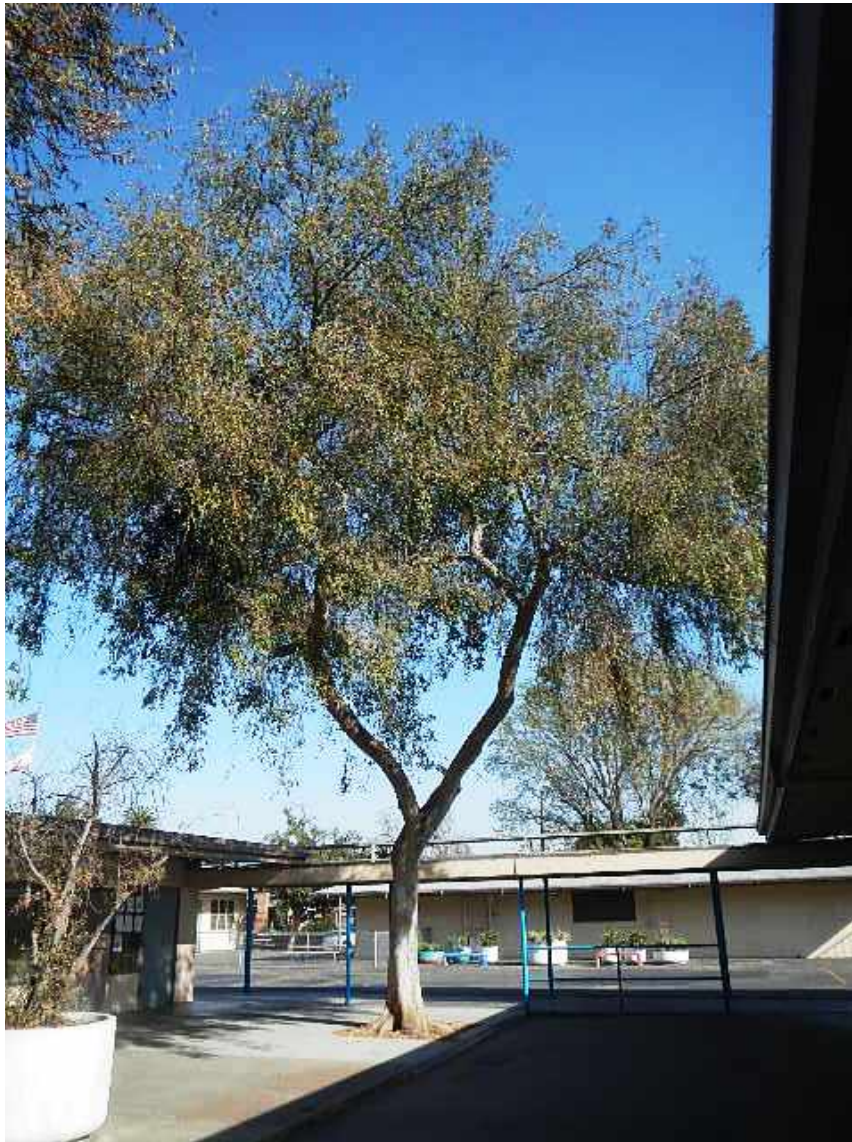
#28 Elm is codominant and lion-tailed

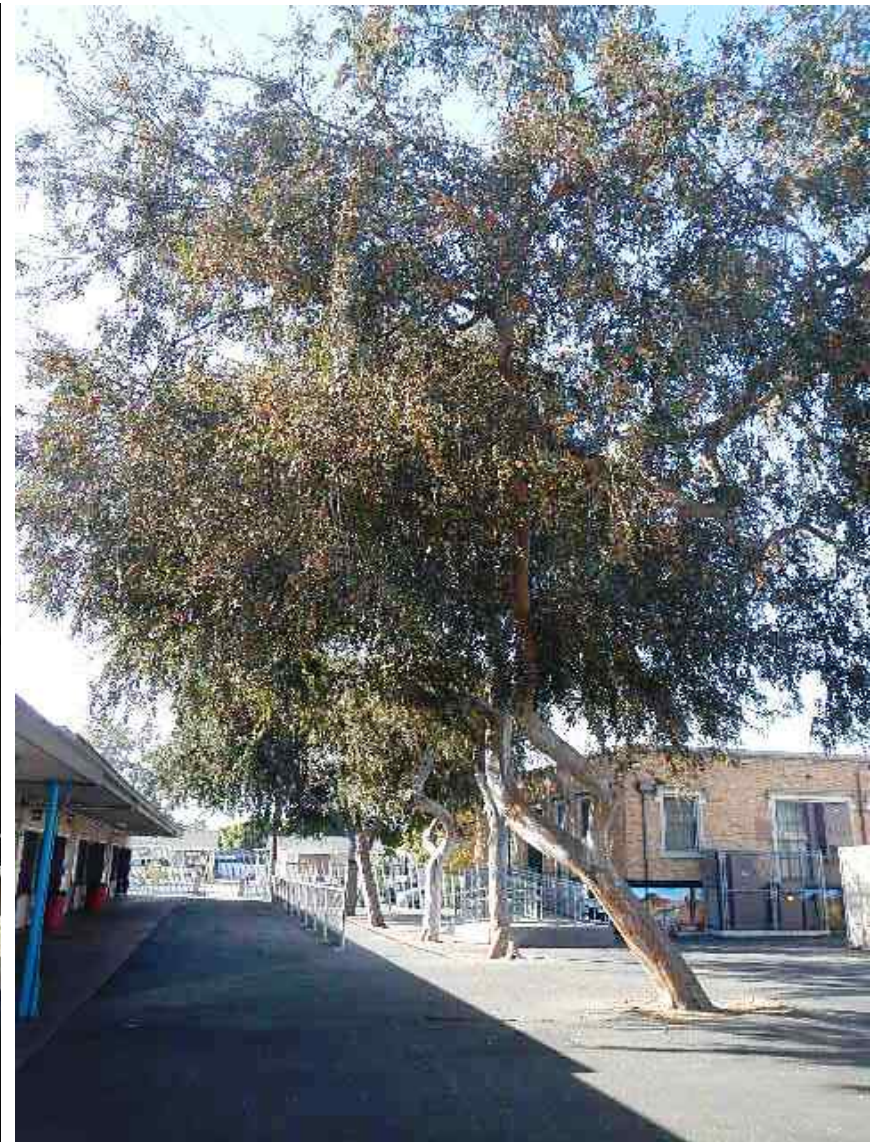
#29 Elm – note severe lean appears stable.

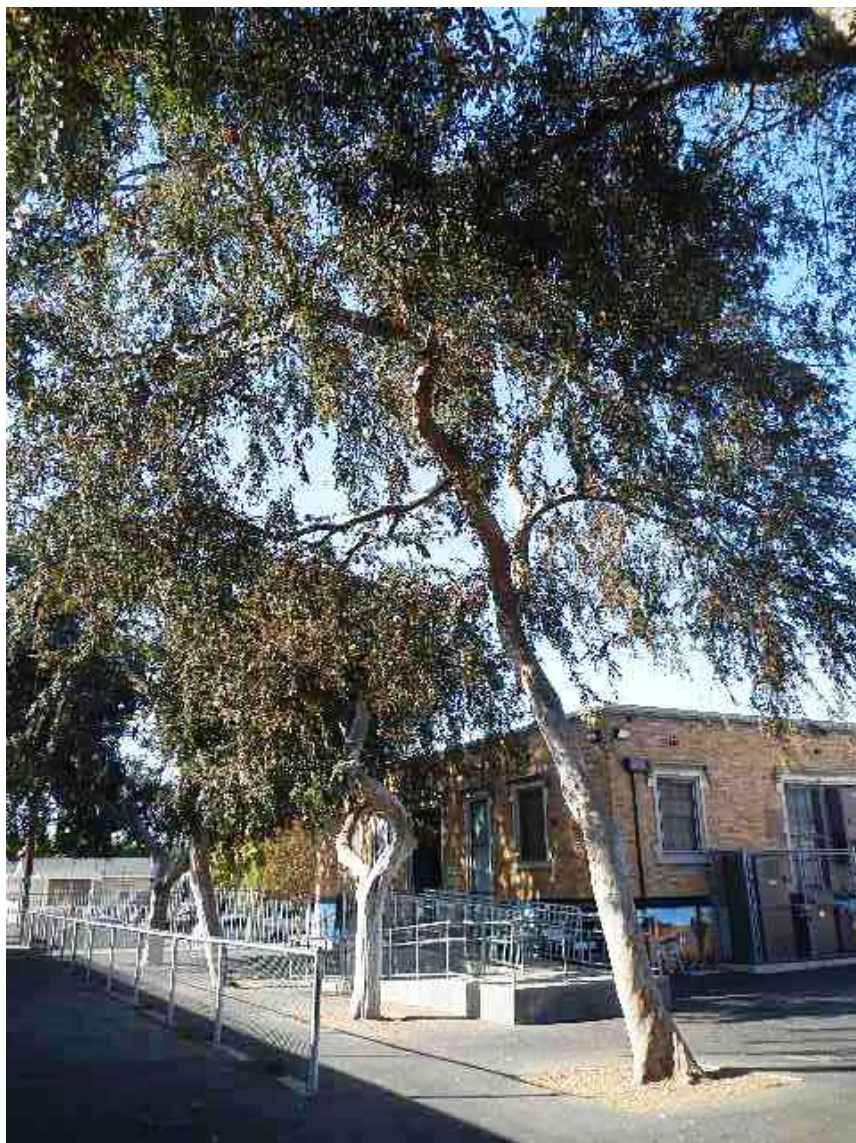
#30 Elm – note lean

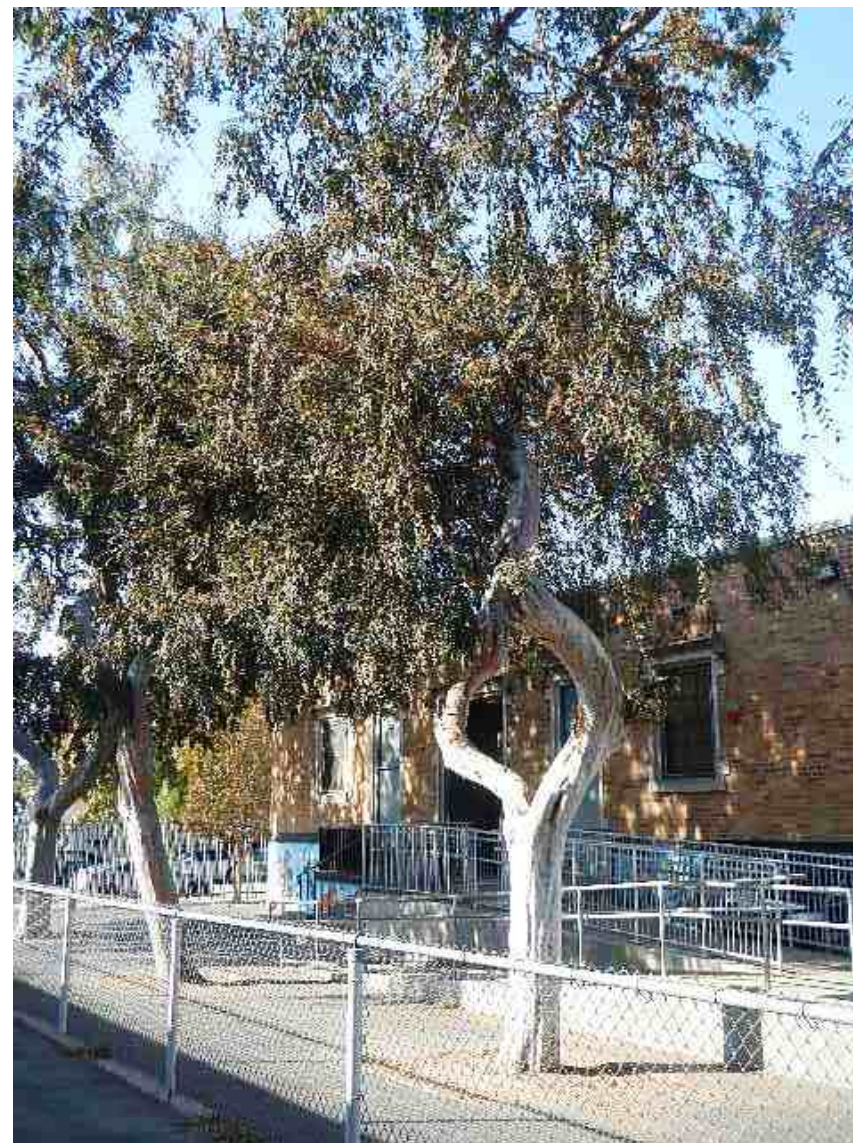
#31 Elm is codominant and has dogleg scaffold limbs.

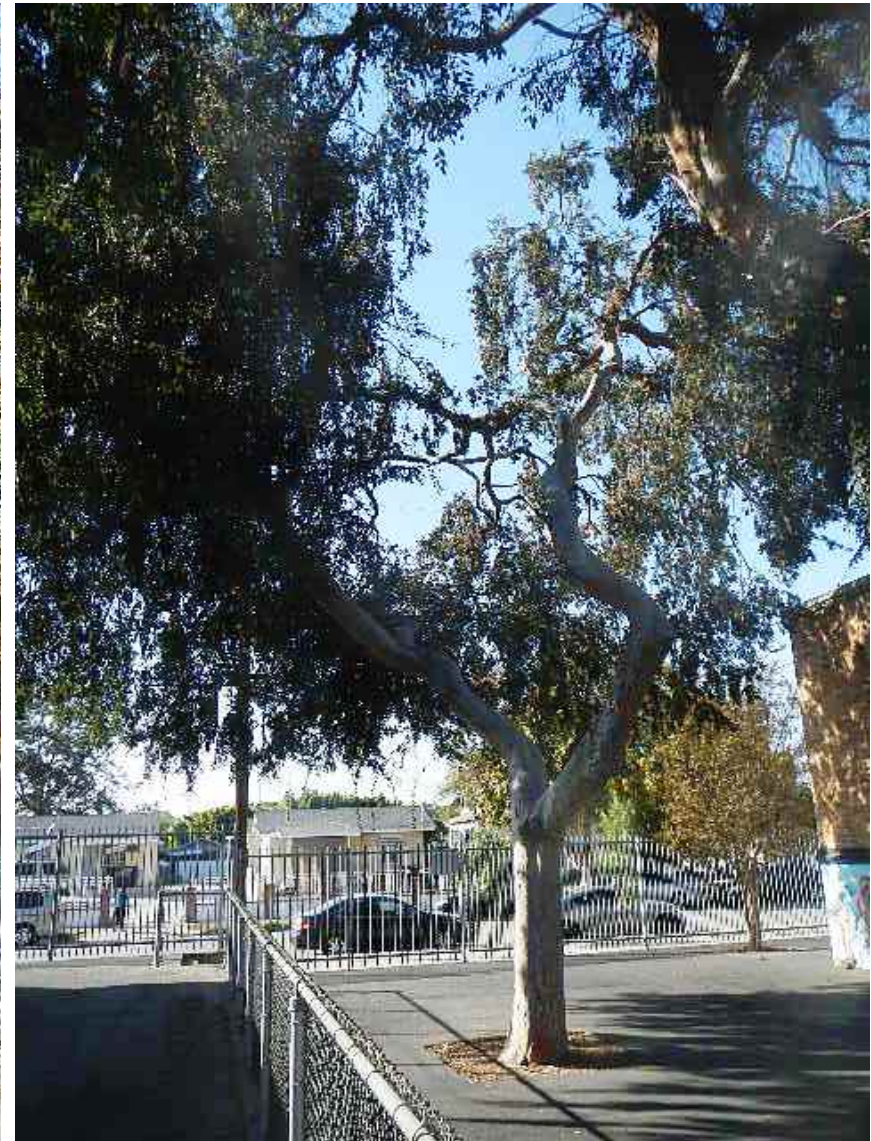
#33 Elm is codominant, one-sided, and doglegs.

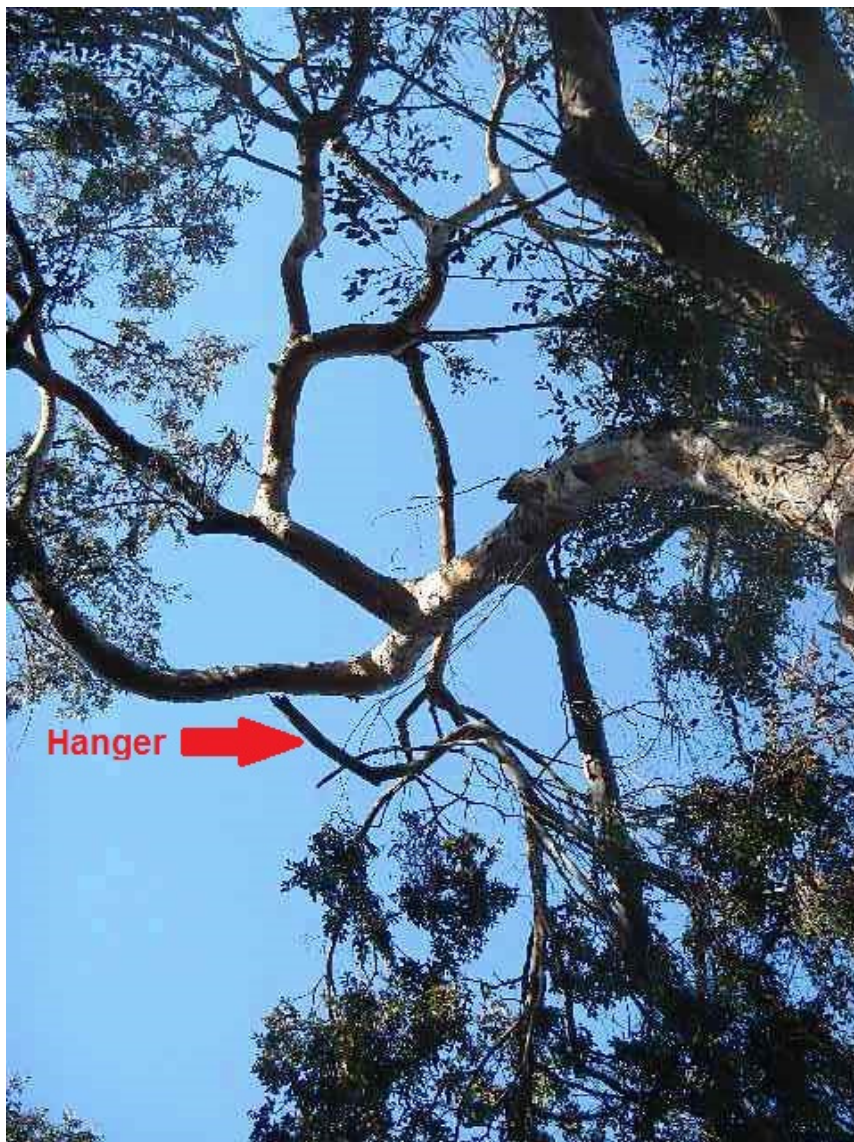
#32 Elm has 2 hangers

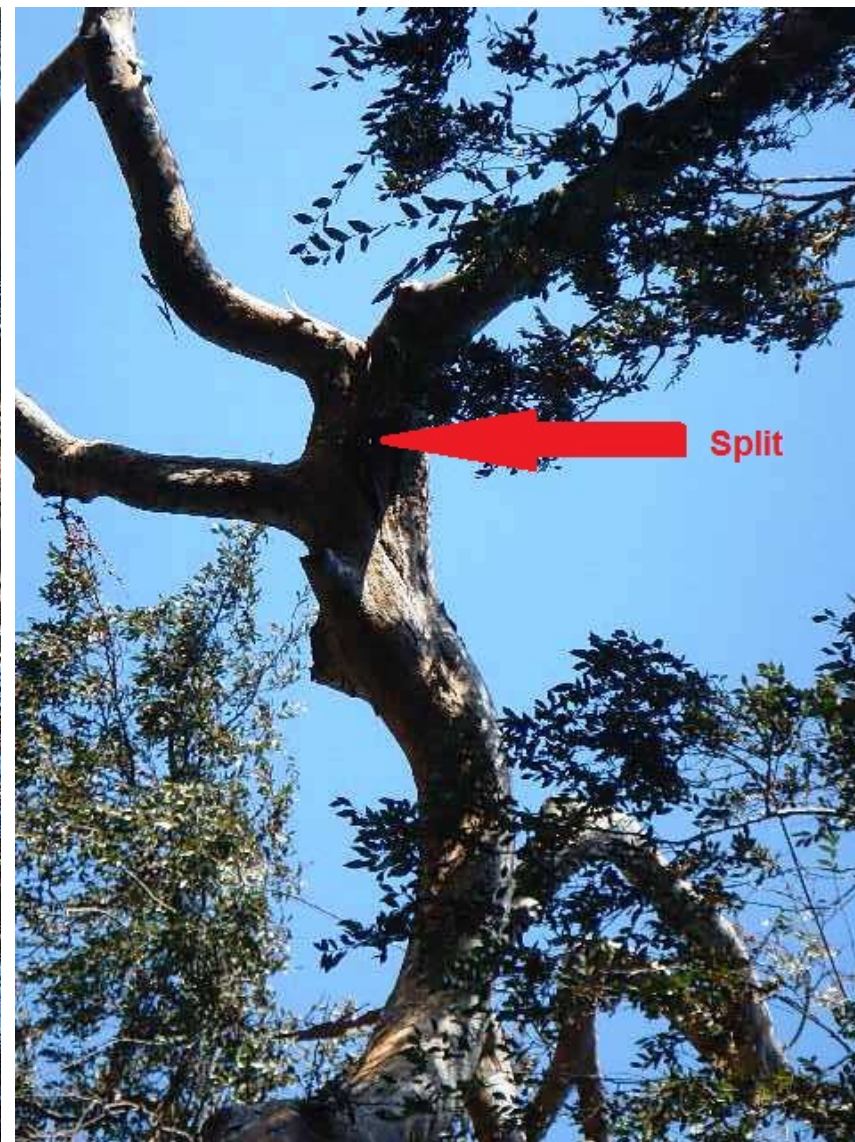
#32 Elm also has a split at a codominant end.

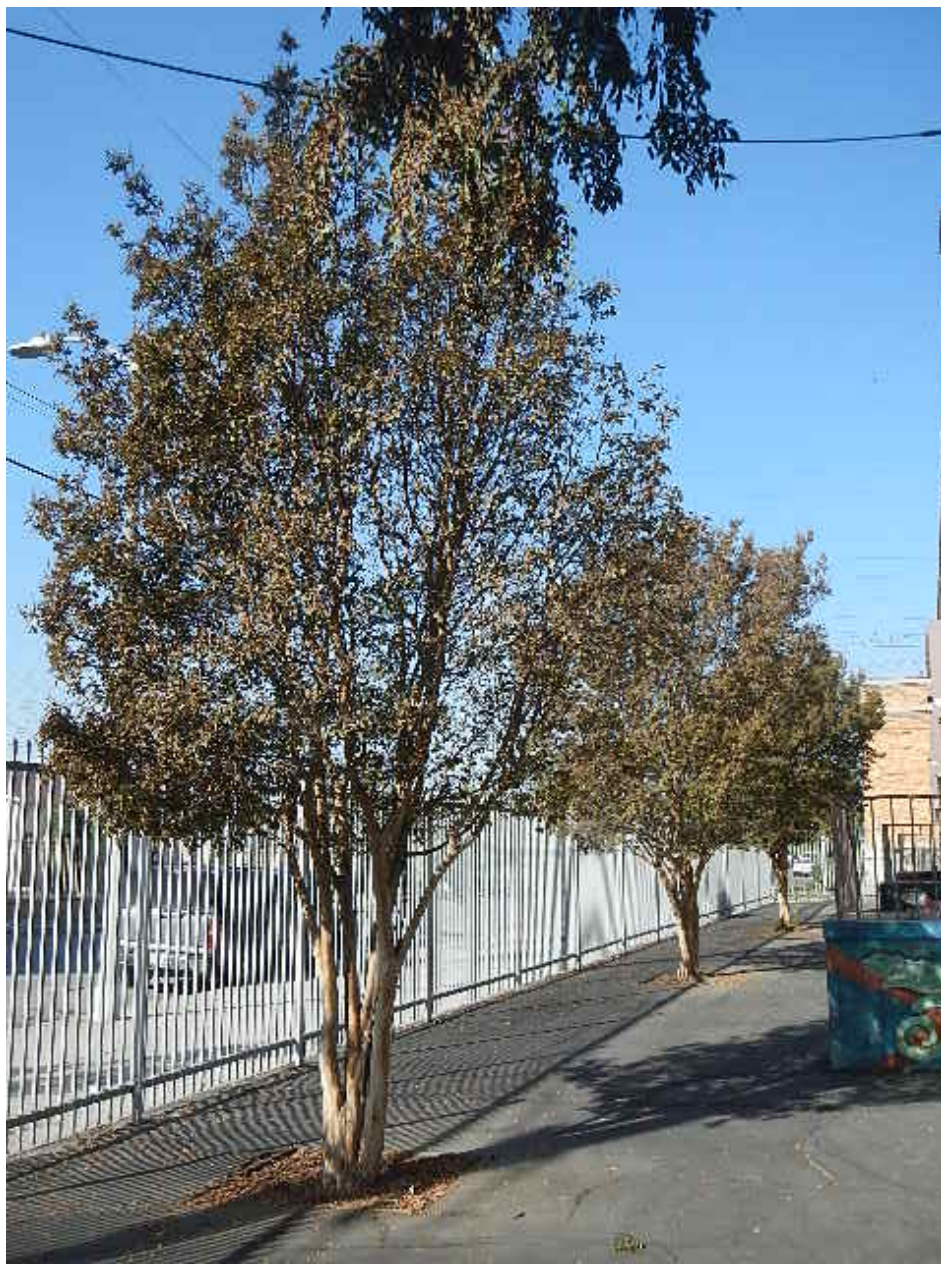
#34 to 36 Crape myrtles (front to back) – note narrow crotches.
