Preliminary Geotechnical Evaluation and Geologic Field Reconnaissance Report

NELSON SLOAN QUARRY RESTORATION AND BENEFICIAL
REUSE OF SEDIMENT PROJECT REPORT
2721 MONUMENT ROAD
SAN DIEGO, CALIFORNIA

File No. 133467-002
April 2021

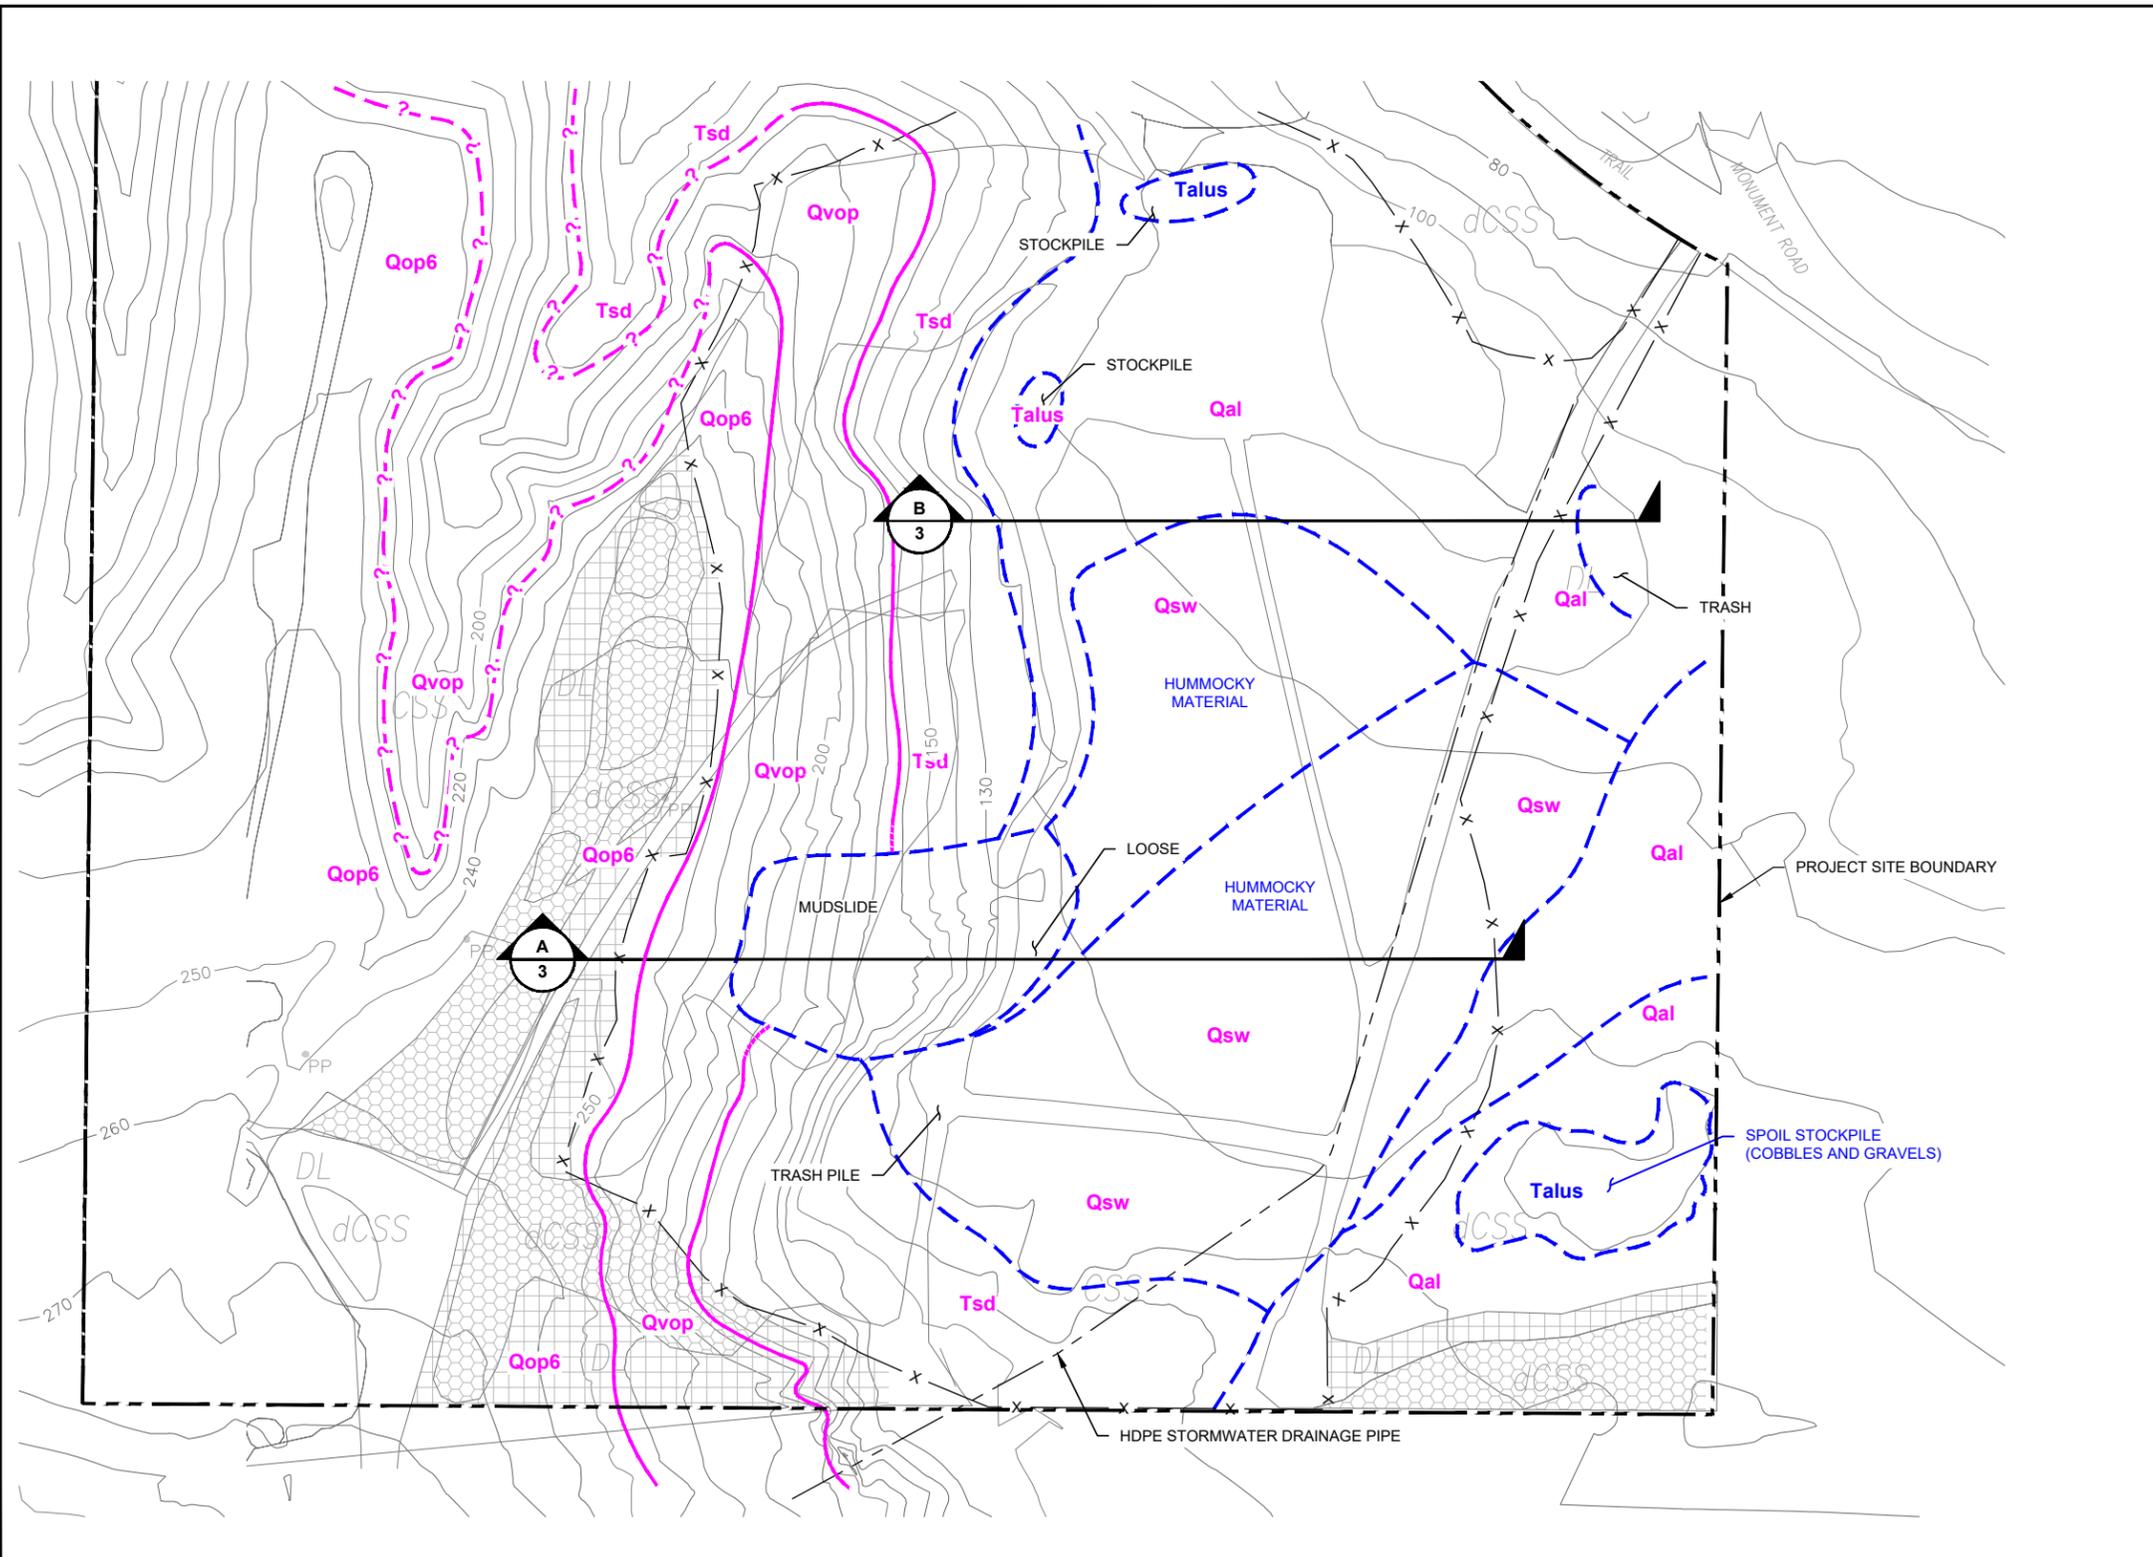
FIELD GEOLOGY MAP

A California registered Certified Engineering Geologist visited the Site on 12 February 2021 to evaluate its geologic conditions as well as the adjacent areas. The geologic conditions were documented in a photo log provided as Appendix A. The surface conditions are presented on the Field geology map, Figure 3; cross sections detailing the conceptual bedrock depths are presented on Figure 4.

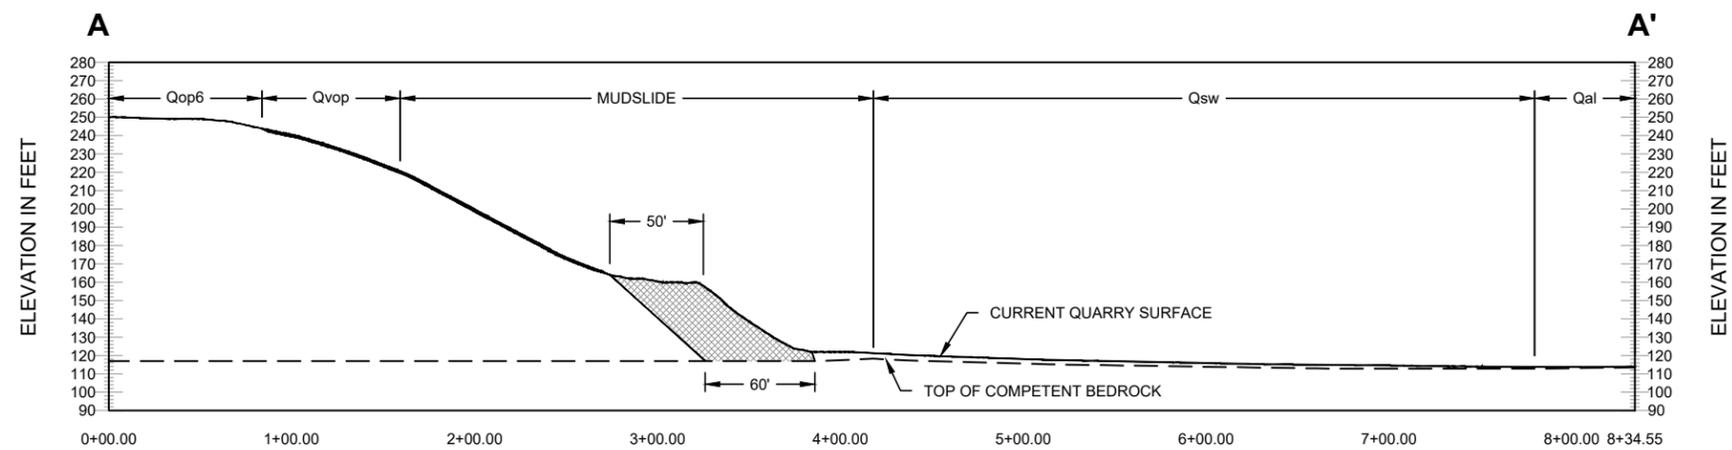
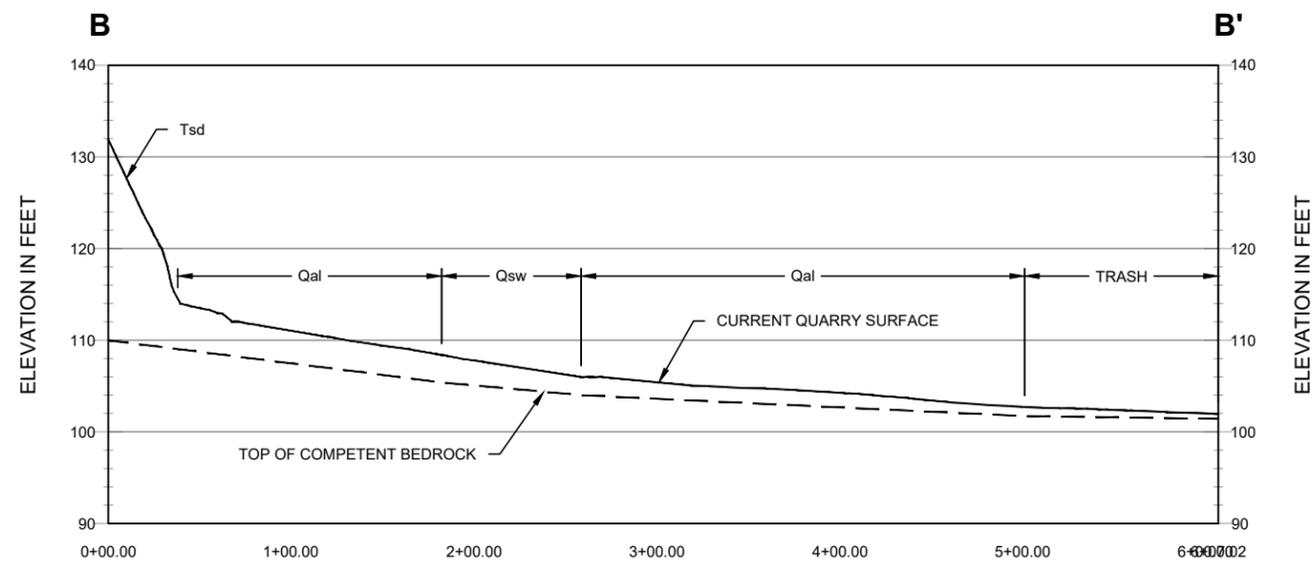
CONCEPTUAL BEDROCK DEPTHS

Loose slope wash and young alluvium deposits draped the surface of the Quarry bottom. Talus piles as high as 8 feet were encountered along the toes of the existing Quarry slopes. The slope wash consisted mostly of the grayish sands of the San Diego Formation. The talus mounds consisted of a mix of all the formations on the quarry slope with mostly mixed sands of the San Diego formation. The thickness of the slope wash and young alluvium material deposit ranged from approximately 6 inches along the eastern section of the Quarry to 5 feet thick along the western edge of the Quarry along the talus mounds, as displayed on the geologic cross sections. The talus was approximately 8 feet in height.

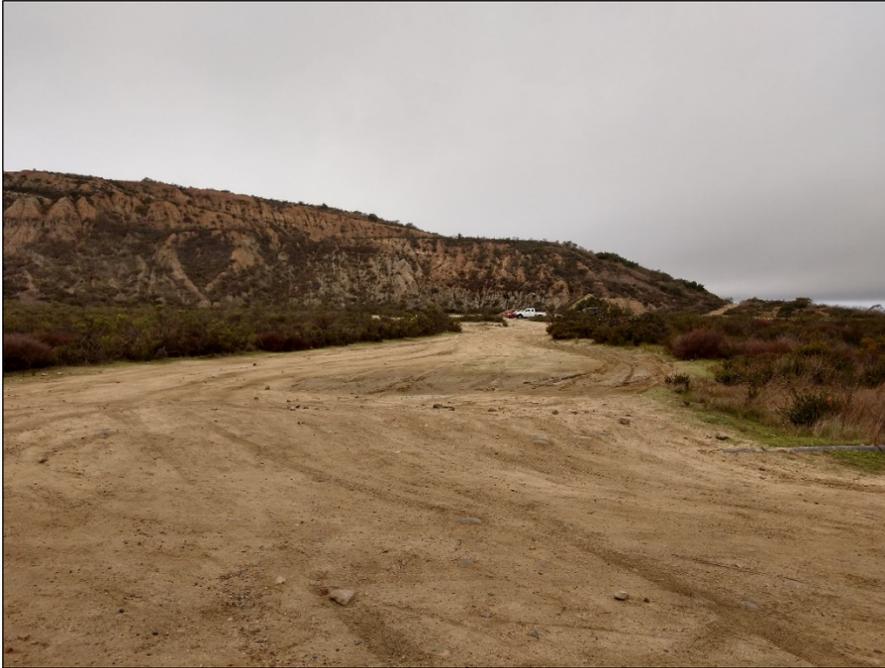
The topographical conditions along the western Quarry wall consist of moderately steep to steep slopes that are approximately 180 feet high along its northern section. Inclinations vary from approximately 2 feet horizontal to 1 foot vertical (2H:1V) along the northern section of the Quarry to near-vertical along the southern section of the Quarry. The slopes are generally vegetated with small trees and brush. Slope inclinations become near-vertical further south toward the International Border, and the surface is highly eroded and less vegetated (Appendix A; Photos 1 and 2).

Photo 1: Looking west across the quarry floor-northern section.

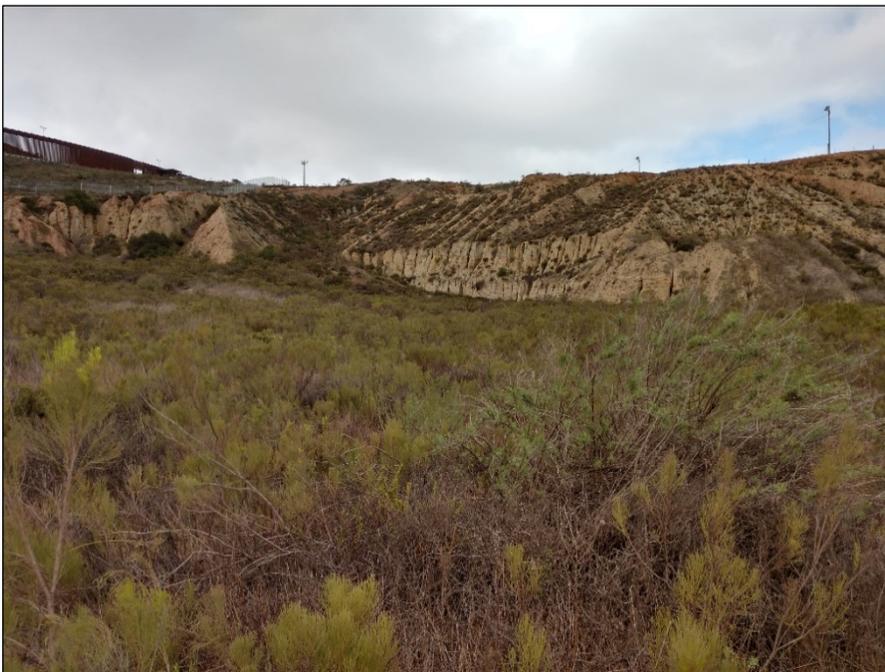
Photo 2: Looking west across the quarry floor -southern section.

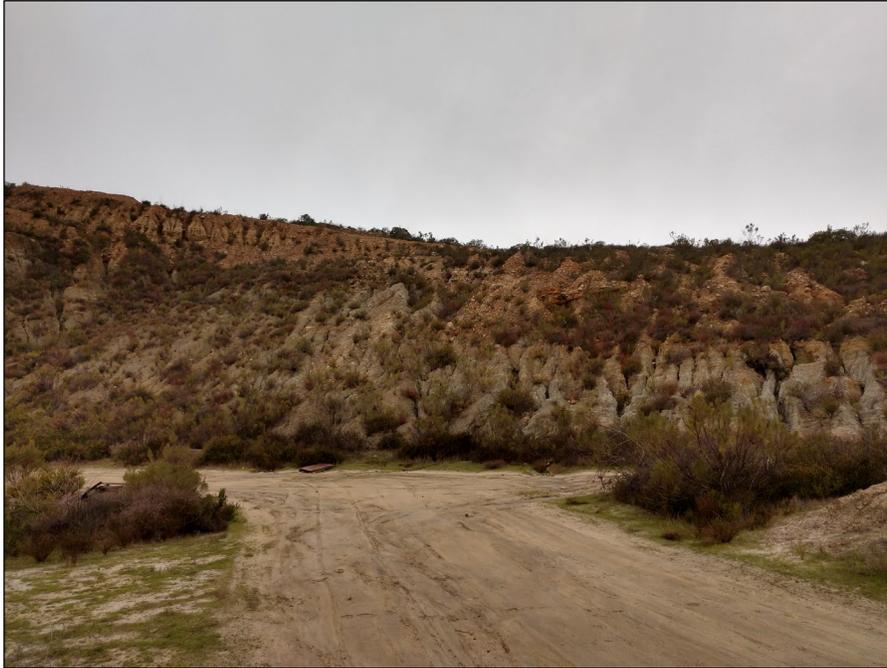
Deep rilling was observed on the highly erodible section of the San Diego Formation along the middle to northern side of the western quarry slope with surface deposit fanning generated by the slope wash (Qsw) and young alluvium material ([Qal]; Appendix A, Photo 3).

Photo 3: Looking west towards the Northern section of the quarry wall.

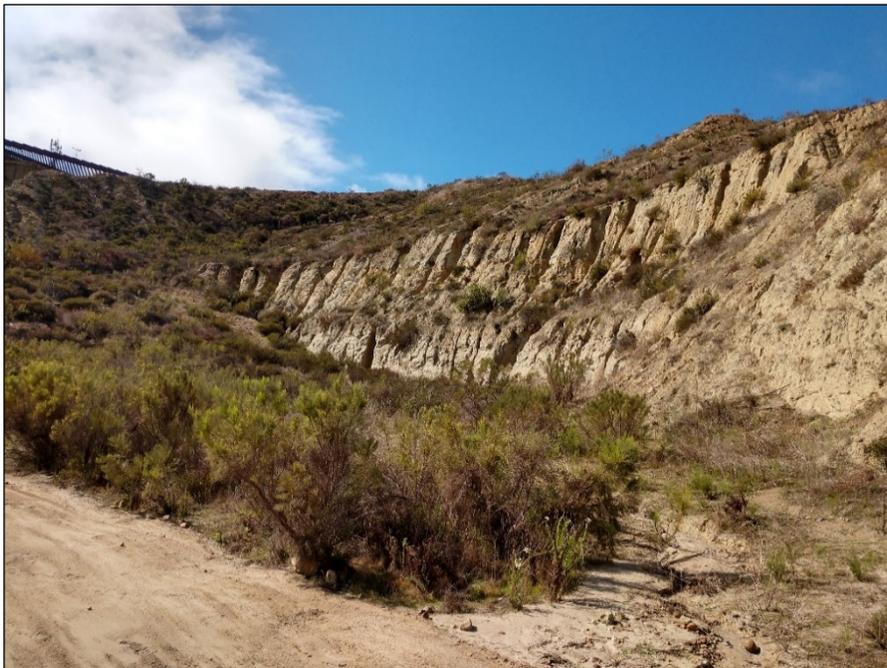
Two- to 3-inch wide vertical fractures were observed in the San Diego Formation along the western Quarry wall. The fractures or rills were infilled with a dark-brown consolidated mud deposit. No evidence of fine-grained sediment was observed outside of the fracture or rills. The southwest corner of the west Quarry wall showed evidence of excavator bucket teeth marks and benching observed in the bench cuts (Appendix A, Photo 4).

Photo 4: Looking west towards the middle section of the quarry wall.

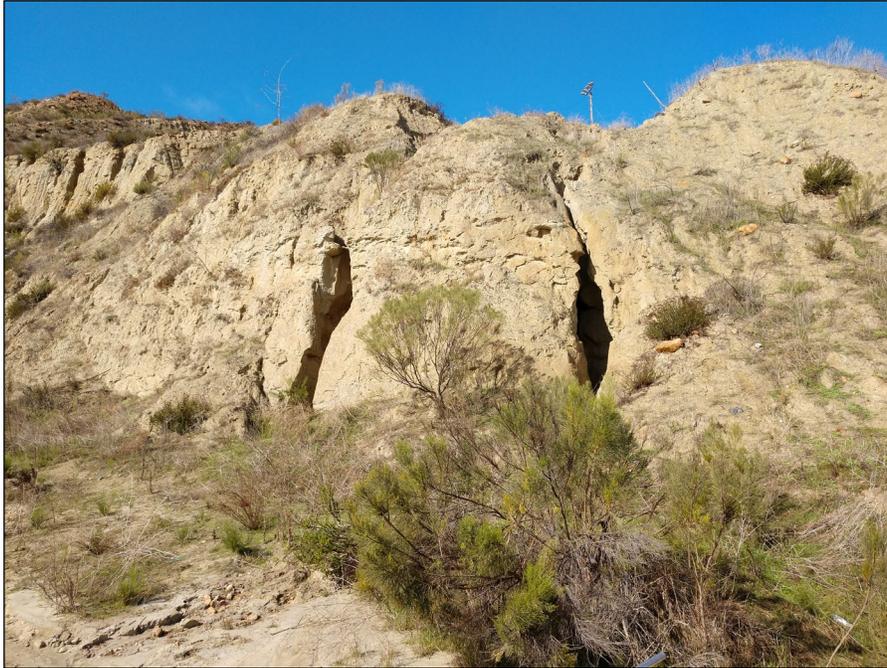
A mudslide feature was observed toward the center of the west quarry wall that comprises the San Diego and Lindavista Formations. The lower section of the mudslide was excavated when the access road was constructed. The mud slide shows high instability because of erosion and voids present at the base of the slide and deep rilling about 20 feet in depth. Bioturbation, slumping, rilling and hoodoos were also observed along the base and body of the mud slide area (Appendix A, Photo 5). The southwest corner of the quarry wall exhibited a near vertical slope and had accumulated debris at its base that ranged from sand to large boulders. Fractures were also observed in the San Diego and Lindavista Formations, Appendix A, Photo 6.

Photo 5: Looking west towards the mudslide feature along the quarry wall.

- Surfaces subject to receiving any fill shall be adequately grubbed and be clean of any loose, unstable, unsuitable soils, rocks, and organics. Rockfalls and previous mudflows shall be excavated to competent material and dense formations. Excavation on slope surfaces shall be performed in general accordance with the provisions of 2019 California Building Code-Appendix J-Section J106.

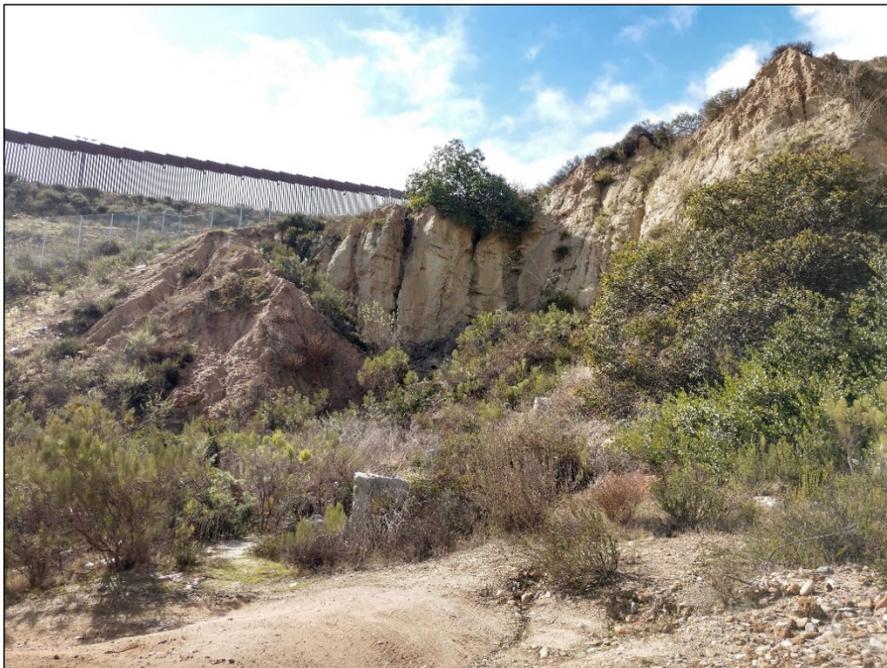
Photo 6: Looking southwest towards the southern section of the quarry wall.
