Appendix D:

Arborist Survey and Assessment of a Single Valley Oak

SUBJECT: Survey of trees at 3195 N. Main Street, Pleasant Hill and their condition at the time of survey. We observed these trees on December 11th, 12th, and 29th, 2018.

SUBJECT: Assessment of a single valley oak at the site of the proposed Cambria Hotel and Suites, North Main Street, Pleasant Hill.

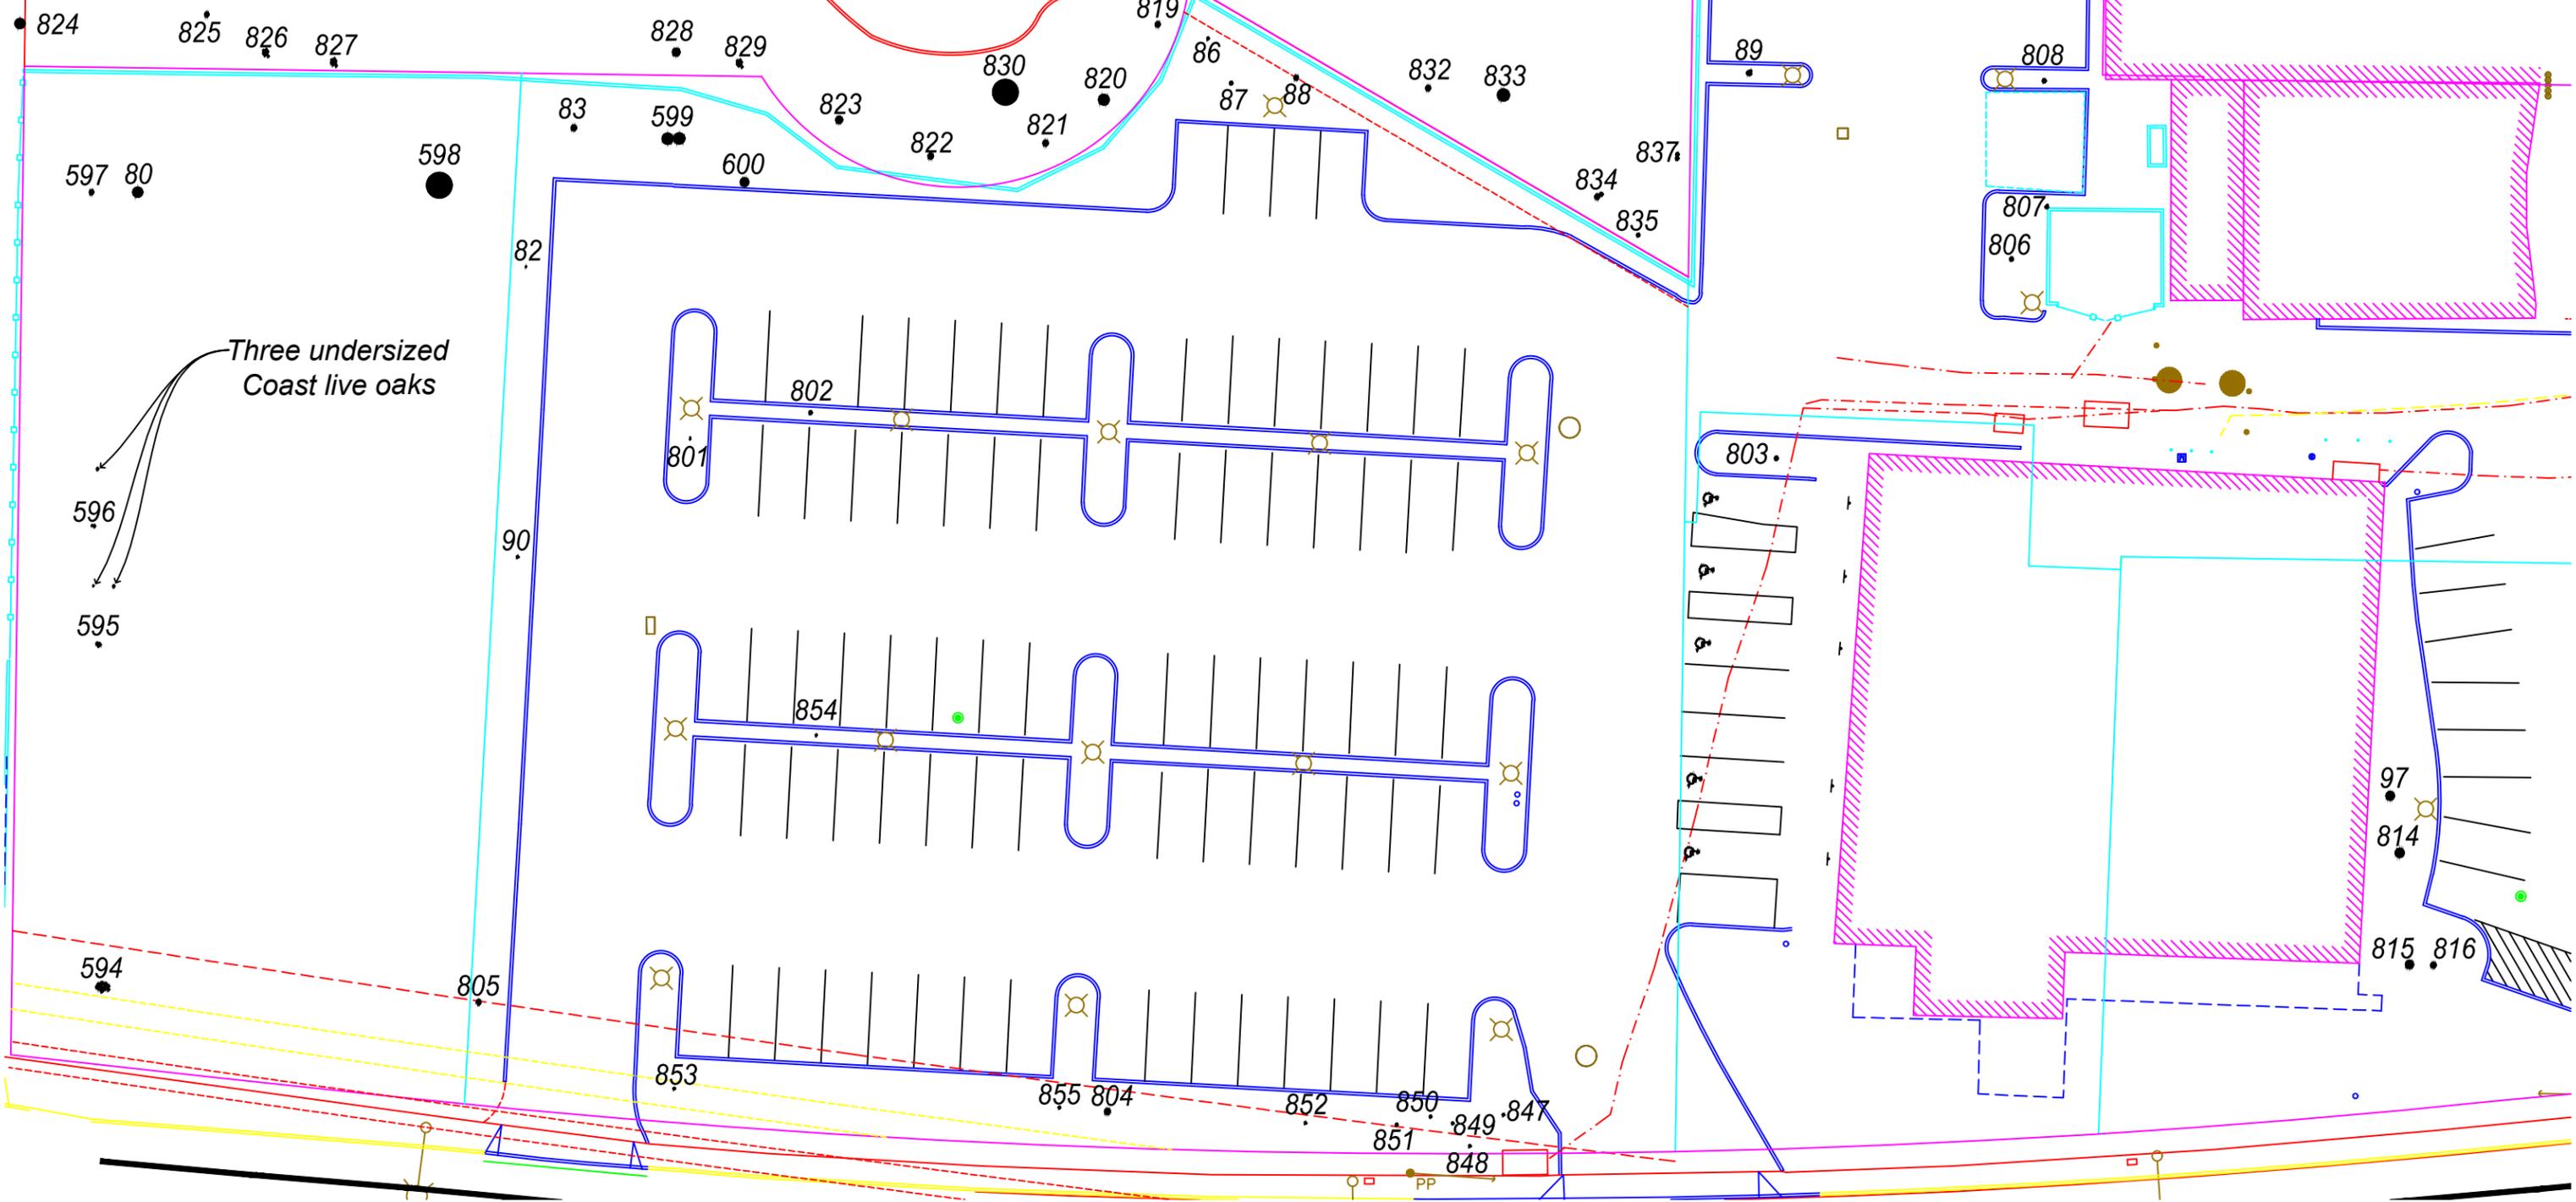
TREES AT THE PROPOSED CAMBRIA HOTEL 3195 N. MAIN STREET, PLEASANT HILL, CA

Tree Number	Species	Diameter	Health	Structure	Suitability	Comments	Neighbor rights
All trees other than 80,83,87,88,97,594,598,599,600,802,803,806,808,811,814,815,& 816 have been located by the arborist, and therefore lack precision of a formal surveyor.							
The accompanying map to this list is provided as an 11 x 17 inch, 30 scale PDF.							
Trees in rows shaded gray are close to the existing western cinderblock wall on the neighboring side, and may be injured by excavation, subexcavation, wall replacement, or other disturbance of existing soil on the hotel side.							
80	Elm spp	23 @ 1'	3	3	3	Codominant at 3 feet with included bark, witches broom on shoots	
82	Crape myrtle	4	4	3	1	Remove stakes	
83	Coast redwood	13	3	4	0		
86	Coast redwood	6	3	4	0	Subordinate beneath 83	
87	Coast redwood	8	3	4	0	Subordinate beneath 83	
88	Coast redwood	10.5	3	4	0	Subordinate beneath 83	
89	Crape myrtle	~3,3,3,3,3,3,3,3,3	4	1	1	No tag, undersized

90	Crape myrtle	~1,1,1,1,1,1,1,1,1,1	2	2	0	No tag, ~50% dieback	
97	Coast redwood	20	4	4	1		
594	Coast live oak	10,9,8,7,6,5,5,5,4,3,3,4,5	5	2	3	Excess soil at base	
595	Coast live oak	6,4,3,3	5	3	2		
596	Coast live oak	5,3	4	3	1		
597	Elm spp	10	3	4	2		
598	Valley oak	55	4	2	3		
599	Mexican fan palm	26,26	4	2	1	Codominant at base

Tree Number	Species	Diameter	Health	Structure	Suitability	Comments	Neighbor rights
600	Mexican fan palm	20	4	4	1		
801	Elm spp	3,1	4	3	1		
802	Holly oak	8	4	3	2		
803	Crape myrtle	9	4	2	1	Topped at 6' and 7'	
804	Mexican fan palm	~14	5	5	1		
805	Crape myrtle	7,2,2,2,2,2,2,2,2,2,2	4	1	1		
806	Holly oak	8.5	5	3	3	Topped at 6'	
807	Privet	4,4,4	4	2	1	Tridominant at base	
808	Crape myrtle	8.5	4	3	1	Root system disrupting curb to east, topped at 6'	
809	Black locust	4	4	3	1		
810	Western cottonwood	5.5	4	4	1		
811	Mexican fan palm	~30	4	5	1		
812	Privet	5	2	3	1	~40% dieback	
813	Privet	4,4,3	4	2	1		
814	Coast redwood	21	1	4	0	Diameter taken just above burl ~5.5' - in severe decline	
815	Mexican fan palm	19	5	5	1		
816	Mexican fan palm	13	5	5	1		
819	Camphor	11.5	2	3	5	Neighbor tree, behind wall - 3' off wall	x
820	Camphor	25	3	3	5	Neighbor tree, behind wall - 6' off wall	x

Tree Number	Species	Diameter	Health	Structure	Suitability	Comments	Neighbor rights
821	Camphor	13	3	3	5	Neighbor tree, behind wall - 4' off wall	x
822	Camphor	12.5	3	3	5	Neighbor tree, behind wall - 4' off wall	x
823	Valley oak	16	4	3	5	Neighbor tree, behind wall - 6' off wall - near HV lines	x
824	Valley oak	23 @ 1.5'	3	3	5	Neighbor tree - codominant at 4' with included bark from 1'-4'	x
825	Silk tree	~10	3	2	5	No tag - neighbor tree behind wall	x
826	Purple plum	~4,4,4,4,4,4 4	3	2	5	No tag - neighbor tree behind wall	x
827	Privet	~4,4,4,4,4,4 4,4,4,4,4,4	3	2	5	No tag - neighbor tree behind wall	x
828	Camphor	~18	2	2	5	No tag - neighbor tree behind wall - topped at 10', 30%-40% dieback	x
829	Privet	3,3,3,3,3,3 ,3,3,3,3	4	2	5	No tag - neighbor tree behind wall	x
830	Canary Island date palm	~60	4	5	5	No tag - neighbor tree behind wall	x
831	Valley oak	~48	4	3	5	No tag - neighbor tree behind wall	x
832	Elm spp	~12	3	2	5	No tag - neighbor tree behind wall	x

833	Elm spp	~28	3	2	5	No tag - neighbor tree behind wall - leans heaviliy over wall	x
834	Valley oak	~12,8	3	3	5	No tag - neighbor tree behind wall - leans heaviliy over wall	x
835	Elm spp	~8	3	3	5	No tag - neighbor tree behind wall - leans heaviliy over wall	x
837	Elm spp	~8,8	3	3	5	No tag - neighbor tree behind wall	x
838	Ailanthus	~12	?	2	5	No tag - neighbor tree behind wall	x
839	Elm spp	~12	3	2	5	No tag - neighbor tree behind wall - topped	x
840	Privet	~6	3	3	5	No tag - neighbor tree behind wall	x

Tree Number	Species	Diameter	Health	Structure	Suitability	Comments	Neighbor rights
841	Ailanthus	~10,6	1	3	5	No tag - neighbor tree behind wall	x
842	Elm spp	~12	3	3	5	No tag - neighbor tree behind wall	x
843	Elm spp	~10,10	3	2	5	No tag - neighbor tree behind wall	x
844	Elm spp	~16	3	2	5	No tag - neighbor tree behind wall - leans over wall	x
845	Western cottonwood	~30	3	2	5	No tag - neighbor tree behind wall	x
846	Privet	~14	4	3	5	No tag - neighbor tree behind wall	x
847	Crape myrtle	~2,2,2,2,2,2,2	4	2	1	No tag, undersized - street tree - can be reconstructed with single leader	
848	Crape myrtle	~1,1,1,1,1	4	2	1	No tag, undersized - street tree - can be reconstructed with single leader	
849	Crape myrtle	~1,1,1,1,1,1,1,1,1,1,1,1,1,1,1	4	2	1	No tag, undersized - street tree - can be reconstructed with single leader	
850	Crape myrtle	~1,1,1,1,1,1,1,1,1,1	4	2	1	No tag, undersized - street tree - can be reconstructed with single leader

851	Crape myrtle	~1,1,1,1,1,1,1,1,1,1,1,1,1,1,1	4	2	1	No tag, undersized - street tree - can be reconstructed with single leader	
852	Crape myrtle	~1,1,1,1,1,1,1,1,1,1,1,1,1,1,1	4	2	1	No tag, undersized - street tree - can be reconstructed with single leader	
853	Crape myrtle	~1,1,1,1,1,1,1,1,1,1,1,1,1,1,1	4	2	1	No tag, undersized - street tree - can be reconstructed with single leader	
854	Elm spp	~4	5	3	0	No tag, undersized - street tree - can be reconstructed with single leader	
855	Crape myrtle	~1,1,1,1,1,1,1,1,1,1,1,1,1,1,1	4	2	1	No tag, undersized - street tree - can be reconstructed with single leader

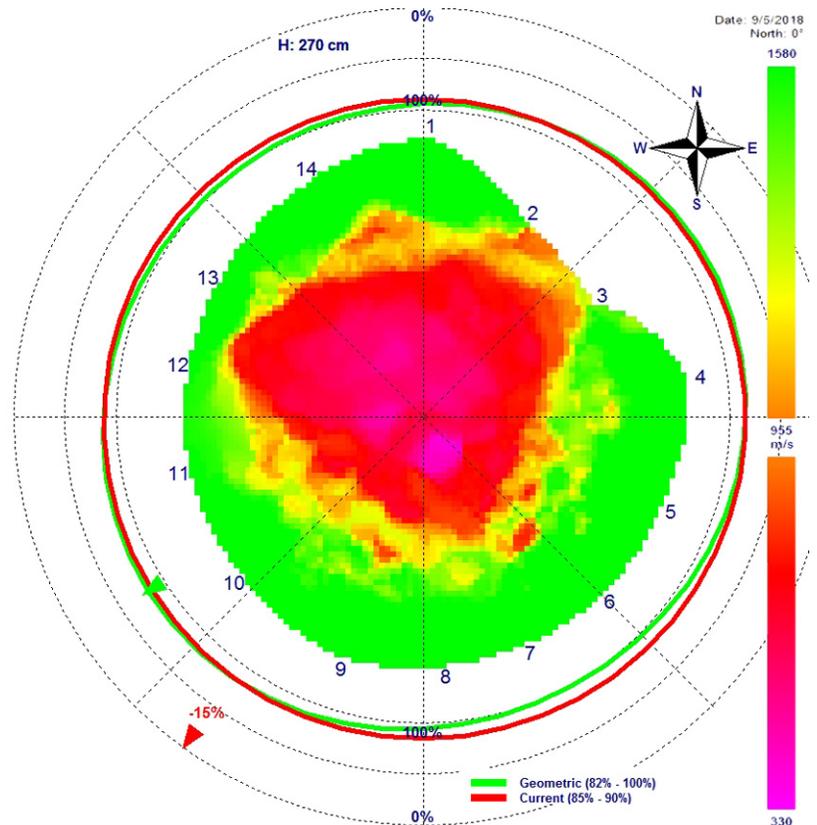
The result of the test at 270 cm, using 14 sensors was a map of the sonic characteristics, soundness, decay and strength of the plane across the trunk below the wound site. It is seen to the right. Green represents the greatest velocity, 1580 cm/second, the densest wood. Purple is the least velocity, 330 cm/sec representing internal defect and loss of strength.

The loss of strength of the trunk at this level is 15 percent, toward the south-southwest, the red arrow point in the diagram. The result of the test at 170 cm was similar. We found central decay, but a similar loss of strength, about 16 percent.

We believe this general area is the cross-section of the trunk most affected by the old wound, and we believe the 15 percent loss of strength does not significantly contribute to potential for failure from this location. Further, reduction of the tree to lessen distal limb mass and potential for limb failure will incidentally decrease potential for failure of the trunk from the tested area.
