# Appendix A

## **Design Specifications and Construction Considerations**

## Site-specific Repair Area Activities

2017 Storm Damage DWR Rehabilitation Program / 130028.39

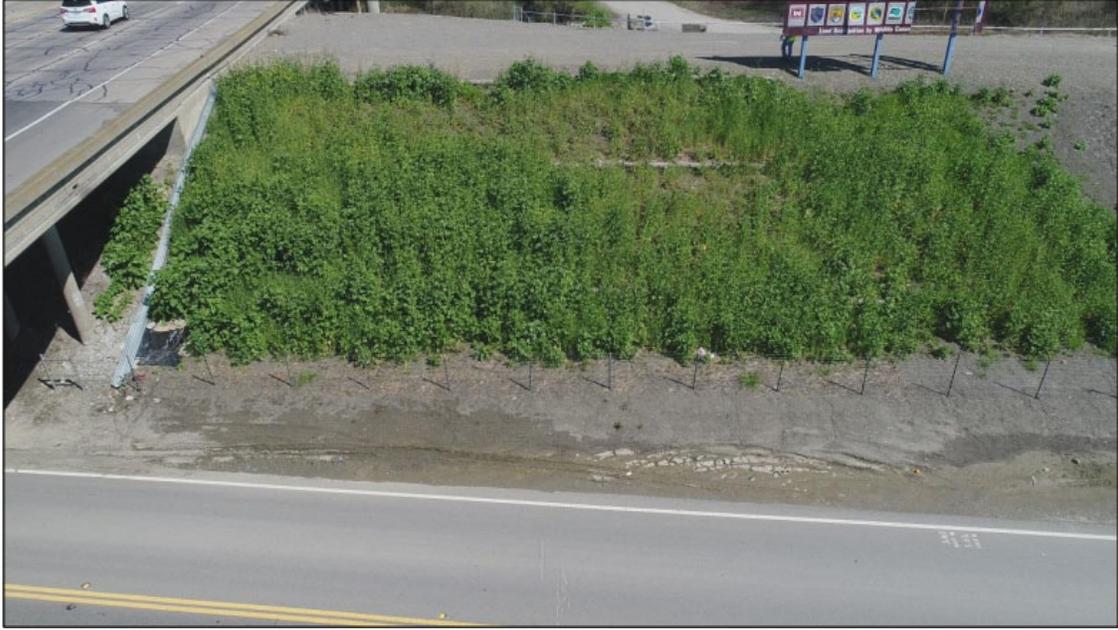
Landside erosion site after interim emergency repairs. Straw waddles for surface erosions control are visible through vegetation.

Repair of the site will consist of removing the slide and interim repair materials down to below the slipout plane, replace and compact select levee fill material to achieve design profile and buttress toe with rockfill to above the landside flooding fetch line. In-water work required to place clean rock to buttress the slope fill.

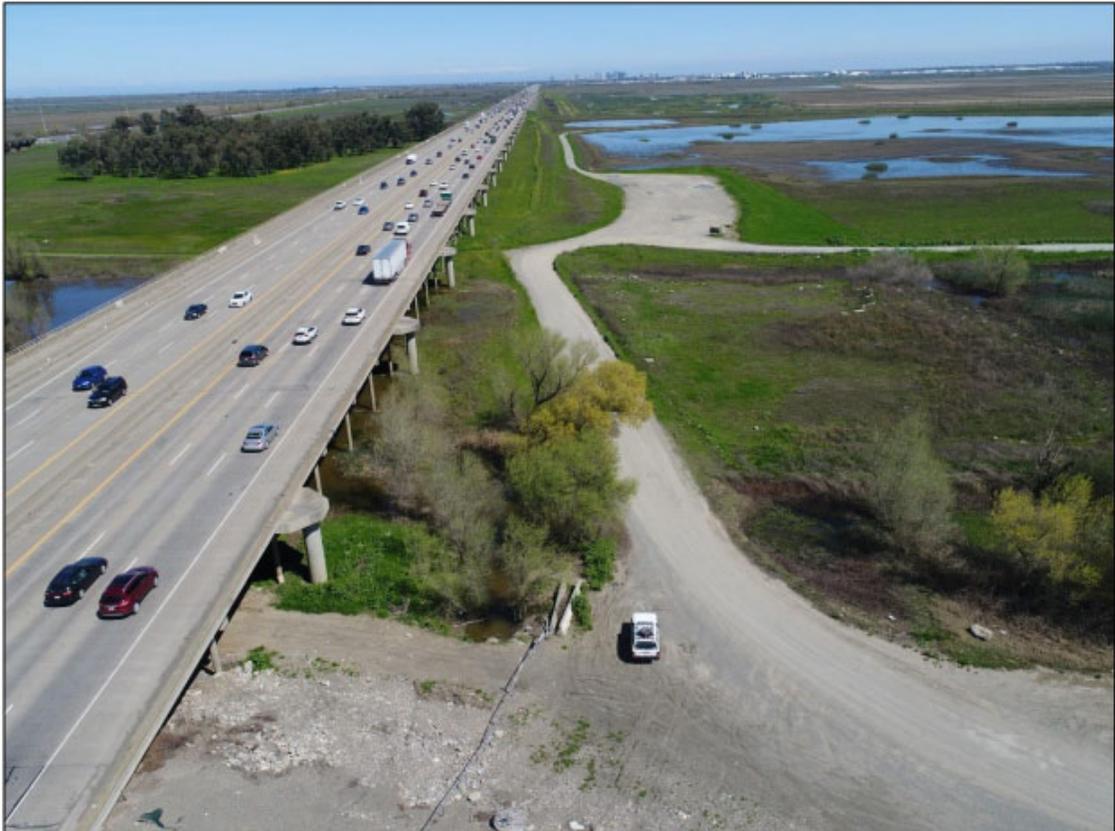
Aerial view looking east with erosion site in the foreground.

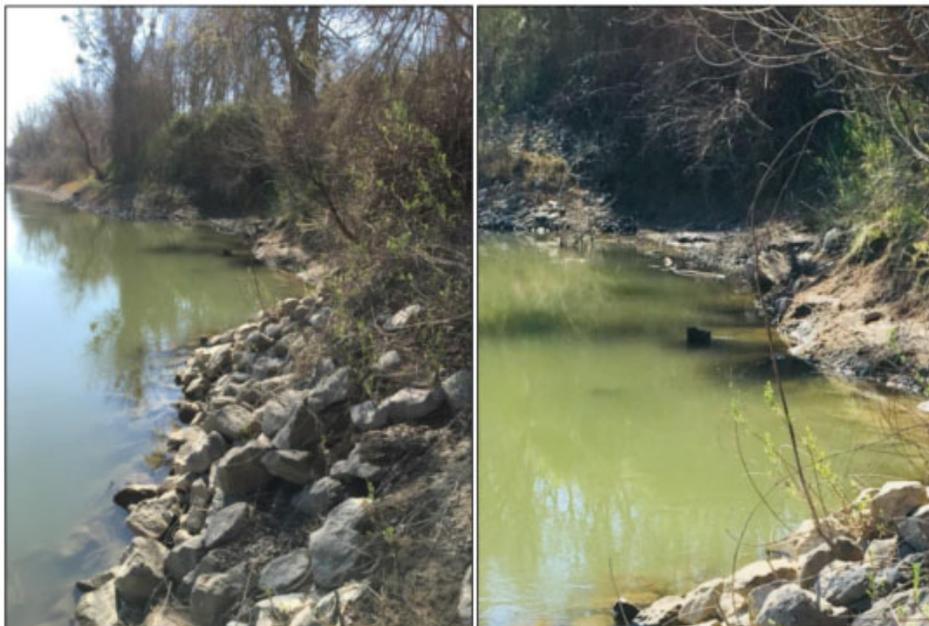
Left. Downstream view of erosion and emergency rock repair at damaged site. Right. Exposed H-pile protruding from water approximately 4-feet from erosions site shoreline. H-pile may be part of submerged water intake structure and is submerged at higher flows.

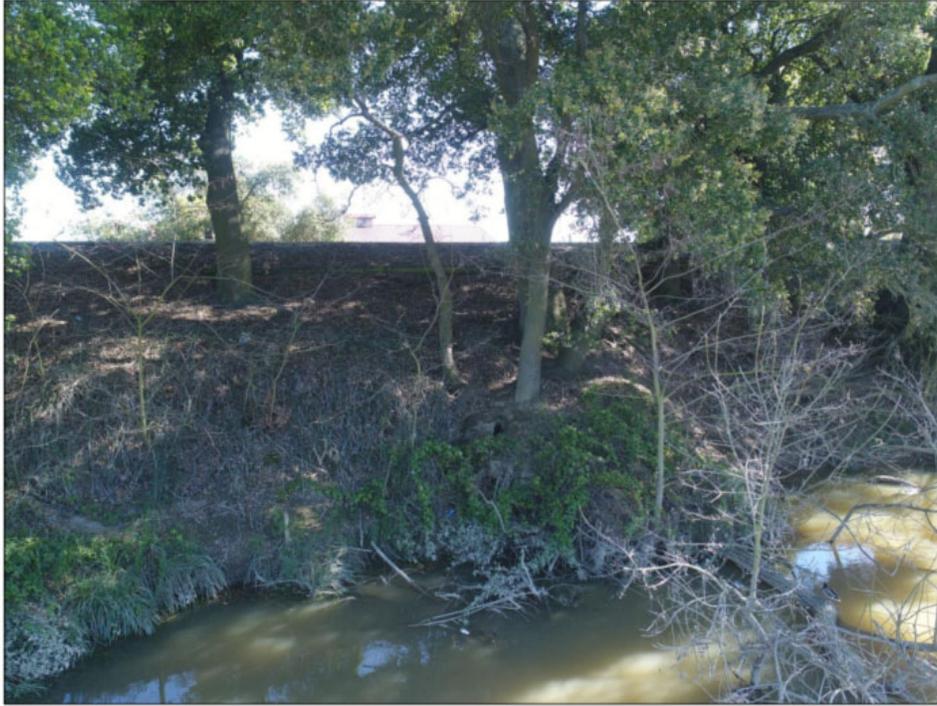
Aerial view looking south at waterside levee slope. Downed tree visible in foreground.

Repair of the site will incorporate rockfill to provide slope stability and erosion protection. The erosion of the toe has caused one large oak tree and several smaller trees to fall into the slough resulting in more erosion of the bank and levee. These downed trees will require removal. Trees in the footprint that are not dead or dying may require protection from construction activities. A number of highly invasive black locust trees were also noted at the repair site and potential staging areas. It is recommended that all black locust trees be removed where feasible and their seed carefully handled during removal (to prevent further dispersal).

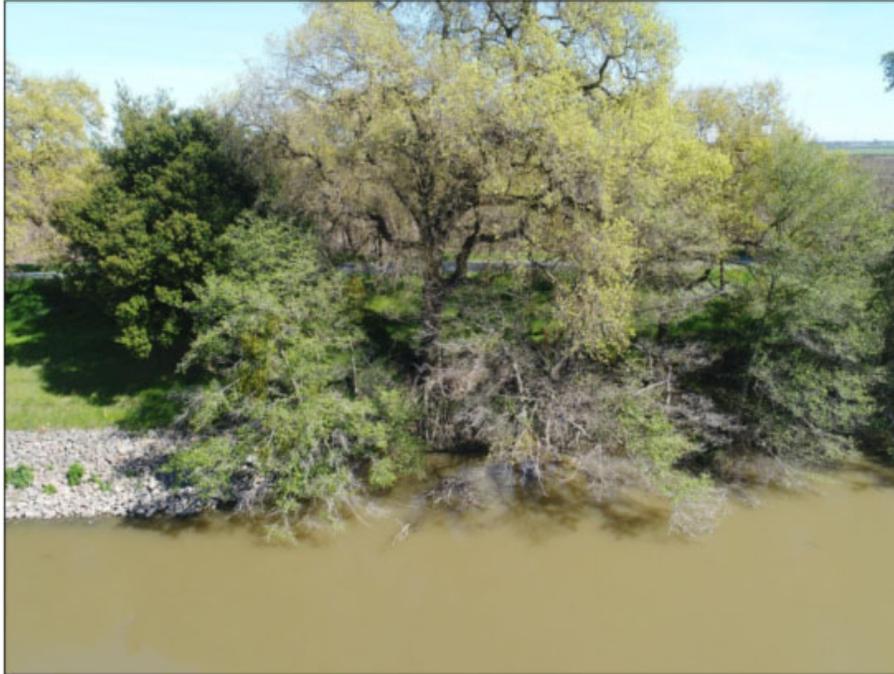
Aerial view of waterside levee slope looking at the upstream end of the erosion damage site. Erosion damage begins at the end of the rock protection, visible on the left side of the photo, placed during emergency repairs.

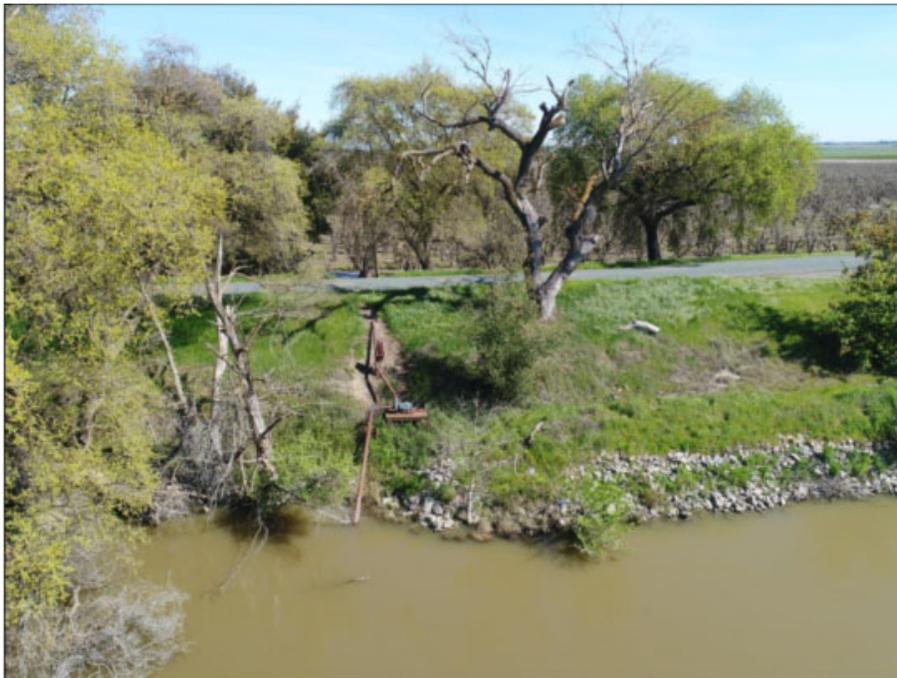
No signs of underground or overhead utilities were observed. However, one levee penetration was observed at the downstream terminus of the erosion damage site. It is a water intake system for delivering water to the land side. Due to its proximity to repair site footprint, this water delivery system will need to be protected from construction activities.

Aerial view looking at water intake pipe, rock slope protection, and dead trees in erosion damage site.

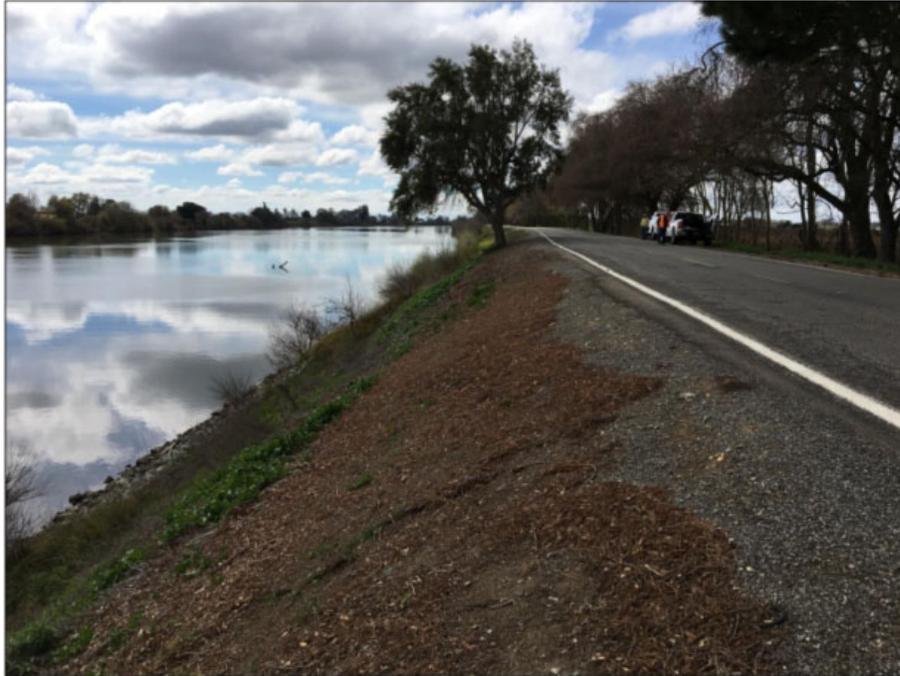
View of repair site with rock slope protection visible along water side levee toe. Cracking of highway pavement appears to be associated with the levee erosion damage.

Repair of the site will incorporate rockfill to provide slope protection against further erosion and tie into existing upstream and downstream repairs. No dead trees/snags in the water were noted for removal, however; small trees and brush may need to be removed.

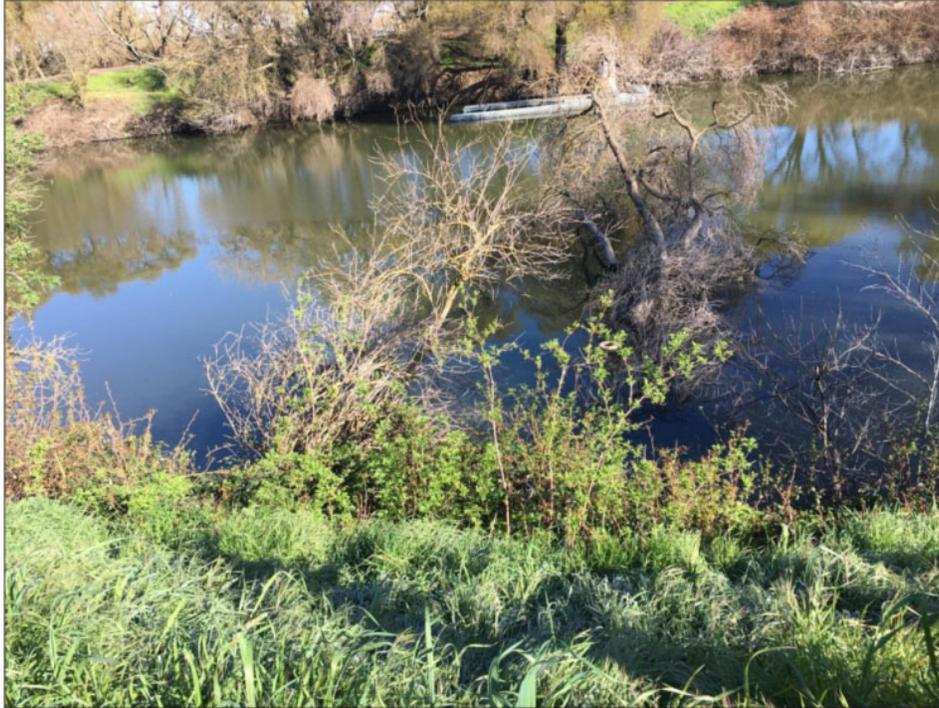
View from levee crest looking at waterside levee toe of erosion damage site. Downed tree in slough will be removed.

The repair footprint has one downed tree and root ball in the slough that will be removed. Trees in the footprint that are not dead or dying may require protection from construction activities. Repair of the site will incorporate rebuilding any missing portion of the levee prism with compacted select levee fill material and blanketed with rockfill to provide erosion protection.

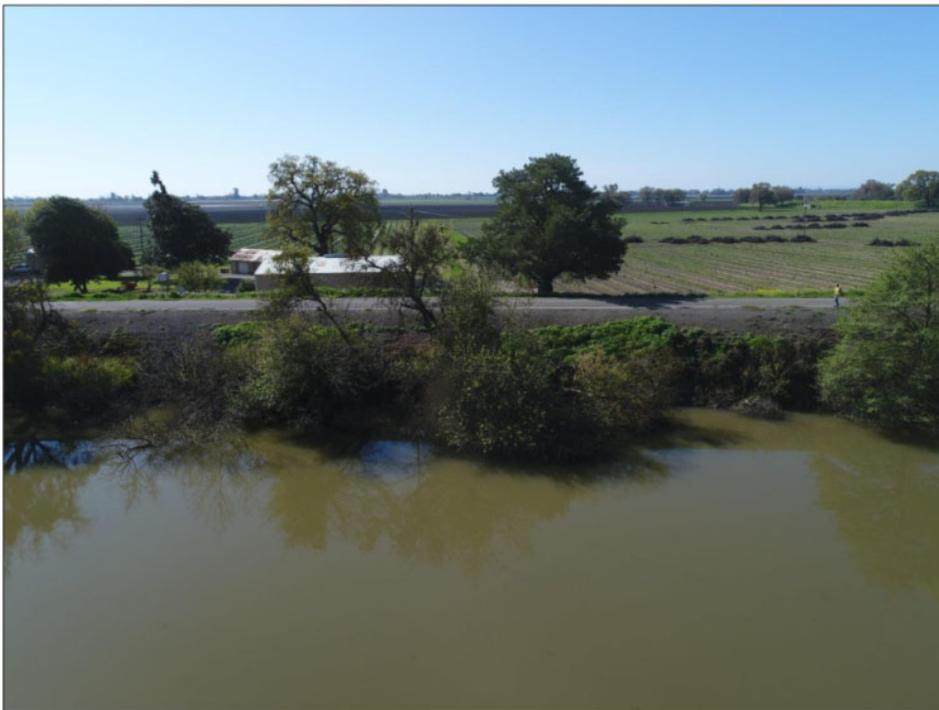
Aerial view looking at erosion site. Potential staging area in the background to the right.

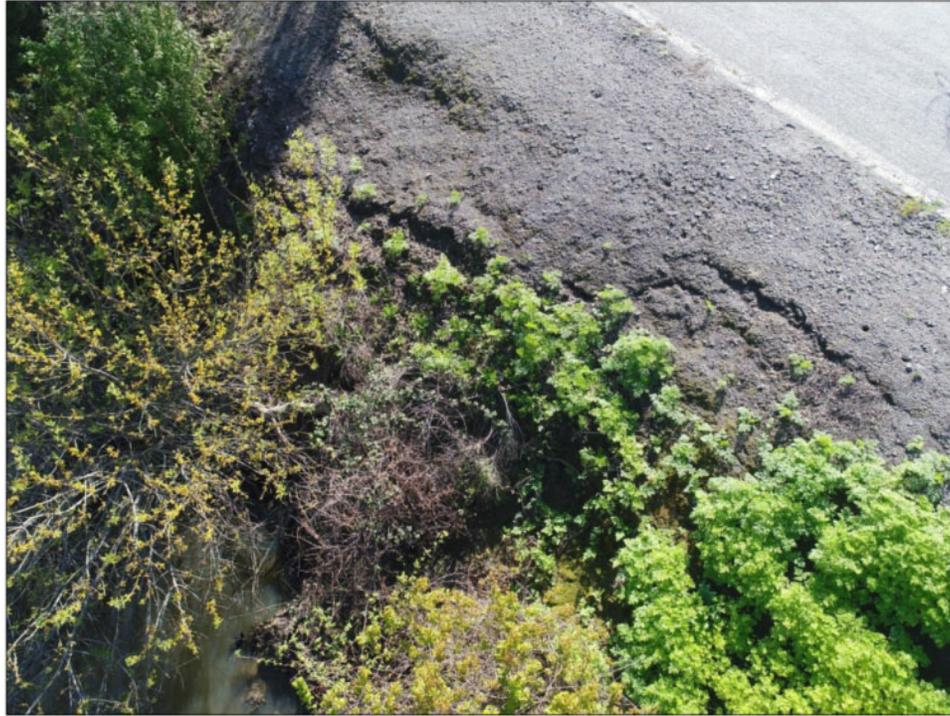
View of bank slope erosion and associated cracking of road along levee crest.

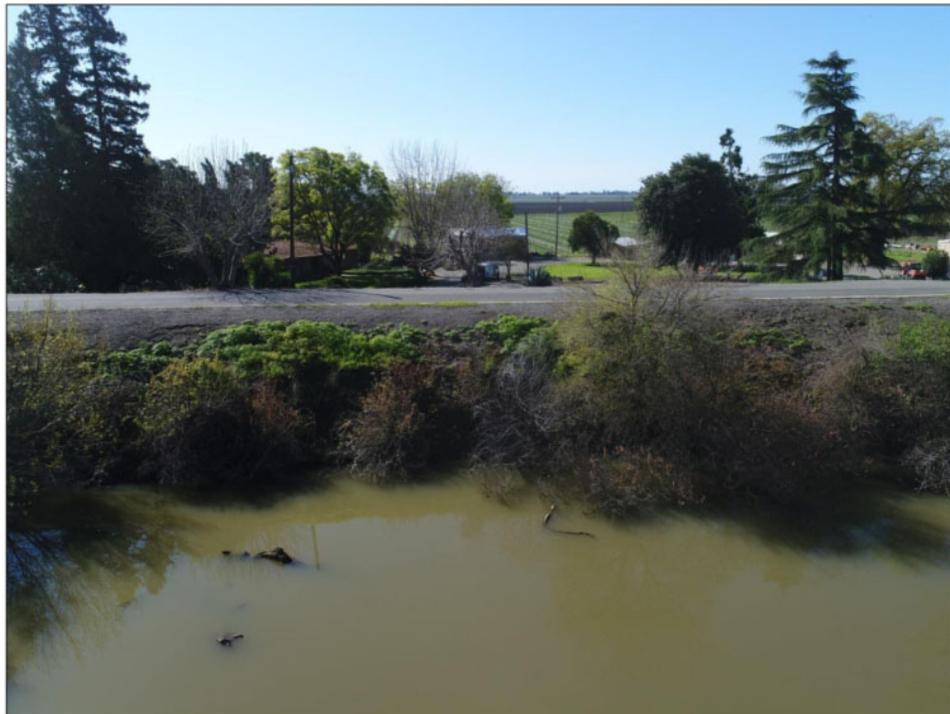
The repair footprint has at least two downed trees in the channel that are amplifying the erosion damage and will be removed. Trees in the footprint that are not dead or dying will require protection.

Aerial of erosion site with downed tree and in water snag.

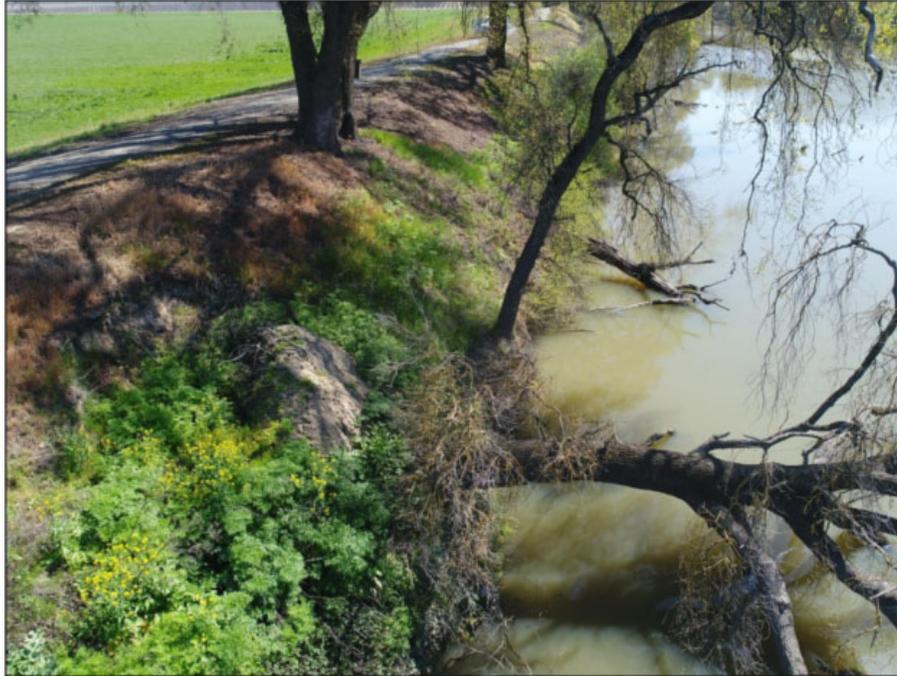
Aerial view of erosions damage site. Hole in bank left by root ball is obscured by vegetation.

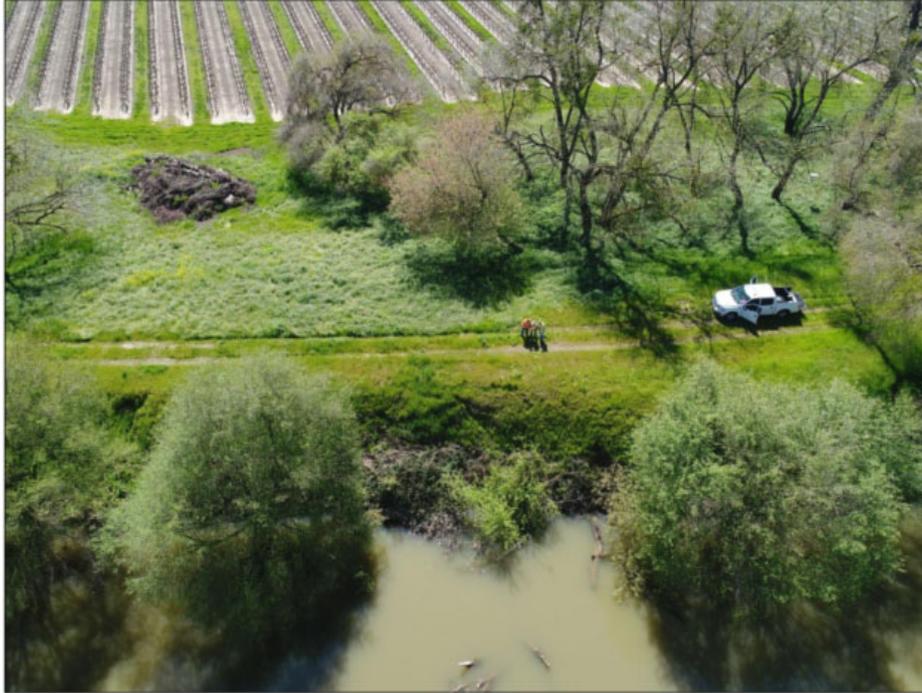
Aerial view looking at southern levee waterside slope erosion damage. Erosion scarp and tension cracking have working into the levee prism and are beginning to encroach on the levee crest.

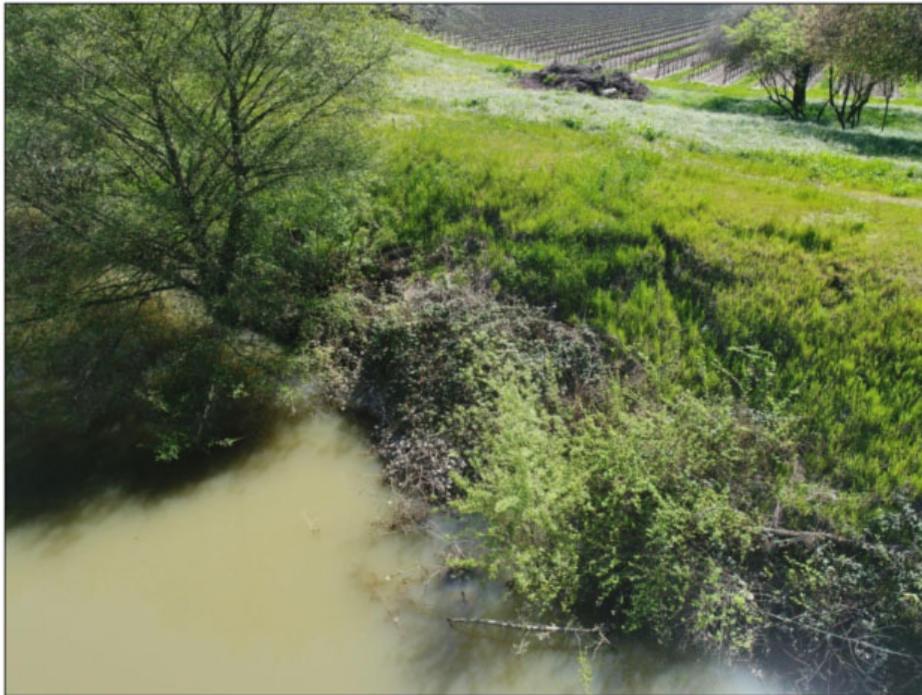
Tension cracking, visible as shadows in the waterside levee slope vegetation.

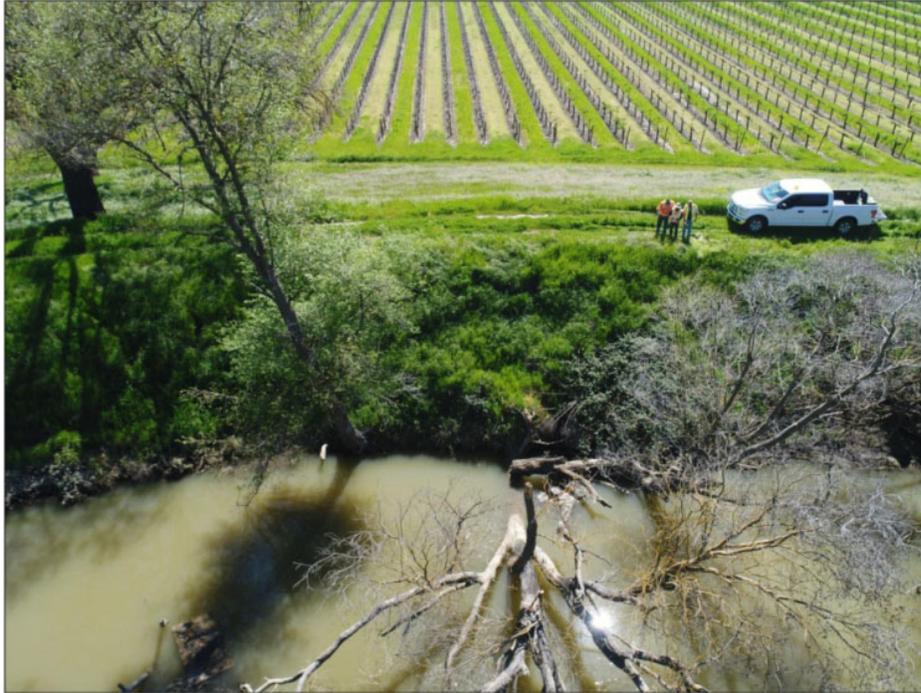
Aerial view looking at southern levee slope erosion damage. Erosion damage has felled the tree and exposed the levee to more erosion around the root ball hole.

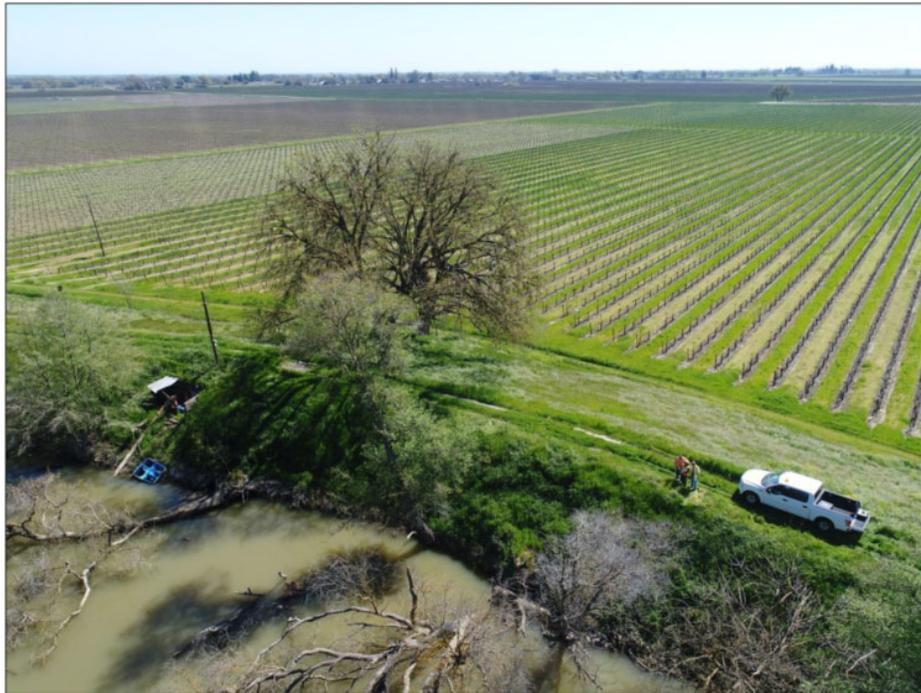
Aerial overview looking at erosion damage site and downed tree.

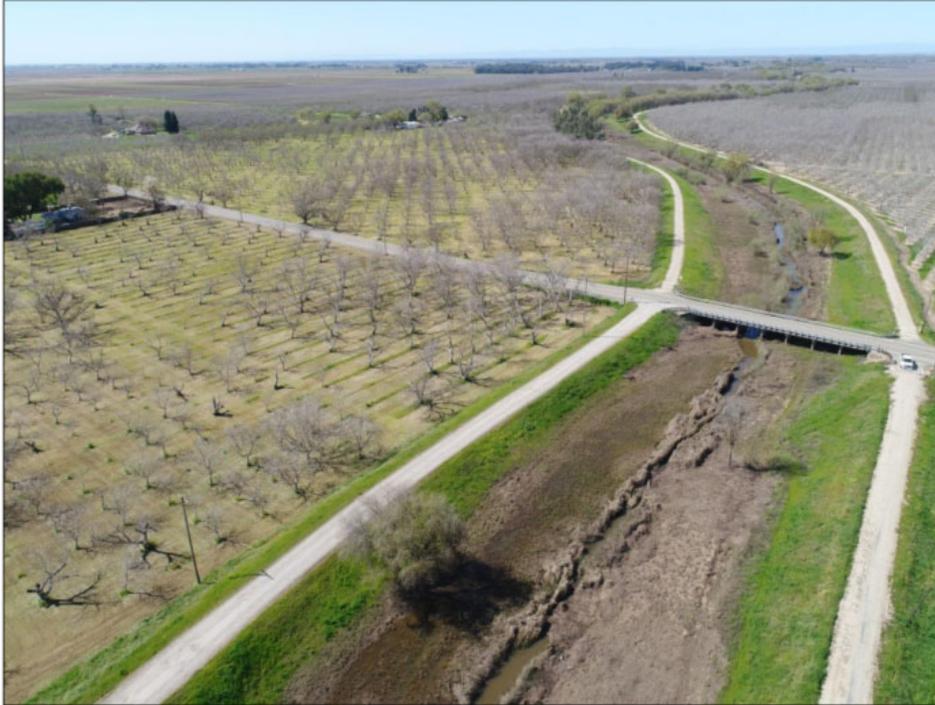
Aerial view looking downstream at Yankee Slough. Erosion damage occurs along the waterside toe of the right levee.

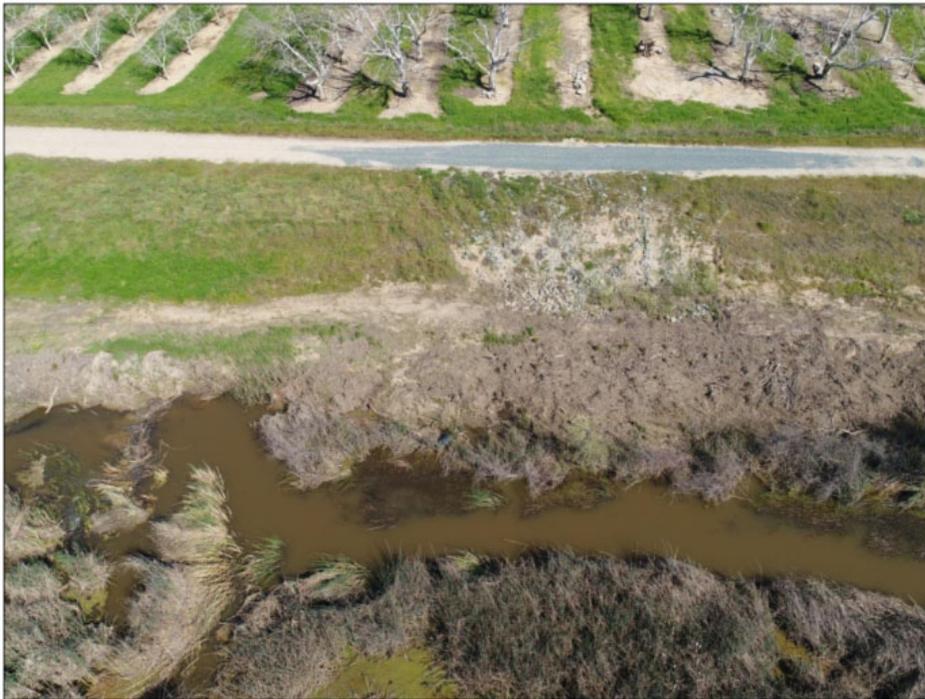
Aerial view looking at erosion site and emergency repair rock placement. Beaver dam crossing the main channel is visible in the left side of the photo.

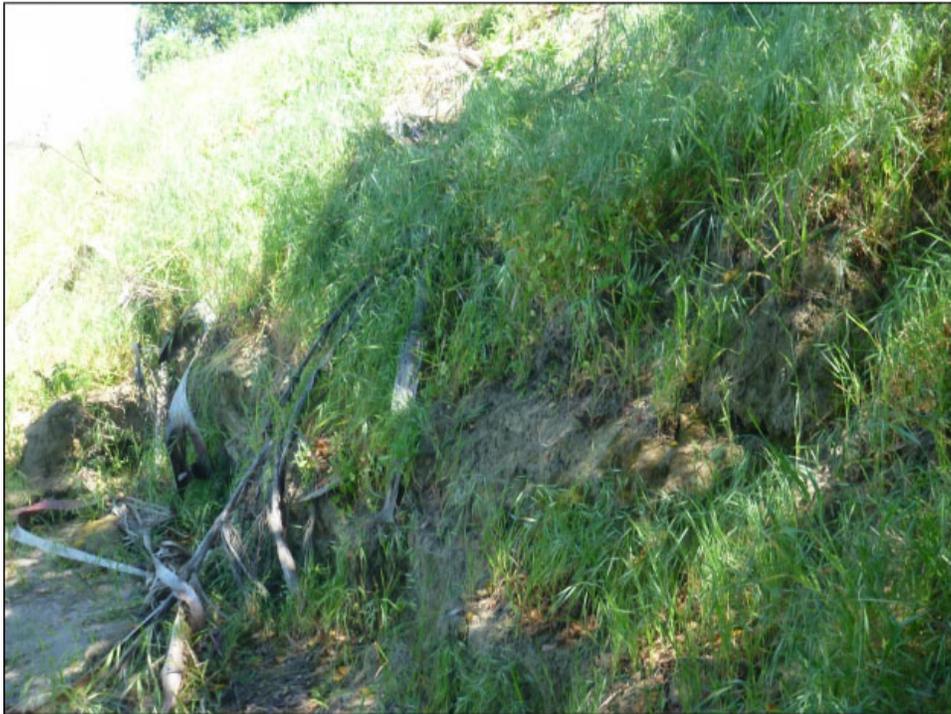
View of waterside levee slope where erosion damage exists.

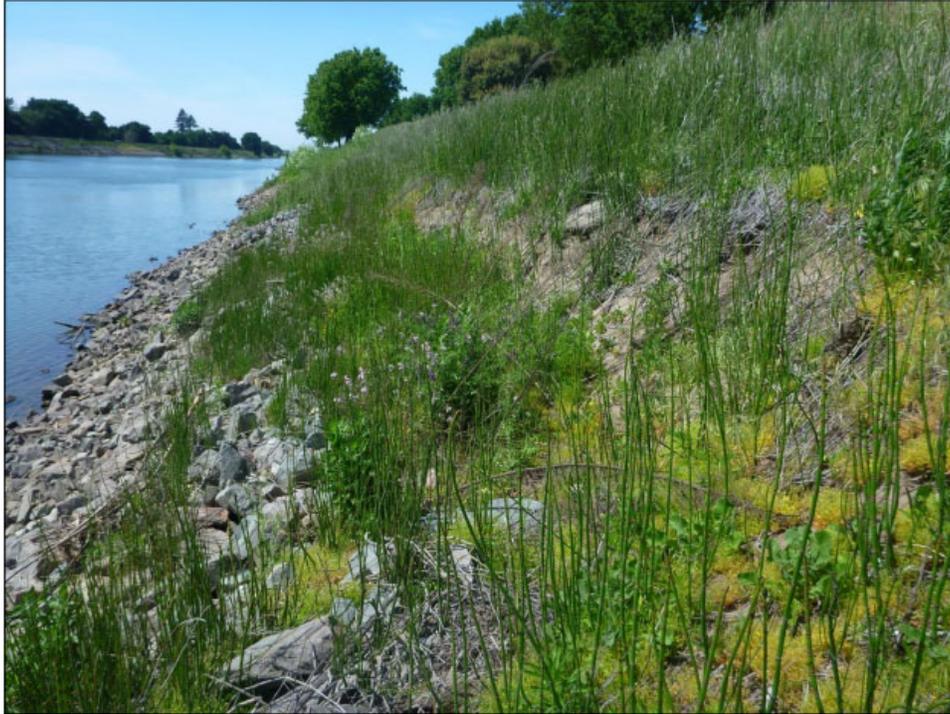
View of waterside levee toe erosion above emergency rock repair.

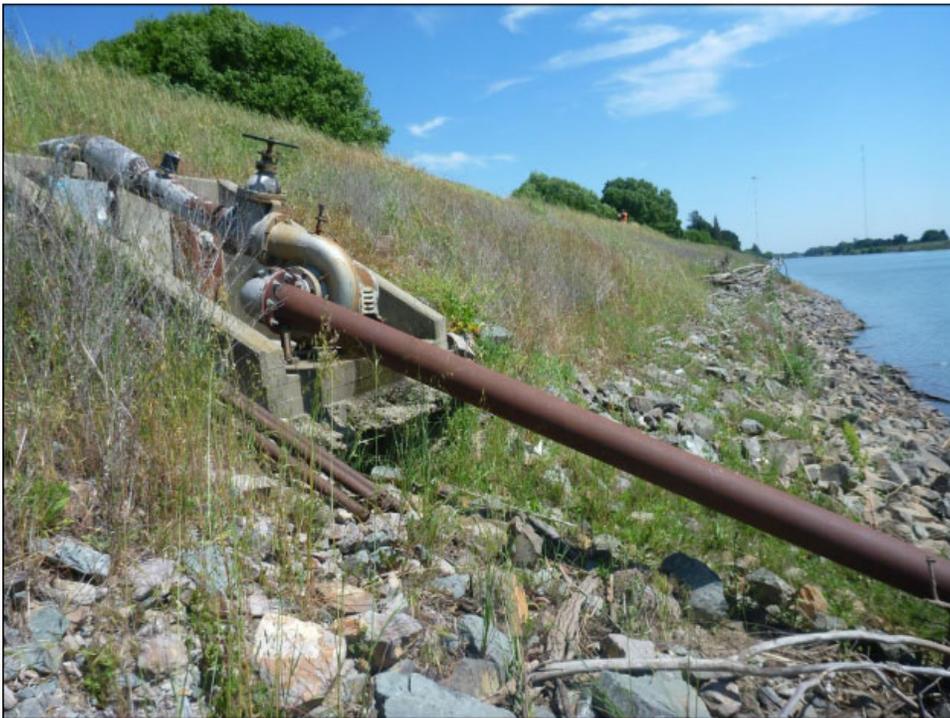
View of levee slope depression beneath pipe structure and emergency rock repair along levee waterside toe.

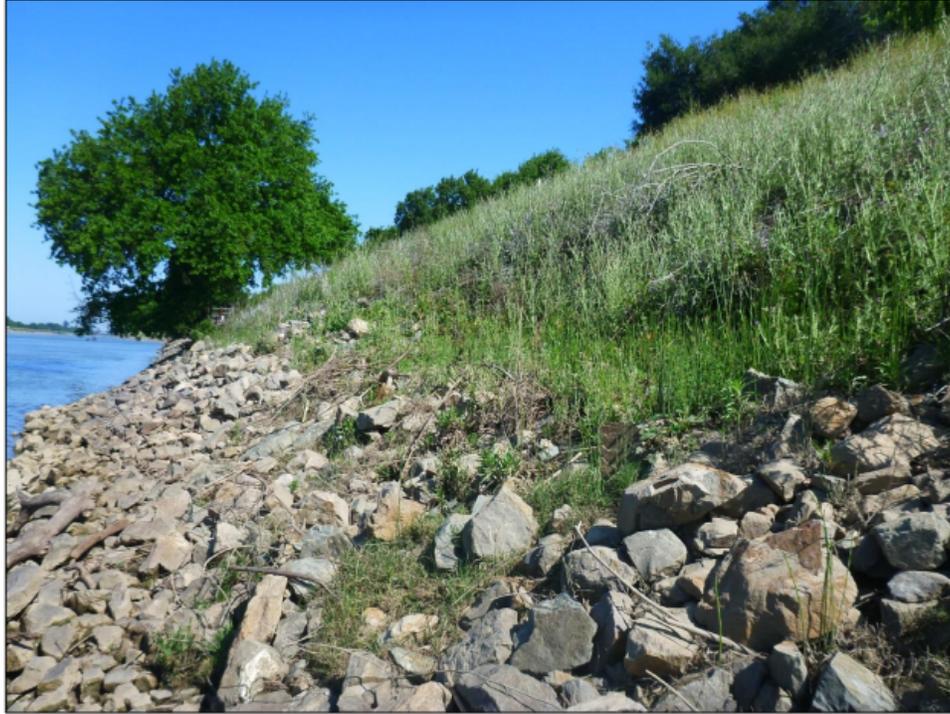
View of waterside levee erosion rock placement repair.

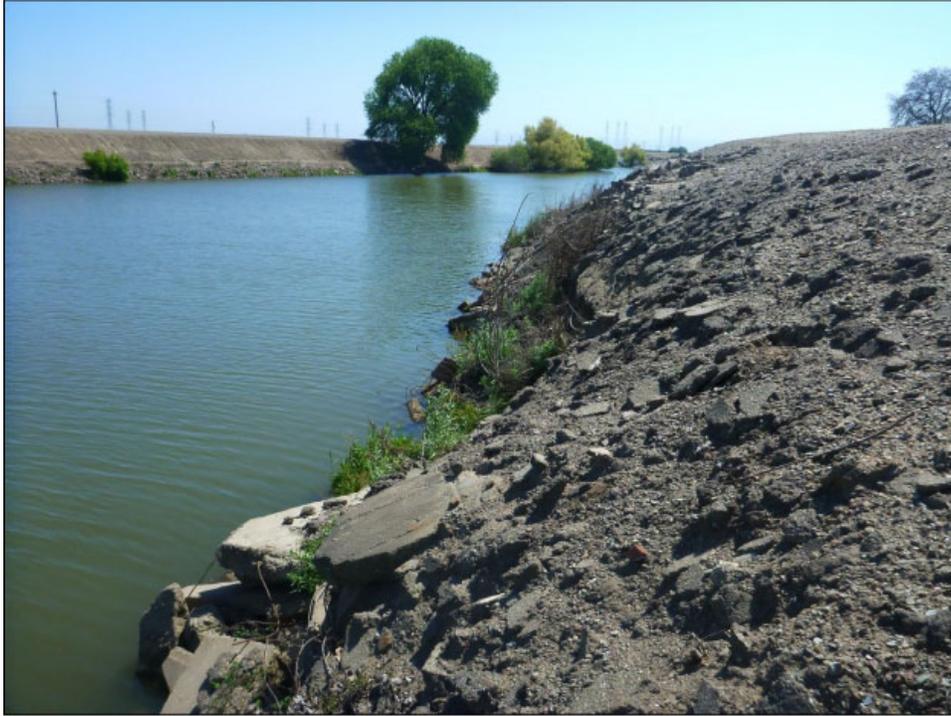
View looking south of eroded bank with construction debris along waterside levee slope.

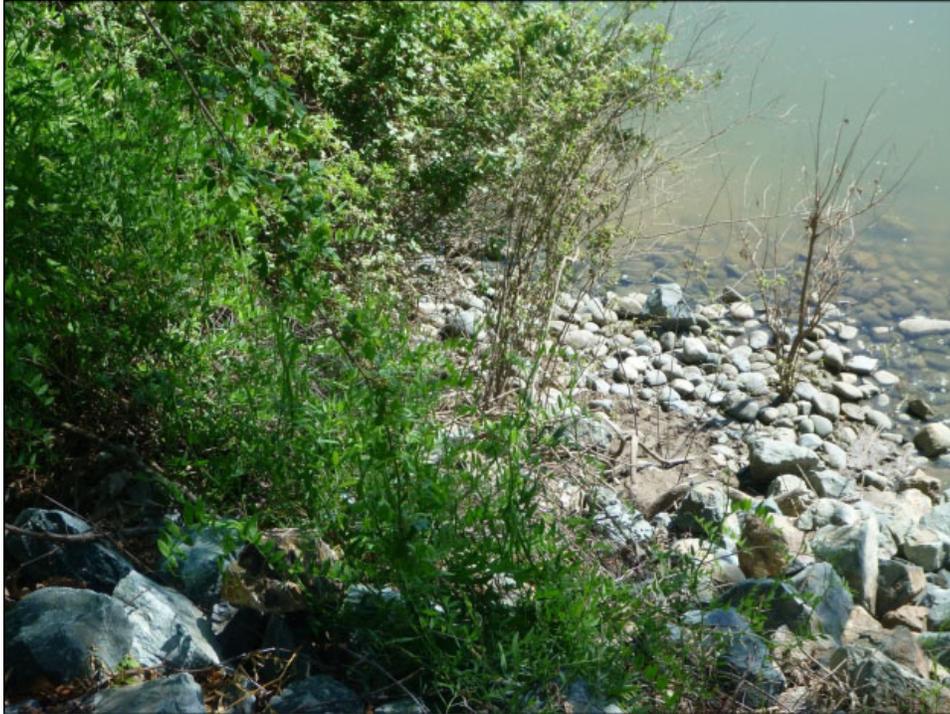
View of erosion and rock placement from emergency erosion repairs visible along waterside toe.

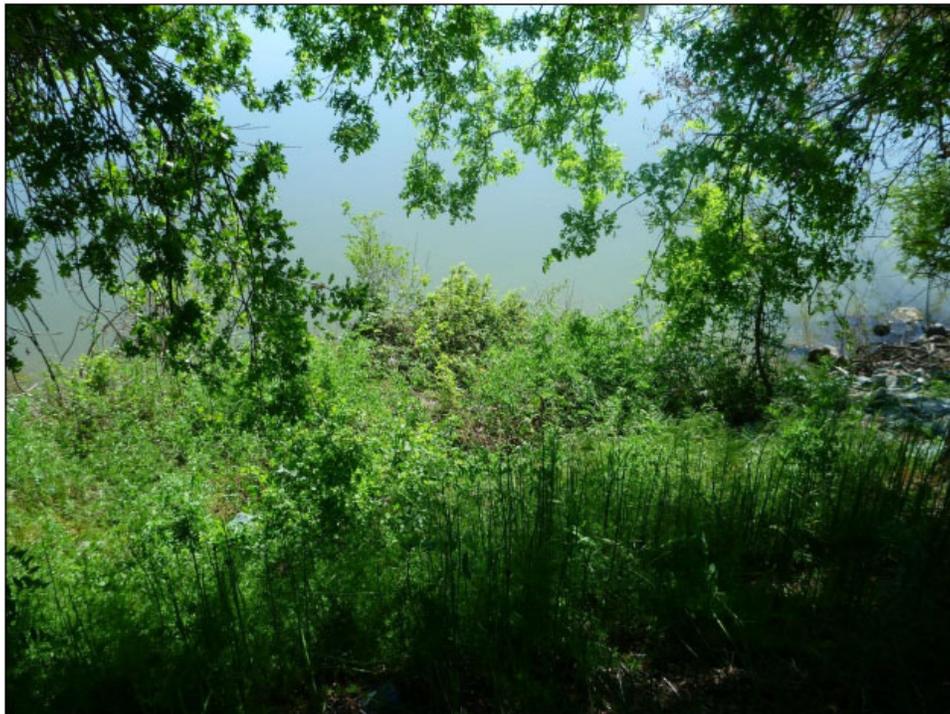
View at east extent of repair site showing erosion along waterside levee toe.

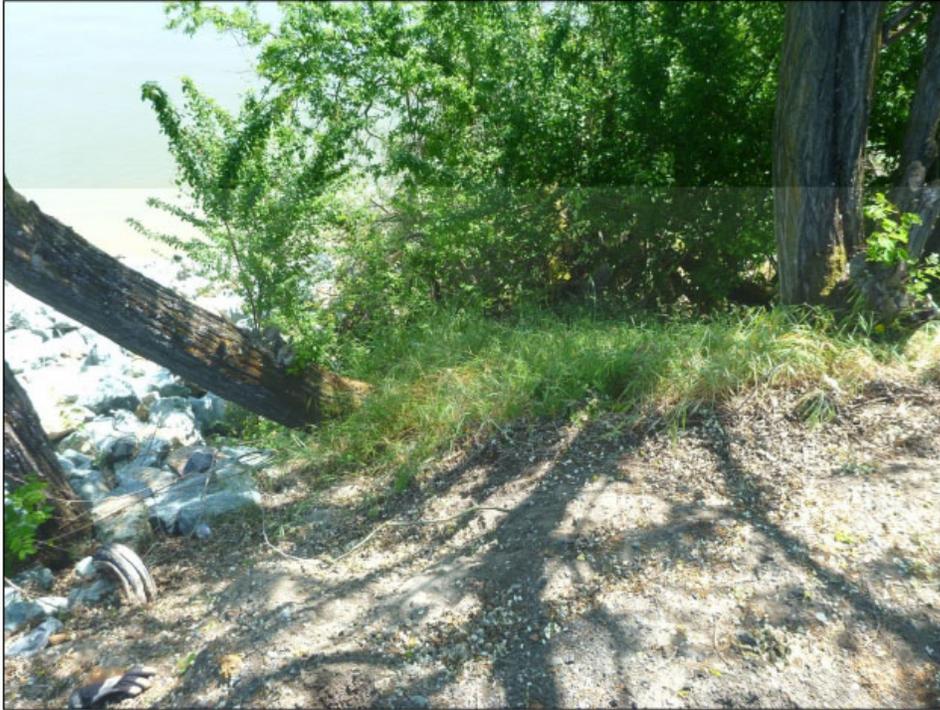
View of erosion repair site where bank erosion occurred along waterside levee toe.

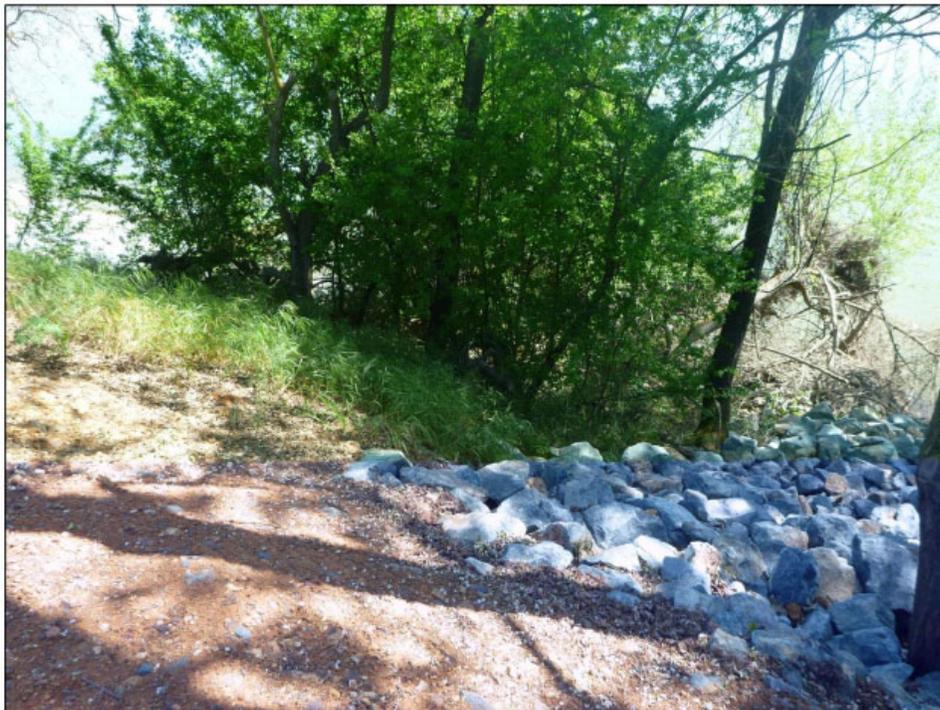
View of northeast extent of repair site where emergency rock was placed.

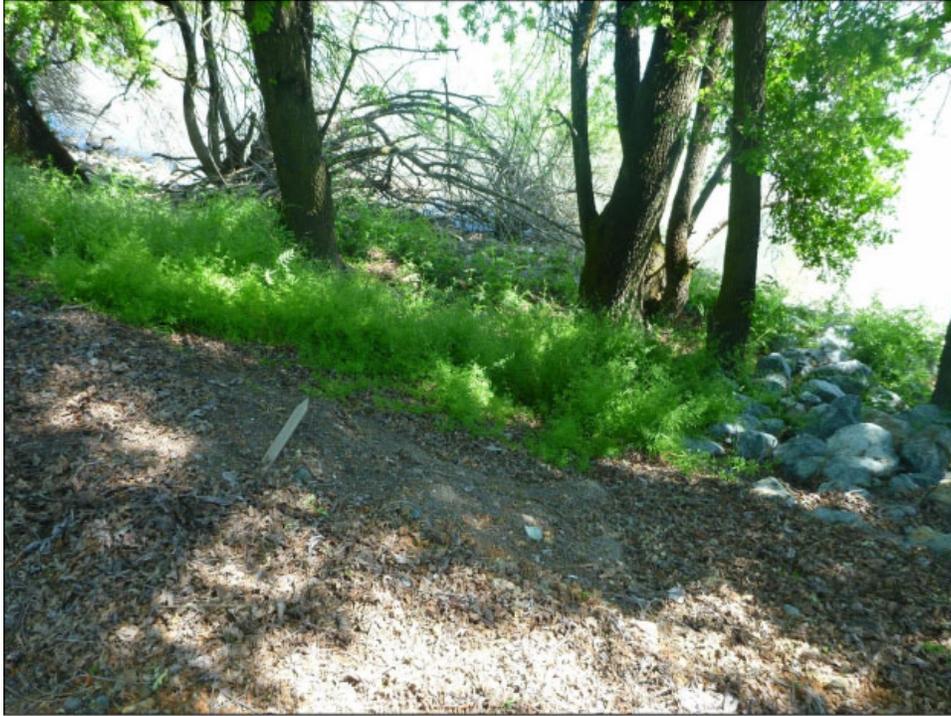
View of northeast extent of repair site. Live trees will be protected during construction.

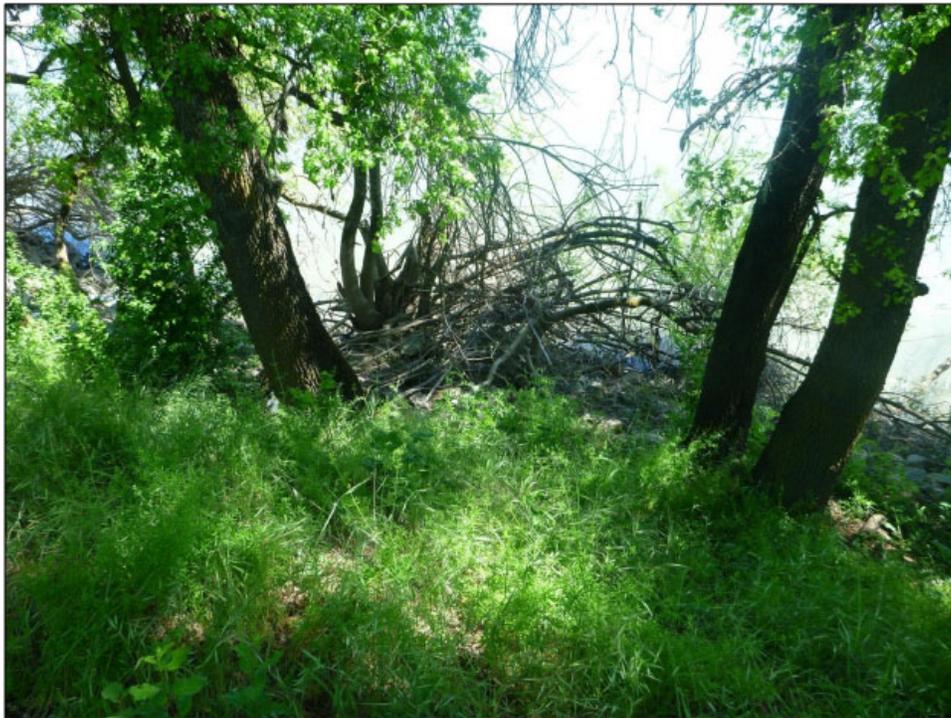
View of waterside levee erosion along waterside toe.

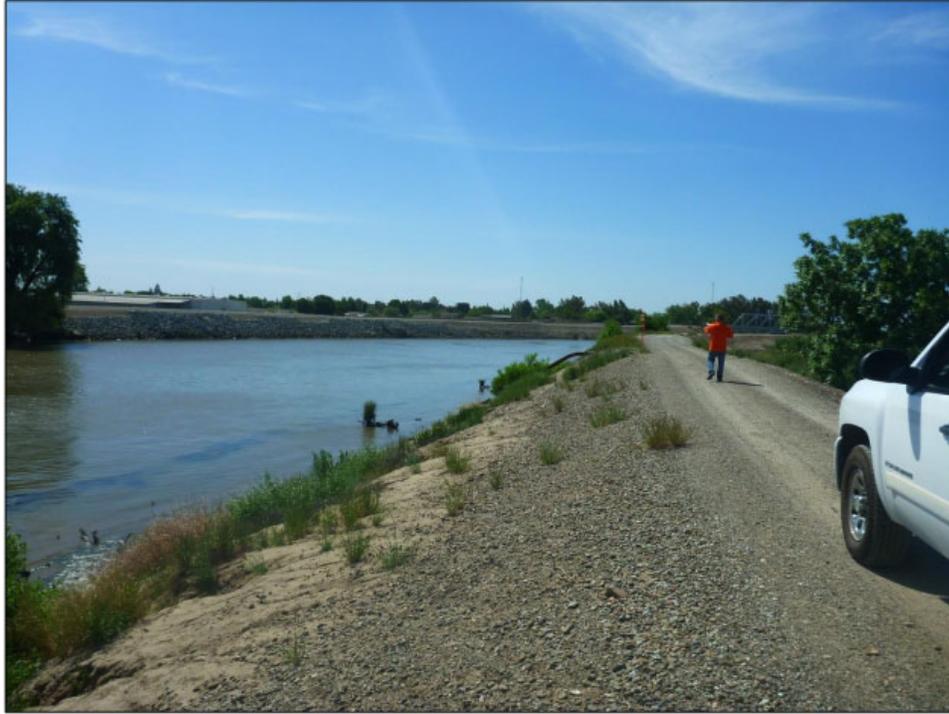
View looking south showing waterside levee erosion.

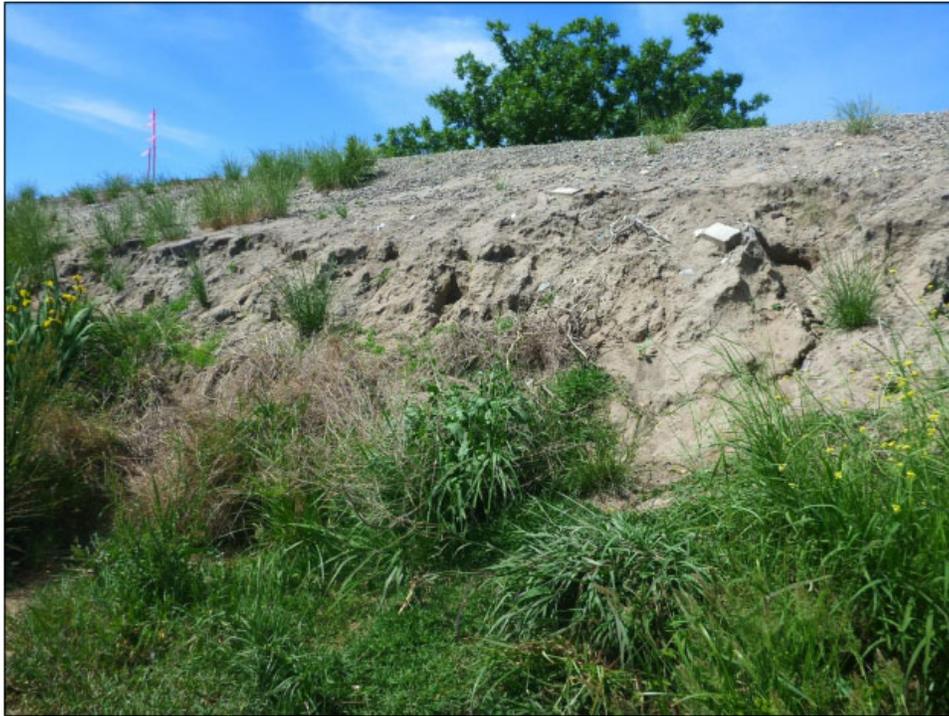
View of waterside erosion, continues throughout the entire repair site.

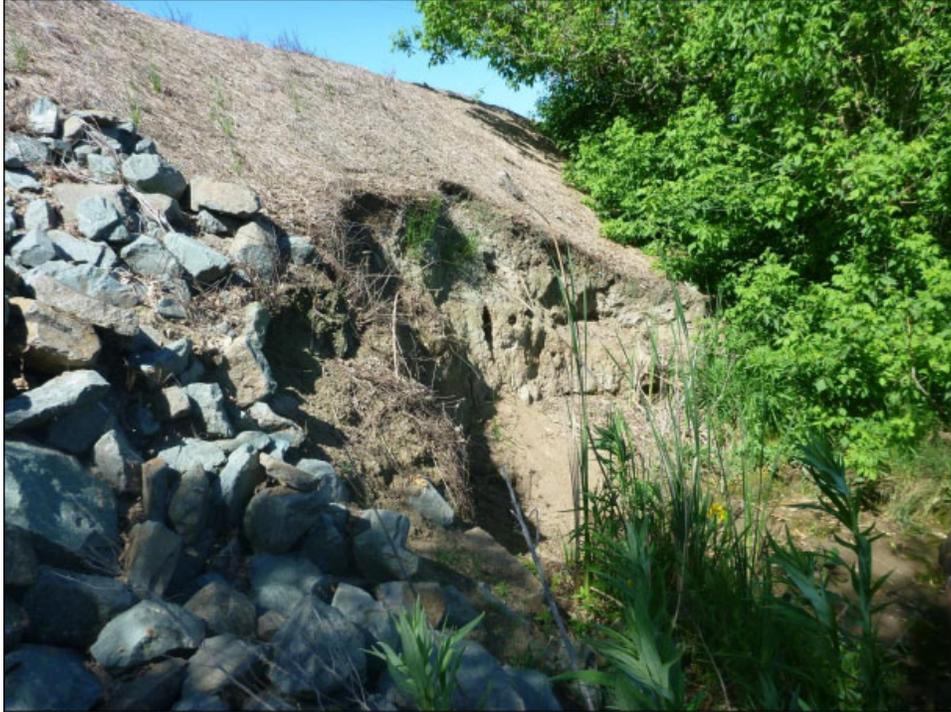
Close up view of erosion on waterside levee bank and loss of waterside toe.
