# Appendix A

## **Design Specifications and Construction Considerations**

## Site-specific Repair Area Activities

2017 Storm Damage DWR Rehabilitation Program / 130028.39

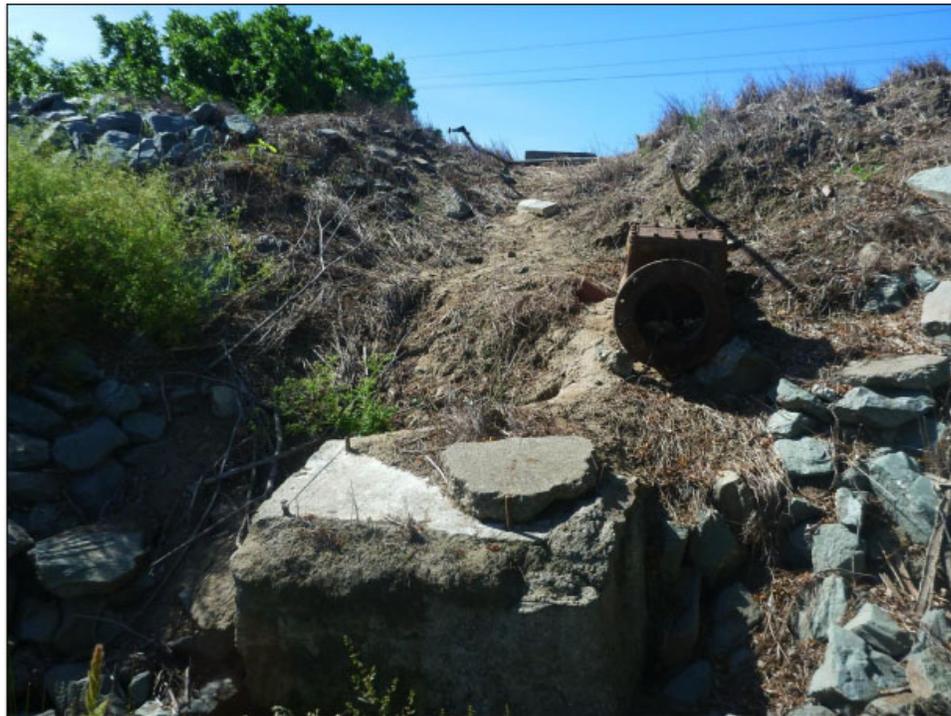
View of piping, rip rap, construction debris, and storm water erosion adjacent to repair

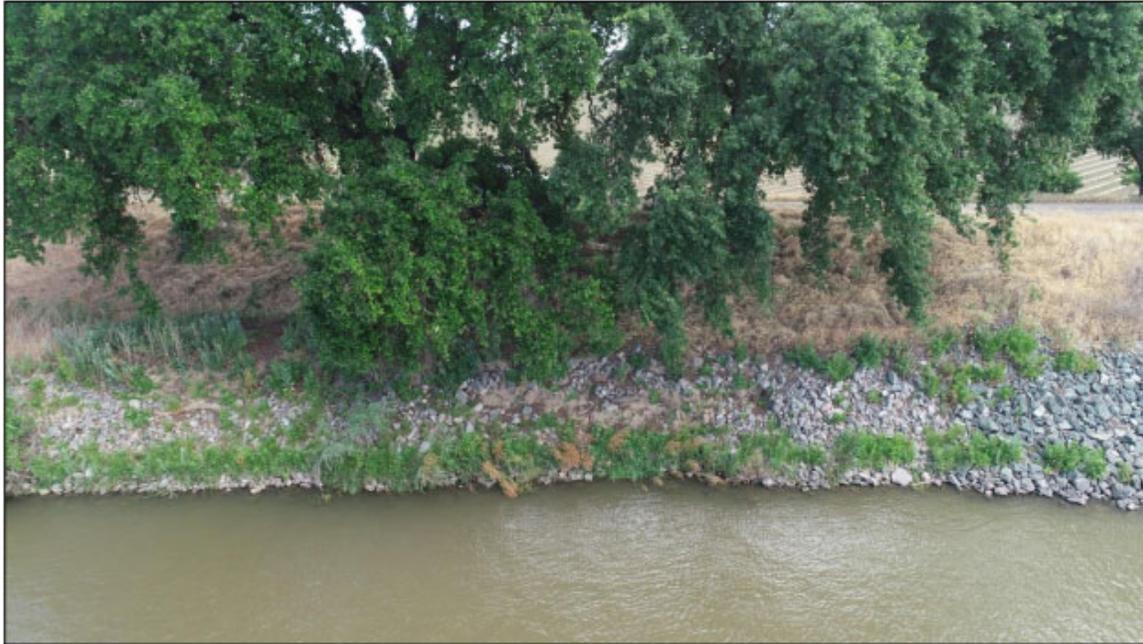
Aerial view of erosion and emergency rock placement repair under tree.

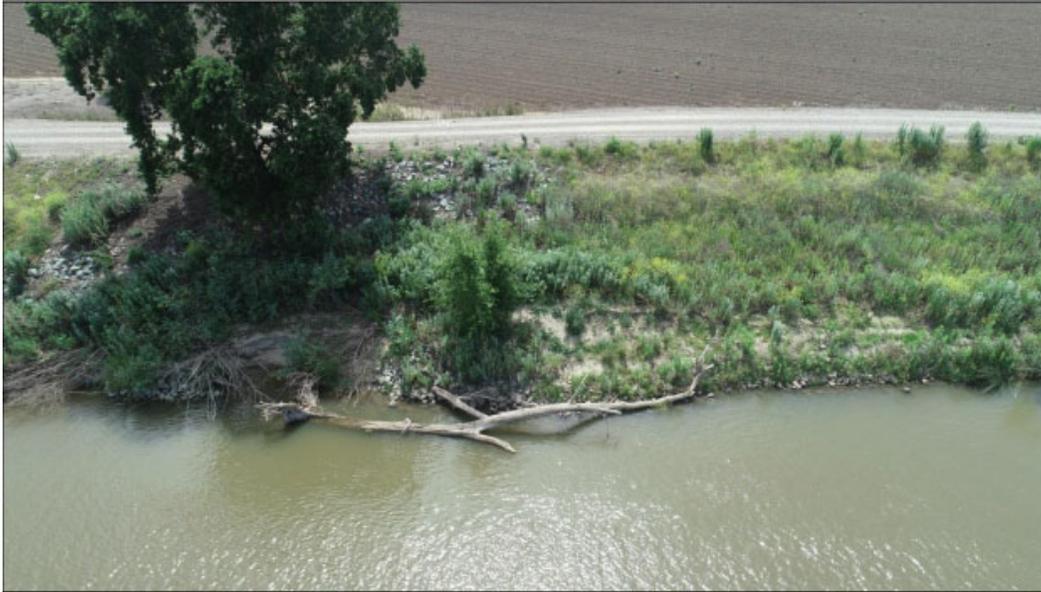
Aerial view of erosion along waterside levee slope. Emergency rock repairs visible beneath existing tree.

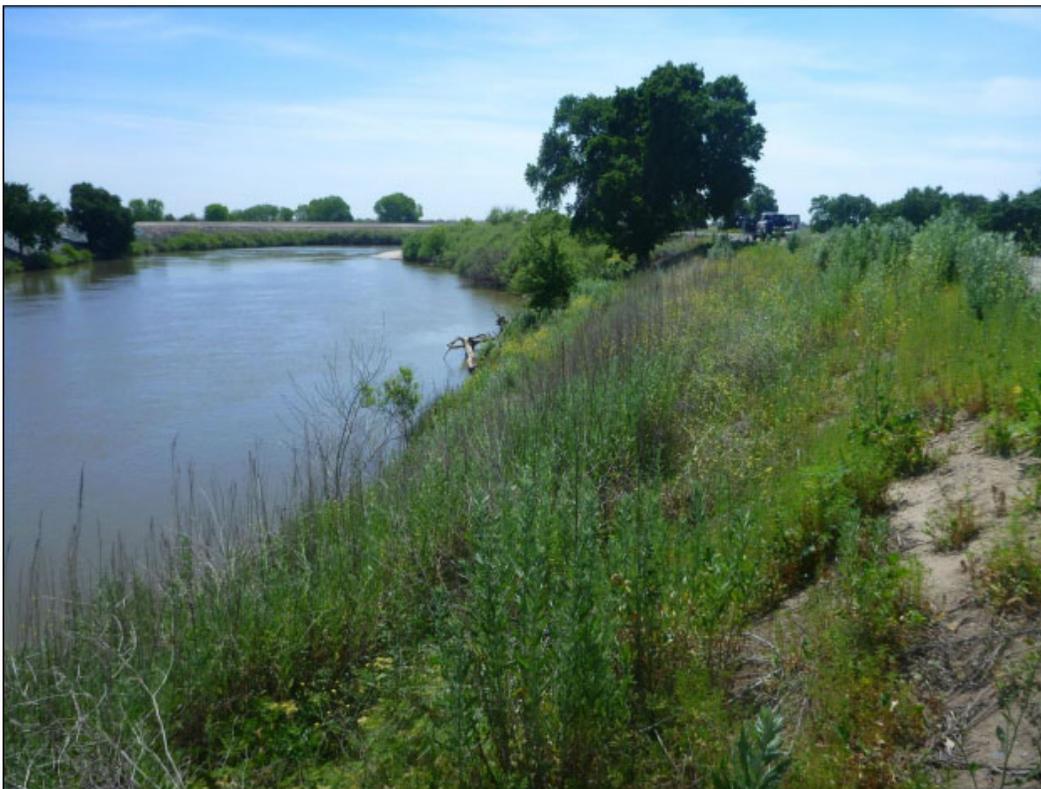
View of waterside levee slope. Downed tree visible in the repair site.

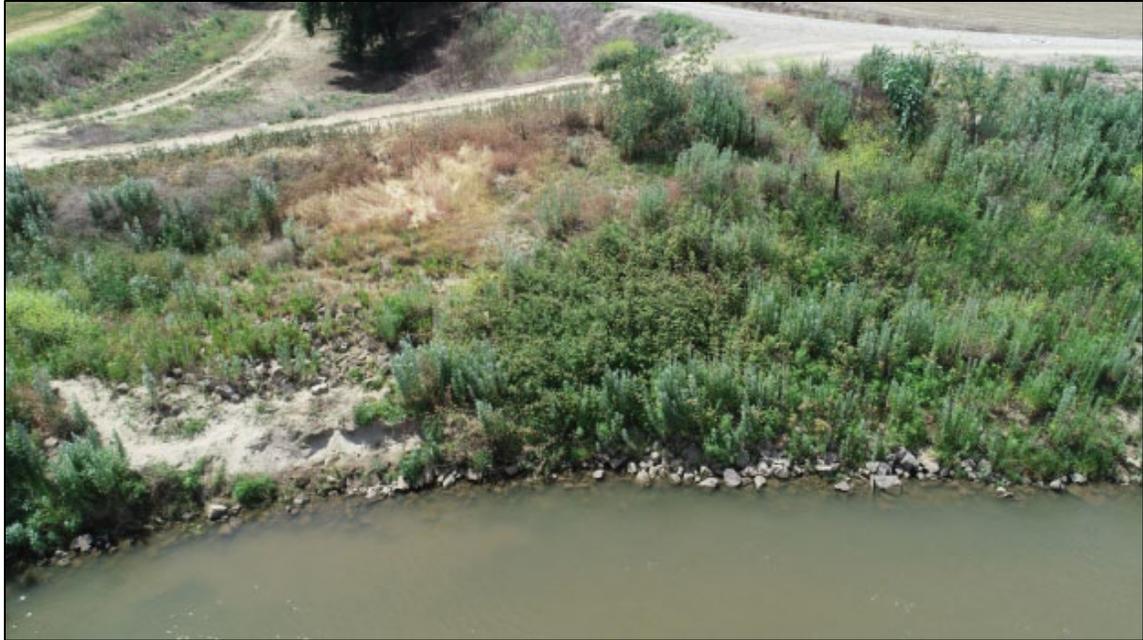
Aerial view of erosion with rock repair armoring longitudinally along repair site.

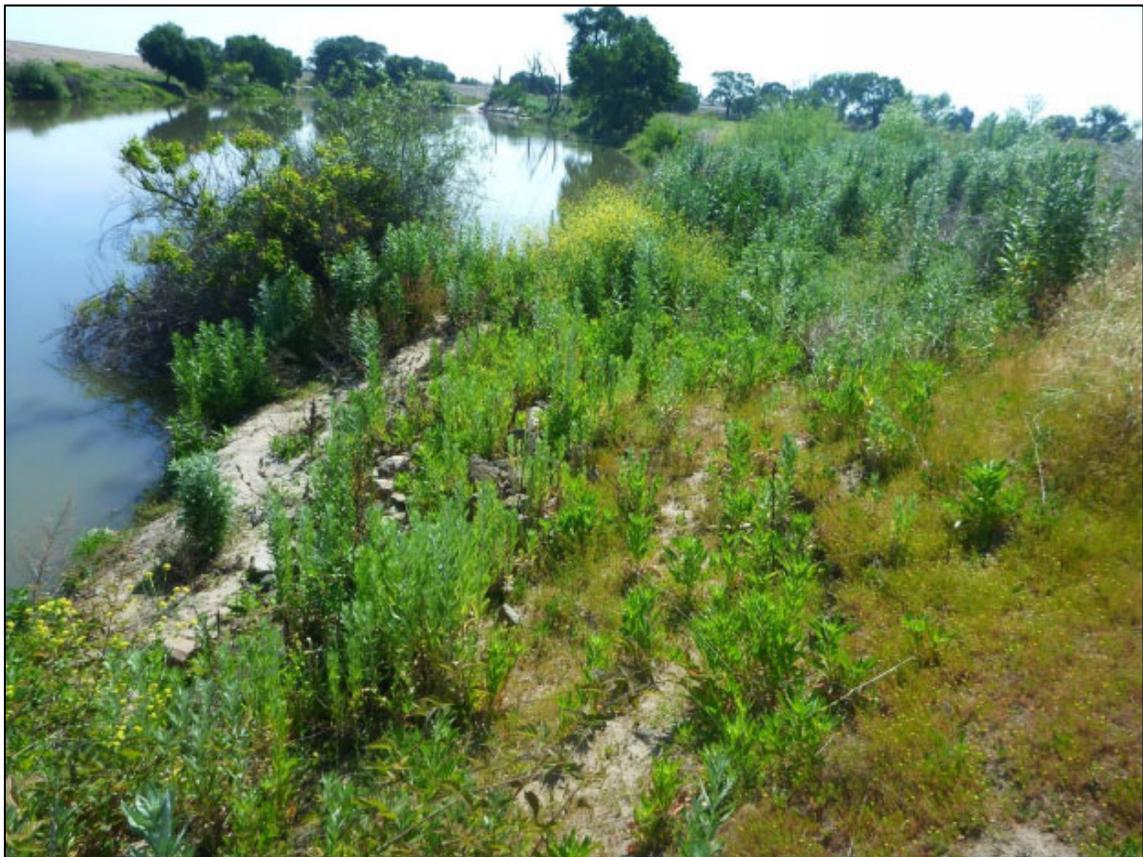
View of southern end of erosion along waterside levee slope.

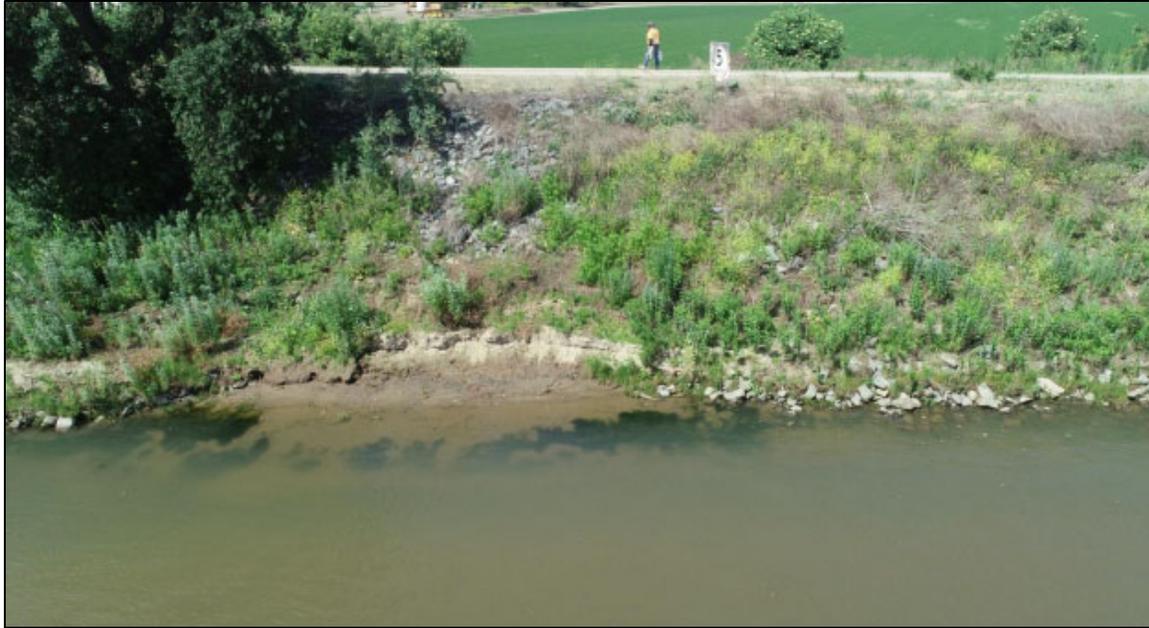
Aerial view of erosion with rock placement along waterside levee toe.

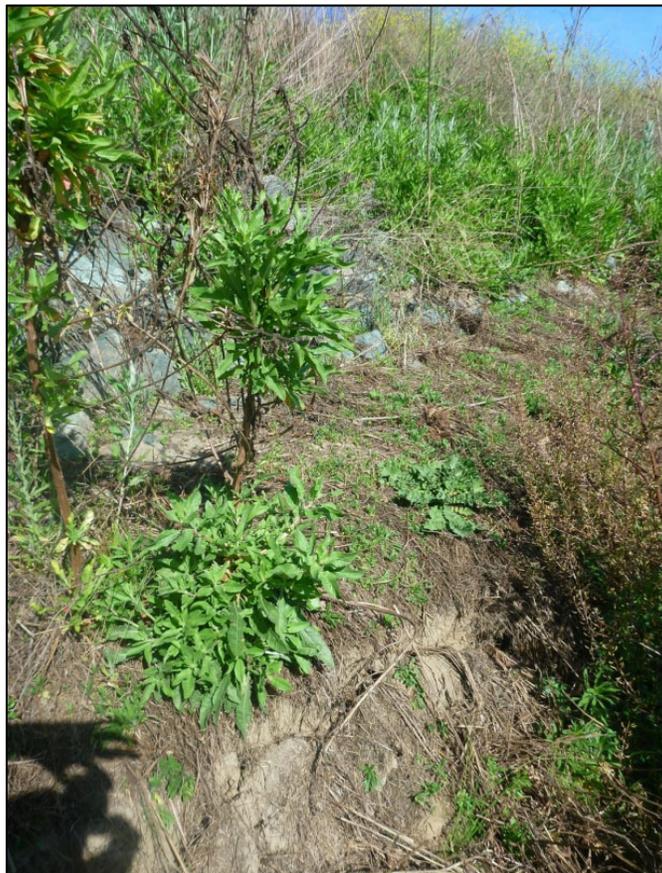
View of rip rap repair above erosion along waterside levee slope.

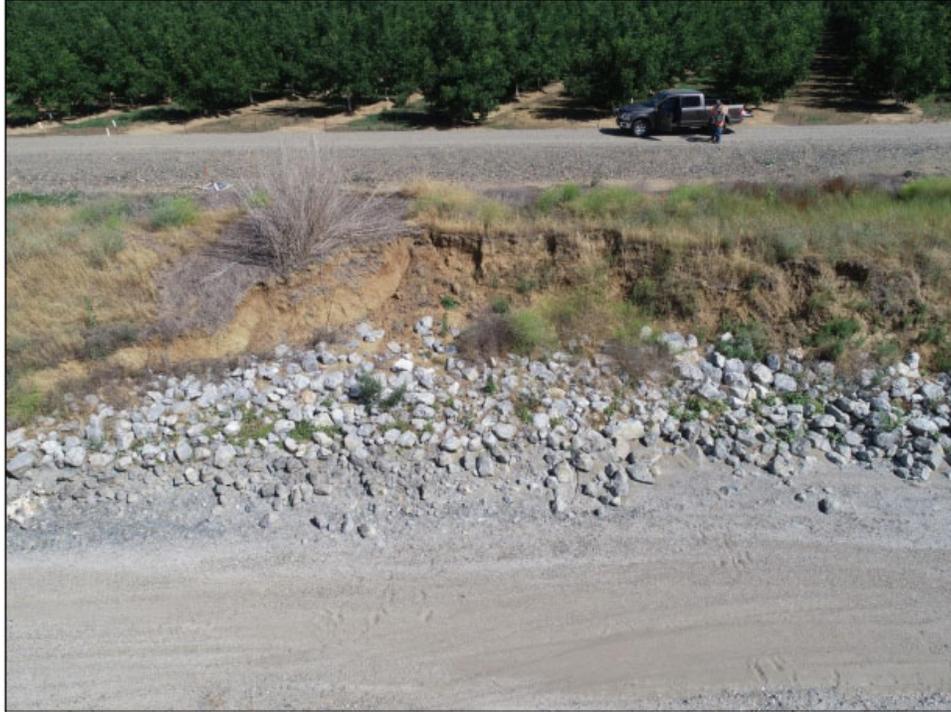
Aerial imagery of erosion and emergency rock repair at the damaged site.

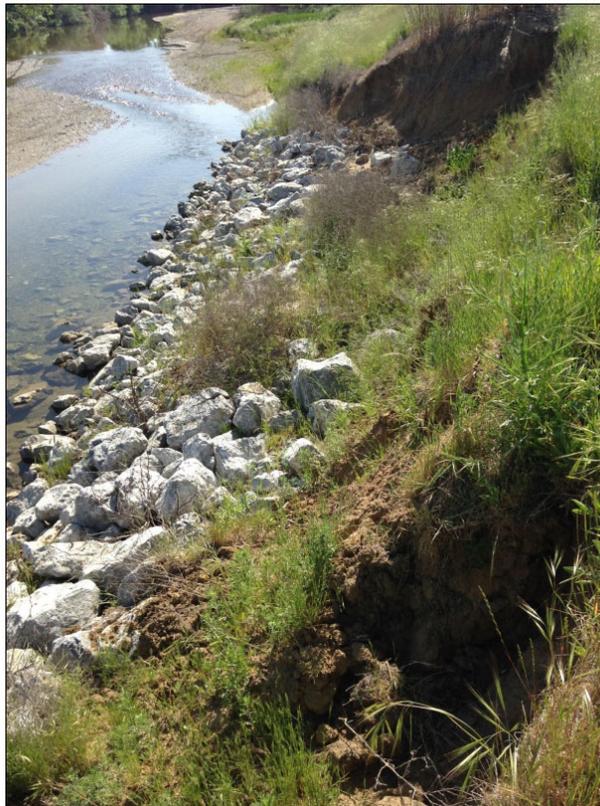
Bank erosion and emergency rock repair at the waterside toe of damaged site.

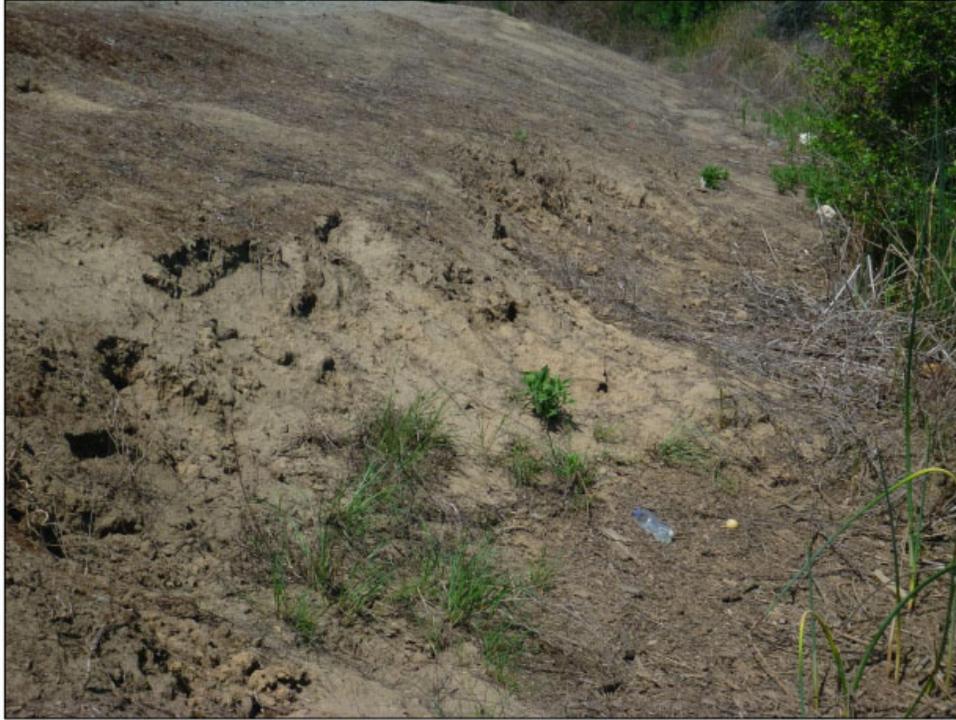
View of erosion along waterside levee slope.

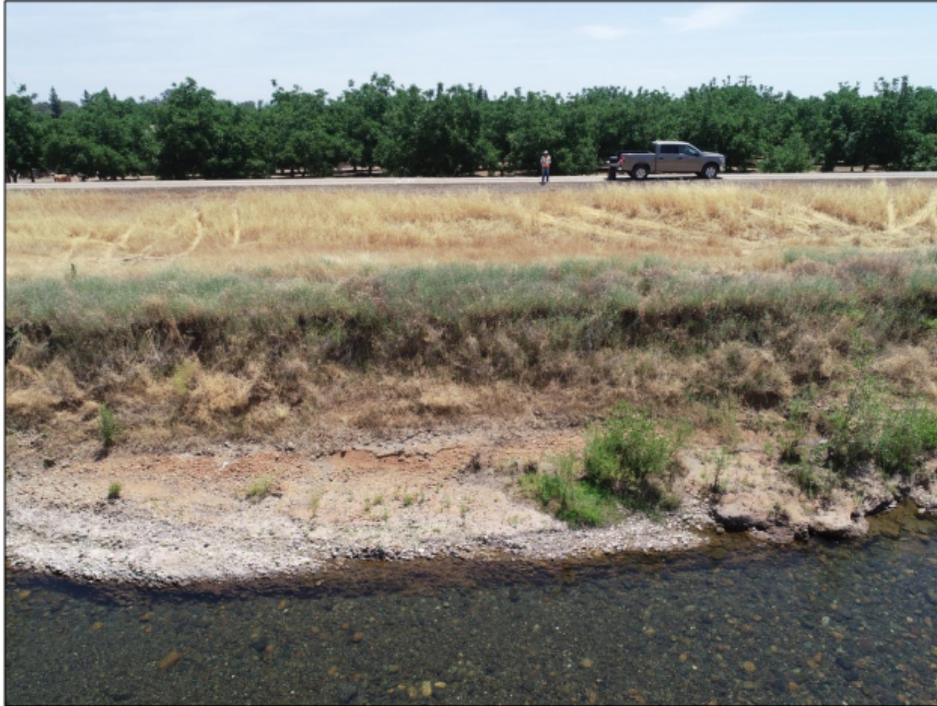
Bank erosion at damaged site.

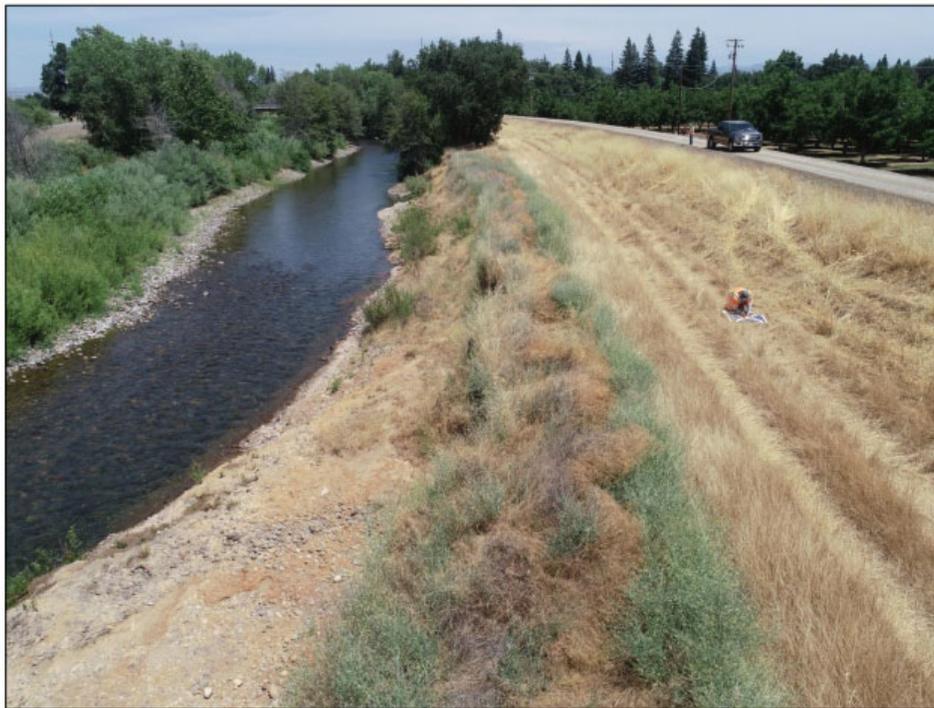
View looking upstream of erosion along southern levee slope.
