### **Fault Hazards Investigation**

**FAULT HAZARD INVESTIGATION  
RIVERSIDE COUNTY REFERENCE GEO 02503  
PROPOSED CHURCH COMPLEX  
APN 376-410-002 and 376-410-024  
CITY OF WILDOMAR, CALIFORNIA**

**PROJECT NO. 4348-F  
FEBRUARY 17, 2017**

Subject: Fault Hazard Investigation Report  
Proposed Church Complex, APN 376-410-002 & 024  
City of Wildomar, Riverside County, California.

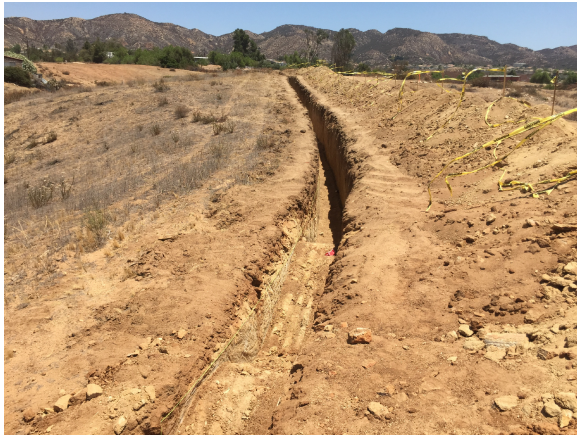
*Completed fault trench FT-1, view northeast from approximately Sta. 0+90. Viewed area is site of proposed sanctuary and classrooms.*

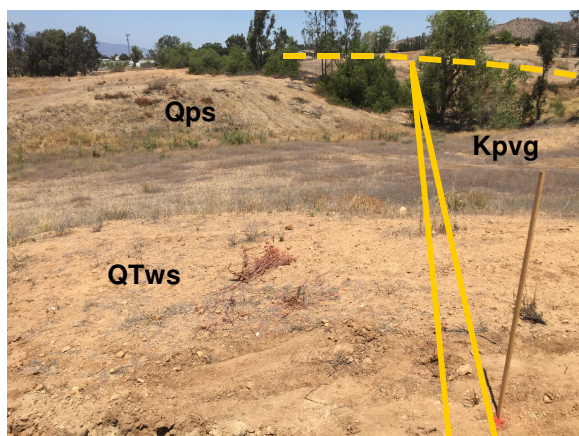
In the FT-1 trench exposure, cracks and shears spanned a width of at least 45 feet, although the most intense disturbances were limited to a narrower zone (*below right*). Very closely spaced cracks and disturbed textures could be traced virtually to the ground surface. Small-scale grabens and half-grabens with south-side-down displacements had been created by apparent normal slip. Some logged fault planes had measurable vertical offsets on the order of a fraction of an inch to more than a foot. Wedge-shaped deposits of colluvium had collected in the depressed surfaces. The lack of erosion of the tops of each graben structure and the stair-stepped lateral changes in thickness of clearly Holocene-age surficial soils were viewed as age-diagnostic for recent activity.

View northwest along edge of splay fault zone at FT-1 Sta. 0+61, showing trend line to intersection of interpreted right step in Glen Ivy North zone (dashed line). Large tree in upper right is native cottonwood, hinting at groundwater barrier effects next to the fault.

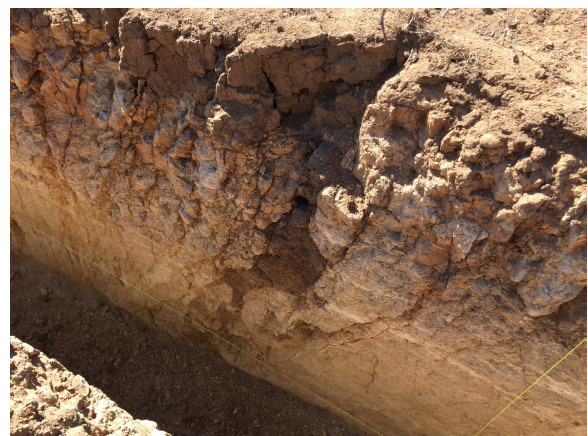
Faulted and fragmented Wildomar sandstone in the southern end of FT-1 was relatively easily excavated to the target depth of about 6 feet. Pedogenic cementation was modest and limited more toward illuvial clay enrichment rather than the very cohesive and siliceous(?) laminar cemented horizons found in some flatter areas of the project site (example: geotechnical trench T-7 on Plate No. 1). Pale-colored and crudely layered sandstone and siltstone were capped with thin darker-brown colored horizons of sandy colluvium. FT-1 colluvium, like all colluvial soils in the project site, was disturbed within a few inches of the ground surface from past cultivation. Deeper deposits filled several minor grabens and half-grabens caused by tectonically displaced sandstone blocks. Colluvium was everywhere interpreted to be Holocene in age.

Intensely fractured and faulted Wildomar sandstone, FT-1 at Sta. 0+35. Pictured soil-filled fissures were exactly on trend with similar soil filled cracks probably mis-identified as Krotovina by LGC Inland (2007) in their trench FT-5, Sta. 0+20.

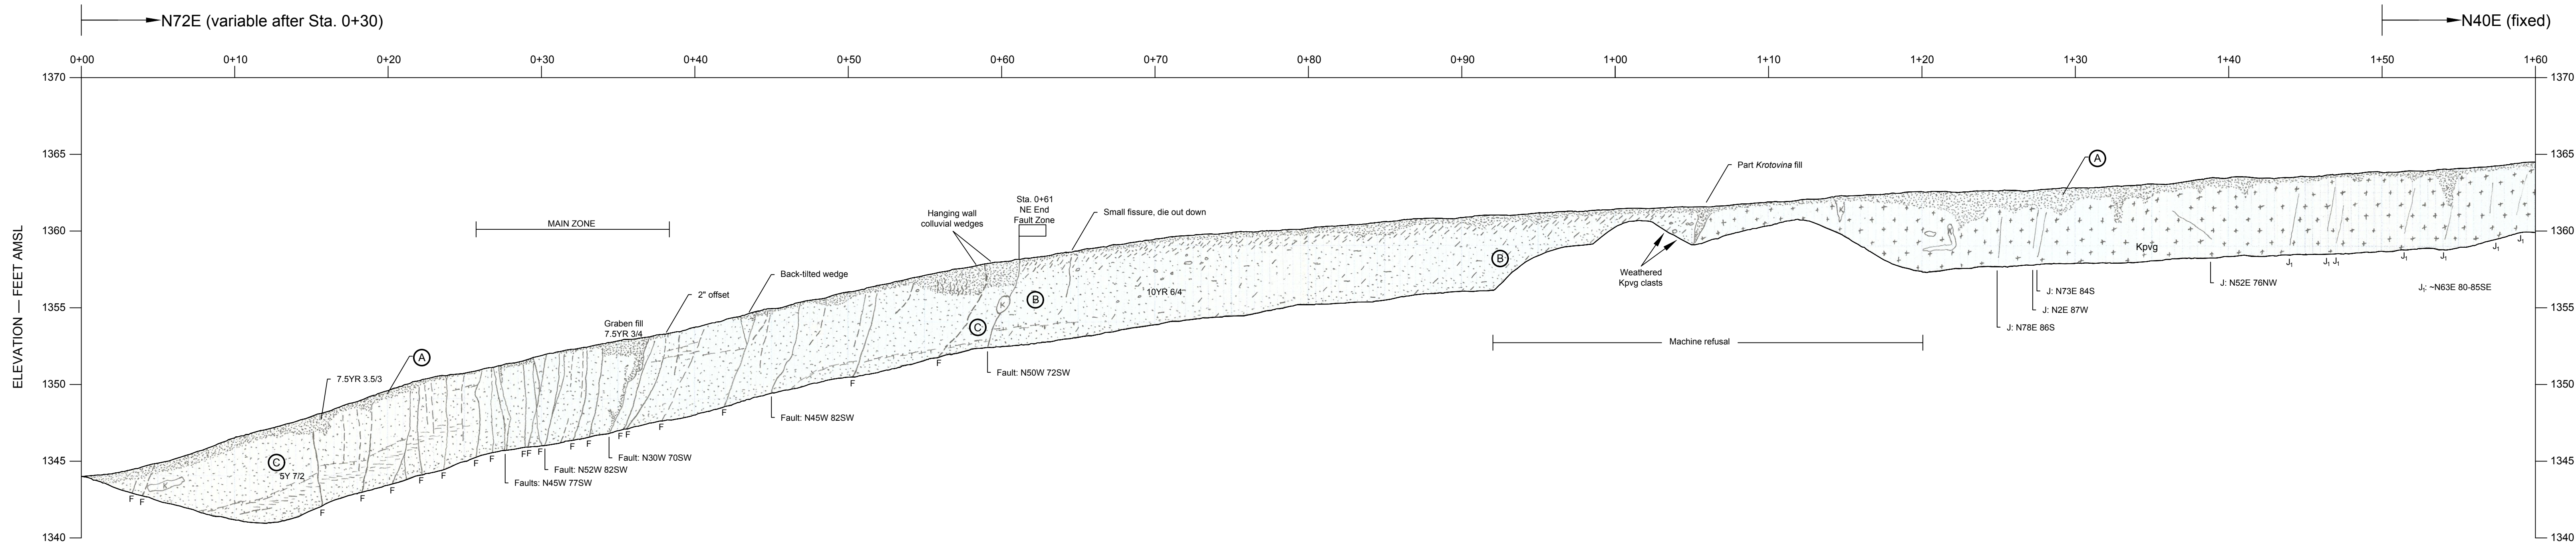
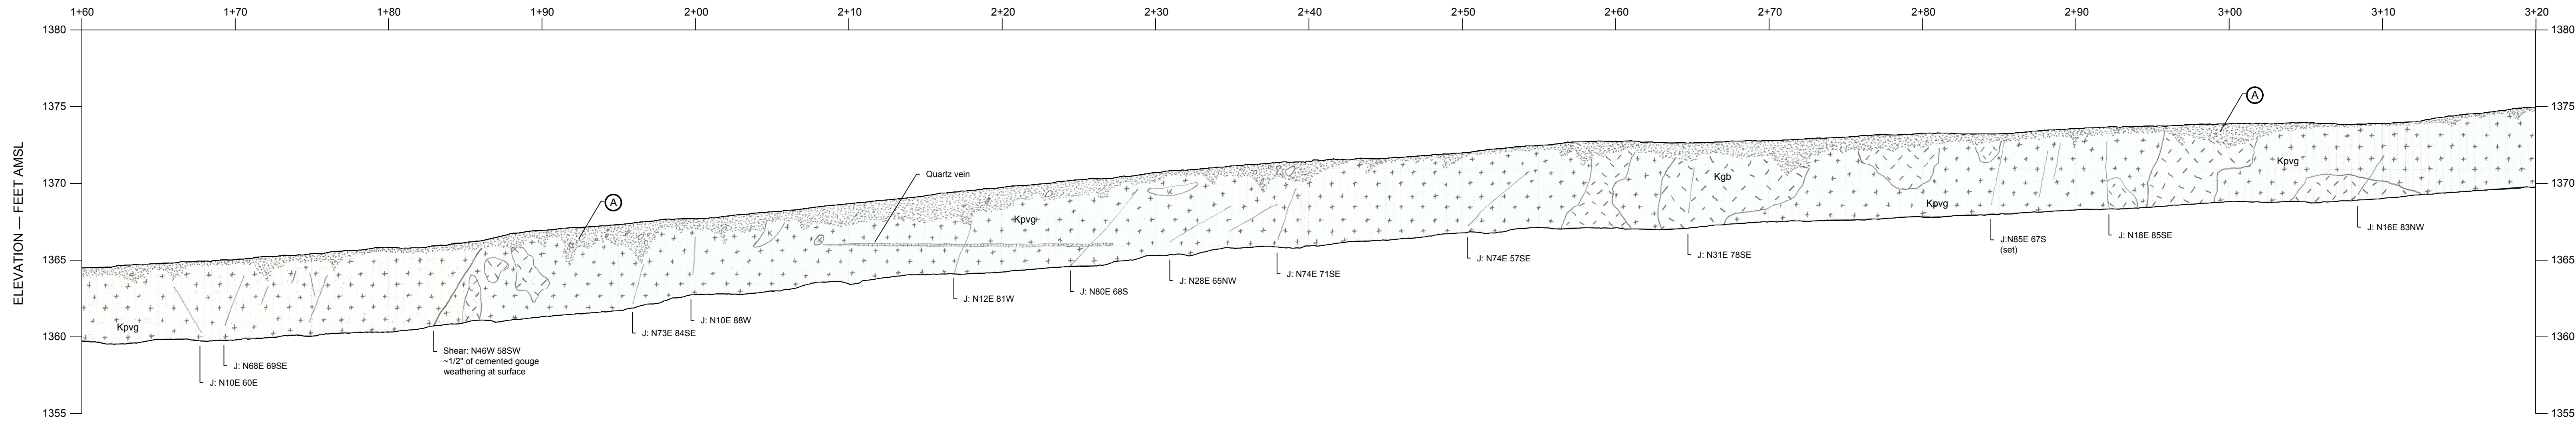
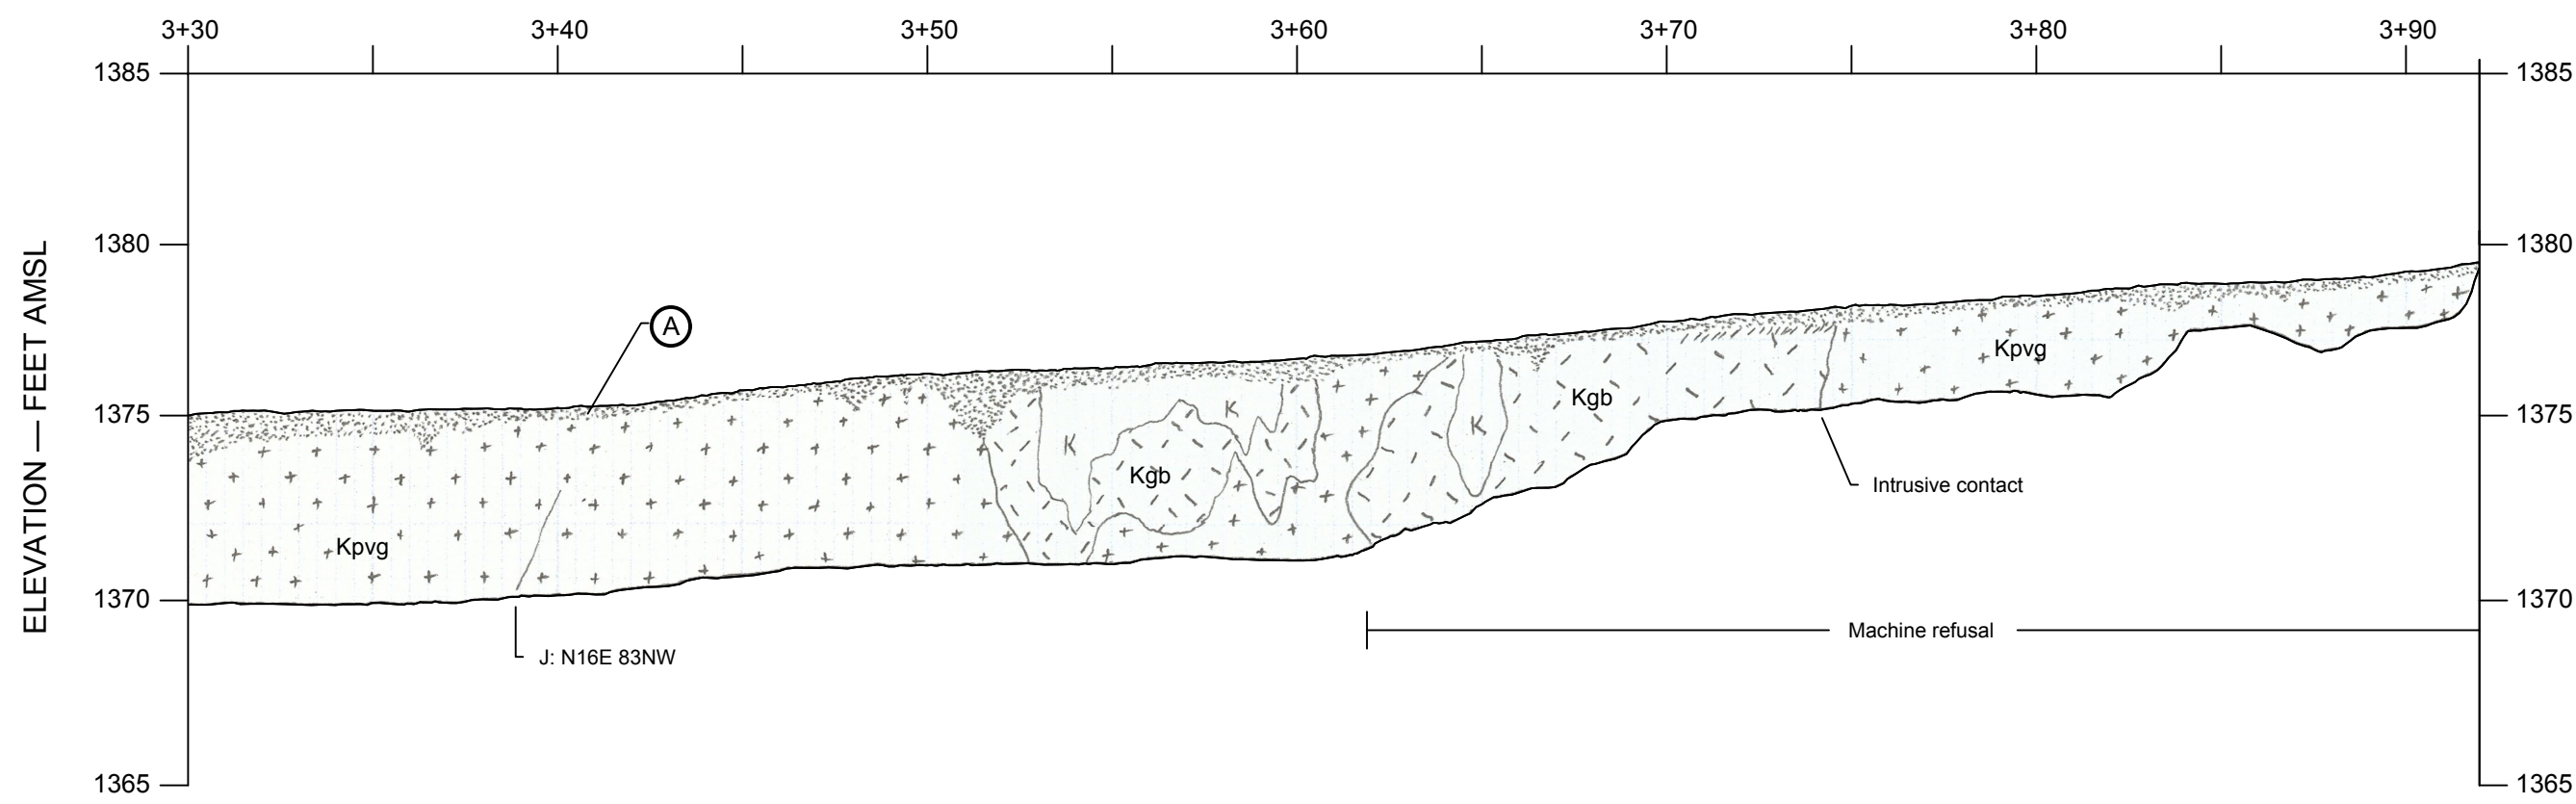
Trench FT-1  
View Northwest

The splay fault's orientation and apparent offsets would be consistent with AGI's interpretation of a trans-tensional shear regime across the right-step. The trench exposures did not permit the development of a chronostratigraphic history of ruptures at the site. However, given the magnitudes of basement rock offsets for the greater Glen Ivy North zone, repetitive offset events have almost certainly occurred. We think future horizontal and vertical offsets in a single event would be small, on the order of inches to a couple of feet, similar to what is inferred for the Glen Ivy North "main zone" in the present tectonic regime.

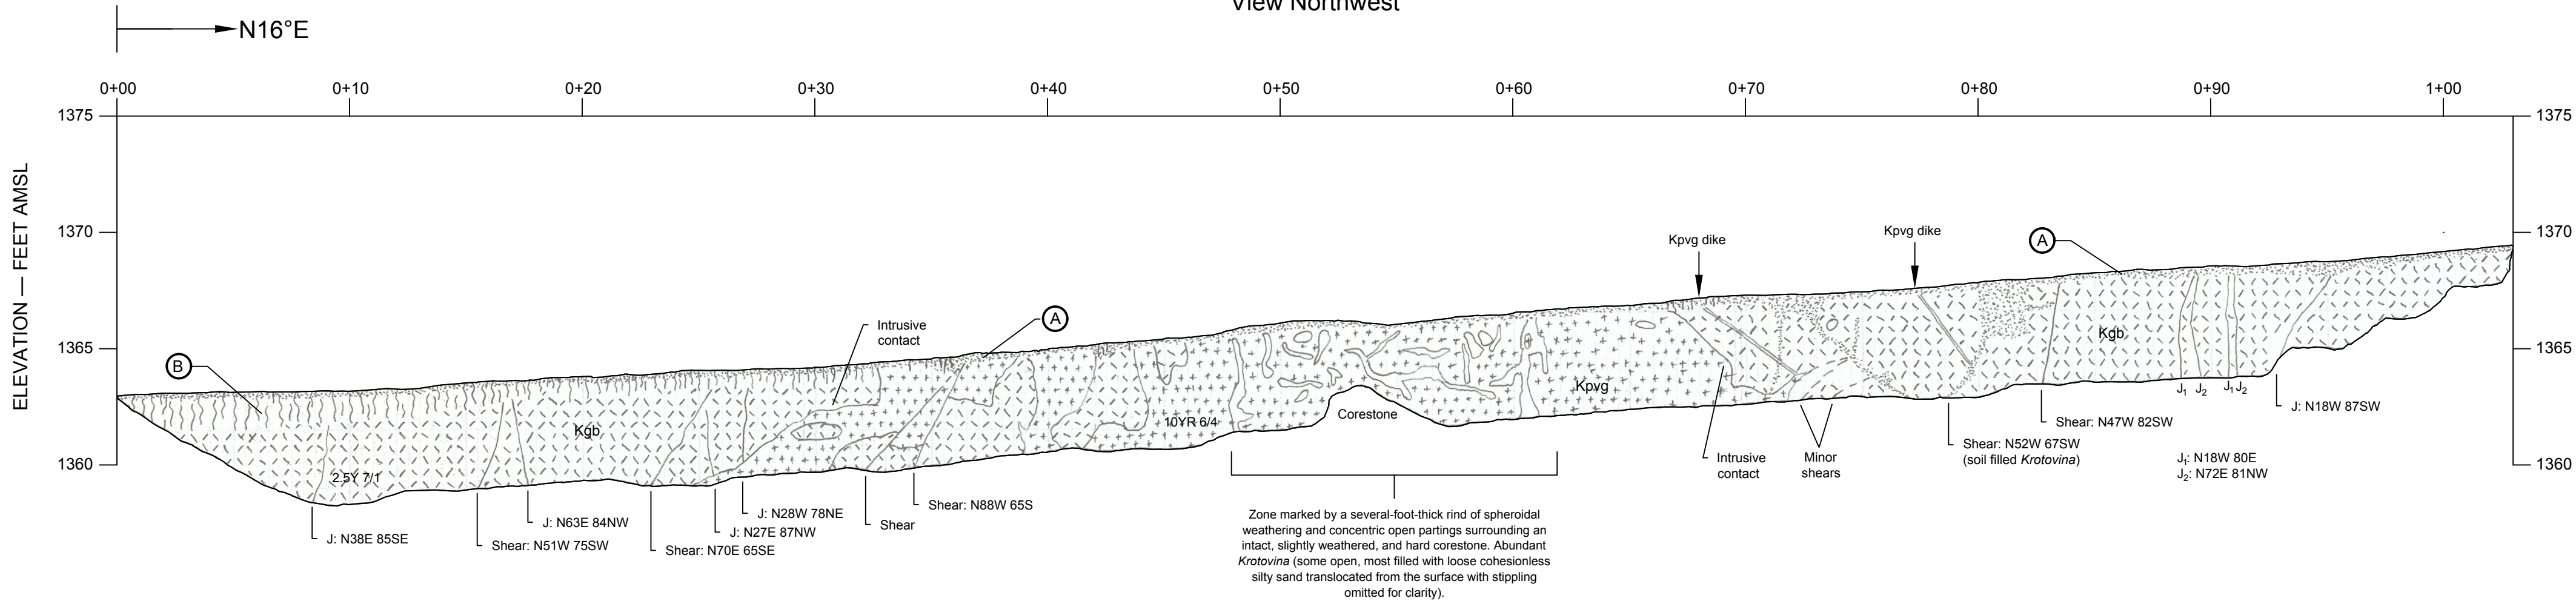
Trench FT-3  
View Northwest

*Fault Trench FT-3.* A tonal lineament observed in several sets of older aerial photographs was evaluated by this shallow excavation through Paloma Valley granitic basement rocks. The northern and southern thirds of the 103-foot-long trench encountered highly weathered gabbro. The middle third of the trench was excavated primarily in friable and weakly foliated monzogranite. One hard monzogranite corestone was found. Abundant animal burrows (*Krotovina*) characterized the monzogranite zone, while burrows were absent from the finer-grained and more-compact gabbro. No faults were found. The trench bottom was relatively hard and difficult to excavate for the entire trench length. The origin of the lineament was thus ascribed to the lithologic contrasts of a monzogranite dike in primarily gabbroic host rock.
