5.0 LANDSCAPE ANALYSIS

GONZALEZ GOODALE ARCHITECTS

Los Angeles Unified School District
Elizabeth Learning Center

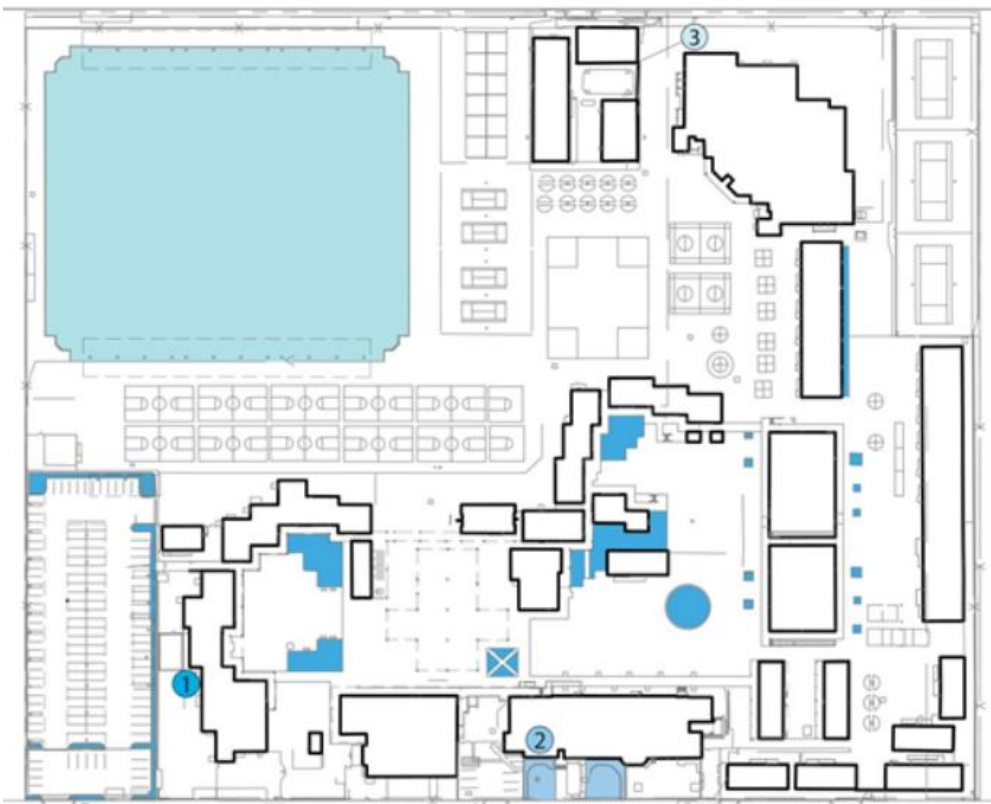
Irrigation Zoning and Point of Connections

- a. Overall the campus lacks a proper irrigation system setup as well as a lack of irrigation to all trees located in tree wells or planting areas within the campus core.
- b. Irrigation controllers - There are three irrigation controllers present on campus, see diagram on the following page. Two of the three controllers are functioning but are not smart controllers required by current applicable regulations. The Plant Manager did not have an access key to the

third irrigation controller box, but due to the valves in the surrounding area not activating when manually turned on shows that the controller has been shut off and is no longer providing irrigation in those zones. A Toro controller with 24 stations is located on the backside of the gymnasium, facing Clara Street. Another Toro controller is located in the front area of the campus.

- a. All areas that will require a new landscape design should have a new irrigation system installed. Where existing landscape areas are to be re-designed, the existing irrigation system should be redesigned as well.
- b. A new point of connection will be required for the scope of the new project. With a new point of connection requires a new backflow, meter, master valve and flow sensor to increase irrigation efficiency.
- c. The irrigation system should be retrofitted with smart controllers to optimize water efficiency. It should be noted that doing so could require trenching through portions of the campus otherwise outside the scope of work for this project to install irrigation control wiring and plumbing.

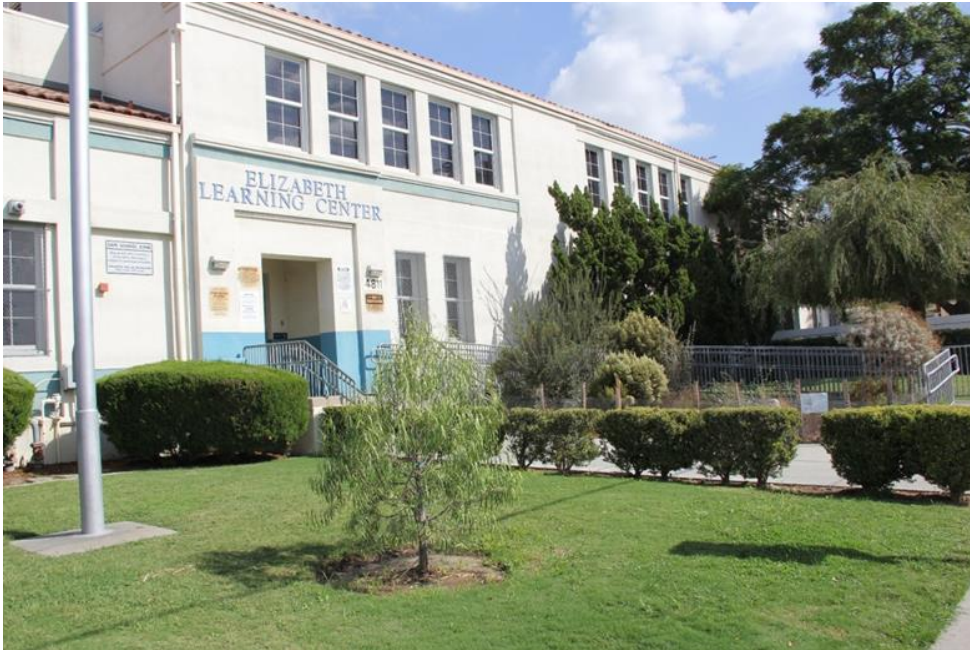
School Entrance Planting

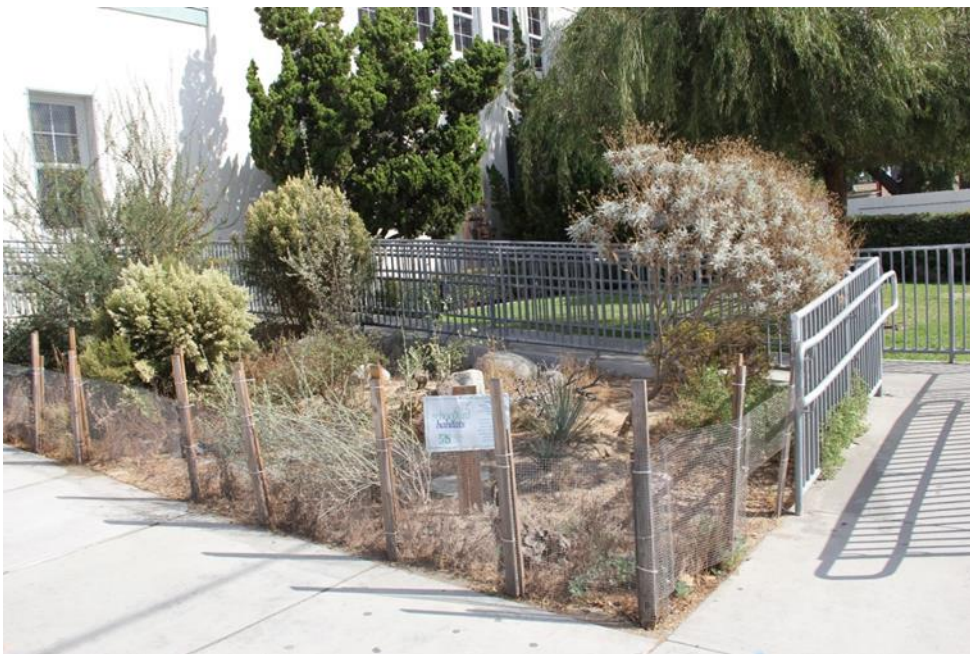
- a. Shrubs are prevalent at the school entrance along Elizabeth Street. The plant palette is a combination of evergreen shrub material, turf and a California native habitat garden created by School Yard Habitats. The evergreen shrubs and turf are doing well; however the California native habitat garden is failing due to lack of proper irrigation and sun exposure.
- b. There is minimal edge condition planting along Elizabeth Street with the main planting areas being in front of the wellness center and the main entrance. Aside from the main entrance, there is no significant "Green" or soft edge between campus and right of way. There is no campus or streetscape planting along the campus' north edge on Clara Street. The west edge of the campus

California Native Habitat Garden

- c. Habitat Gardens to be revitalized with a new plant palette guaranteed to succeed.
- d. All new trees to install root barriers correctly to inhibit uplifting in AC paving or concrete.

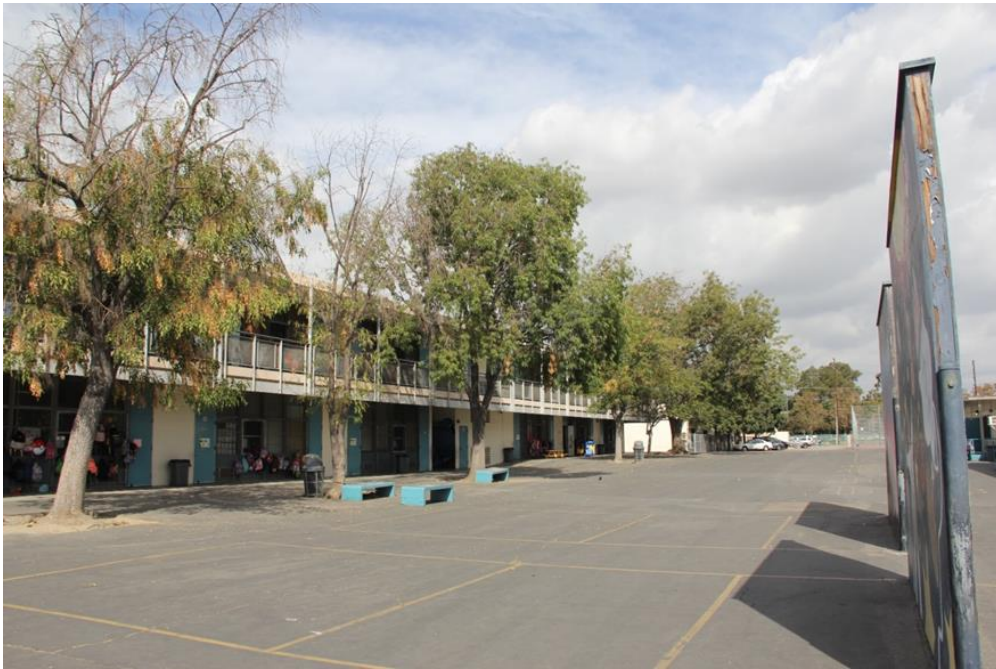
Mature Tree Canopy Within Campus Core

- a. Campus shall make all attempts to protect and preserve as many mature trees as possible that are deemed healthy and structurally sound per the arborist evaluation.

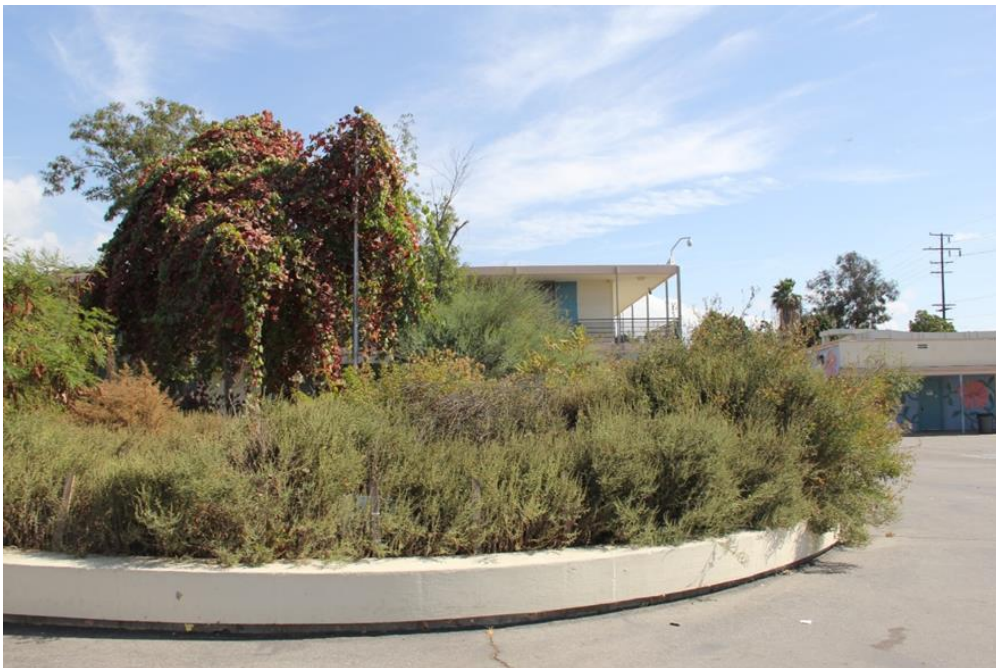
Flagpole Planter

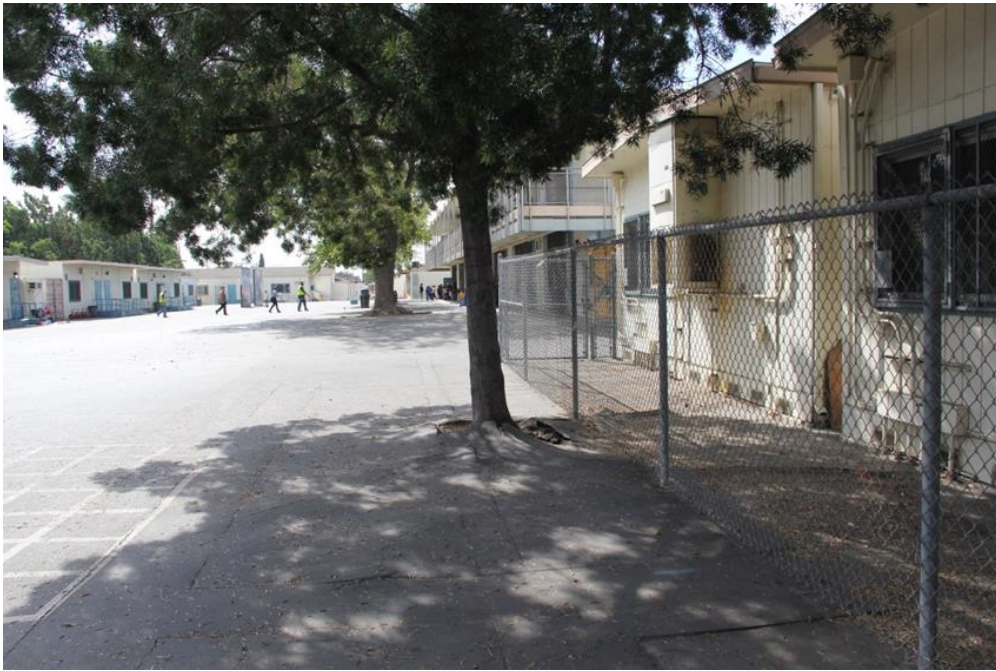
- d. The redwood edging and in some cases concrete curb around tree wells cut into the asphalt paving have cracked or deteriorated. This may pose a trip hazard in instances where it is lifted above the adjacent paving.

Cracked and Lifted Asphalt Paving

- e. New redwood edging and concrete curbs to be installed near tree wells to prevent tripping hazards.
- f. Any new project will trigger low impact development and storm water management per current regulations. Additional and increased planting/ landscaped areas should be included in any campus plans to help treat and mitigate storm water run-off. Refer to civil section for additional information.

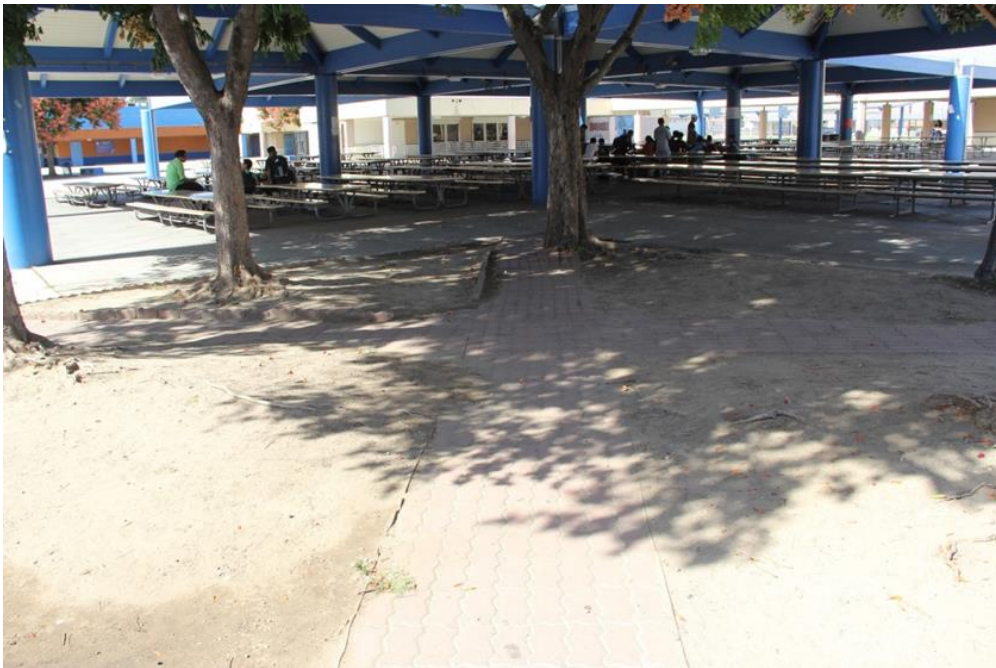
- b. Several of the campus trees are currently located within inadequately sized tree wells. Although the tree wells may have been appropriate at the time of planting, they are currently constraining the trees. Small tree wells combined with lack of root barrier installation and lack of irrigation has caused the trees to develop large surface roots causing lifting and buckling of the adjacent paving, which may pose trip hazards in high traffic areas.

Trees Causing Uplift On Brick Pavers

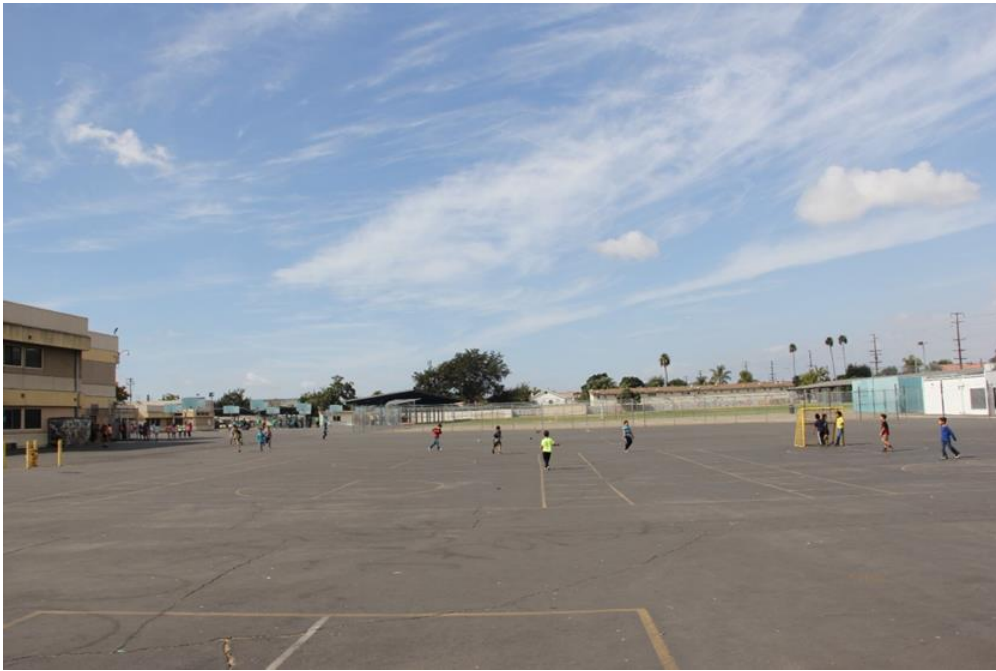
Campus Interior Lacks Shade; Pavement Cracking

- b. The campus courtyards lack natural shade and so additional trees should be planted to increase the canopy coverage throughout the campus as a part of any future projects. Increasing the internal campus tree canopy will reduce the paving heat island effect and create a nicer environment for the students.
- c. Regardless of scope of work, it is suggested by the arborist that two trees are to be removed as soon as possible, as they are a safety and health concern. The trees to be removed are as follows: #7 (Shamel Ash), and #9 (Shamel Ash)
- d. For additional tree information: Type, size, quantity, and health refer to Table 1- Tree Inventory.

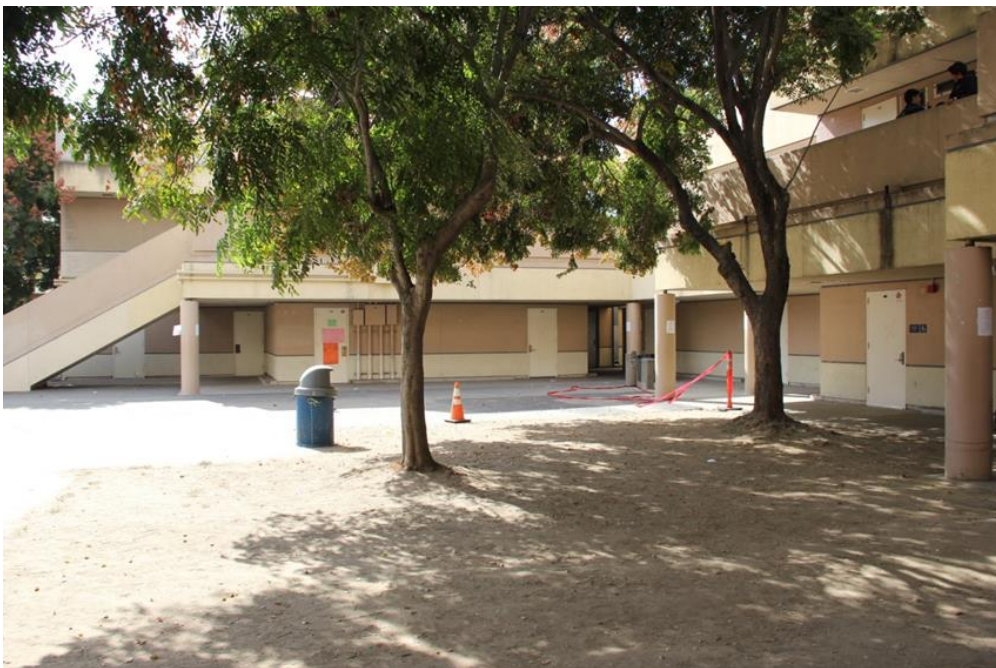
- c. Planting areas within the campus core are generally void of any shrubs or other landscape material. Most of the landscape “planting areas” consists of exposed sandy soil and leaf litter from the mature tree canopy. As a result, the students use these planting areas as a path of travel, tracking soil and dust into classrooms as well as compacting the soil.

Planting Area Void of Mid-Level Shrub Material

- a. Where landscape areas in the campus interior lack mid-level planting, an enhancement effort is recommended to improve the campus environment.
- b. A campus-wide mid-level plant palette should be designated and used for enhancement and replacement of mid-level planting as needed. The existing native garden within the flag pole planter provides an appropriate example plant palette that could be followed and expanded due to the success of that area.
