## 5.0 LANDSCAPE ANALYSIS

### 5.1 Analysis of Existing Landscaping

Los Angeles Unified School District  
Elizabeth Learning Center

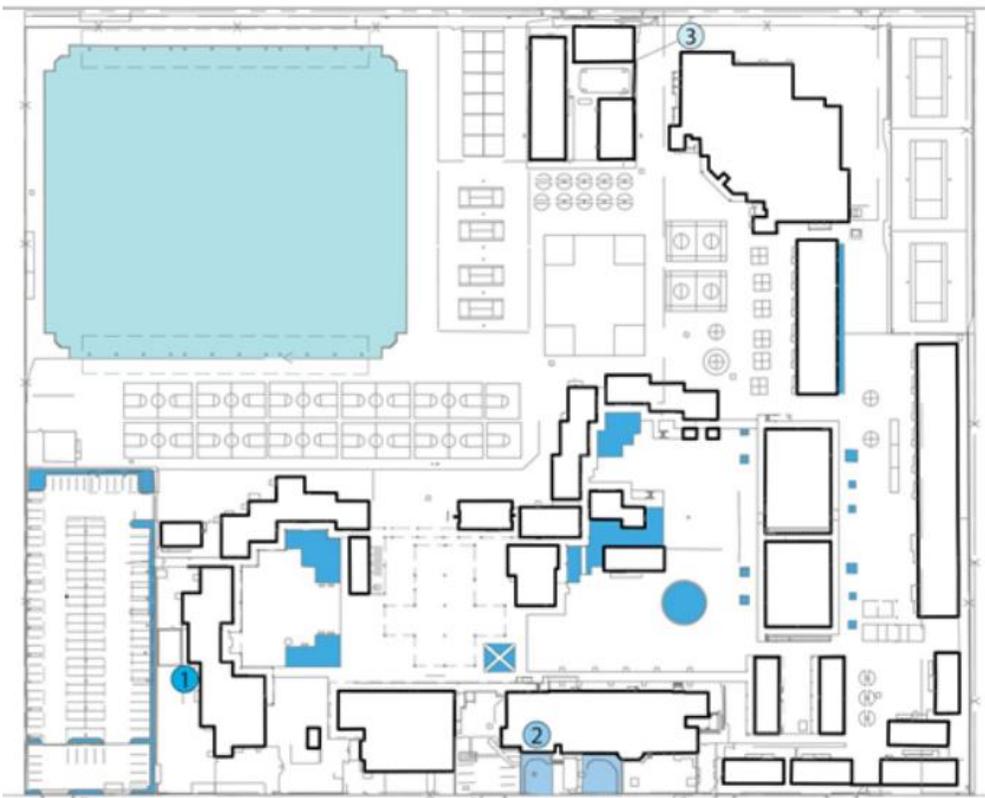
third irrigation controller box, but due to the valves in the surrounding area not activating when manually turned on shows that the controller has been shut off and is no longer providing irrigation in those zones. A Toro controller with 24 stations is located on the backside of the gymnasium, facing Clara Street. Another Toro controller is located in the front area of the campus.

- c. Irrigation Valve Boxes
  - i. Valve boxes are not labeled-except for irrigation in the school entrance area
  - ii. There were multiple valve boxes installed incorrectly elevated above the adjacent finish grade
  - iii. Multiple valve boxes are inaccessible due to the box being buried with soil
- d. Irrigation within the soccer field requires a new layout to deter both dry and overly saturated from appearing. Turf areas that fall underneath the solar panels shadow need to be on their own system to inhibit overwatered turf
- e. California native habitat areas lack supplemental irrigation. The addition of irrigation will cause these plants to thrive in their current location

*Irrigation Zoning and Point of Connections*

- a. All areas that will require a new landscape design should have a new irrigation system installed. Where existing landscape areas are to be re-designed, the existing irrigation system should be redesigned as well.
- b. A new point of connection will be required for the scope of the new project. With a new point of connection requires a new backflow, meter, master valve and flow sensor to increase irrigation efficiency.
- c. The irrigation system should be retrofitted with smart controllers to optimize water efficiency. It should be noted that doing so could require trenching through portions of the campus otherwise outside the scope of work for this project to install irrigation control wiring and plumbing.

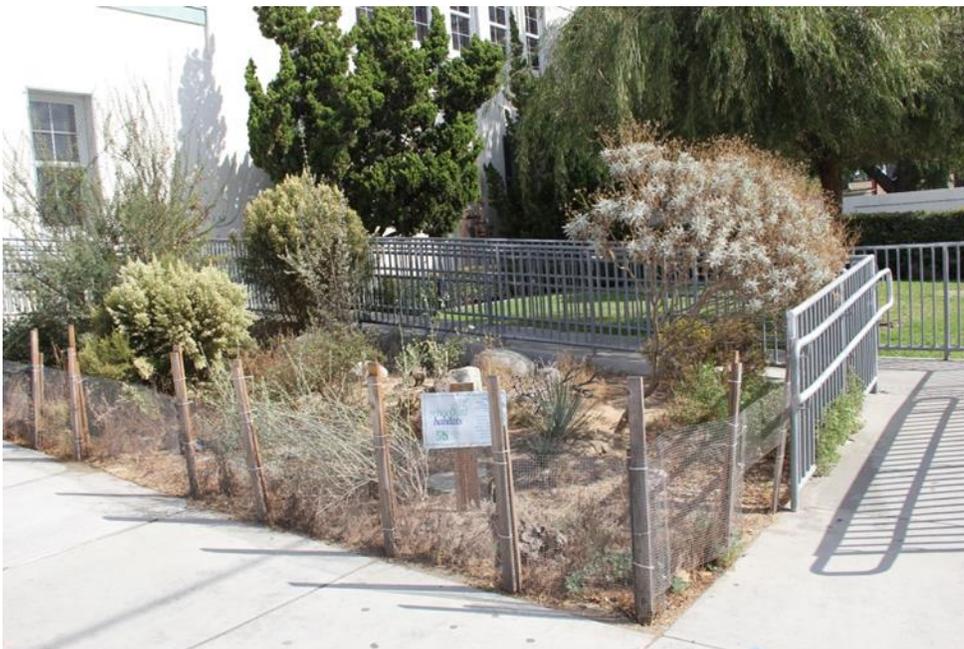
*California Native Habitat Garden*

- c. Habitat Gardens to be revitalized with a new plant palette guaranteed to succeed.
- d. All new trees to install root barriers correctly to inhibit uplifting in AC paving or concrete.

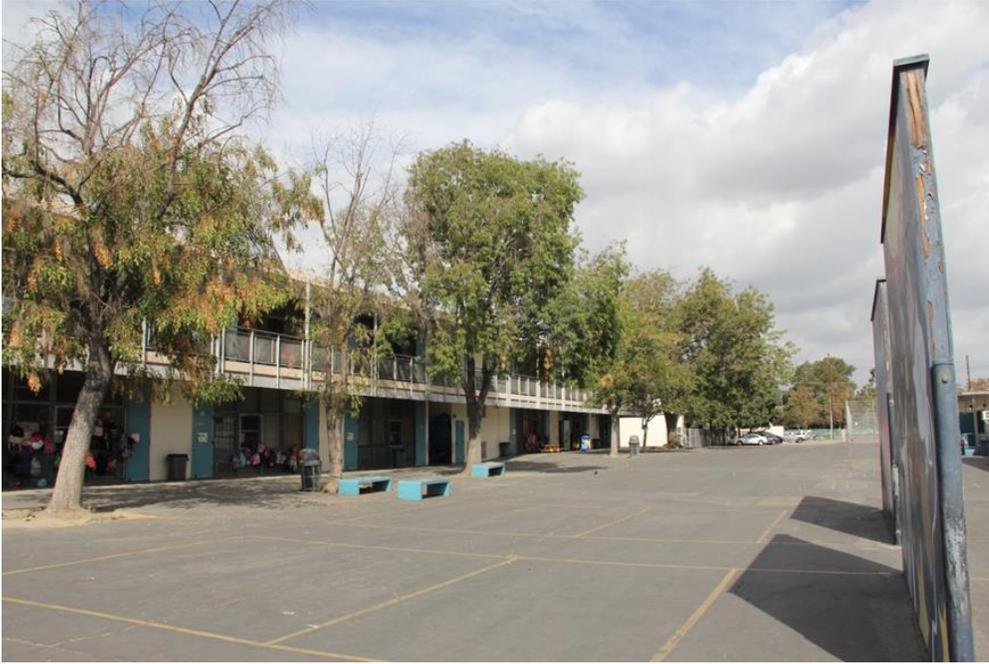
- a. The campus tree canopy is sparsely planted with clusters of mature trees within the campus core separated by large amounts of paving. Trees are relatively healthy despite their growing conditions and lack of current irrigation.

*Mature Tree Canopy Within Campus Core*

- a. Campus shall make all attempts to protect and preserve as many mature trees as possible that are deemed healthy and structurally sound per the arborist evaluation.

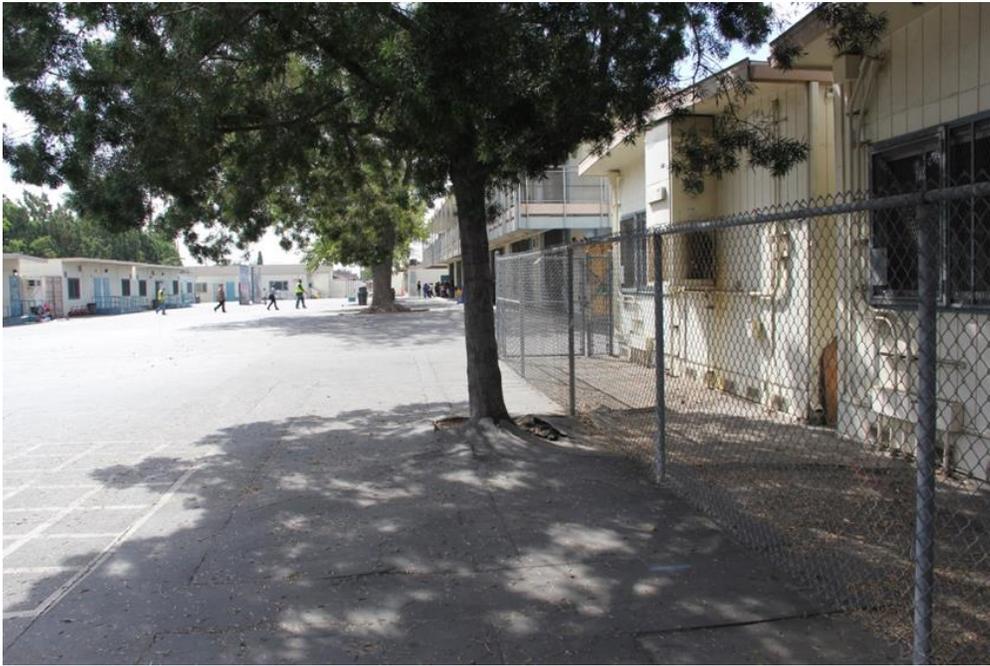
- d. The redwood edging and in some cases concrete curb around tree wells cut into the asphalt paving have cracked or deteriorated. This may pose a trip hazard in instances where it is lifted above the adjacent paving.

*Cracked and Lifted Asphalt Paving*

- e. New redwood edging and concrete curbs to be installed near tree wells to prevent tripping hazards.
- f. Any new project will trigger low impact development and storm water management per current regulations. Additional and increased planting/ landscaped areas should be included in any campus plans to help treat and mitigate storm water run-off. Refer to civil section for additional information.

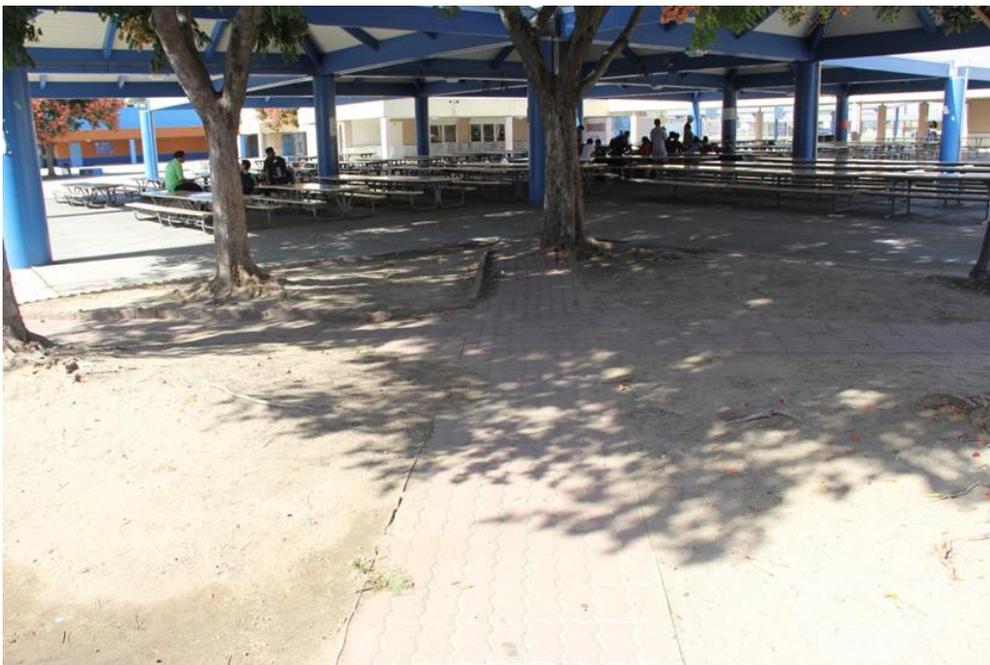
- b. Several of the campus trees are currently located within inadequately sized tree wells. Although the tree wells may have been appropriate at the time of planting, they are currently constraining the trees. Small tree wells combined with lack of root barrier installation and lack of irrigation has caused the trees to develop large surface roots causing lifting and buckling of the adjacent paving, which may pose trip hazards in high traffic areas.

*Trees Causing Uplift On Brick Pavers*

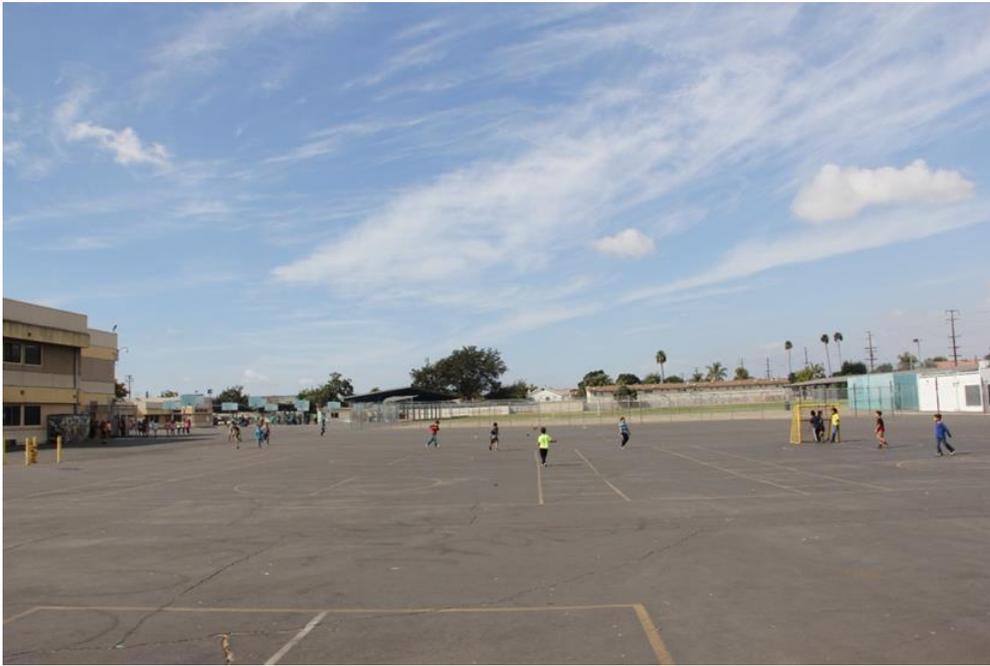
From a landscape standpoint, Elizabeth Learning Center lacks natural shade throughout the campus with expansive paved areas and nearly all trees located on the south east portion of the campus, leaving the remainder of the campus with no trees to reduce the heat island effect during hot days. Overall the campus lacks uniformity with only a handful of planted areas, little to no under planting throughout the campus, and neglected or undefined exterior student spaces. Aside from the main campus entrance and sport field the campus lacks a proper irrigation system which contributes to the lack of planting, health of trees and root intrusion.

*Campus Interior Lacks Shade; Pavement Cracking*

- b. The campus courtyards lack natural shade and so additional trees should be planted to increase the canopy coverage throughout the campus as a part of any future projects. Increasing the internal campus tree canopy will reduce the paving heat island effect and create a nicer environment for the students.
- c. Regardless of scope of work, it is suggested by the arborist that two trees are to be removed as soon as possible, as they are a safety and health concern. The trees to be removed are as follows: #7 (Shamel Ash), and #9 (Shamel Ash)
- d. For additional tree information: Type, size, quantity, and health refer to Table 1- Tree Inventory.

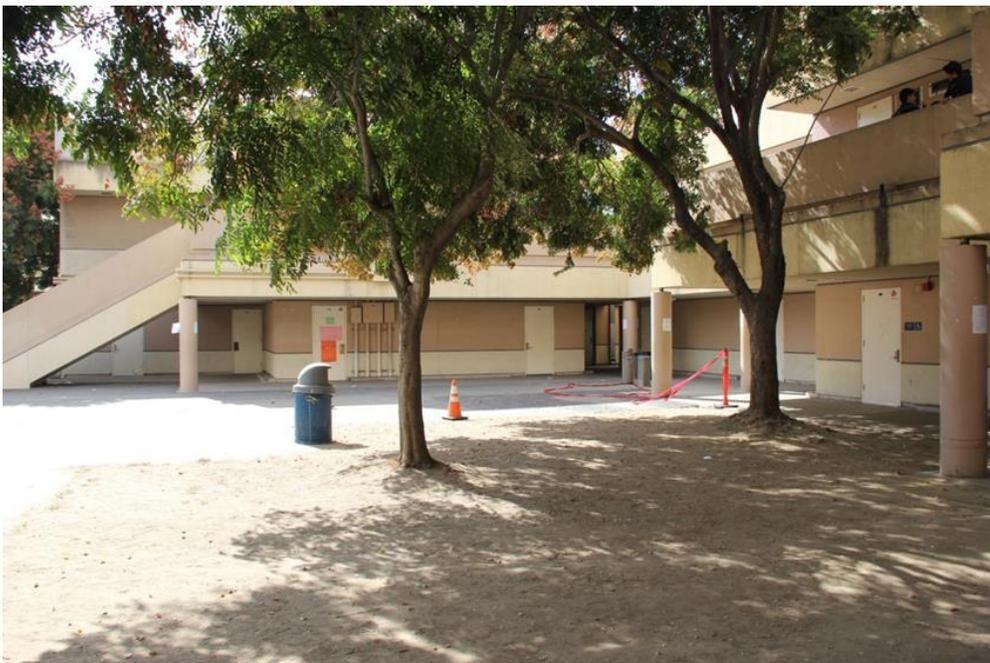
- c. Planting areas within the campus core are generally void of any shrubs or other landscape material. Most of the landscape “planting areas” consists of exposed sandy soil and leaf litter from the mature tree canopy. As a result, the students use these planting areas as a path of travel, tracking soil and dust into classrooms as well as compacting the soil.

*Planting Area Void of Mid-Level Shrub Material*

- a. Where landscape areas in the campus interior lack mid-level planting, an enhancement effort is recommended to improve the campus environment.
- b. A campus-wide mid-level plant palette should be designated and used for enhancement and replacement of mid-level planting as needed. The existing native garden within the flag pole planter provides an appropriate example plant palette that could be followed and expanded due to the success of that area.
