COMPREHENSIVE ASBESTOS, XRF-LEAD AND HAZMAT SURVEY

Christ's Church of the Valley

7576 Etiwanda Avenue, Nursery Building and Patio, Storage

Project Number: Atch-180926

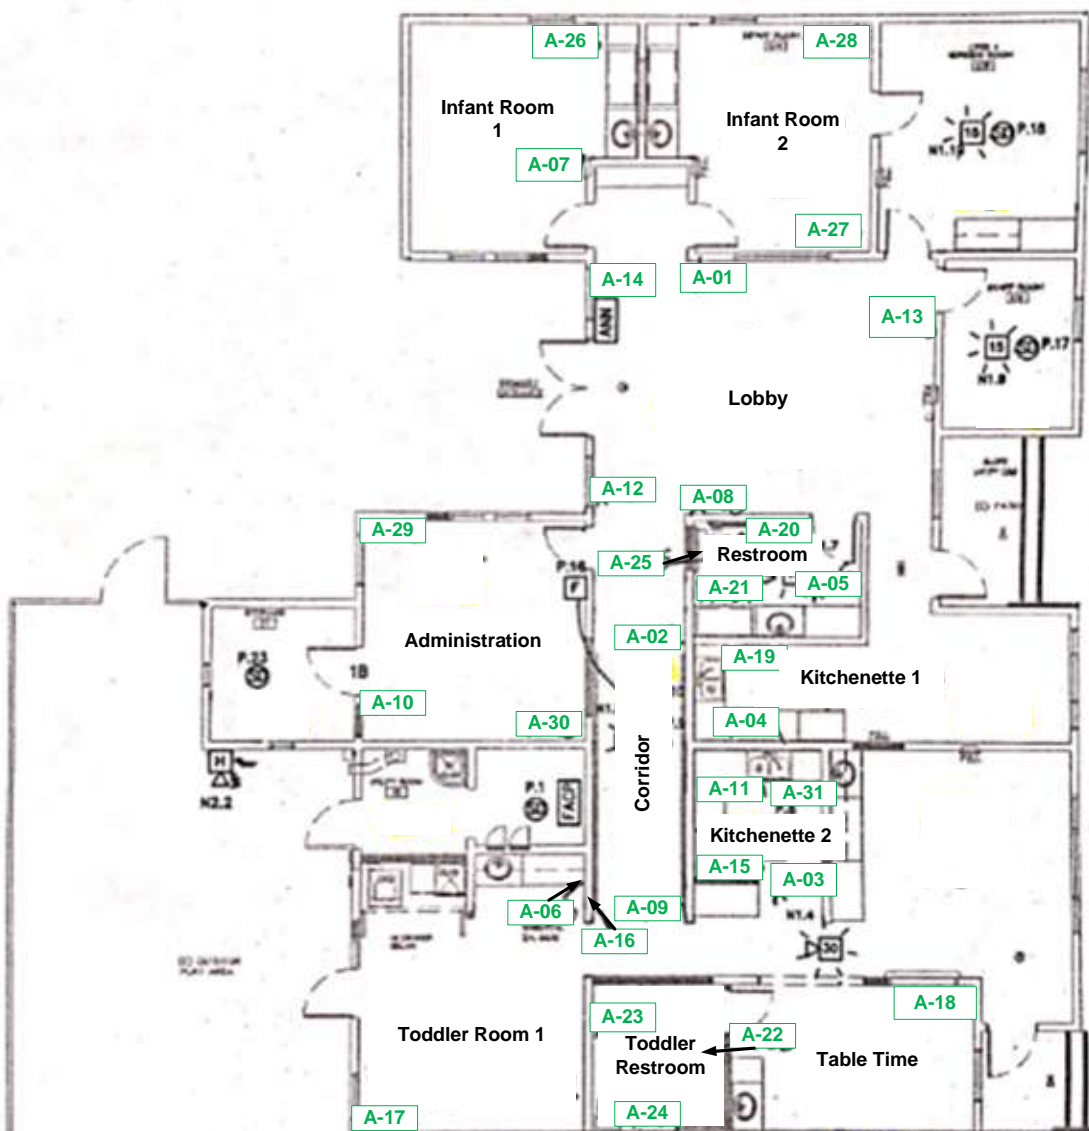
Site Drawing – Asbestos – Page 1 of 3

Nursery Building

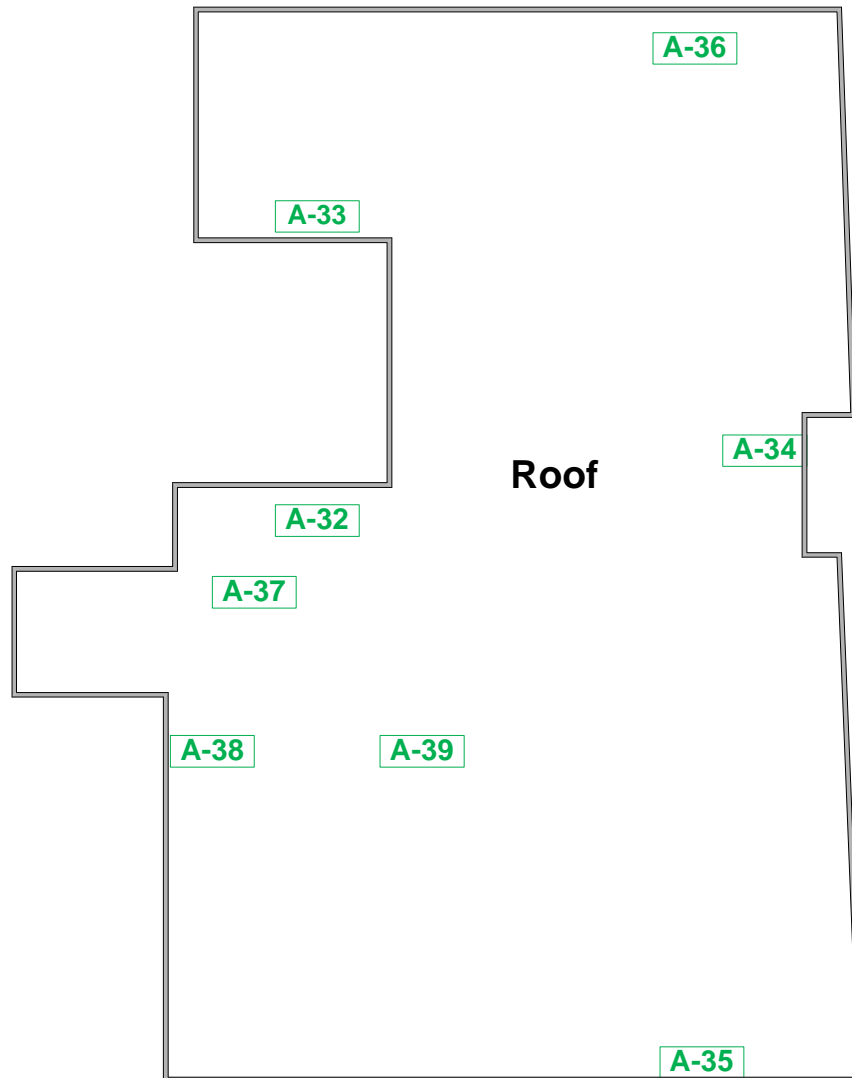
Site Drawing – Asbestos – Page 2 of 3

Nursery, Roof
