Tree & Palm Evaluation Report

4555 Executive Drive, San Diego, CA

Arborgate Consulting, Inc.
Greg Applegate, RCA #365
1131 Lucinda Way
Tustin, CA 92780
714/ 731-6240

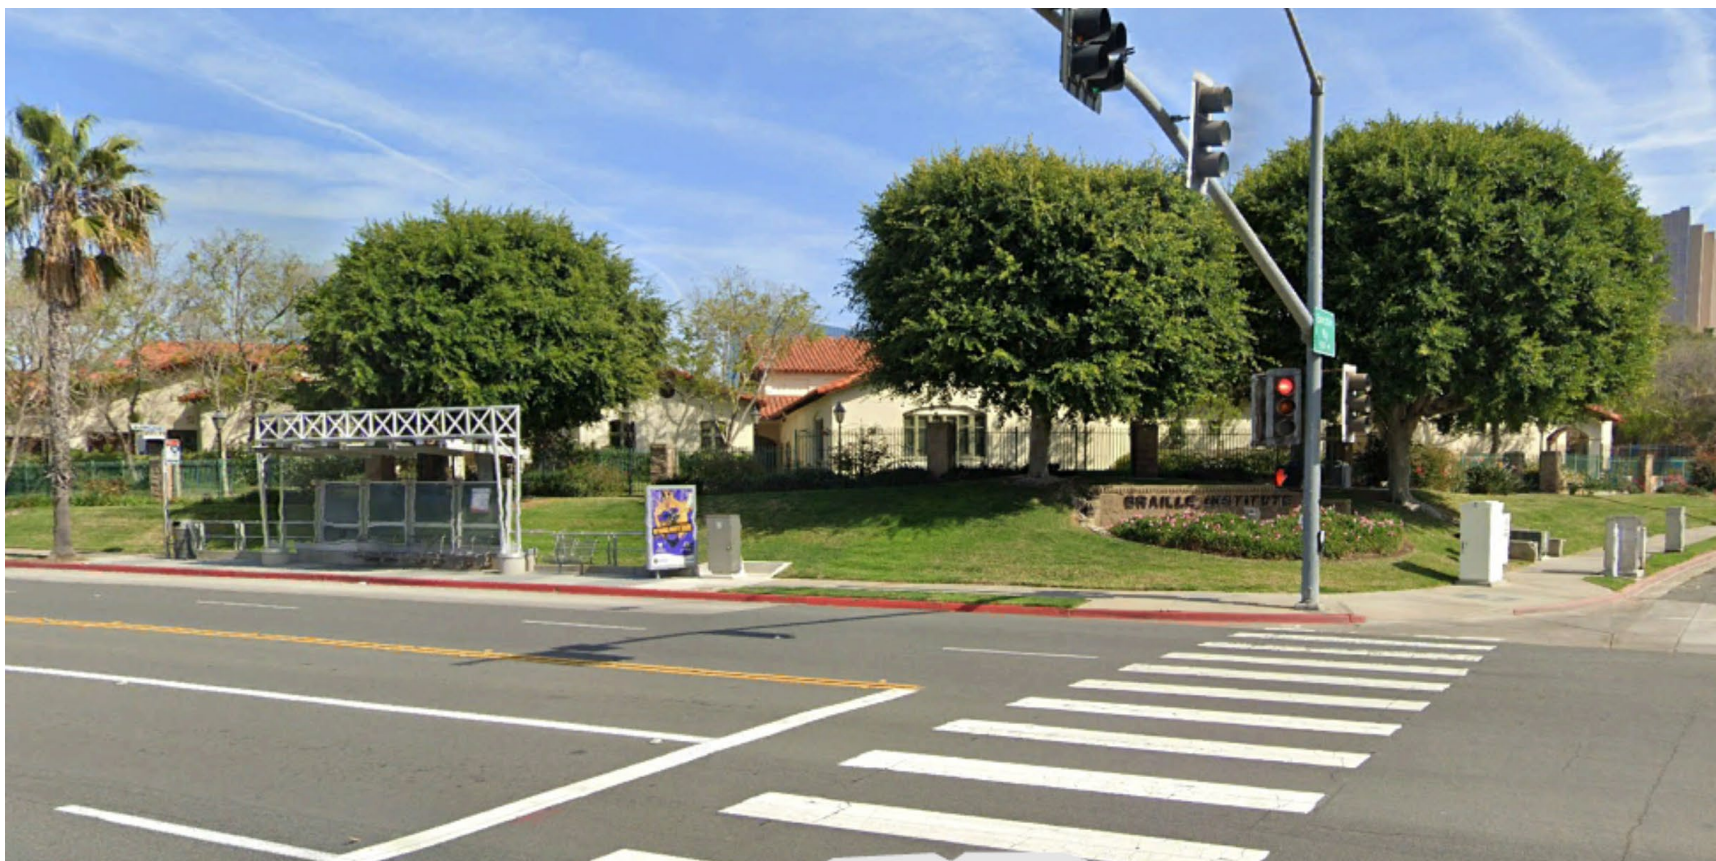
There are four large Indian laurels at the corner. Three are outside the fence, #21, 22 & 23. The fourth is inside, #149

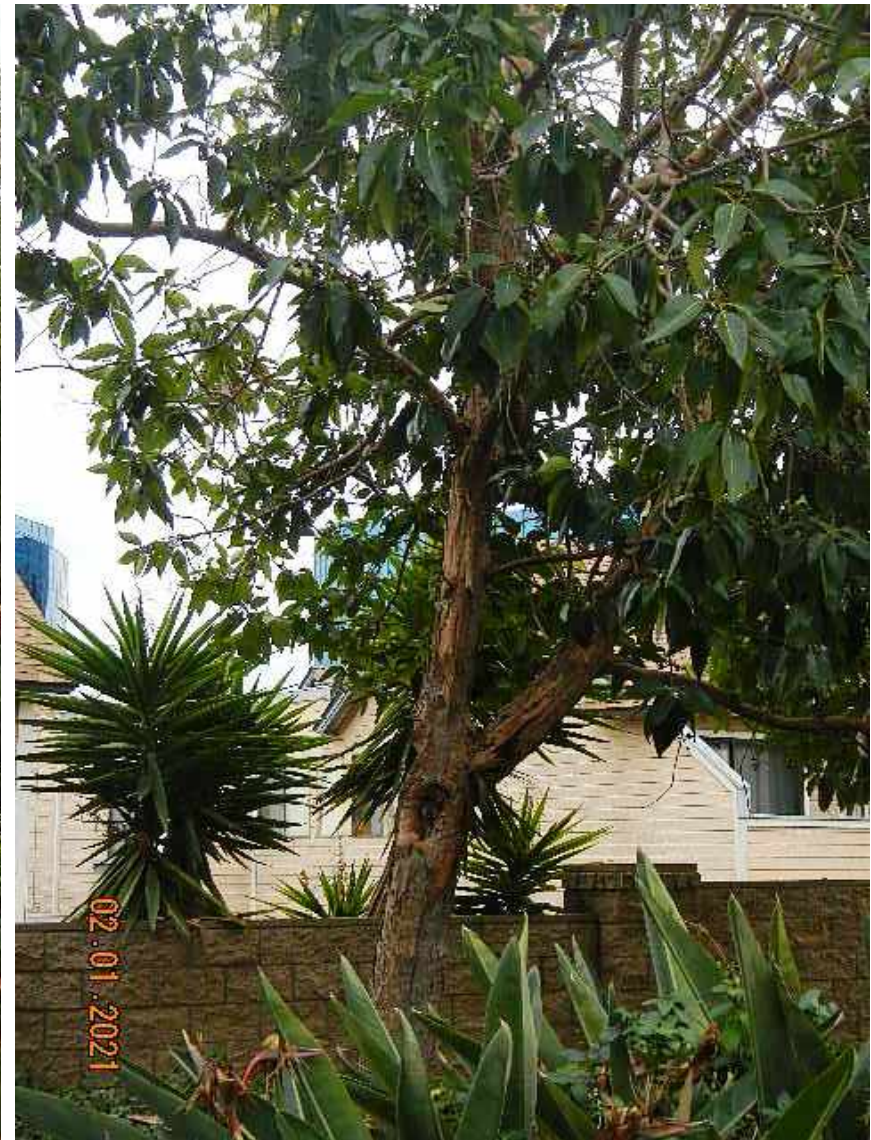
#93 Brisbane box, with several large tear-outs due to being too long.

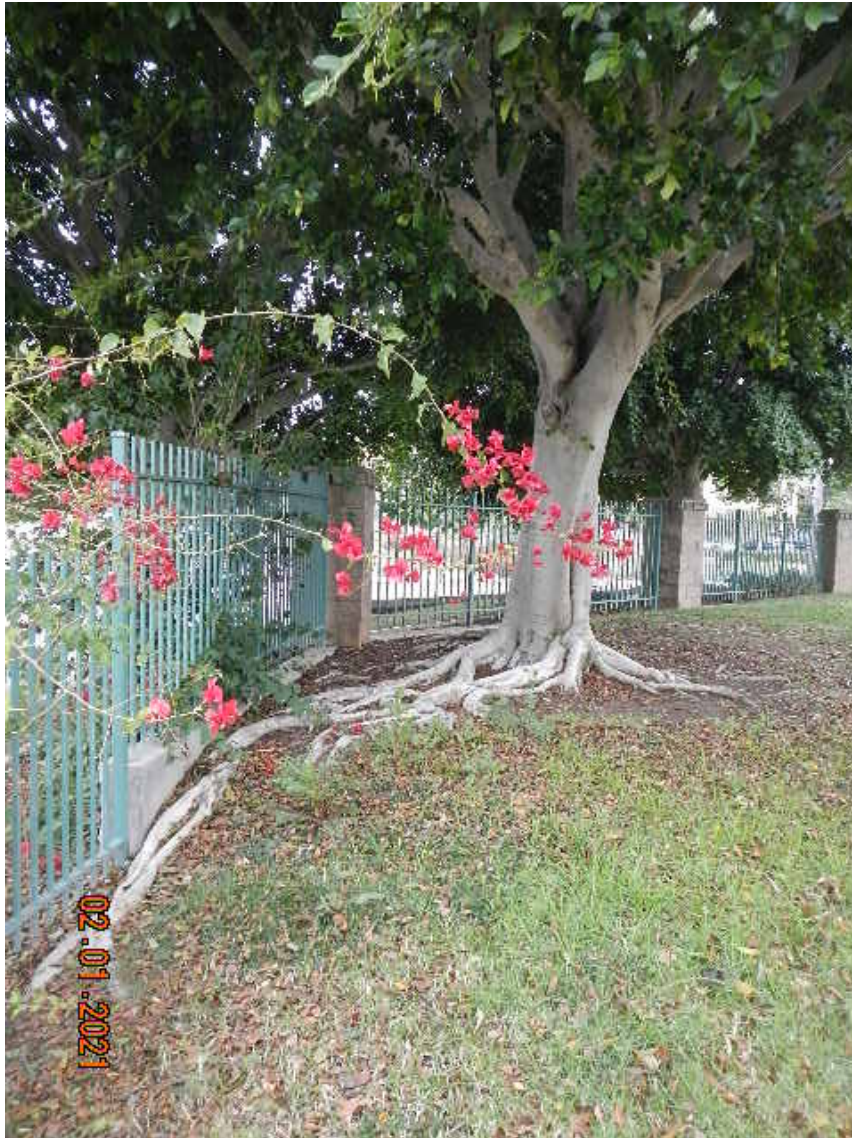
#149 Indian laurel – note surface roots

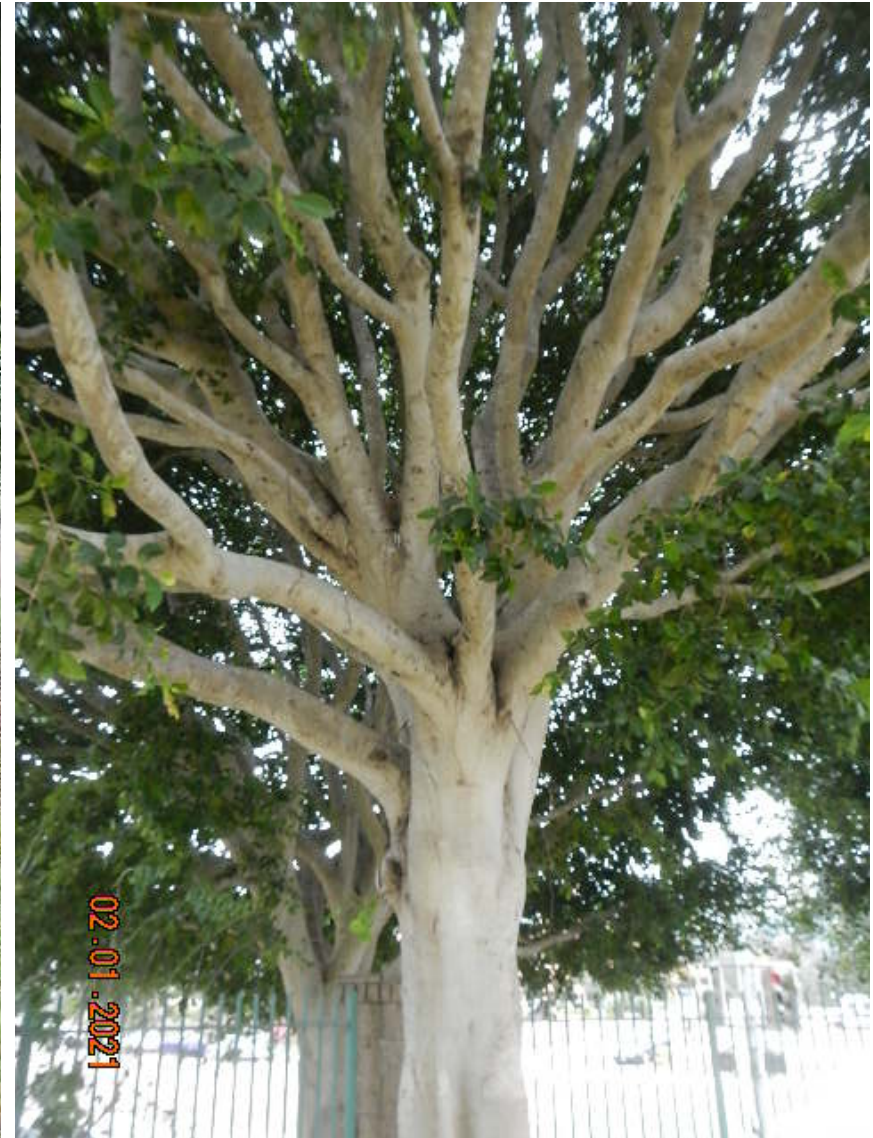
#149 – note crowded limbs.

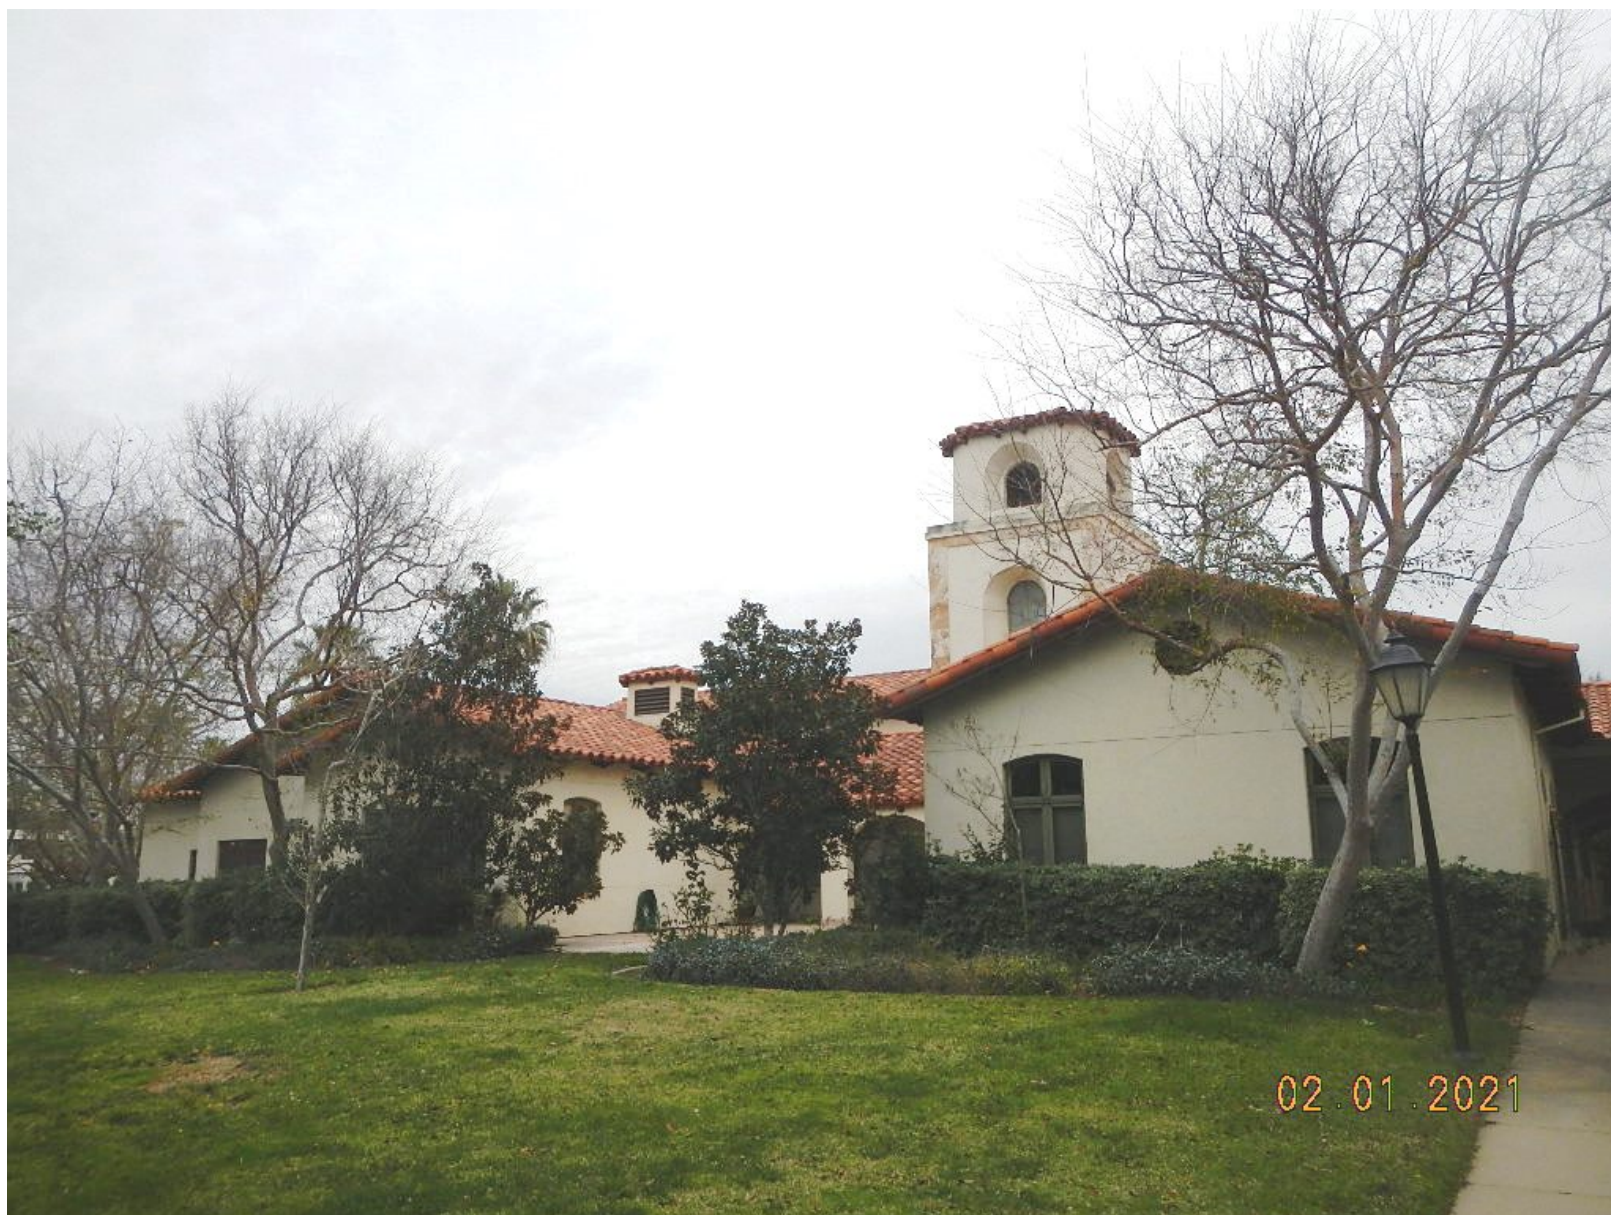
#150 Elm at right, dwarf magnolias #151 to 155 in middle, #154 London plane at left.

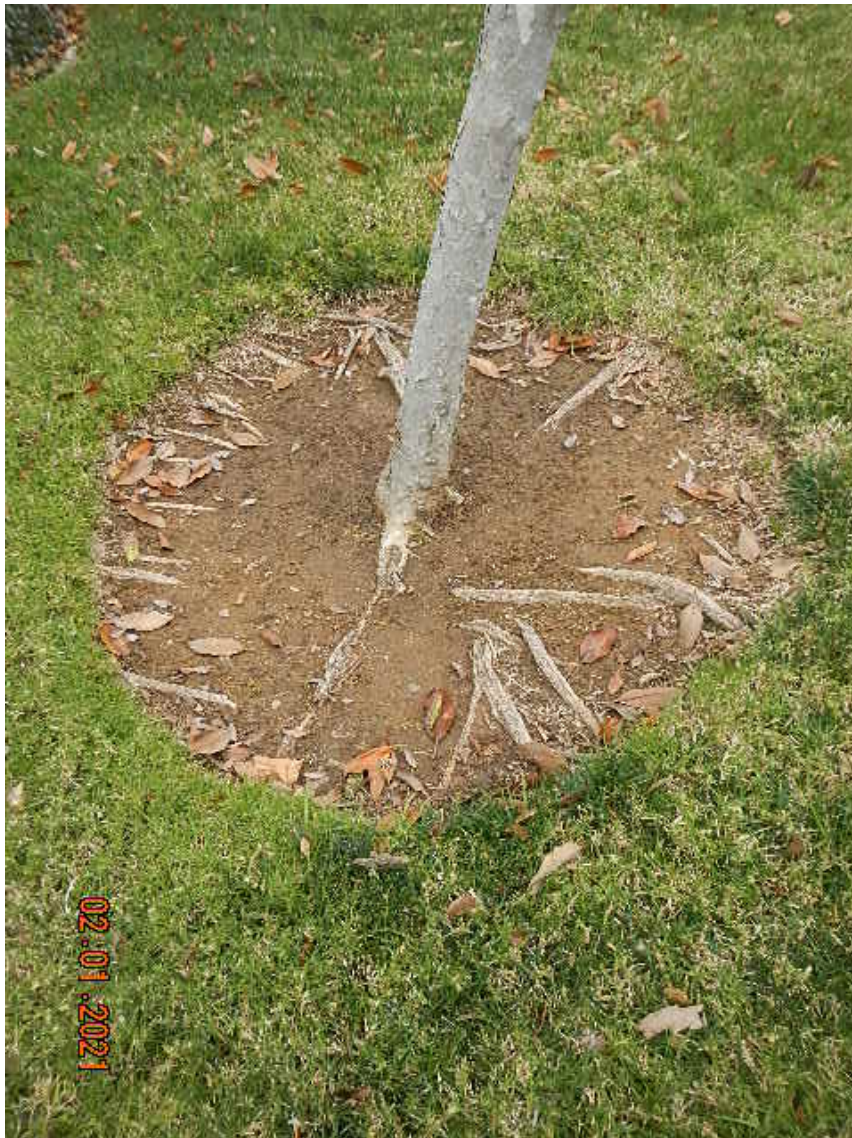
#154 London place with lawn mower or string trimmer root damage

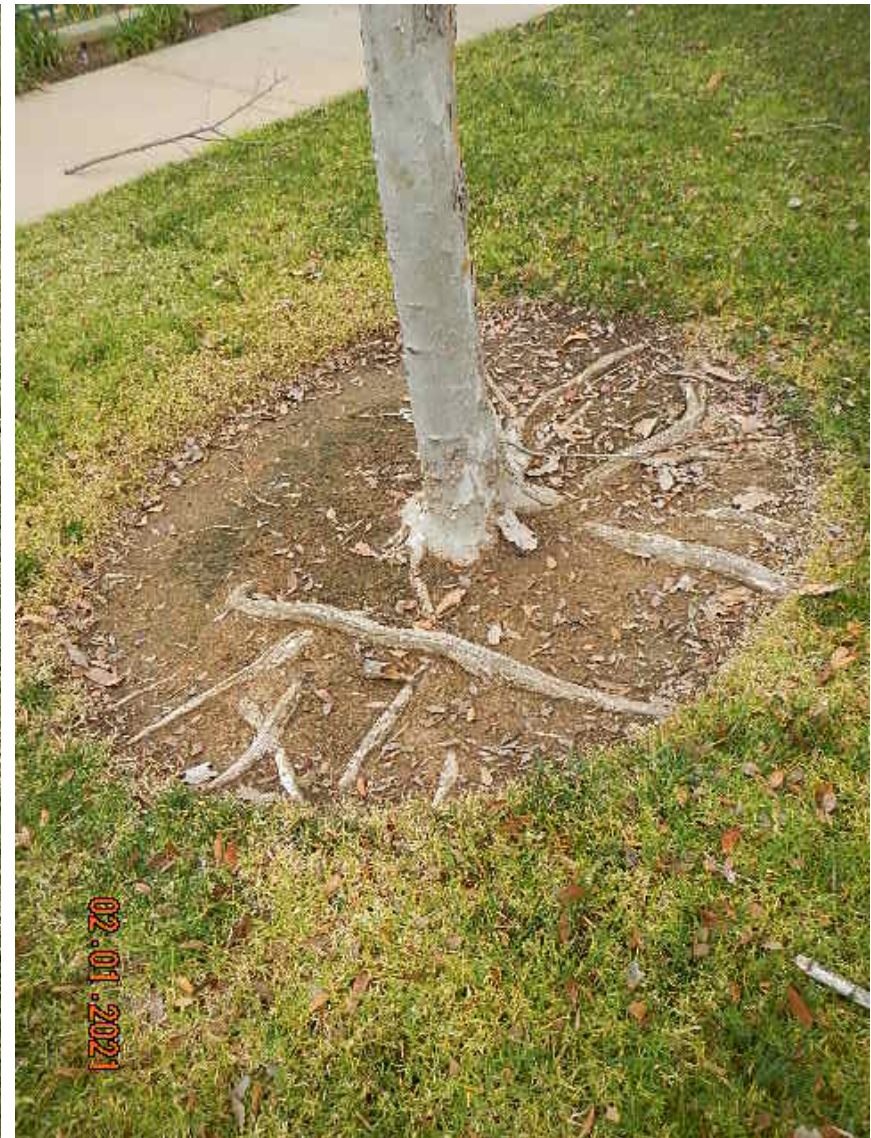
#156 London place with lawn mower or string trimmer root damage.
