Hazardous Building Materials Survey

Boyle Heights Sports Center Gym Project

2500 Whittier Boulevard

July 2, 2018 | Project No. 209403013

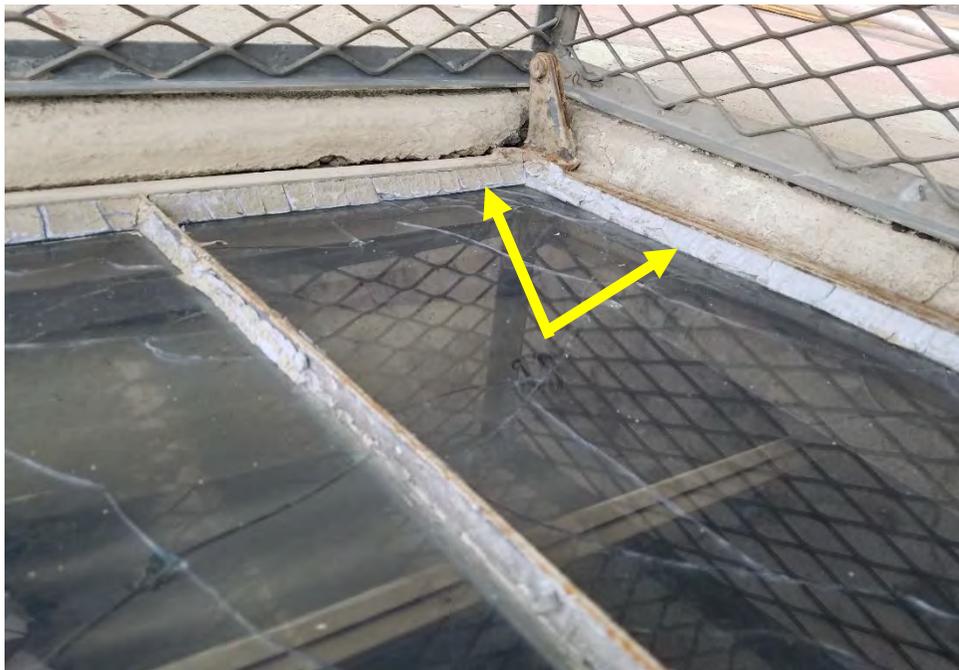
Photograph 2: Building 1: view of asbestos-containing window putty.

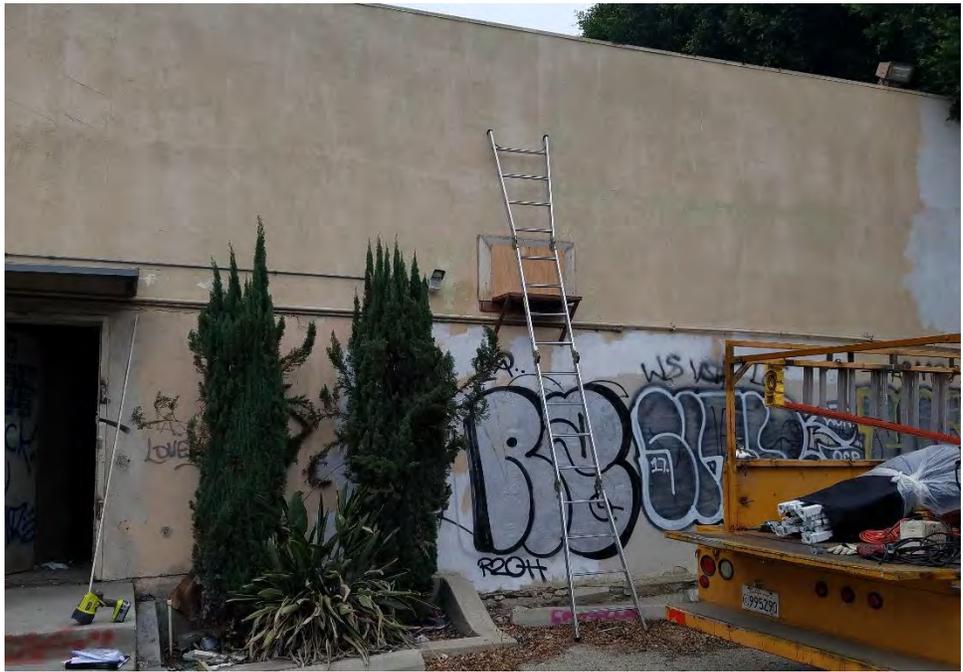
Photograph 3: Building 1: view of asbestos-containing exterior stucco.

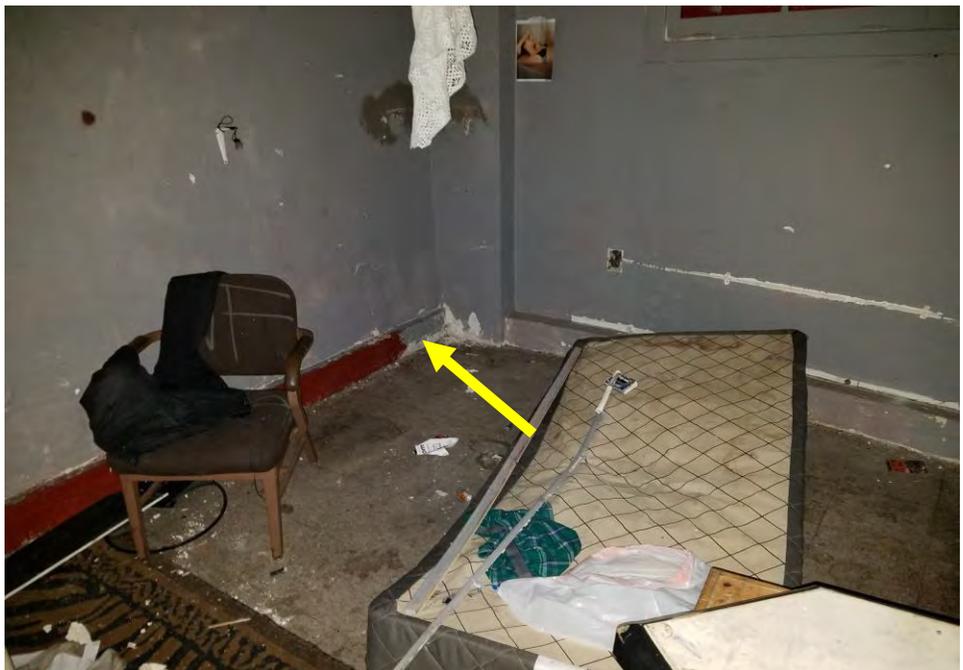
Photograph 4: Building 1: view of asbestos-containing baseboard plaster.

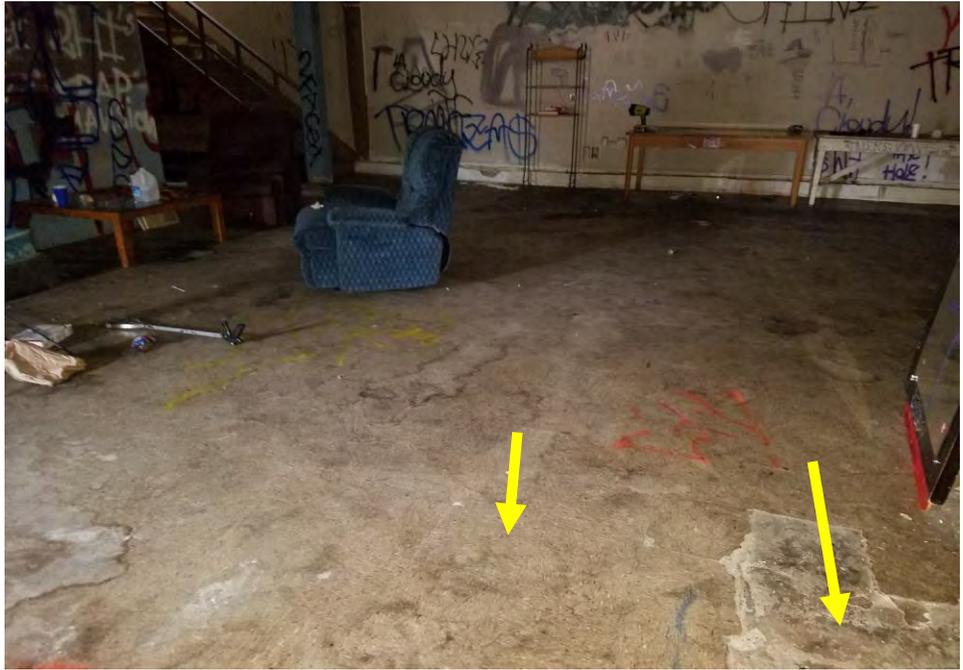
Photograph 5: Building 1: view of asbestos-containing 1'x1' vinyl floor tile and mastic.

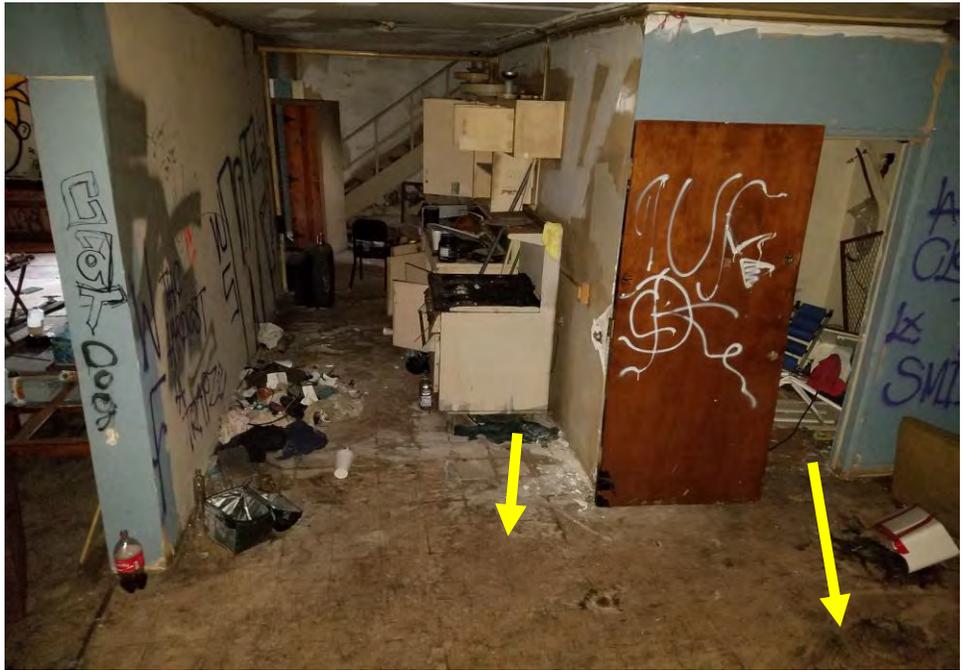
Photograph 6: Building 1: view of asbestos-containing 9"x9" vinyl floor tile.

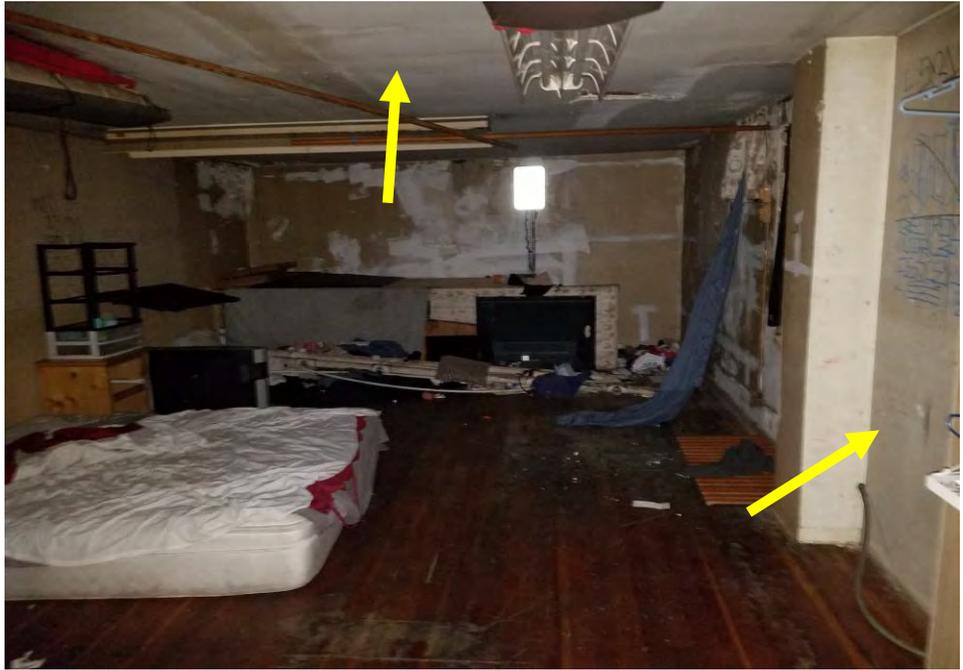
Photograph 7: Building 1: view of asbestos-containing button board (plaster/drywall) throughout walls and ceilings.

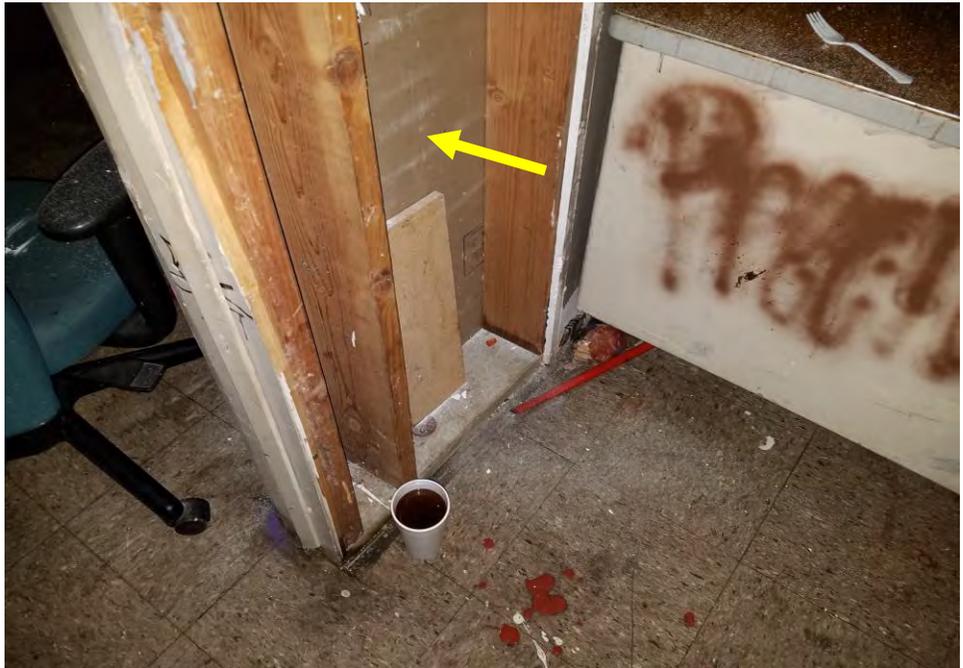
Photograph 8: Building 1: view of asbestos-containing joint compound associated with drywall.

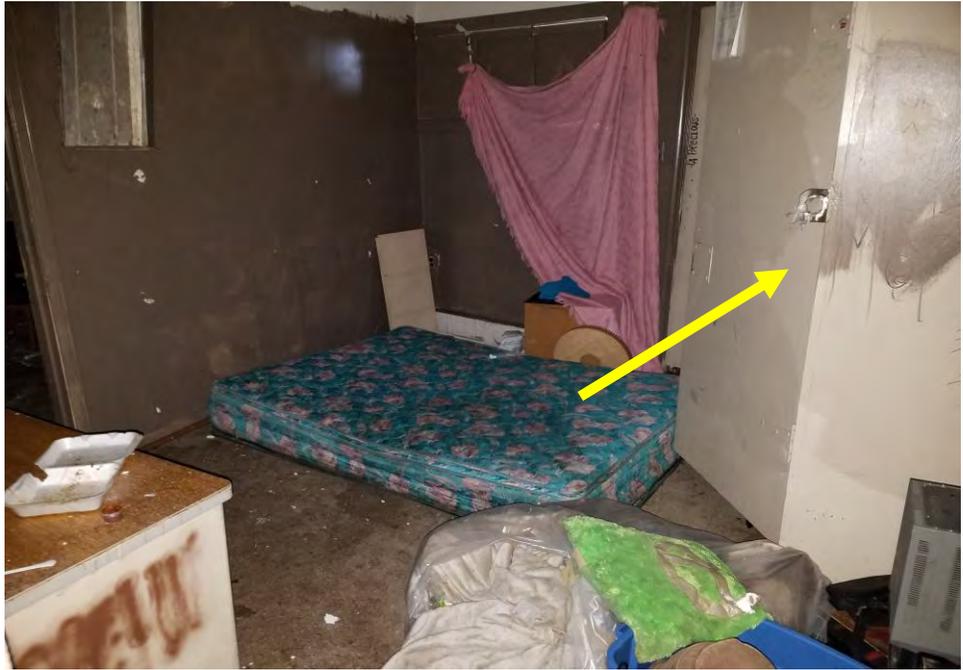
Photograph 9: Building 1: view of lead containing door.

- The identified LCSs should not be disturbed. All disturbances and removal activities should be performed by a licensed abatement contractor with certified lead personnel. Any painted LCSs in a non-intact condition should be stabilized and the substrate should be encapsulated. All lead related removal activities should be performed in accordance with the DOSH Lead in Construction Standard, Title 8 California Code of Regulations (CCR) 1532.1.

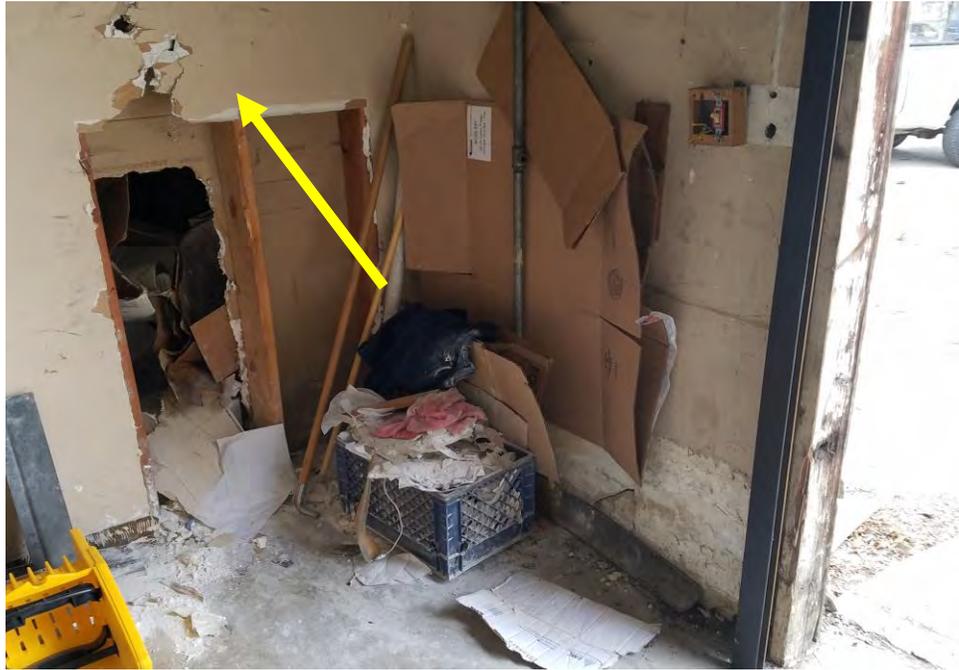
Photograph 11: Building 2: view of asbestos-containing joint compound associated with drywall.

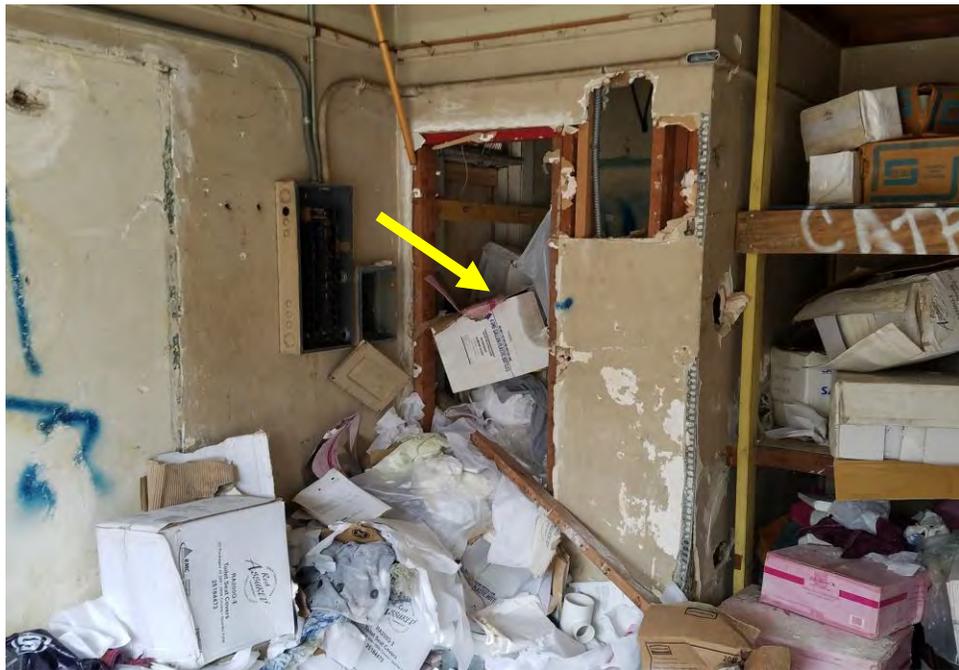
Photograph 12: Building 2: view of restroom with lead containing sink and toilet.

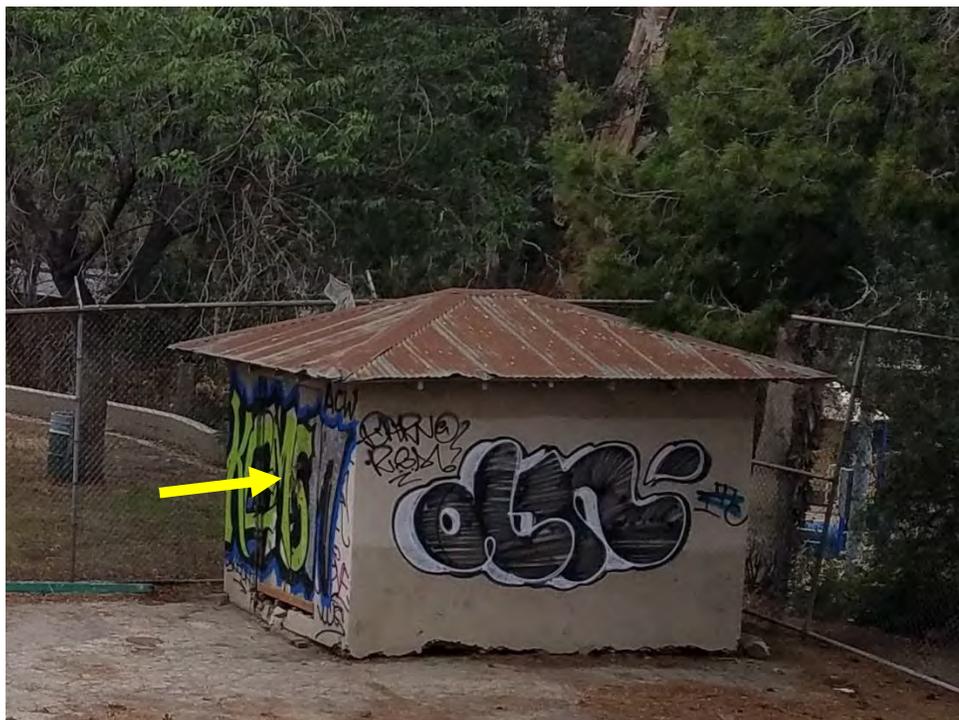
Photograph 14: Shed 1: view of lead-containing main door.

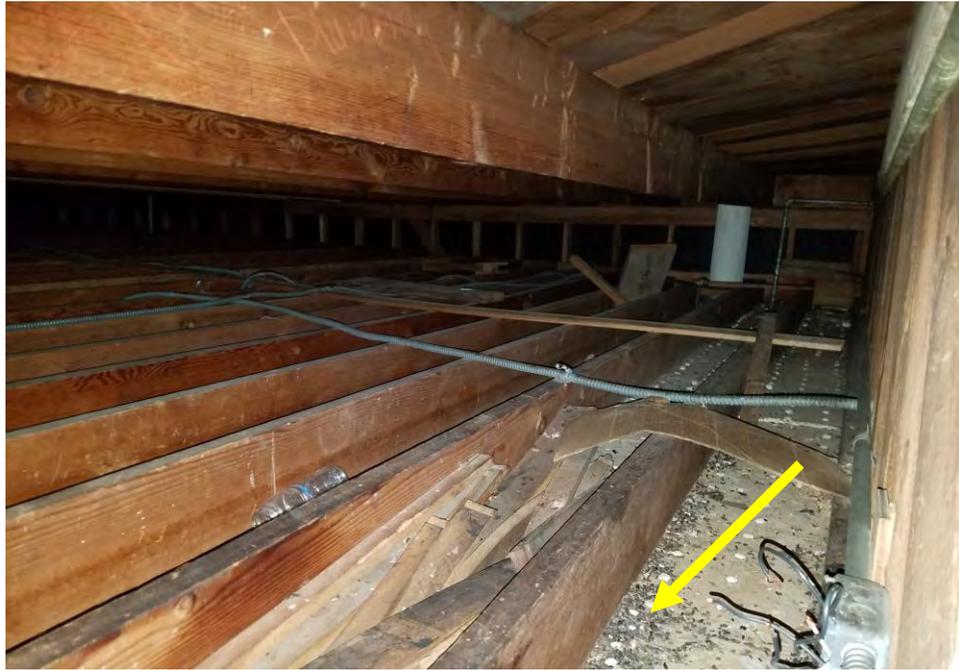
Photograph 15: Shed 1: view of rodent feces throughout ceiling plenum.

- Universal wastes discussed in this report (Table 4), should be removed and properly recycled or disposed by the licensed abatement contractor prior to demolition activities. The rodent droppings are not required to be removed in preparation for demolition of Building 1.
- Contractor should provide proper manifesting for all hazardous materials removed and recycled to prove the disposal of all materials was completed in accordance with local, state, and federal requirements.
- Monitoring consulting services should be performed by a third party environmental consultant, to ensure the appropriate removal of hazardous materials prior to building demolition activities.
