PREPARED FOR City of Redwood City

April 2020

Project No. 047-60-19-23

WEST YOST ASSOCIATES

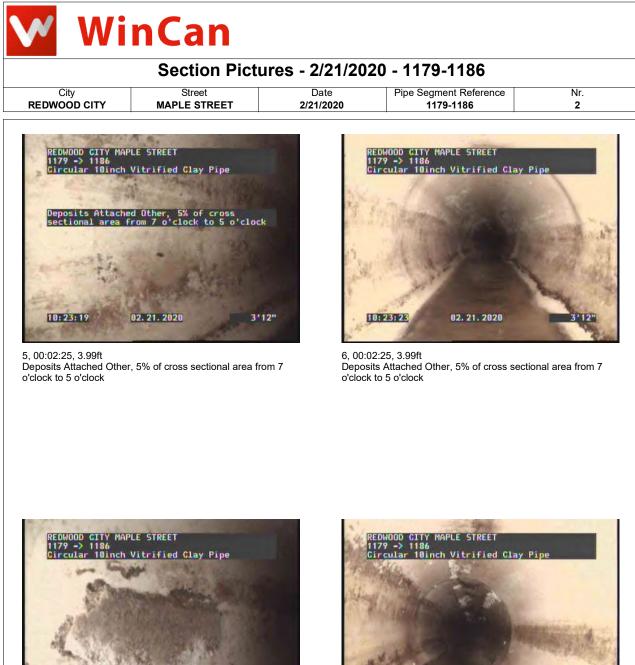
7, 00:03:05, 10.47ft Deposits Attached Grease, 5% of cross sectional area at 11 o'clock

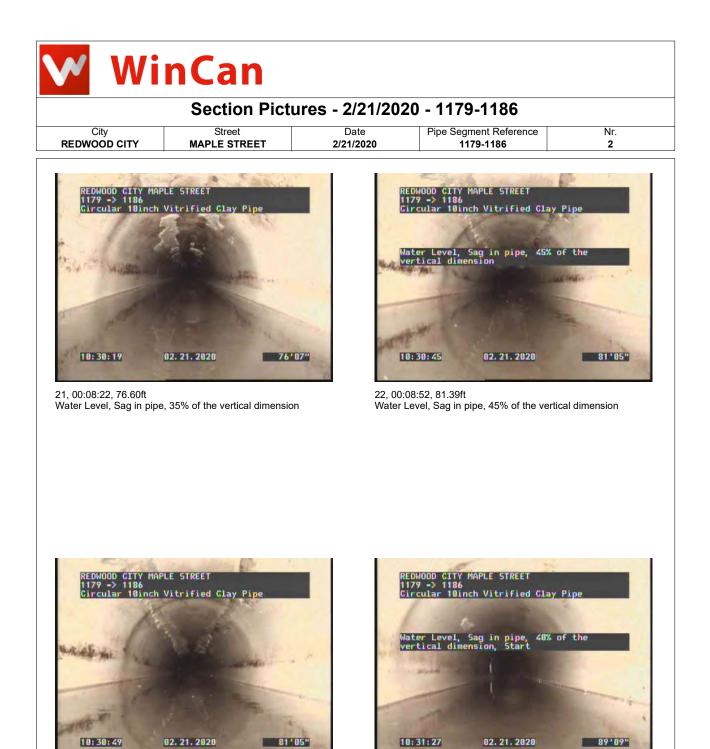
23, 00:08:52, 81.39ft Water Level, Sag in pipe, 45% of the vertical dimension

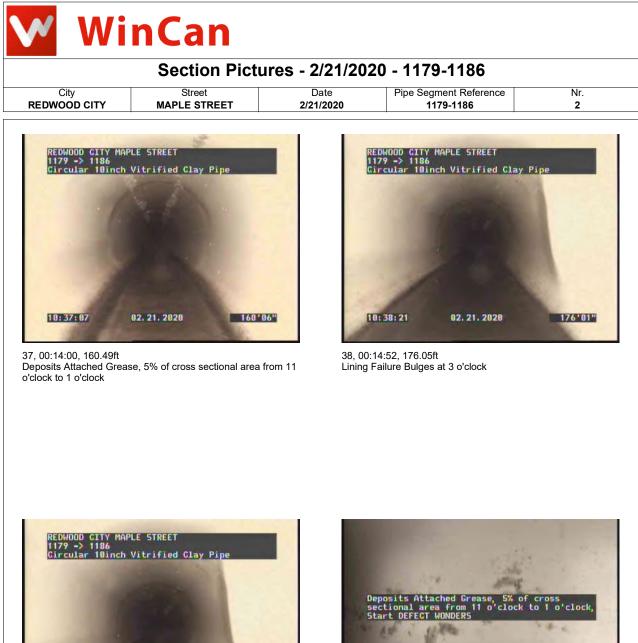
39, 00:14:52, 176.05ft Lining Failure Bulges at 3 o'clock

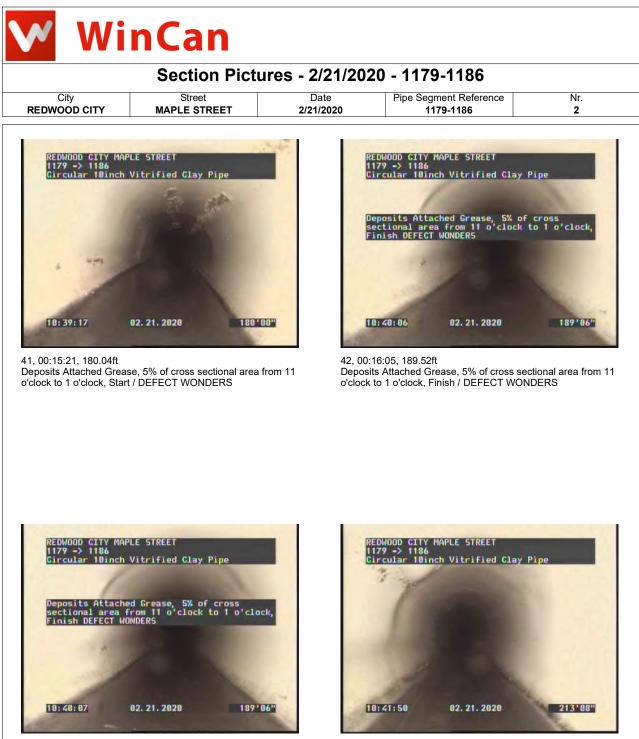
Deposits Attached Grease, 5% of cross sectional area from 11 o'clock to 1 o'clock, Finish / DEFECT WONDERS

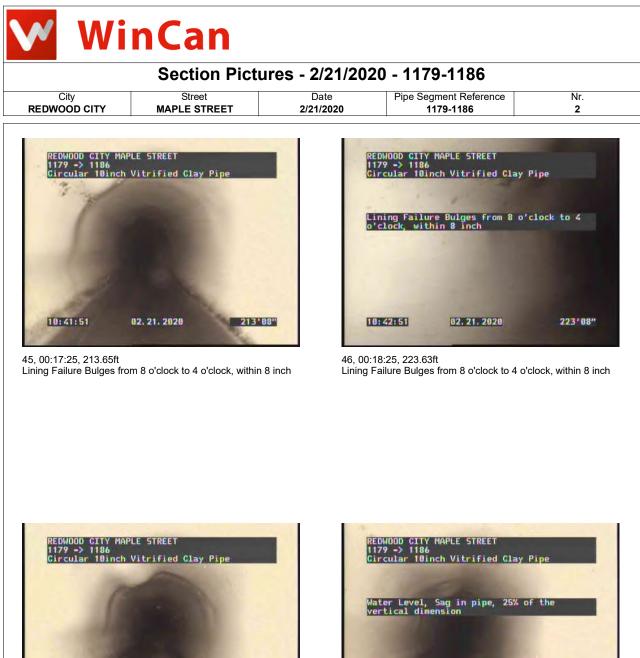
47, 00:18:25, 223.63ft Lining Failure Bulges from 8 o'clock to 4 o'clock, within 8 inch

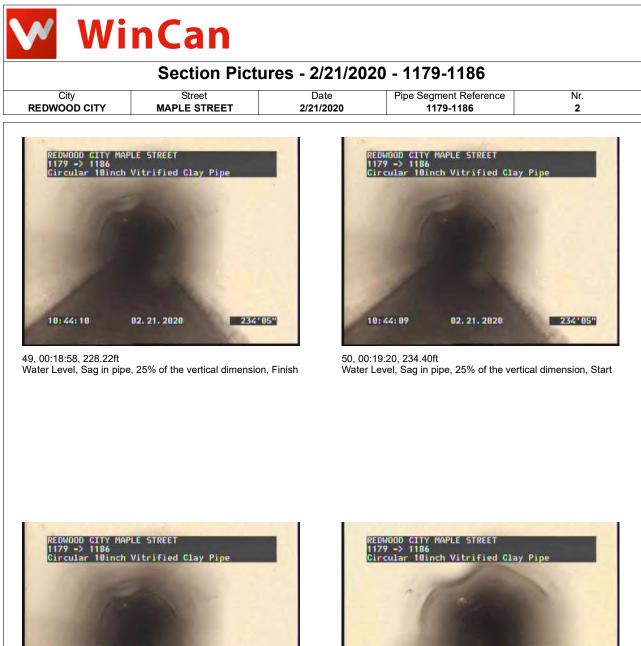
51, 00:19:20, 234.40ft Water Level, Sag in pipe, 25% of the vertical dimension, Start

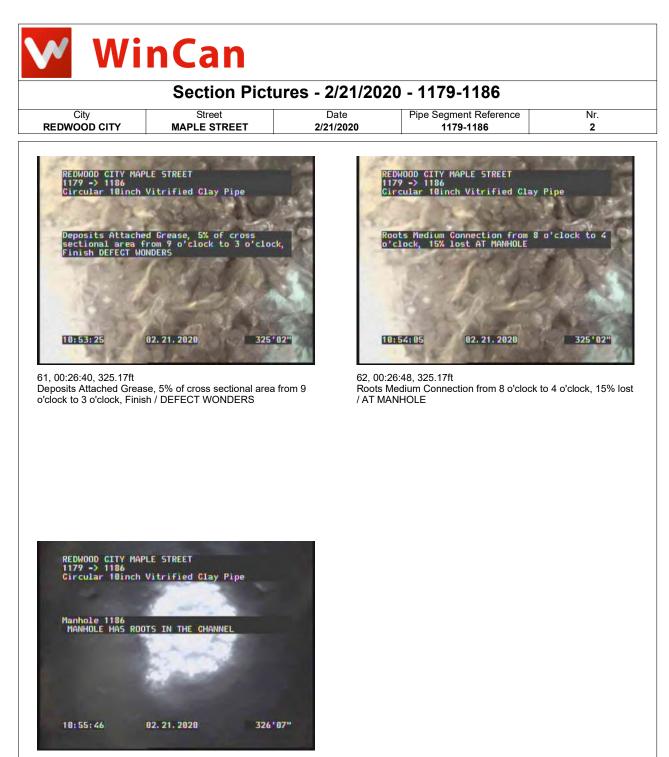
63, 00:27:13, 326.57ft Manhole / 1186 MANHOLE HAS ROOTS IN THE CHANNEL

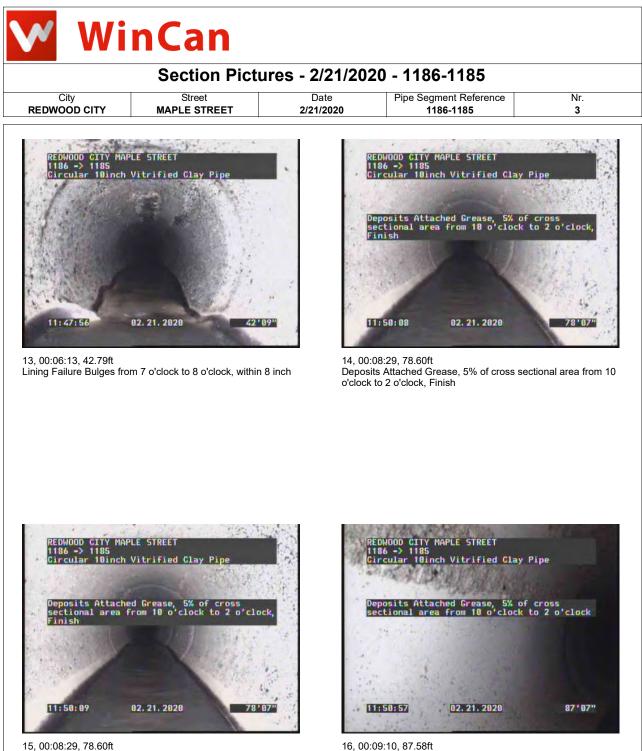
16, 00:09:10, 87.58ft Deposits Attached Grease, 5% of cross sectional area from 10 o'clock to 2 o'clock

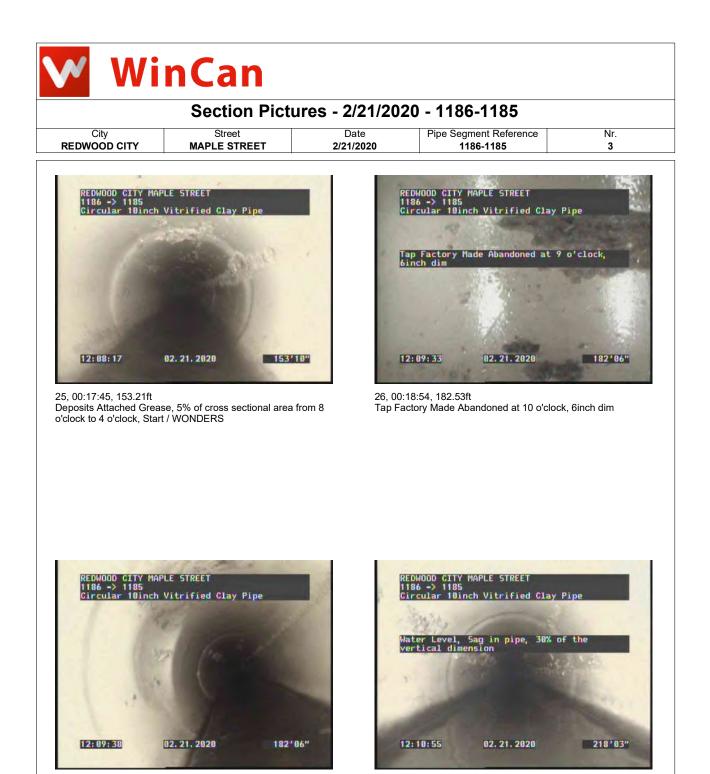
27, 00:18:54, 182.53ft Tap Factory Made Abandoned at 10 o'clock, 6inch dim

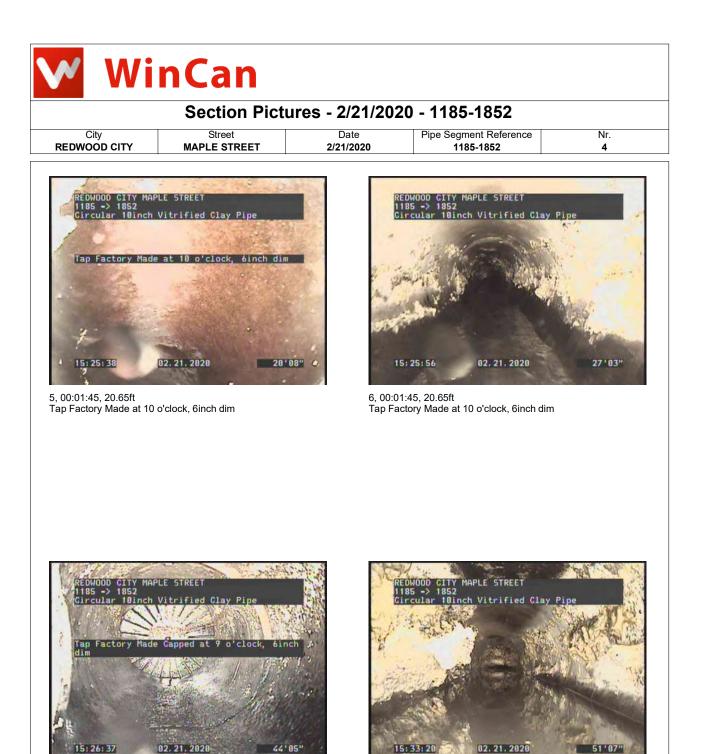
7, 00:02:40, 44.39ft Tap Factory Made Capped at 9 o'clock, 6inch dim

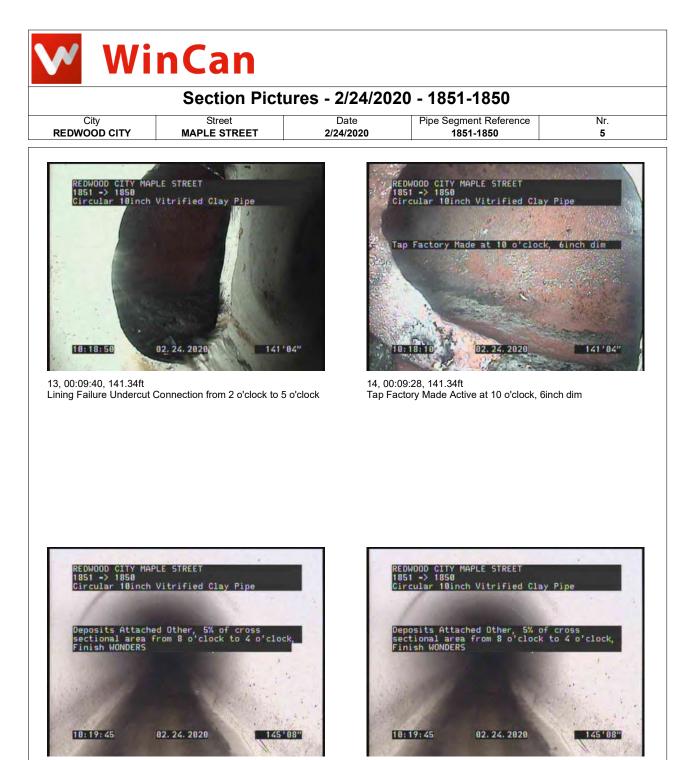
15, 00:10:41, 145.63ft Deposits Attached Other, 5% of cross sectional area from 8 o'clock to 4 o'clock, Finish / DEFECT WONDERS

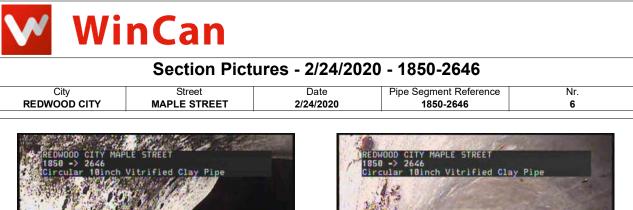
17, 00:14:59, 254.75ft Water Level, Sag in pipe, 35% of the vertical dimension, Finish

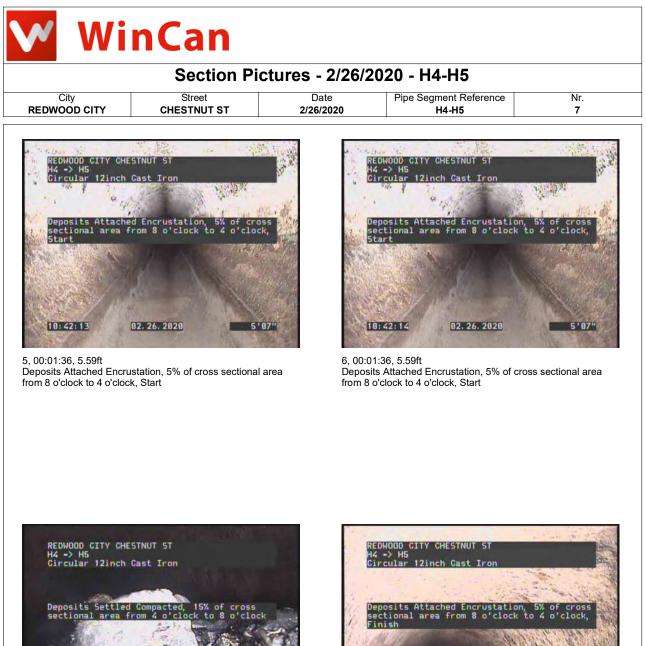
7, 00:02:45, 18.75ft Deposits Settled Compacted, 15% of cross sectional area from 4 o'clock to 8 o'clock

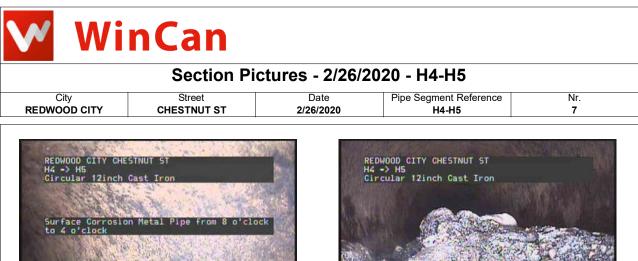
9, 00:03:14, 18.75ft Surface Corrosion Metal Pipe from 8 o'clock to 4 o'clock

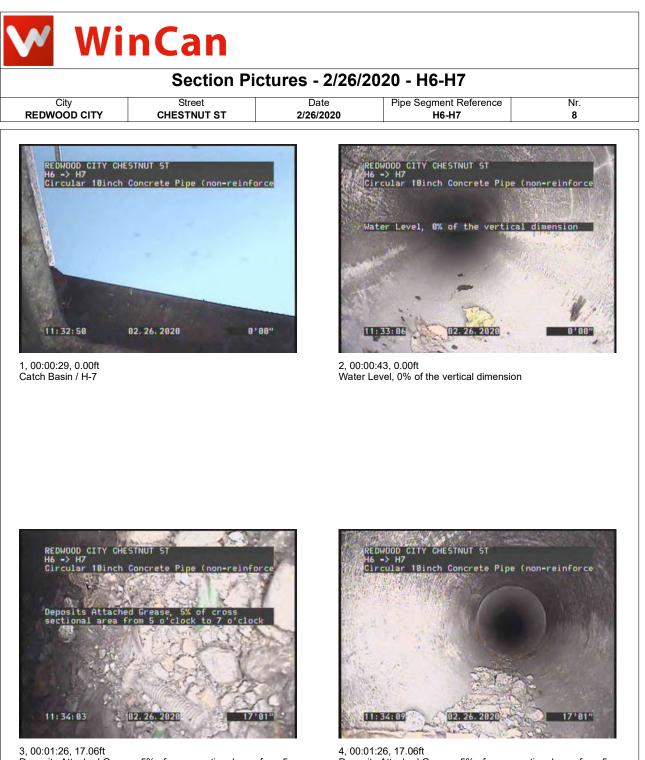
4, 00:01:26, 17.06ft Deposits Attached Grease, 5% of cross sectional area from 5 o'clock to 7 o'clock

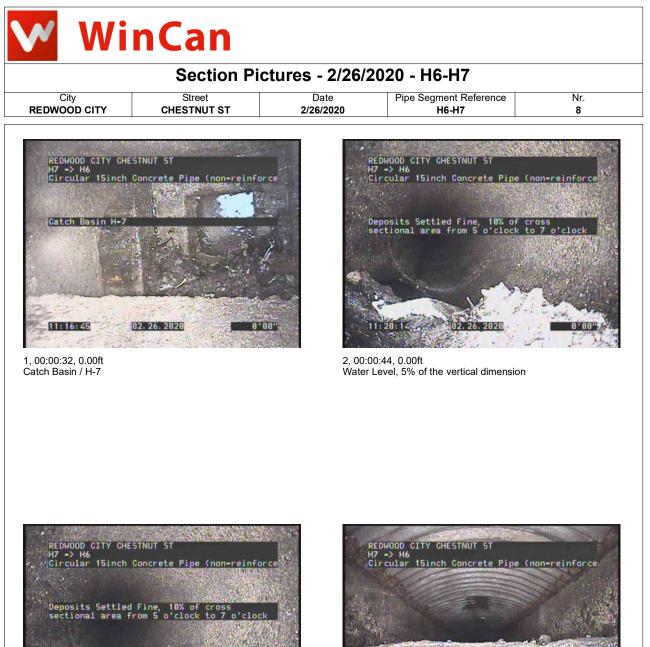
3, 00:00:49, 0.00ft Deposits Settled Fine, 10% of cross sectional area from 5 o'clock to 7 o'clock

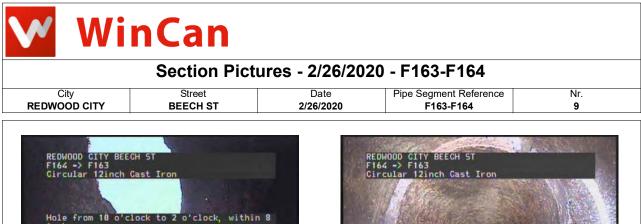
5, 00:02:10, 28.93ft Hole from 10 o'clock to 2 o'clock, within 8 inch

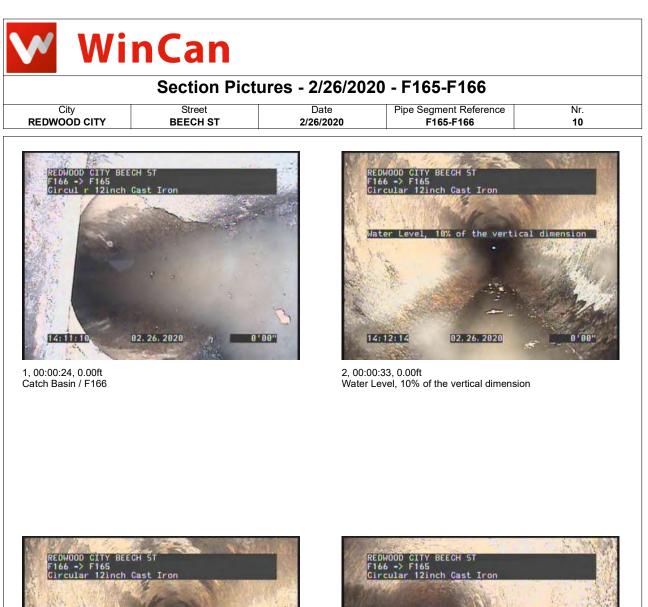
3, 00:00:37, 0.00ft Surface Corrosion Metal Pipe from 7 o'clock to 5 o'clock, Start
