May 25, 2017 SCST No. 170213N Report No. 1

Subject: GEOTECHNICAL UPDATE

9046 LA JOLLA SHORES LANE

LA JOLLA, CALIFORNIA

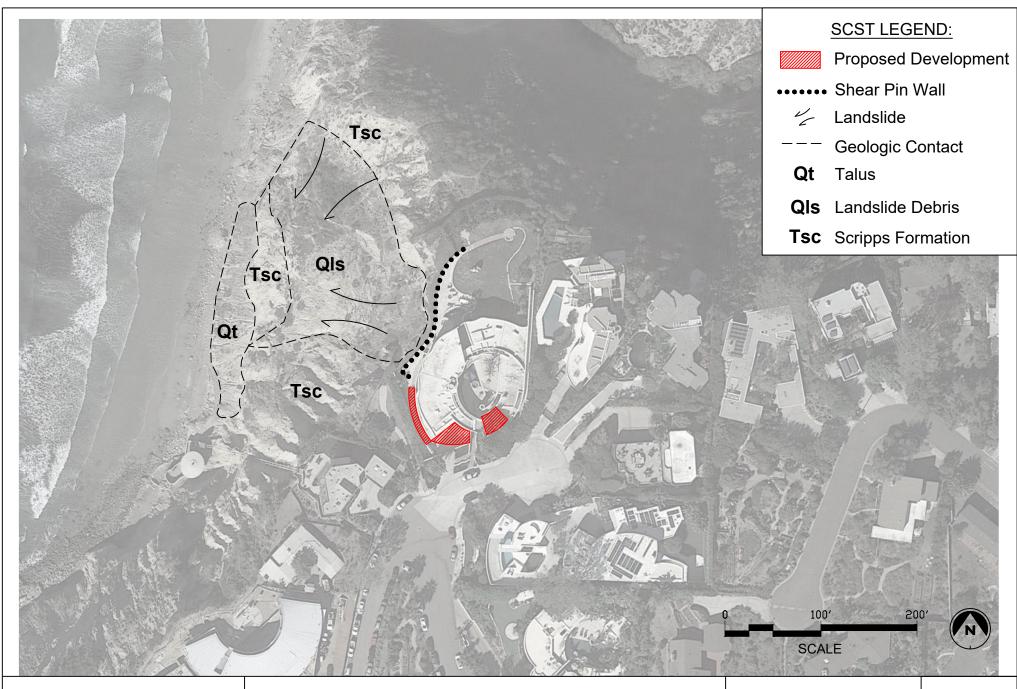
GEOTECHNICAL MAP 9046 La Jolla Shores Lane La Jolla, California

The site is located at 9046 La Jolla Village Lane in La Jolla, California (Figure 1). The site is bound to the north by open space, to the east by a single-family residence, to the south by La Jolla Village Lane and to the west by a single-family residence and a roughly 270-foot high coastal bluff. The southern portion of the property is occupied by a two-story steel and wood-framed single family residence (Figure 2). The residence is supported by deep foundations bearing in Scripps Formation.

A site reconnaissance was performed on April 18, 2017. There are no major cracks in the stucco exterior of the house or in the concrete patio. Measurements of the current edge of bluff to the building columns on the west side of the house range from 17 feet to 35 feet. We could not find an accurate map showing the 1999, post repair bluff top so the measurements may be considered a

baseline for future measurements. The nearest bluff-edge-to-shear wall measurement was about 3 feet. Using Google Earth images, it appears there may have been a few feet of bluff top retreat due to scarp erosion. There is no evidence of extension or vertical offsets to suggest impending slope failure or creep.
