## Preliminary Arborist Report

### **Mountain View Transit Center Grade Separation & Access Project Mountain View, CA**

**October 16, 2019**

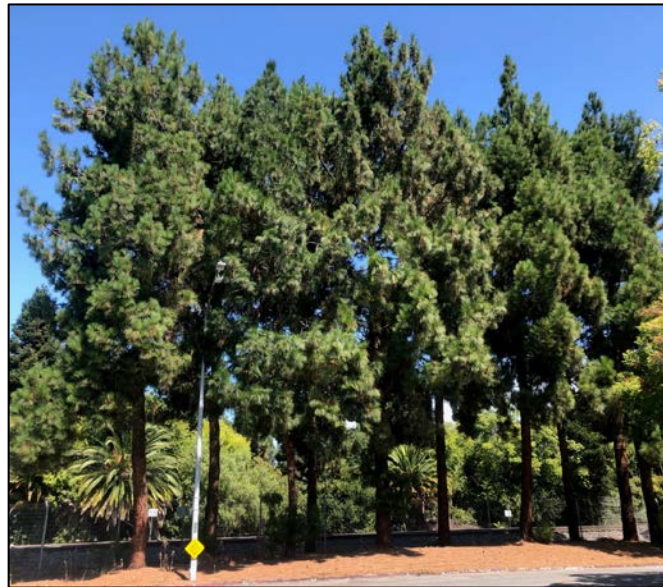
Canary Island pine was the most frequently occurring species, with 53 trees. Pines were semi-mature to mature, with trunk diameters from 12 to 36 inches. Trees were concentrated in the center medians on Central Expressway. A group of 10 pines was located at the Franklin St. and Evelyn Ave. intersection. Most of the trees were in good and excellent condition (85%) with good structure and dense crowns (Photo 1). Only 8 trees were rated in fair condition with slightly thin crowns, codominant trunks, or asymmetrical form.

**Photo 1** (right): Canary Island pines #36-45 located at the end of Franklin at Evelyn were in good condition.

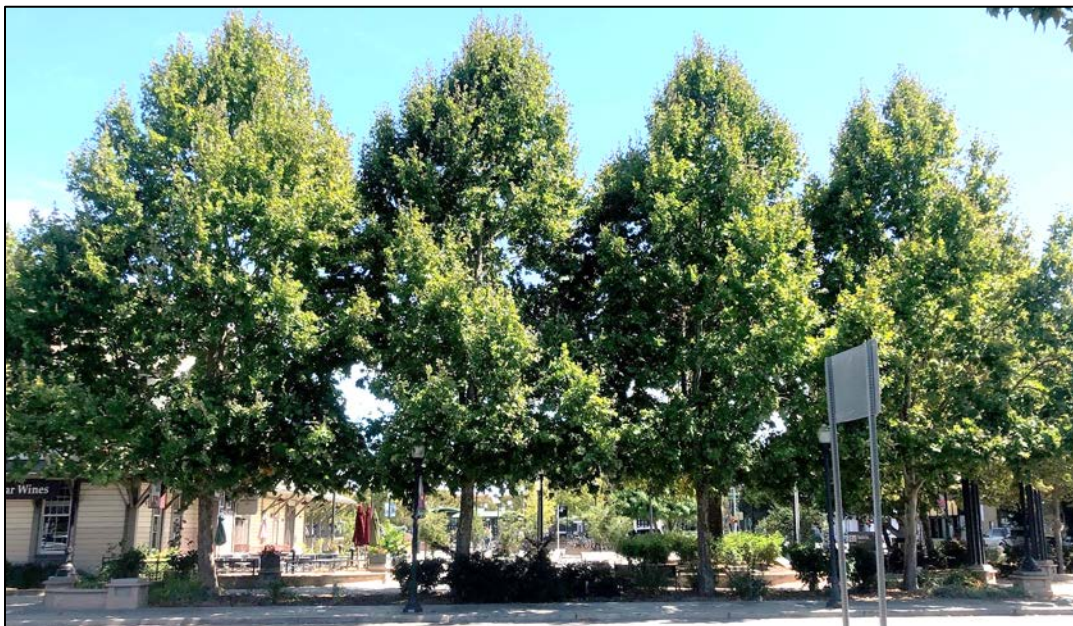
**Photo 2** (bottom): London planes #302-305 were in excellent condition.

All 47 London planes evaluated were in good and excellent condition (Photo 2). All but three trees were semi-mature to mature with trunk diameters from 8 to 21 inches. All trees had good structure and dense crowns. Several trees were growing close to one another resulting in crowded or asymmetrical form. Trees were located along the north side of Evelyn Ave. and in the northwest corner of the transit center site. Three newly planted trees were located at Stierlin Rd.

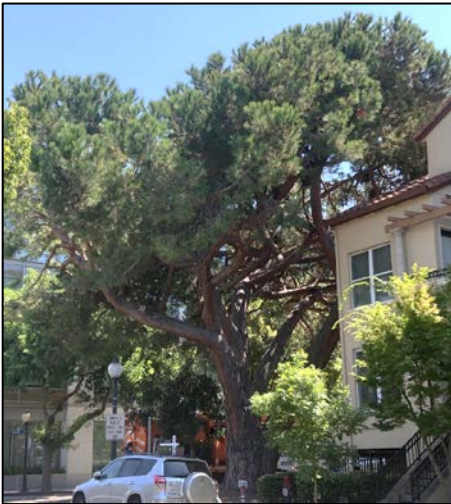
- Italian stone pine (64" DBH) in good condition, at the corner of Evelyn Ave. and Bryant St. identified for preservation (Photo 3)
- Canary Island pines #155 (36") and #214 (33") in good condition, in the Central Expy. median. Tree #214 is identified for removal.
- Coast live oak #446 (33") in good condition, located in the CalTrain ROW and identified for removal (Photo 4)

**Photo 3** (top left): Italian stone pine #79, located at the corner of Evelyn and Bryant, was the largest tree evaluated.

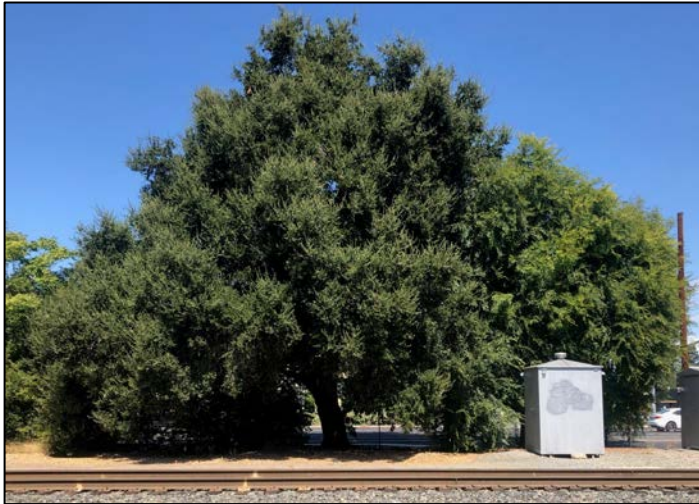
**Photo 4** (top right): Coast live oak #446, located in the CalTrain ROW was in good condition.
