Tree Inventory Report

**1095 Rollins Road
Burlingame, CA**

November 21, 2018

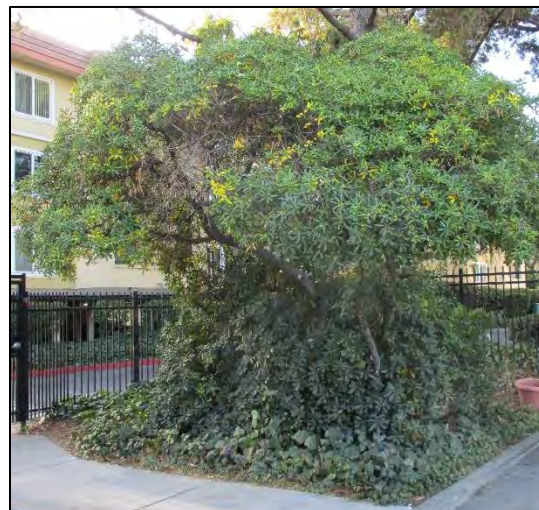
- A small Pittosporum shrub/tree (#137) was in fair condition growing in the south eastern corner of the property (Photo 1).
- A small olive (#143) in fair condition was covered in ivy along Rollings Road.

Photo 1 – Tobira #137 was a short shrub-like tree.

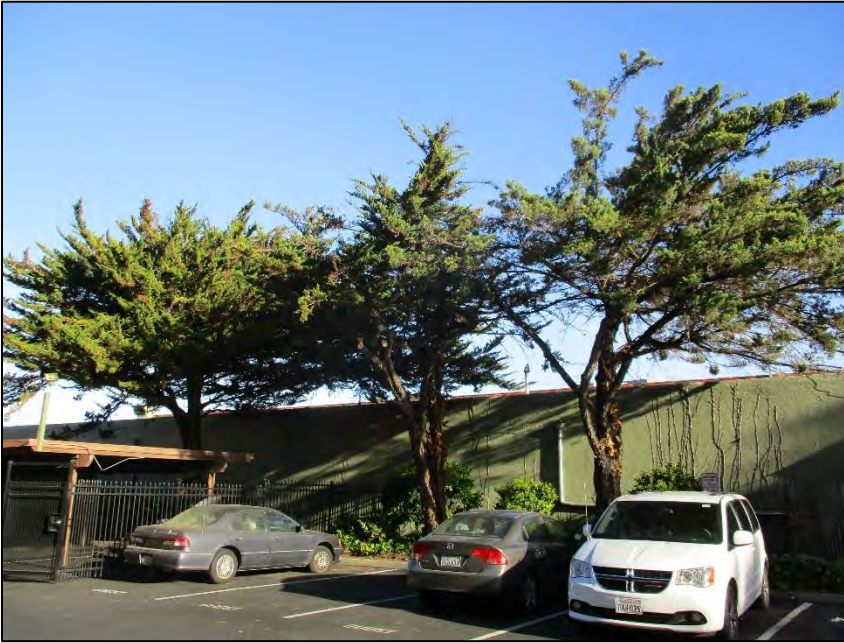
- Three Monterey pines (#135, 136 and 138) were growing in the southwestern corner of the property. They had trunk diameters of 22, 22 and 26” respectively and were in fair condition.
- Four Monterey cypresses (#139-142) were growing along the southern boundary. They were mature in development with at least one trunk 18” or greater in diameter. They were in fair condition except for #140 which had a thinner crown than the others (Photo 2).
- Chinese elm #144 was semi-mature and growing near the eastern property boundary.

Photo 2 – Monterey cypresses #142-140 (left to right) were growing along the southern property boundary.
