Appendix F

TREE REPORT PER THE GENERAL MSHCP HABITAT ASSESSMENT/CONSTRAINTS ANALYSIS FOR THE 15.78-ACRE MURRIETA PROJECT SITE

WESTERN RIVERSIDE COUNTY, CALIFORNIA

July 1, 2019

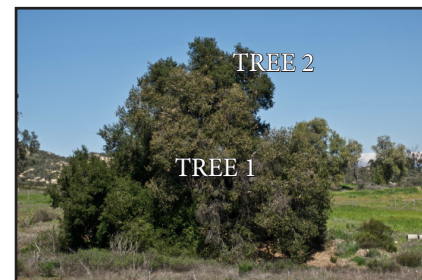
Figure 4. Coast Live Oaks trees #1&#2

Both trees were surrounded by a chain link fence, making the access to measure the trunks impossible, except for Tree #2, Trunk B2. Trunk 2B was able to be measured with a diameter tape, and showed a DBH of 24.5 inches. The other DBH measurements were estimated. Tree #2's Trunk B1 is estimated at 30 inches. Tree #2's DBH totals 54.5 inches. Tree #1's DBH is estimated at 26 inches. The combined canopy spread of the trees is 75-80 feet along the North-South axis, and 55-60 feet along the East-West axis. The combined tree height is approximately 40-45 feet. The trees are growing too close to each other to have distinctly separate canopies. Both trees are in a relatively healthy, natural condition, unpruned, with no apparent mechanical or biological damage visible. See Attachment A.

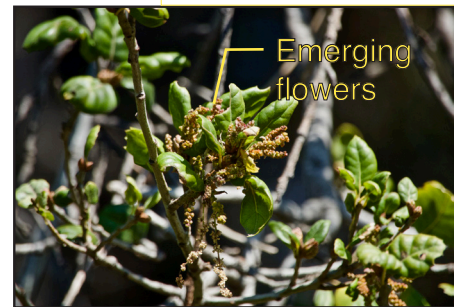
Tree #1 appears to have been under considerable drought related stress in the past. The trees' color, typical of the species, is "off", as can also be clearly seen in photographs of the tree. Tip dieback in the canopy is evident, and a "thinning" in the overall canopy leaf density was observed. It should be noted that the thinning of the canopy is not a negative health issue at this point, but may have been related to the current drought. Currently, the tree is already flowering, see Figure 6, which is a good sign. Recent rain events will also help the tree to regain its vigor. The tree is rated a "B" in health and a "B" in aesthetics, for an overall rating of "B".

Figure 6. Tree #1 is flowering, a sign of improving good health.

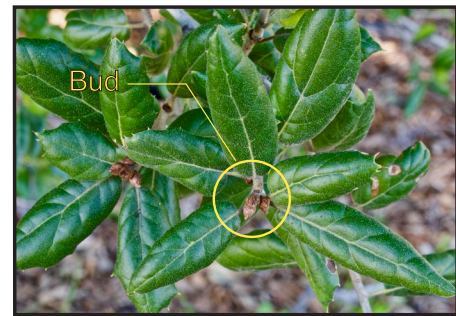
Tree #2 shows good color, typical to the species, and new shoot elongation indicates that the tree is healthy and growing. Bud formation, size and color of the buds and leaves is indicative of excellent growth and health as well, see Figure 7. New growth is present at the tips of the branches. Older leaves, closer to the center of the tree have been shed. Unlike Tree #1, there did not appear to be any lingering drought stress. The tree is rated an "A" in health and an "A" in aesthetics, for an overall rating of "A". See Attachment B for a tree rating explanation.

Figure 7. Excellent bud formation, color and shoot elongation on Tree #2.

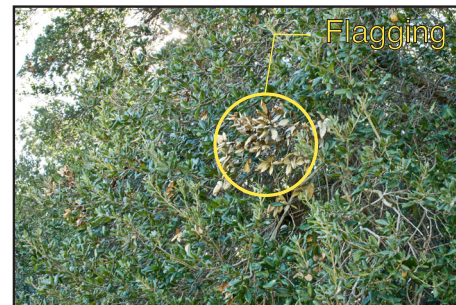
There are no notable mechanical or biological injuries to the trunk or the scaffold branches of both trees. On the underside of the canopy there are many smaller branches that have died back due to shading from the outer canopy. This is typical of the species, and should be of no concern. Eventually these small branches will fall from the tree by themselves.

Figure 8. Minor "flagging" present on both oak trees.

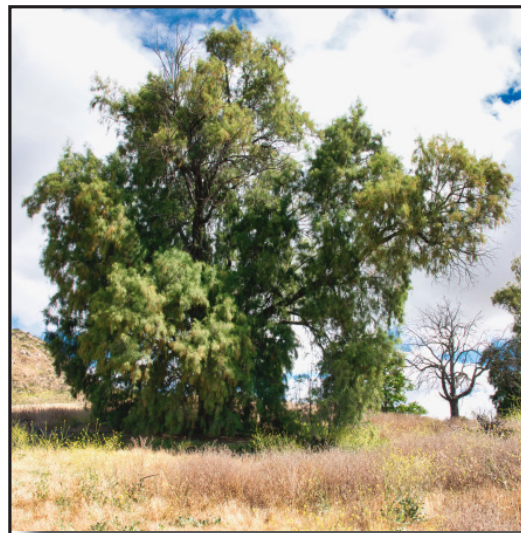
Figure 9. The larger Athel tree, #6.

There are two Athel trees on the property. The largest of the two Athel trees on the site, is designated as tree #6, see Figure 9. Athel tree #6 has two trunks, with a DBH of 18” and 38”, for a total DBH of 56”. Tree height is approximately 60’ with an average spread of 40’. One of the main scaffold branches is at a precipitous lean of about 45 degrees. Broken branches and branch dieback are clearly visible, although the tree, overall, appears to be in fair health. Good new growth, the lighter green foliage, is conspicuous as can be seen in Figure 10. Insects and diseases were not observed. In terms of health and aesthetics, tree #6 is rated a ‘D’ in aesthetics and a ‘C’ in health, for an overall grade of ‘C’.

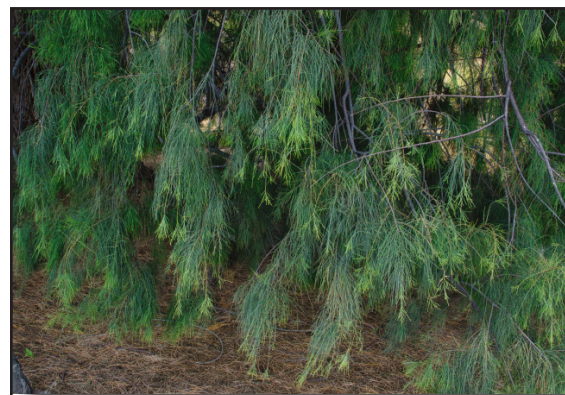
Figure 10. Good new growth, the light green foliage seen here, is evident on both ‘A’ and ‘B’ Athel trees.

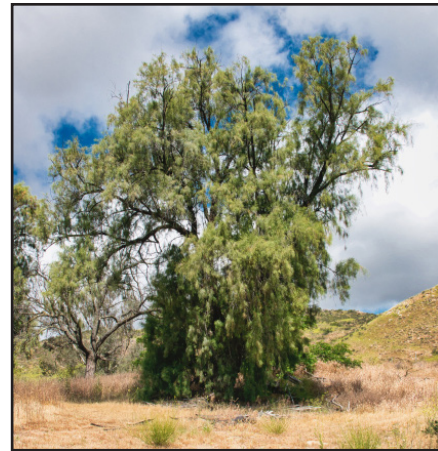
Figure 11. The smaller Athel tree, #5

The smaller of the Athel trees, tree #5, is shown in Figure 11. This tree has one trunk, with a DBH of 24”, a height of approximately 35’ and an average spread of 25’. The tree is judged to be in fair condition, with many broken branches, dieback of smaller branches and lots of resultant epicormic

shoots, resulting in a dense regrowth in that area of the canopy where the branches had been broken off. The canopy appeared to be very thin, with branch dieback evident. Even though branch dieback was observed, this tree is in fair health, with good new growth evident throughout, as seen in Figure 11. Some browning of foliage was visible, but not due to disease or insects, as the foliage is being shed by the tree, to be replaced by the new foliage.

In terms of health and aesthetics, tree #5 is rated a 'D' in aesthetics and a 'C' in health, for an overall grade of 'C'. A good pruning would help improve the aesthetics, and thereby the health, of these trees.

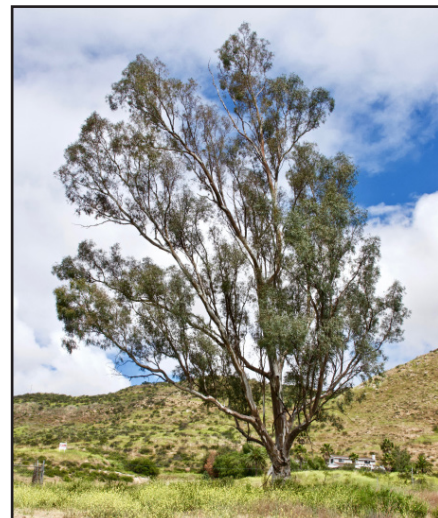
Figure 12. Red Gum, (*Eucalyptus camaldulensis*). Tree #3.

This eucalyptus has one trunk with a DBH of 33.5", a height of approximately 60' and an average spread of 45'. The canopy looks thin and some branch dieback is evident, which may be related to past drought stress. Good new growth is noticeable, however. The tree is infested with Tortoise Beetles, (*Trachymela sloanei*) and/or (*Chrysophtharta m-fuscum*) which were introduced into California in the 1990's. Notched leaves, or semicircular holes in the leaves, are the obvious indication of the beetles presence, see Figure 13. When not feeding on the leaves they hide under the loose bark of the tree. Established and well maintained trees can tolerate the beetle, and beetle control is usually not necessary, unless the tattered leaves present a serious aesthetic problem in a high profile location. Beetle control is also difficult because they do hide under the bark.

In terms of health and aesthetics, this tree is rated a 'C' in health, and a 'D' in aesthetics, (due to the beetle damage), for an overall grade of 'C'.

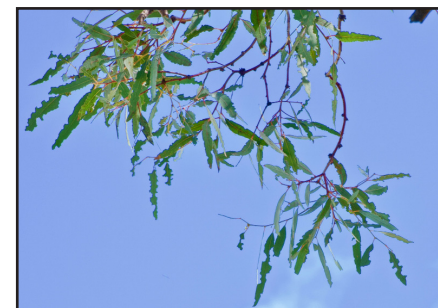
Figure 13. Tattered leaves resulting from tortoise beetle feeding.

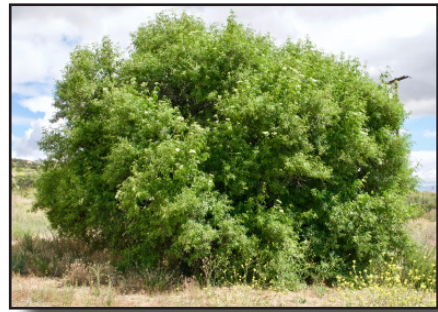
This Elderberry, Figure 14, and tree #4, is a very nice specimen. It has a single trunk at ground level, which then splits at 18" above grade into seven major trunks, at 3 to 4 inches each, for a total DBH of approximately 21". It is about 12 feet in height, with an average spread of 28 feet. It could, over time, be pruned/trained to grow into a proper tree. The interior of the tree contained many dead branches, which have died off due to a lack of light penetrating through the dense canopy. Tip dieback of the branches was not observed. There were no insects or diseases noted.

Figure 14. Elderberry. A large shrub at this point, which could grow to become a tree.

In both health and aesthetics, tree #4 is rated an 'A' in health, and an 'A' in aesthetics, for an overall grade of 'A'.

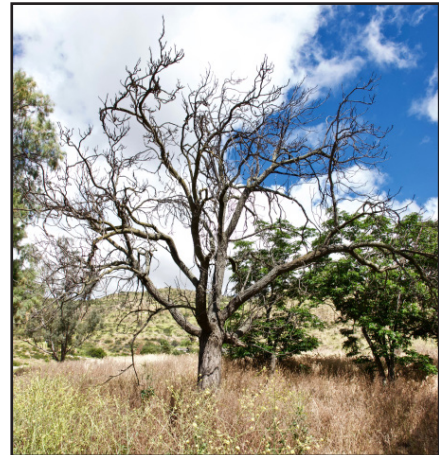
These trees, Figure 15, 16 and 17, do not meet the requirements of the Municipal Code 16.42, because of their small trunk size, or because they are dead.

Figure 15. An unknown, dead, tree.
