APPENDIX B
ARBORIST REPORT

Tree Report
Jefferson Union High School

July 10, 2019

Tree Report
Jefferson Union High School
Daly City CA

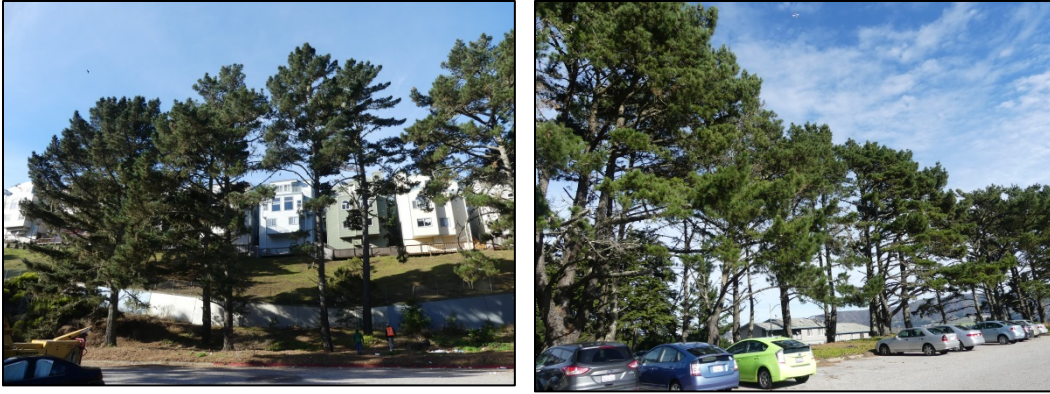
Monterey pine was the most frequently occurring species with 82 trees (57% of the total). Pines formed a buffer planting between Serramonte Blvd. and the campus (Photo 1). This planting included steep slopes. Pines were also present along the west side of the site. Trees ranged from young to mature in development. Trunk diameters varied from four- to 51-inches. Thirteen of 82 trees had more than one stem that arose close to ground level. Approximately 50% of trees were 25-inches or smaller.

Tree condition was variable. Monterey pines #22 and 70 were dead. Thirty-two trees were in poor condition while 24 were fair. Sixteen pines were in good condition while trees #21, 36, 69, 71, 73, 79, and 82 were excellent. As a general observation, tree condition was related to trunk diameter: smaller trees were in better condition than larger. This is not surprising given the intense disease and insect pressure faced by this species. Factors important in determining tree condition included trunk orientation (lean, bow, sweep), the presence of two more stems, asymmetric or suppressed form, presence of pine pitch canker (*Fusarium circinatum*) and red turpentine beetle (*Dendroctonus valens*), and overall tree vigor.

Photo 1. Monterey pine was the most frequently occurring species at the site. **Left:** Trees #39 – 43 were located along the west side of the site. **Right:** Trees #128 to 139 formed a buffer between Serramonte Blvd. and the east parking area.

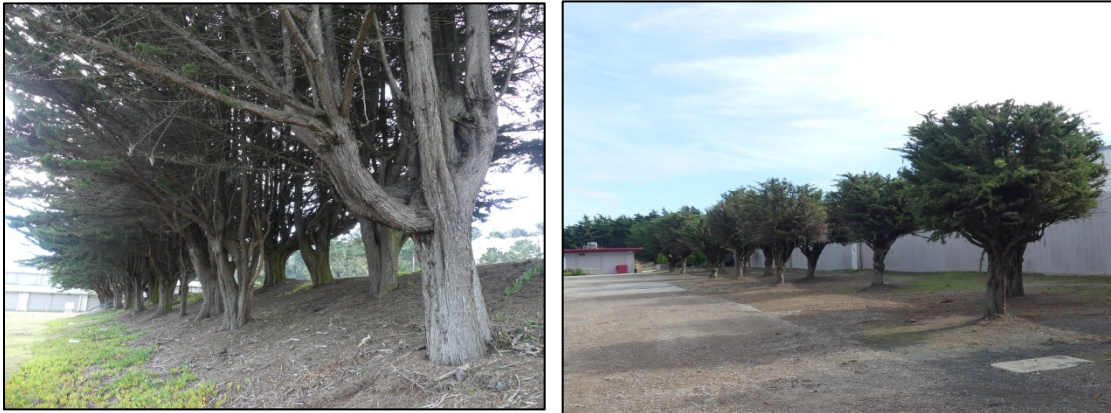
Thirty-eight (38) Monterey cypresses were present (Photo 2). Cypresses were present in two locations: 1) a long double row between the two entrances and 2) a double row in front of one of the buildings.

- The first row (trees #83 – 105) had a north-south orientation. Trees had been topped below 10-feet and allowed to resprout. Most trees had multiple stems that arose close to the ground. Condition was either poor or fair. Trunk diameters ranged from 12- to 35-inches.
- The second row (#106 to 120) was oriented to the east and west. Trees had been topped, allowed to resprout, then crown reduced. Tree condition was poor. Trunk diameters ranged from 16- to 28-inches.

Photo 2. Monterey cypress trees were located in two areas. **Left:** The north-south oriented row in the center of the site. **Right:** The east-west oriented row north of one of the existing buildings.
