Nike Site Demolition Project

Alameda County, Annual

Project Information		Date:	07/23/2019 Tuesday	Project Number:	2062-163.00
Project Name:	Alameda County General Services Agency Nike Site Hazardous Materials Abatement and Demolition.				
Project Address:	2892 Fairmont Drive, San Leandro, Ca, Building B, Building C, Building D & the guard shed structure by the gate.				
Project Technician:	M.Massoud Navvab CAC # 98-2531 Lead # 8555	Project Manager:	Stephen Jackson (OAK)

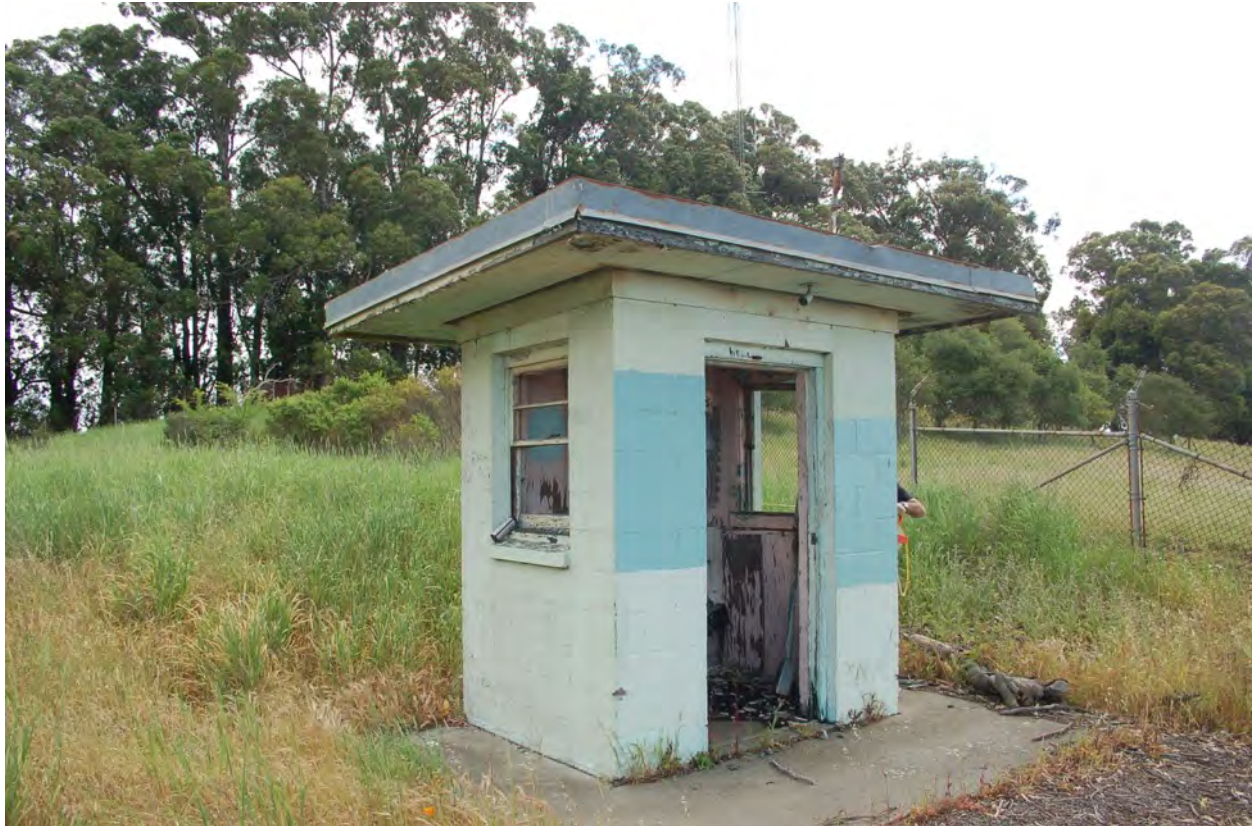
Figure 5: Guard station, looking east.

- The Guard Station is somewhat deteriorated but retains its structural integrity and clearly evokes the experience of entering the base during its period of significance.
- The Generator Building, Corridor Building, and HIPAR Building retain their integrity of location, design, setting, materials, feeling, and association and are typical examples of this now-rare type of Nike facility. Together, the three buildings represent the main functions of a Nike Control area (electrical power, target acquisition, signal processing, and targeting).

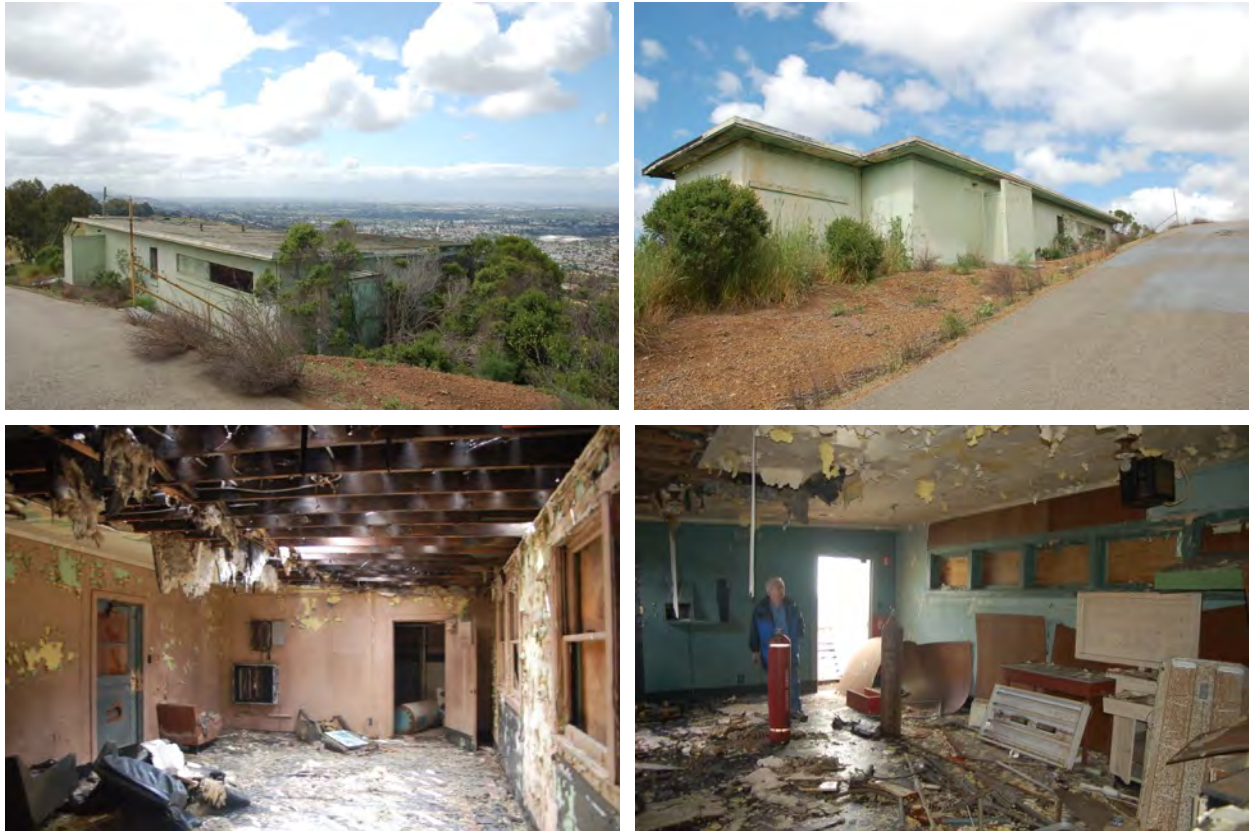
Inside, the Quarters Building is divided into two major spaces arranged on a north/south axis. In the main space on the south, the roof has collapsed resulting in extensive water damage, mold and dry rot deterioration to the interior. The interior originally included a kitchen, a living area and a sleeping area for the approximately 10 military personnel posted to area SF-31C.

Figure 6: Quarters Building. Upper left: north and east façades, looking south. Upper right: south and east façades, looking north. Lower left: Interior of southern room. Lower right: interior of northern room..

By contrast, the Quarters Building and the Radar Storage Shed do not appear to be eligible. The Quarters Building is dilapidated and has major structural defects, so that it lacks integrity of materials. Compared to the two surviving barracks buildings at SF31-A, the Quarters Building is small and a minor example of a residential structure on the Nike Base. The Radar Storage Shed, which is attached to the Corridor Building, is a corrugated metal building built as a later addition. The design of this later addition is not compatible with the other Nike Base buildings and apparently its function is not related to the IFC's function during its period of significance. For that reason, the Radar Storage Shed does not appear to be a contributing resource to the potential California Register historic district.

Alameda County proposes to demolish the Radar Storage Shed and the Quarters Building at SF-31C. As noted above, the Radar Storage Shed is a later addition to the Corridor Building, is architecturally unrelated to the other buildings on the base, and has no relationship to the function of the Control area. The Quarters Building is badly dilapidated and lacks integrity of design and materials, since much of the interior has been destroyed. It is also the least significant of several barracks buildings that remain on the base. Given this, neither of these buildings appear to be eligible to the California Register as contributing elements of the potential Nike SF-31 historic district.

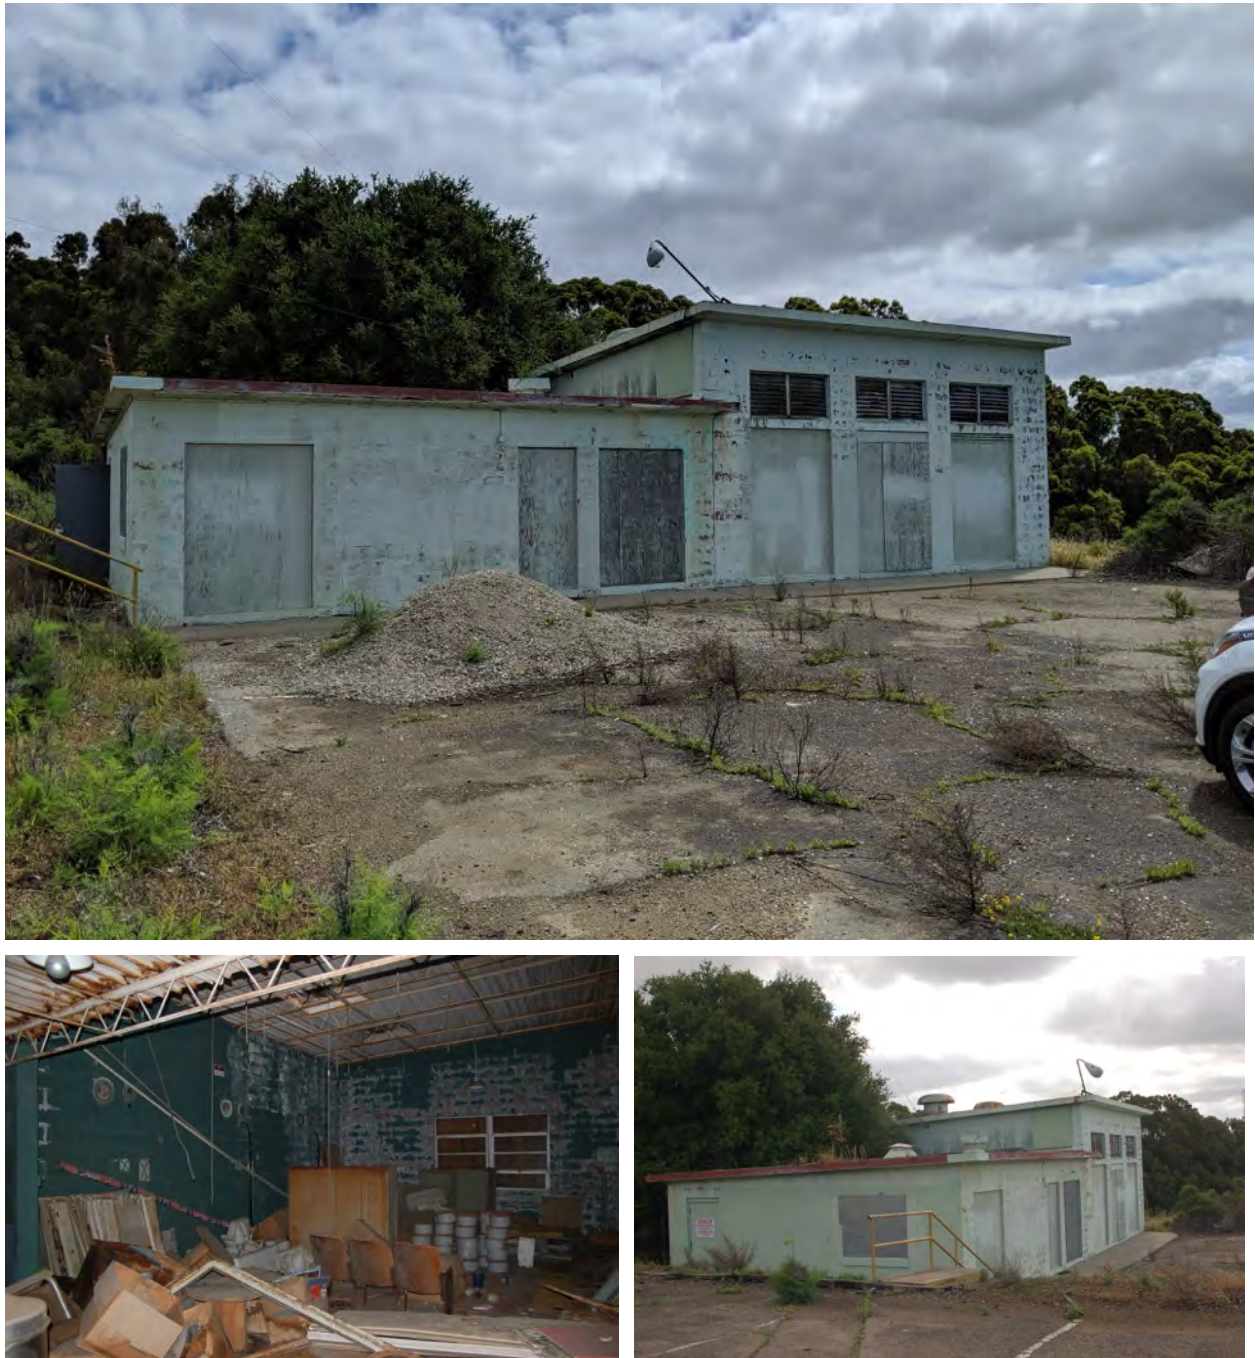
area and for storing parts. No generator equipment remains inside the building, which has extensive mold damage and is used to store miscellaneous items.

Figure 7: Generator Building. Upper: west façade. Lower left: interior of generator room on south side of building. Lower right: north and east façade.

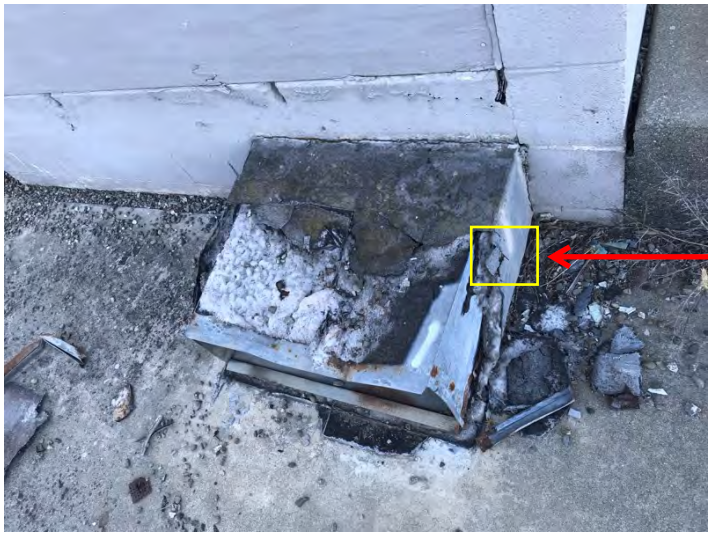
Remaining ACM Patching Compound on the Metal Duct & Concrete Flooring around the Bldg B Exterior.

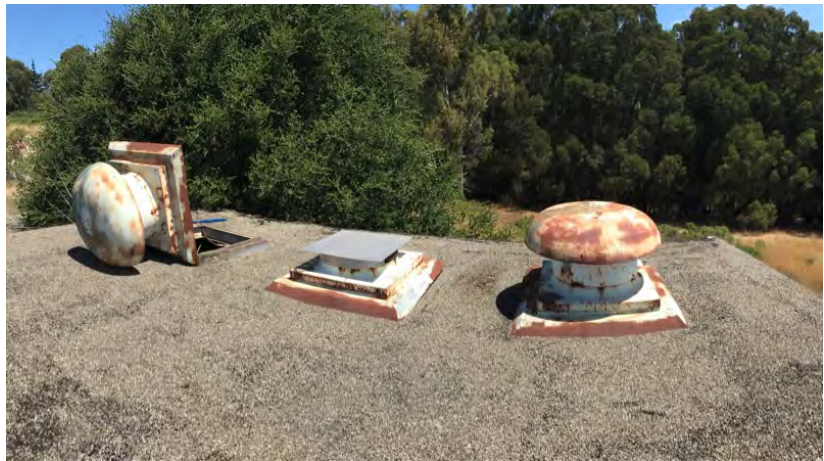
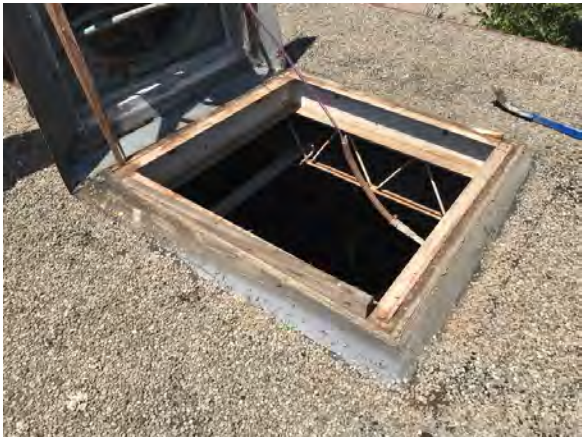
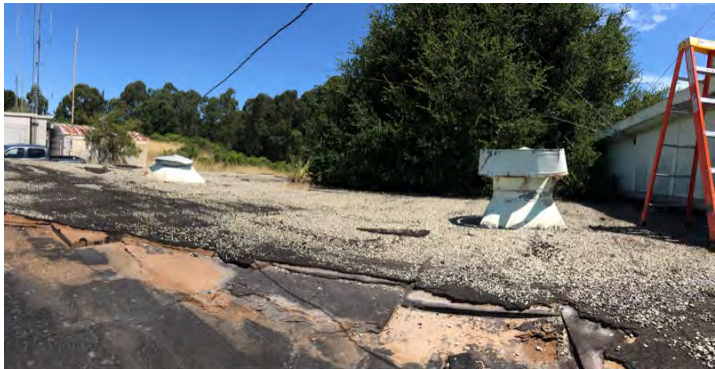
Building C Roof area with ACM Roof Patching Compound & ACM Transit Panels
