Appendix G: **Hydrology and Water Quality Supporting Information**

**SUBJECT: DESCRIPTION OF STORMWATER CONVEYANCE STUDY
SANDHOLM LN. AND FOOTHILL BLVD., CLOVERDALE CA**

STORMWATER CONVEYANCE EXHIBIT

PREPARED BY: WALSH ENGINEERING
DATE PREPARED: 3/20/2018
DATE OF SITE INVESTIGATION: 3/19/2018

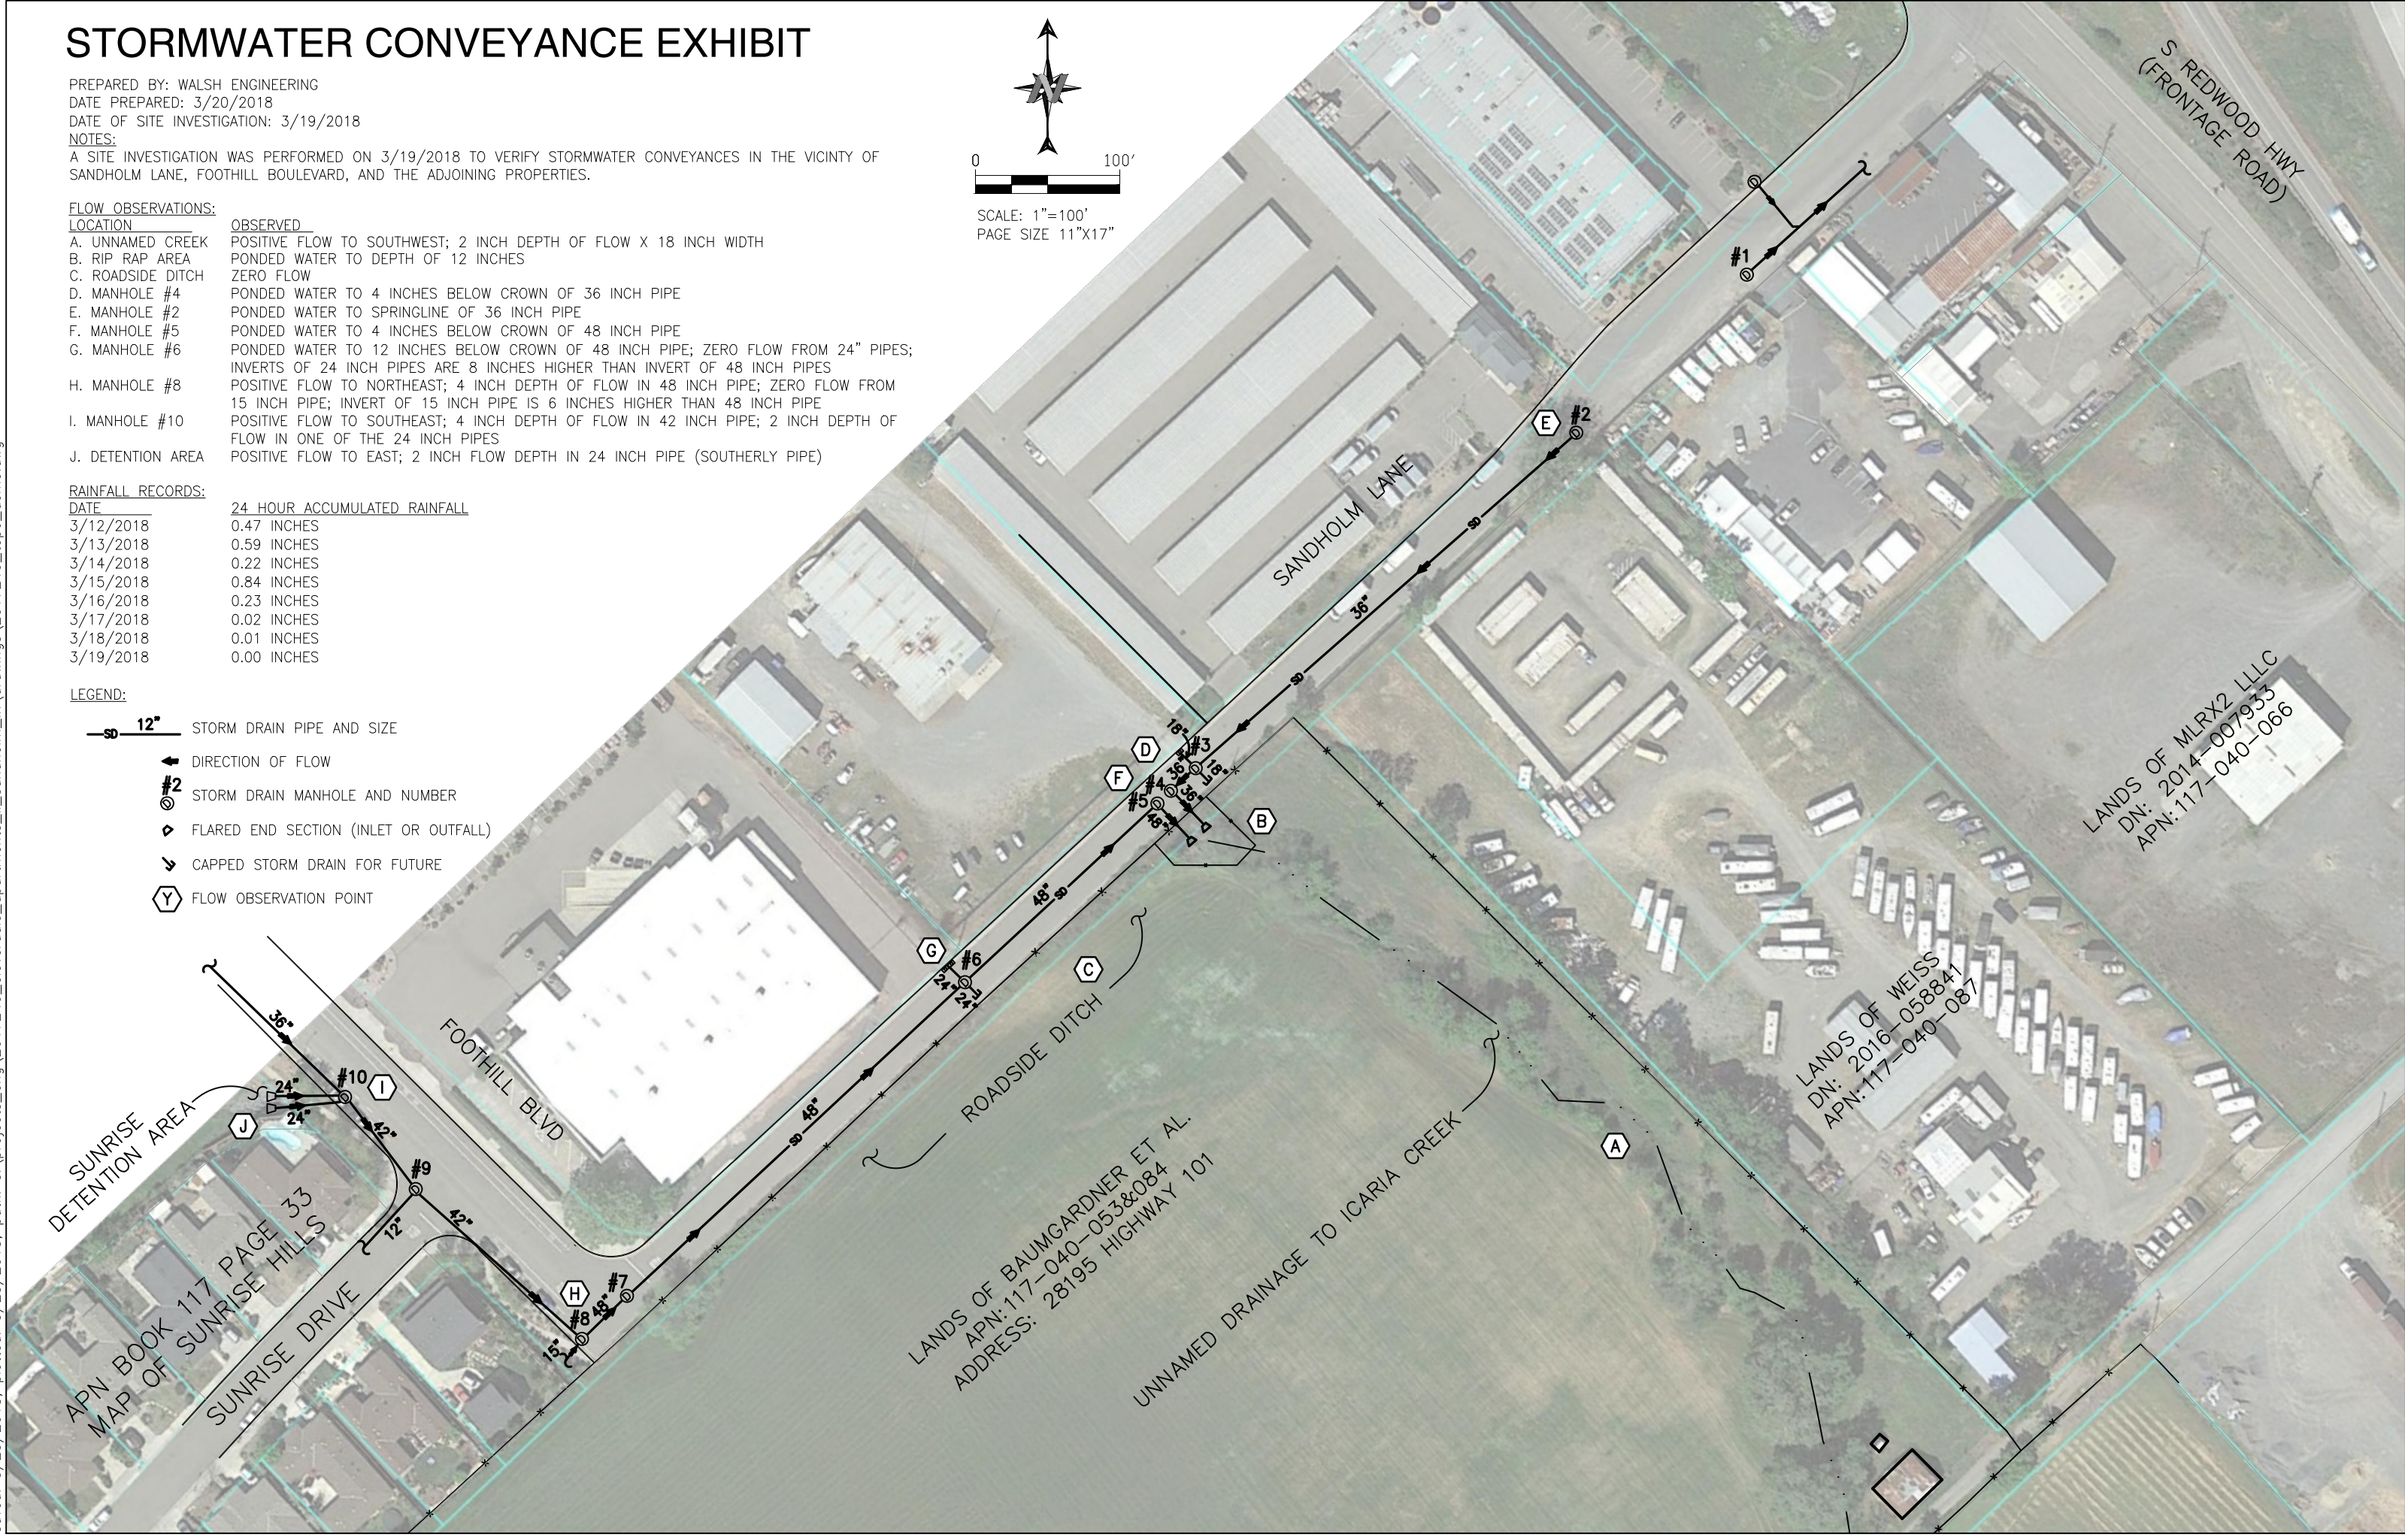
LOCATION	OBSERVED
A. UNNAMED CREEK	POSITIVE FLOW TO SOUTHWEST; 2 INCH DEPTH OF FLOW X 18 INCH WIDTH
B. RIP RAP AREA	PONDED WATER TO DEPTH OF 12 INCHES
C. ROADSIDE DITCH	ZERO FLOW

D. MANHOLE #4	PONDED WATER TO 4 INCHES BELOW CROWN OF 36 INCH PIPE
E. MANHOLE #2	PONDED WATER TO SPRINGLINE OF 36 INCH PIPE
F. MANHOLE #5	PONDED WATER TO 4 INCHES BELOW CROWN OF 48 INCH PIPE

G. MANHOLE #6	PONDED WATER TO 12 INCHES BELOW CROWN OF 48 INCH PIPE; ZERO FLOW FROM 24" PIPES; INVERTS OF 24 INCH PIPES ARE 8 INCHES HIGHER THAN INVERT OF 48 INCH PIPES

H. MANHOLE #8	POSITIVE FLOW TO NORTHEAST; 4 INCH DEPTH OF FLOW IN 48 INCH PIPE; ZERO FLOW FROM 15 INCH PIPE; INVERT OF 15 INCH PIPE IS 6 INCHES HIGHER THAN 48 INCH PIPE

I. MANHOLE #10	POSITIVE FLOW TO SOUTHEAST; 4 INCH DEPTH OF FLOW IN 42 INCH PIPE; 2 INCH DEPTH OF FLOW IN ONE OF THE 24 INCH PIPES
J. DETENTION AREA	POSITIVE FLOW TO EAST; 2 INCH FLOW DEPTH IN 24 INCH PIPE (SOUTHERLY PIPE)
