May 23, 2018

Subject: Tree Evaluation Report for the 1330 West Pico Boulevard Project Site, City of Los Angeles, California

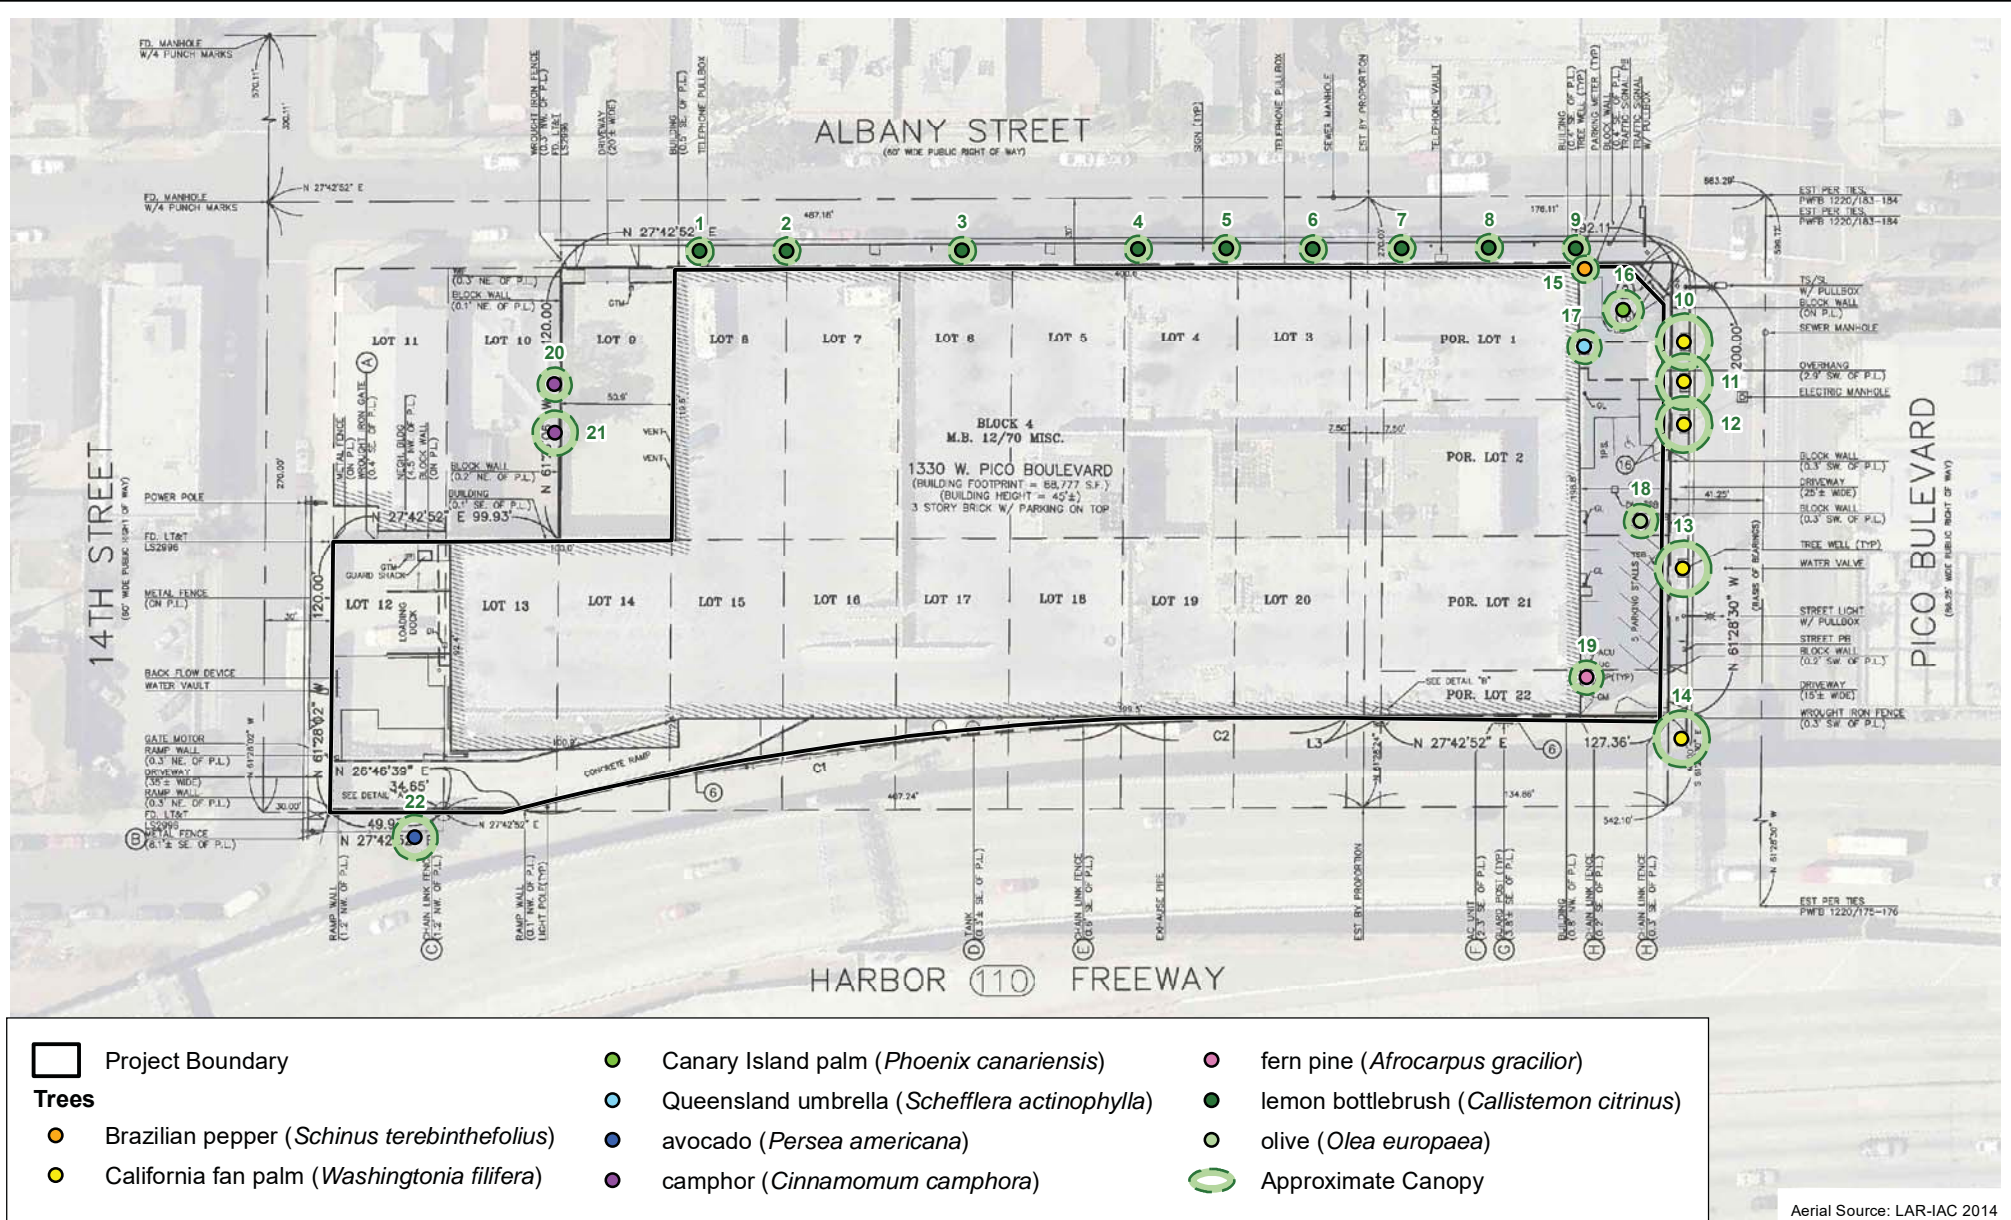
As mentioned above, the project site currently contains an unoccupied office/commercial building with two surface parking lots. A total of 22 trees were documented during the tree survey. These trees are shown in Exhibit 2 and summarized in Table 1. Five trees occur on the project site associated with the building entrance on the northern site boundary. These trees consist of one Brazilian pepper (*Schinus terebinthefolius*), one Canary Island palm (*Phoenix canariensis*), one Queensland umbrella tree (*Schefflera actinophylla*), one olive tree (*Olea europaea*), and one fern pine (*Afrocarpus gracilior*).

A total of 14 street trees were encountered during the survey. This includes nine lemon bottlebrush trees (*Callistemon citrinus*) that are growing in 4-foot by 4-foot sidewalk cutouts along Albany Street and five California fan palms (*Washingtonia filifera*) that are growing in 4-foot by 8-foot sidewalk cutouts along West Pico Boulevard.

Finally, there are three trees that are located immediately outside the project site boundaries but are included in this tree inventory report in case they are affected by project development. These off-site trees include two camphor trees (*Cinnamomum camphora*) and one avocado tree (*Persea americana*).

The trees that are on the project site are approximately 10-15 years old and in reasonably good health considering they have likely not been watered or otherwise maintained since the building was vacated. No significant health issues were observed such as decayed wood or thinning foliage.

The street trees are also in good condition. The lemon bottlebrush trees along Albany Street are in average health and of uniform size. The dbh of these trees range from 6.6 to 9.6 inches are all approximately 20 feet tall. Of these nine trees, seven are below the eight-inch threshold described above. While these trees are in average health with no major defects, they do not display any significant new growth. The roots of two trees (Trees 6 and 9) have caused minor uplift to the surrounding sidewalk. Two of the sidewalk cutouts on Albany Street are not occupied by a tree. The California fan palms that are growing along West Pico Boulevard appear vigorous and are not causing any damage to the surrounding curb and sidewalk.

Three off-site trees were observed during the tree survey. The two camphor trees (Trees 20 and 21) are located immediately southwest of the project site. The trunks of these trees are located off-site but their roots likely extend under the surface parking lot that is on the project site. The trunks of these trees are touching a block wall that separates the project site from the adjacent property and over time would likely cause damage to this wall. Ground disturbance in the vicinity of these trees that may occur as part of project development has the potential to impact their root zone. The avocado tree located near the southeast corner of the site is in reasonably good health and is likely able to withstand the stresses of project development, although some minimization measures may be needed (e.g., protective fencing, supplemental watering).
