Environmental Assessments and Solutions

May 25, 2017

Re: Soil Vapor Survey 1330 W. Pico Boulevard, Los Angeles Centec Project #0517030-A

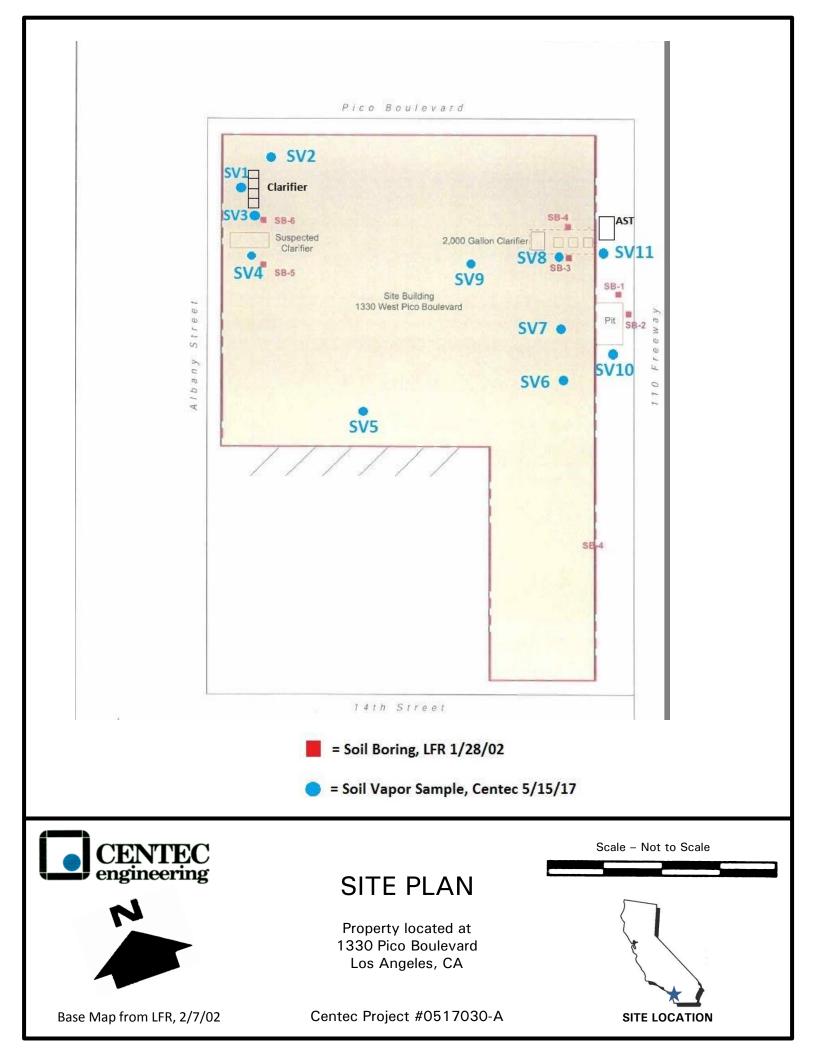
Based on the inspection, 11 locations were chosen to representatively investigate the site. All of the samples were collected at a depth of 5 feet bgs, Sample SV1 and SV2 were collected adjacent to and slightly northeast of the northwest clarifier. Sample SV3 was collected near the south end of the clarifier and near LFR's boring Sample SV4 was collected farther to the south near former SB6 for reference. boring SB5. Sample SV5 was collected in the south side of the main production area in an area that appeared to have been cut out or disturbed by the former use of the equipment. Samples SV6 and SV7 were collected among various floor drains and drain lines (or filled trenches) in the east side of the room. Sample SV8 was collected adjacent to the eastern clarifier, and Sample SV9 was collected to the southwest of the clarifier near a former possible sump. Finally, Samples SV10 and SV11 were collected outside adjacent to the ink collection sump and between the generator and AST. These locations have been added to a Site Plan previously prepared by LFR and included at the end of this report. All of the samples were collected at representative depths of 5 feet below ground surface within dry silty sand soils.
