Tree Report

May 23, 2018

Subject: Tree Evaluation Report for the 1330 West Pico Boulevard Project Site, City of Los Angeles, California

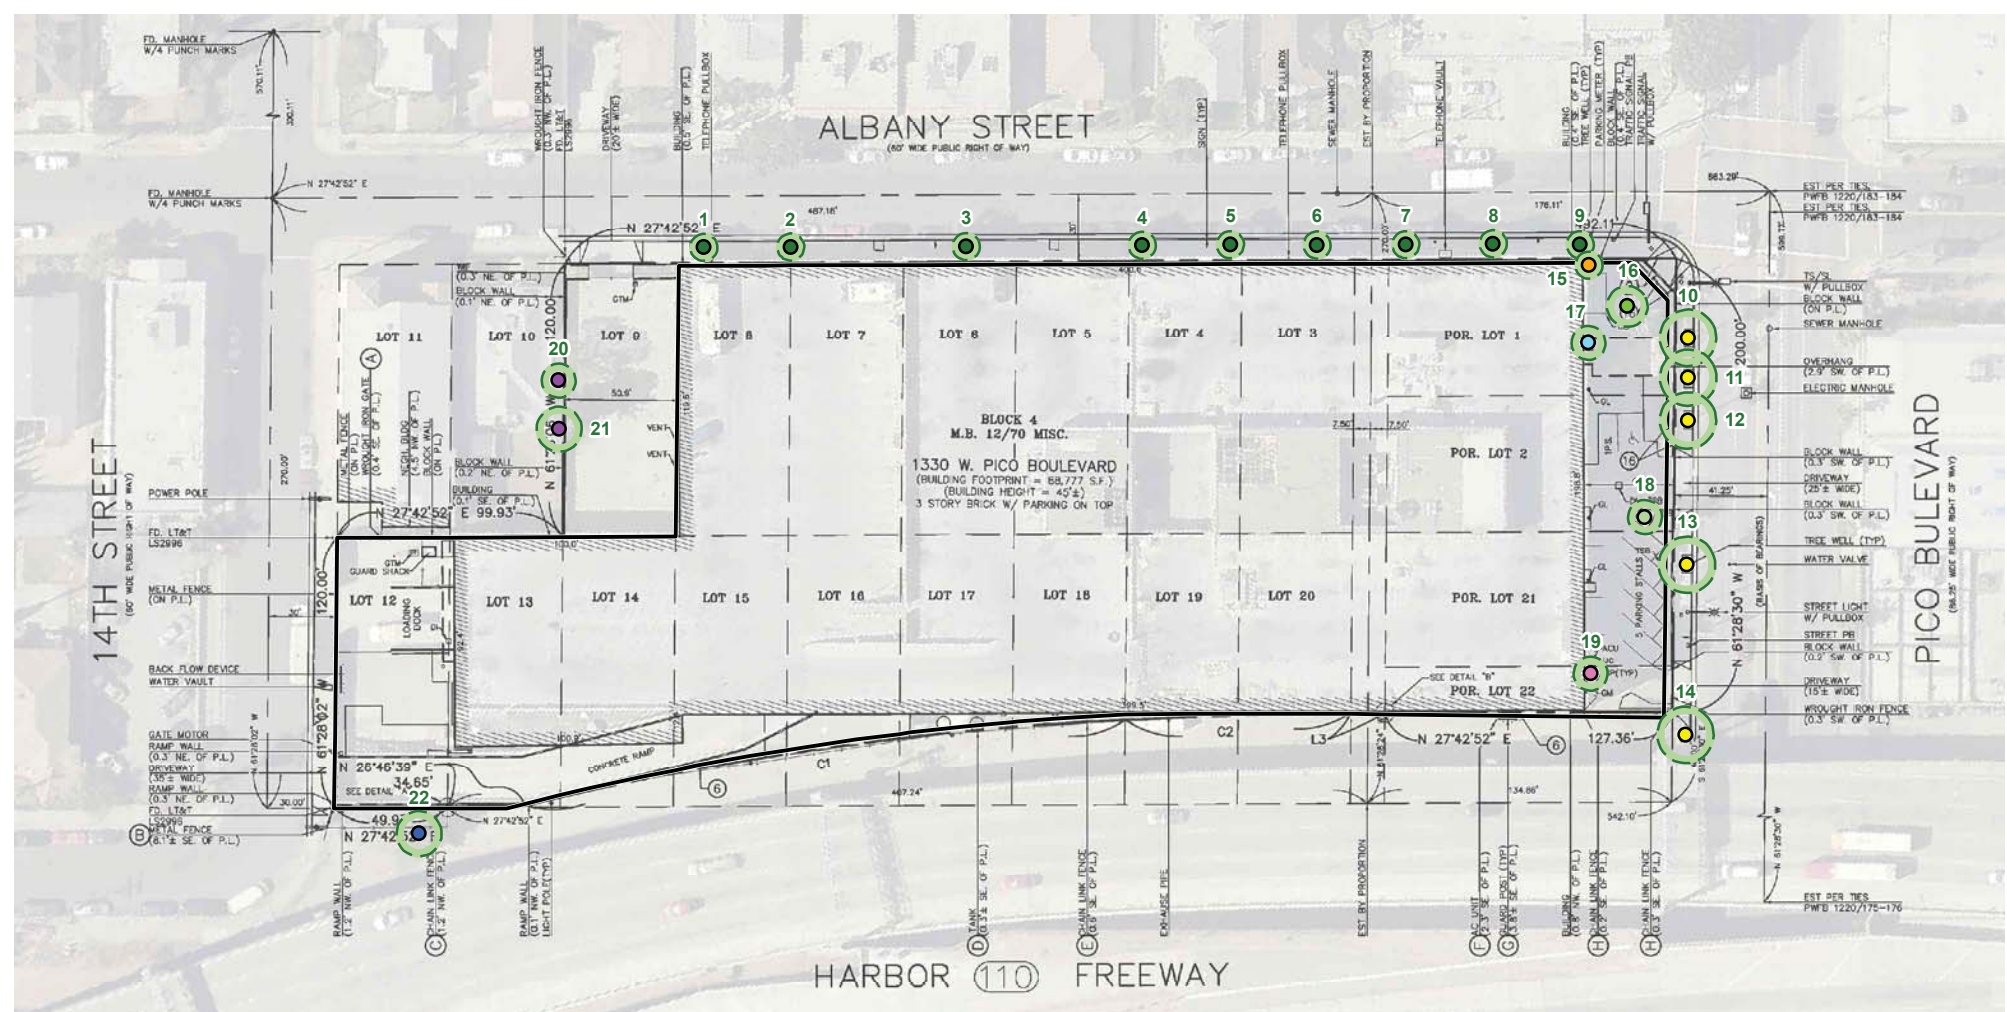
## Exhibit 2

As mentioned above, the project site currently contains an unoccupied office/commercial building with two surface parking lots. A total of 22 trees were documented during the tree survey. These trees are shown in Exhibit 2 and summarized in Table 1. Five trees occur on the project site associated with the building entrance on the northern site boundary. These trees consist of one Brazilian pepper (*Schinus terebinthefolius*), one Canary Island palm (*Phoenix canariensis*), one Queensland umbrella tree (*Schefflera actinophylla*), one olive tree (*Olea europaea*), and one fern pine (*Afrocarpus gracilior*).

## Tree Locations
