## Tree Inventory Report

Hummingbird Energy  
San Jose, CA 95139

PREPARED BY:  
**HortScience | Bartlett Consulting**  
325 Ray Street  
Pleasanton, CA 94566

July 16<sup>th</sup>, 2019

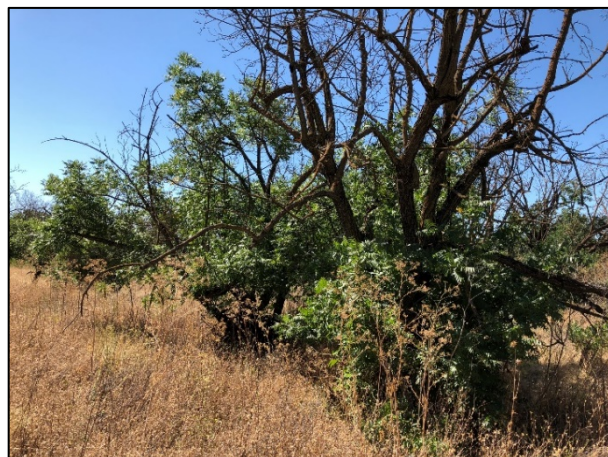
California black walnut was the most common species assessed (90 trees, 66% of the inventory). Of these, 80 water stressed walnuts were growing around Coyote Creek and ranged in condition from poor (40 trees) to fair (37 trees) (Photo 1). Two of the Coyote Creek California black walnuts (#18 and 137) were standing dead. The remaining ten walnuts (#8-17) were located in between Monterey Road and Caltrain railroad tracks. These walnuts were generally larger and in better condition than those growing around the creek.

**Photo 1** – The Coyote Creek California black walnuts exhibited signs of water stress and canopy dieback.

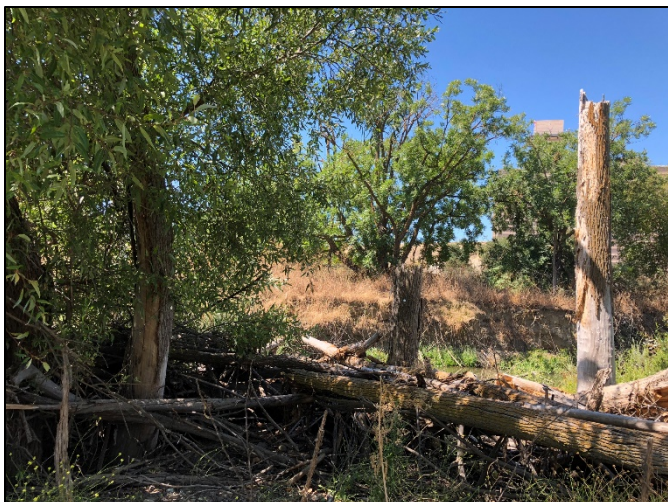
**Photo 2** – Fremont cottonwoods #54-56 were old, weathered snags with low suitability for retention.

Thirteen (13) Fremont cottonwoods were growing in clumps around Coyote Creek as well. Like the California black walnuts in the area, they exhibited varying degrees of canopy dieback and water stress. Eight (8) were dead standing snags (62% of the cottonwood population, Photo 2), two were in poor condition, two were in fair condition, and a single cottonwood, tree #60, was observed to be in good condition. Trunk diameters ranged from 12-inches to 42-inches and averaged 19-inches. Should these trees be located where damage to people or property is likely, then the majority are poor candidates for retention due to the presence of structural defects.
