Appendix A
Tree Report

Los Lirios Apartments Arborist Report

Prepared for East LA Community Corporation
Jacqueline Monterrosas
2917 E. 1st Street, Suite 101
Los Angeles, CA 90033

Prepared by James Komen
BCMA WE-9909B
RCA #555

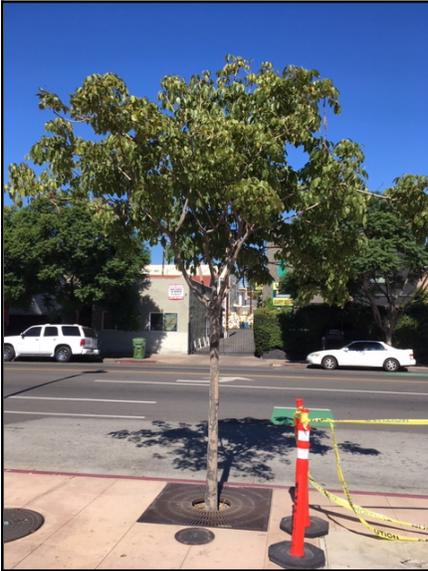
Tree 1

This is a street tree. It shows signs of sunburn and a mechanical injury on the trunk. No treatment is recommended at this time. This tree is not likely to be affected by the proposed construction. This tree is far enough from the construction site that no tree protection fencing is needed.

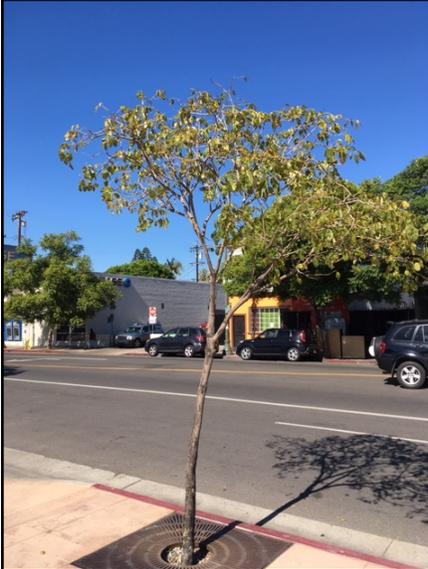
Tree 2

This is a street tree. It shows signs of sunburn and a mechanical injury on the trunk. No treatment is recommended at this time. This tree is not likely to be affected by the proposed construction. This tree is far enough from the construction site that no tree protection fencing is needed.

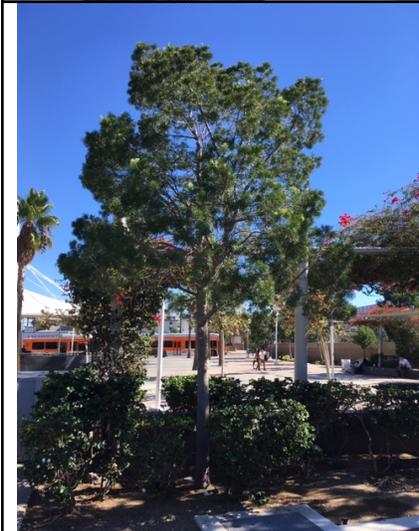
Tree 3

This tree is not protected. It has a buried root collar and a thinning canopy. This tree will be removed as part of the proposed construction.

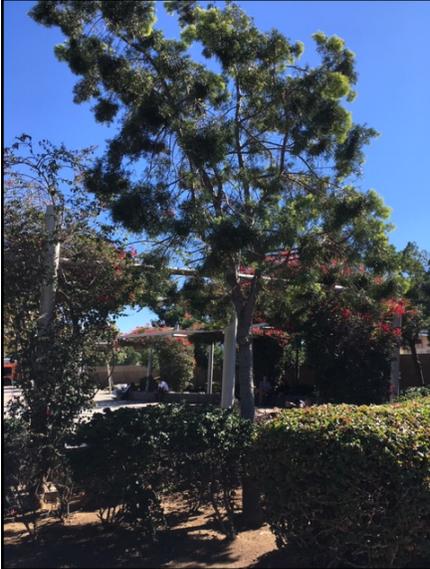
Tree 4

This tree is not protected. It has a thinning canopy. This tree will be removed as part of the proposed construction.

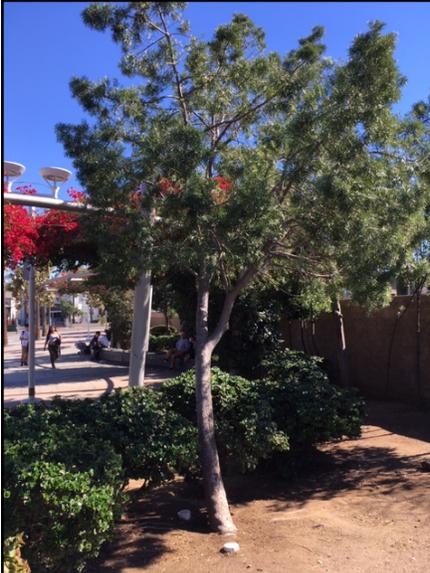
Tree 5

This tree is not protected. It is leaning and has a thinning canopy. This tree will be removed as part of the proposed construction.

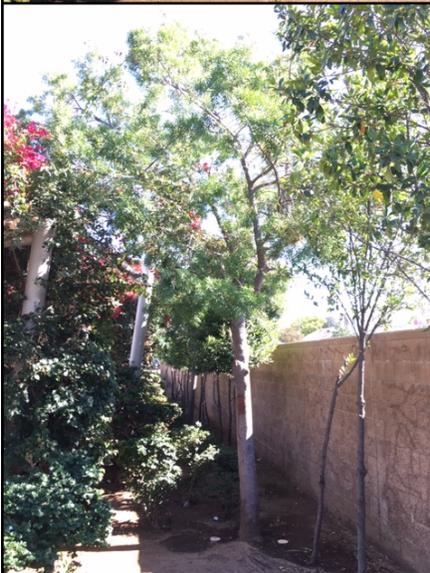
Tree 6

This tree is not protected. It has a thinning canopy. This tree will be removed as part of the proposed construction.

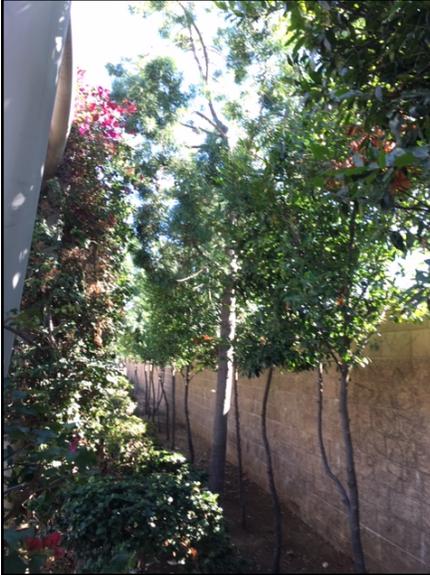
Tree 7

This tree is not protected. It has a thinning canopy. This tree will be removed as part of the proposed construction.

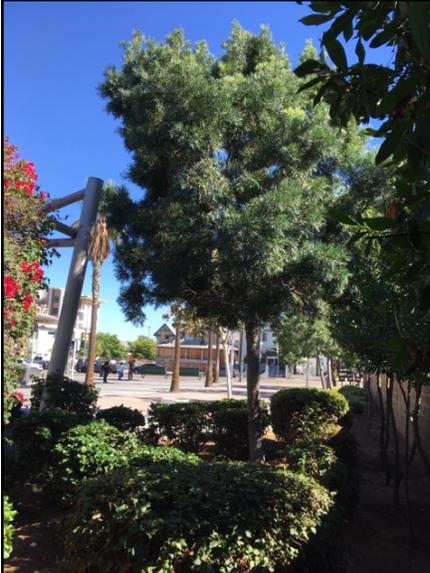
Tree 8

This tree is not protected. It is healthy. This tree will be removed as part of the proposed construction.

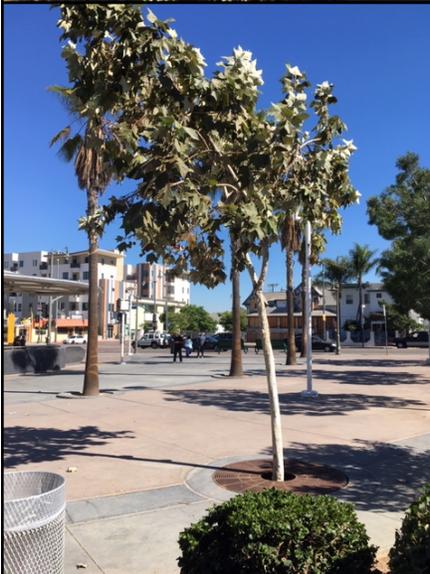
Tree 9

This tree is not protected. It shows signs of minor anthracnose. It is still healthy. This tree will be removed as part of the proposed construction.

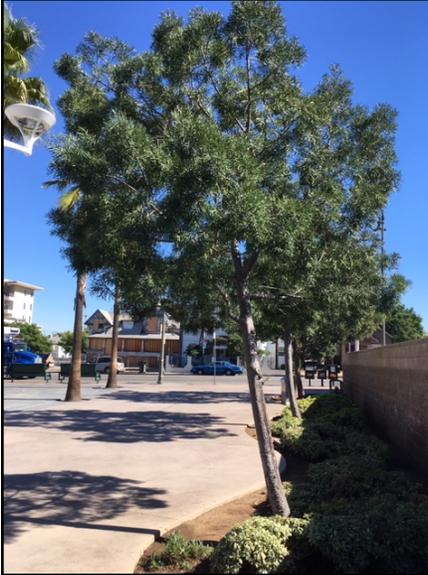
Tree 10

This tree is not protected. It has a thinning canopy This tree will be removed as part of the proposed construction.

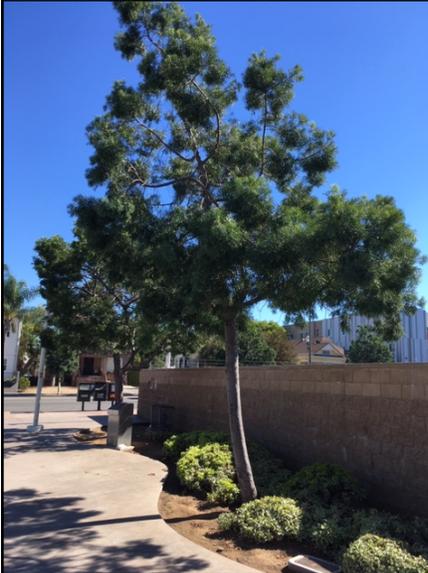
Tree 11

This tree is not protected. It is healthy. This tree will be removed as part of the proposed construction.

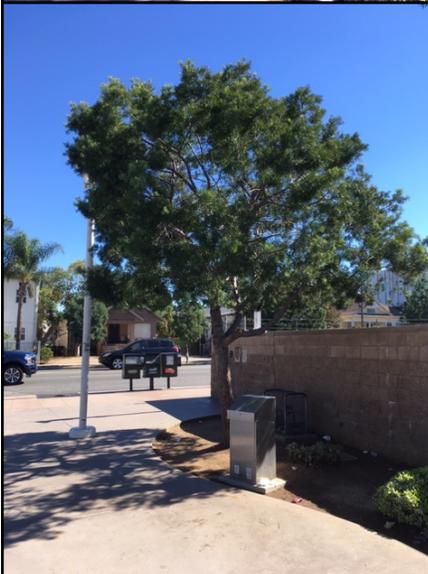
Tree 12

This tree is not protected. It has a thinning canopy. This tree will be removed as part of the proposed construction.

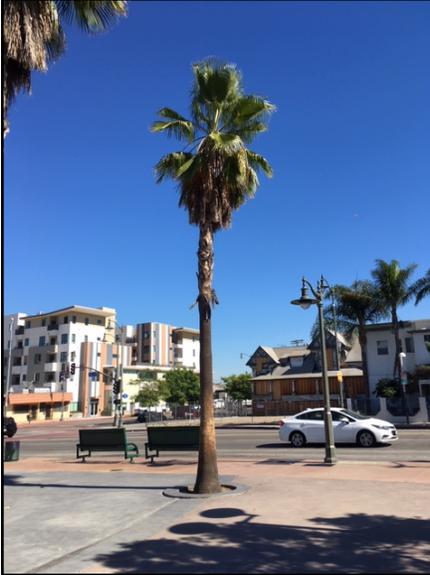
Tree 13

This tree is not protected. It is healthy. This tree will be removed as part of the proposed construction.

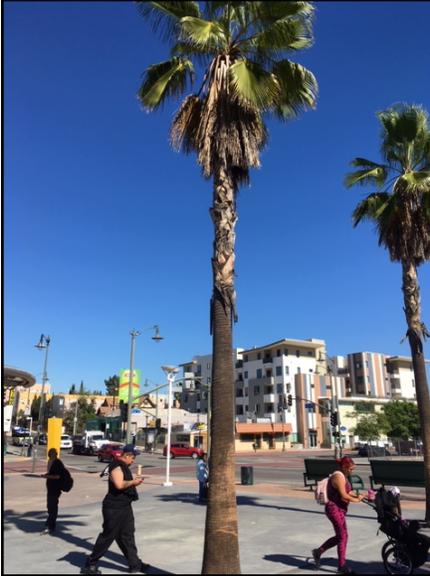
Tree 14

This tree is not protected. It is healthy. This tree will be removed as part of the proposed construction.

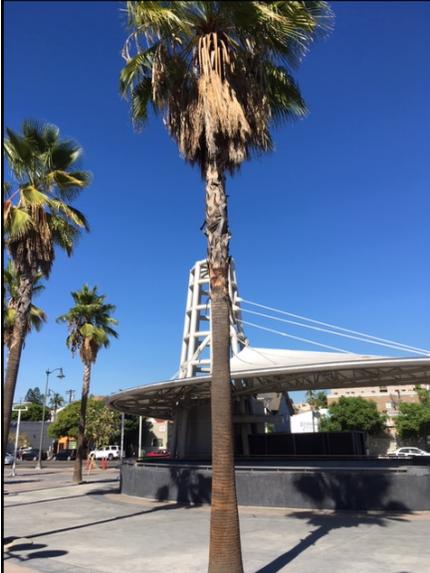
Tree 15

This tree is not protected. It is healthy. This tree will be removed as part of the proposed construction.

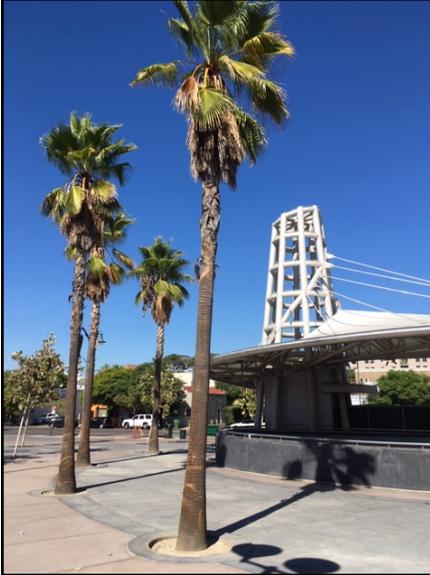
Tree 16

This tree is not protected. It is healthy. This tree will be removed as part of the proposed construction.

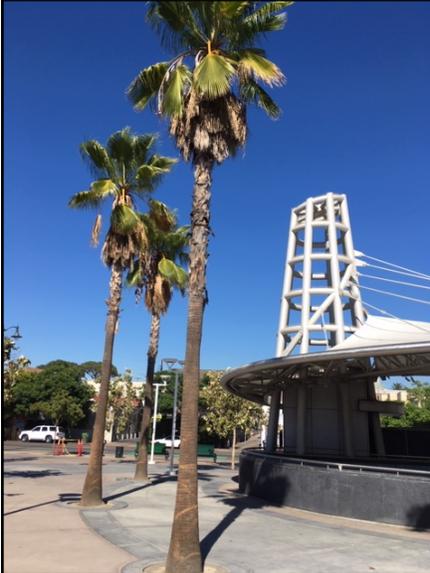
Tree 17

This tree is not protected. It is healthy. Pruning of dead fronds is recommended. This tree will be retained in the landscape.

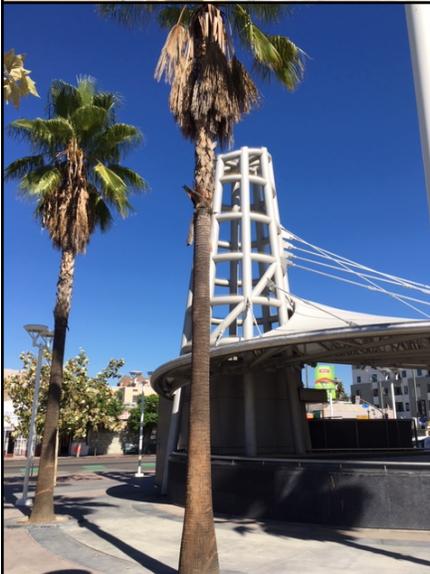
Tree 18

This tree is not protected. It is healthy. Pruning of dead fronds is recommended. This tree will be retained in the landscape.

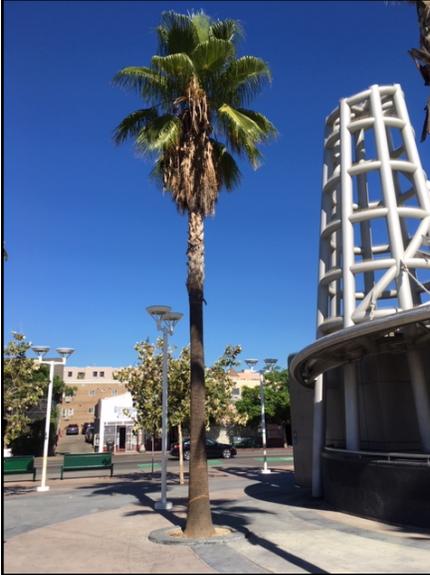
Tree 19

This tree is not protected. It is healthy. Pruning of dead fronds is recommended. This tree will be retained in the landscape.

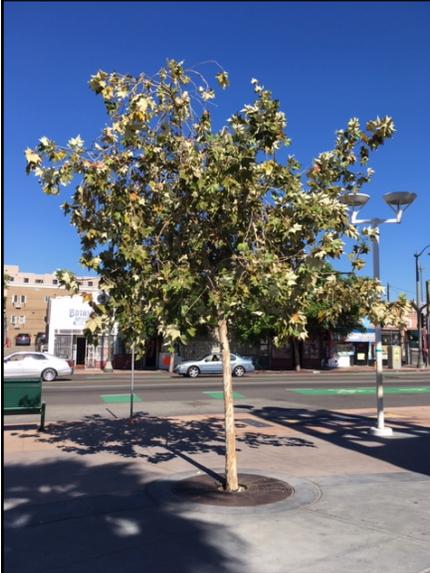
Tree 20

This tree is not protected. It shows signs of minor anthracnose. It is still healthy. Crown raising to 10 feet is recommended. This tree will be retained in the landscape.

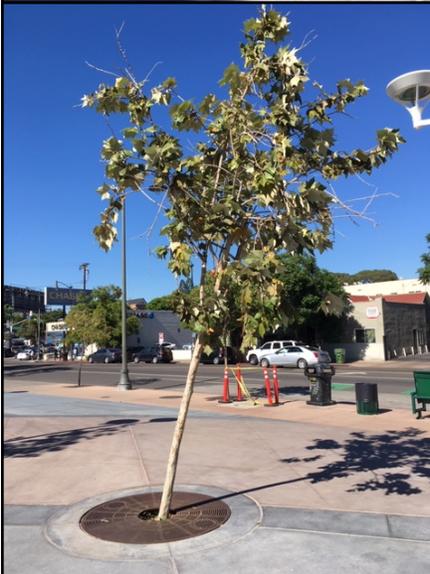
Tree 21

This tree is not protected. It shows signs of minor anthracnose. It is still healthy. Crown raising to 10 feet is recommended. This tree will be retained in the landscape.

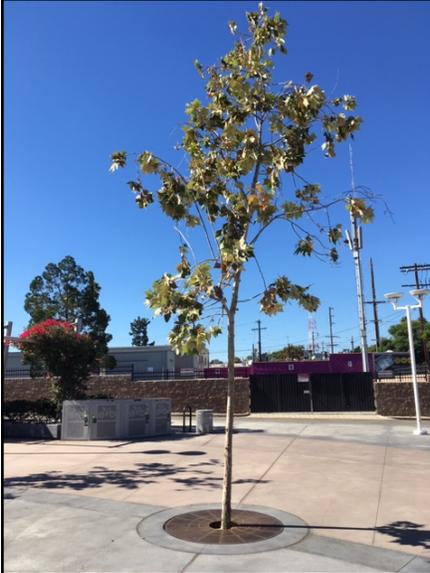
Tree 22

This tree is not protected. It shows signs of minor anthracnose. It is still healthy. Crown raising to 10 feet is recommended. This tree will be retained in the landscape.

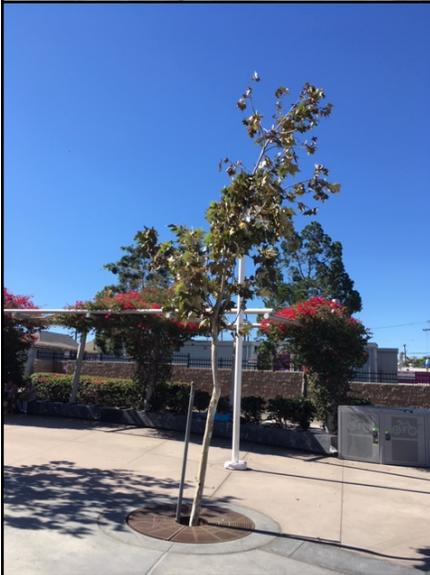
Tree 23

This tree is not protected. It shows signs of anthracnose. This tree will be removed as part of the proposed construction.

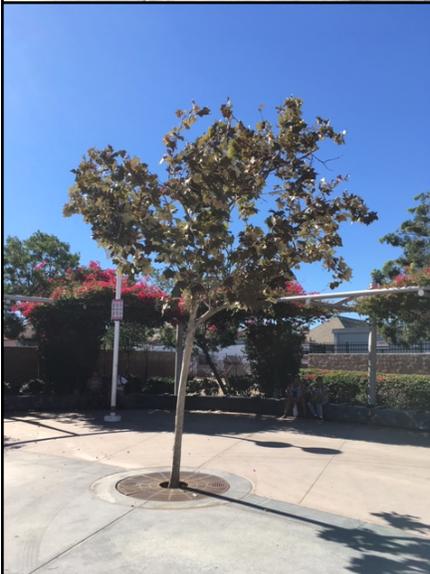
Tree 24

This tree is not protected. It shows signs of anthracnose. This tree will be removed as part of the proposed construction.

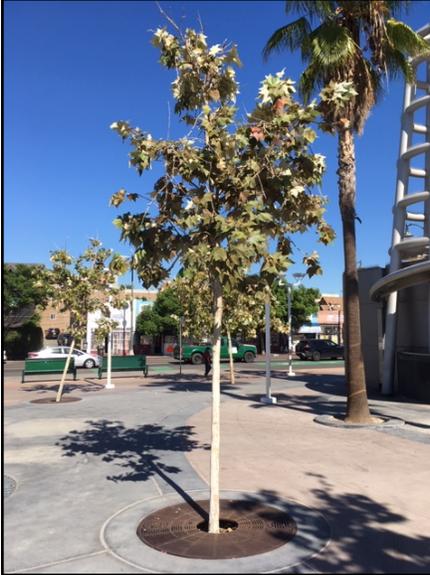
Tree 25

This tree is not protected. It shows signs of anthracnose. This tree will be removed as part of the proposed construction.

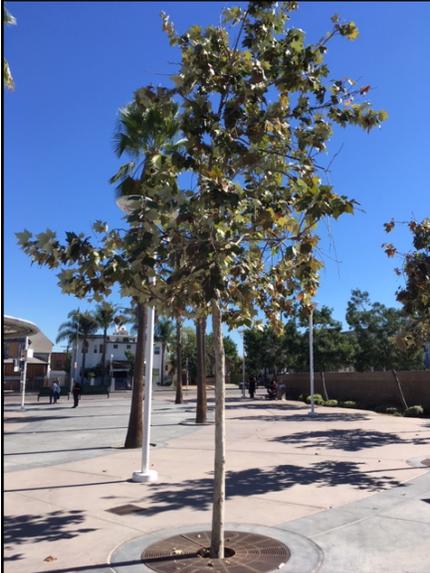
Tree 26

This tree is not protected. It shows signs of anthracnose. This tree will be removed as part of the proposed construction.

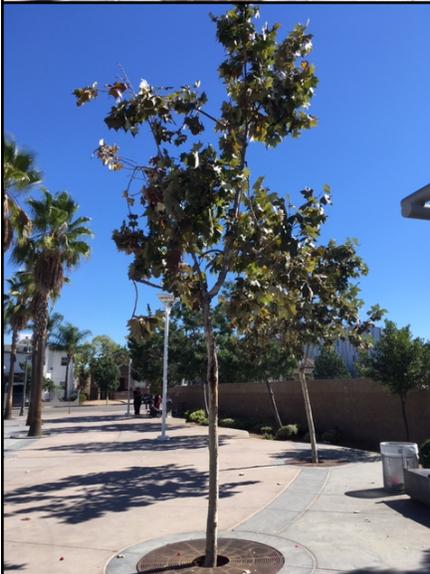
Tree 27

This tree is not protected. It shows signs of anthracnose. It has a bleeding canker and a mechanical injury on the trunk. This tree will be removed as part of the proposed construction.

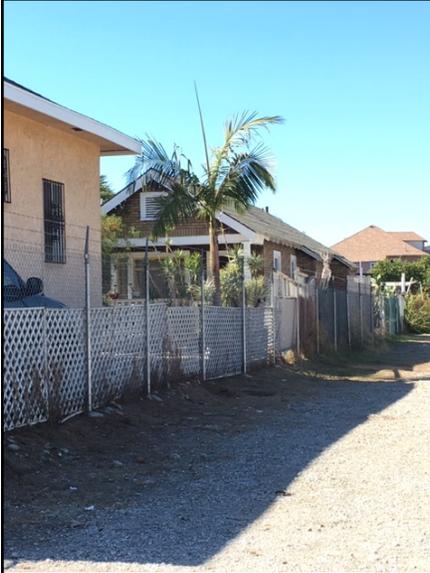
Tree OP28

This tree is not protected. It is growing on a neighboring property. It shows signs of minor drought stress. No treatment is recommended at this time. This tree is not likely to be affected by the proposed construction.

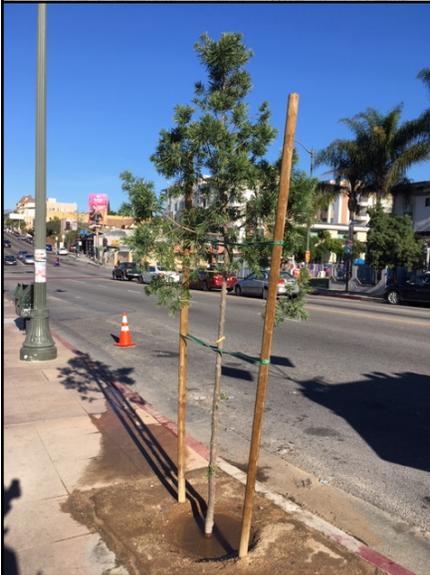
Tree 29

This tree is a street tree. It was recently planted within the past year. It is healthy. No treatment is recommended at this time. This tree is not likely to be affected by the proposed construction if the tree protection fencing is not crossed.

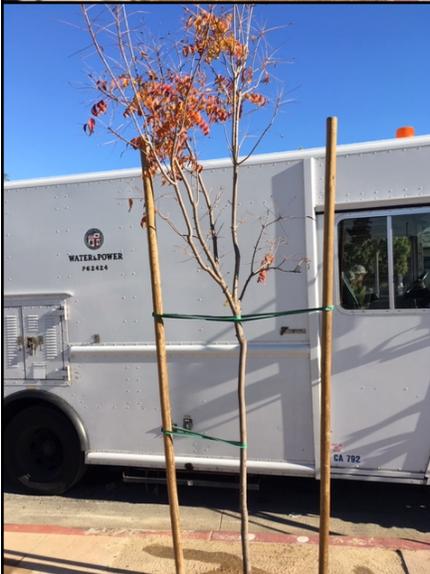
Tree 30

This tree is a street tree. It was recently planted within the past year. It is healthy. No treatment is recommended at this time. This tree is not likely to be affected by the proposed construction if the tree protection fencing is not crossed.

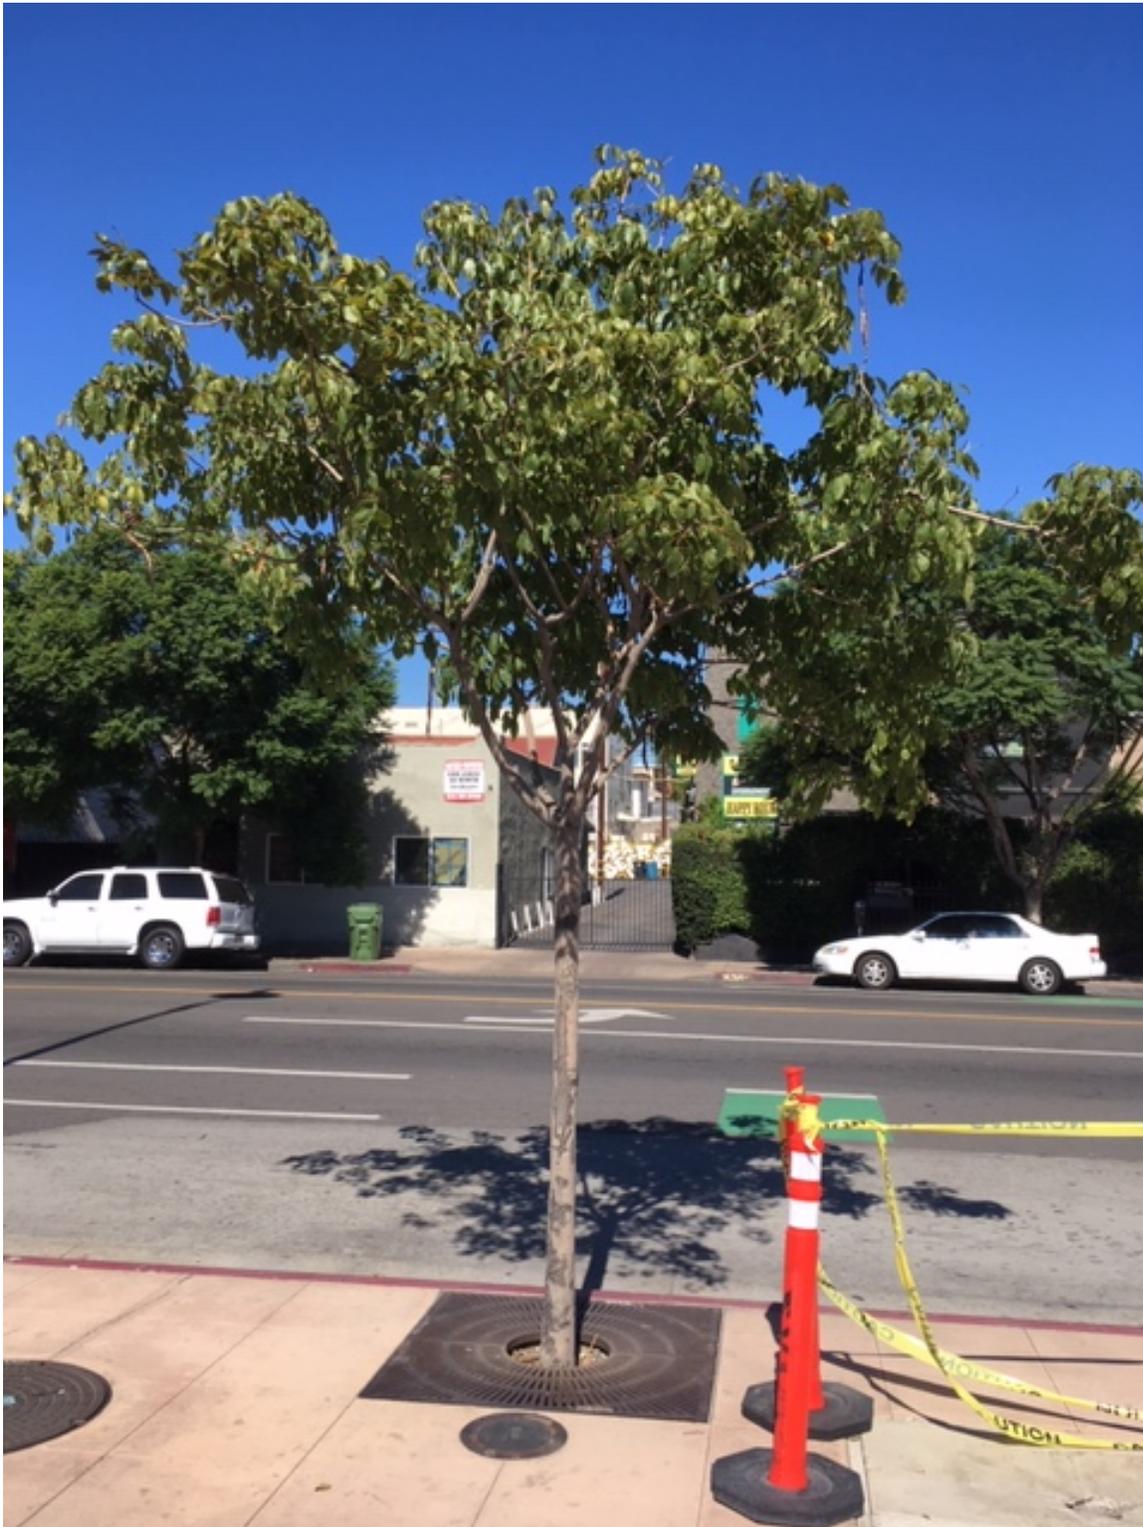
Figure 2 : Tree 1 is a street tree. It is not likely to be affected by the proposed construction.

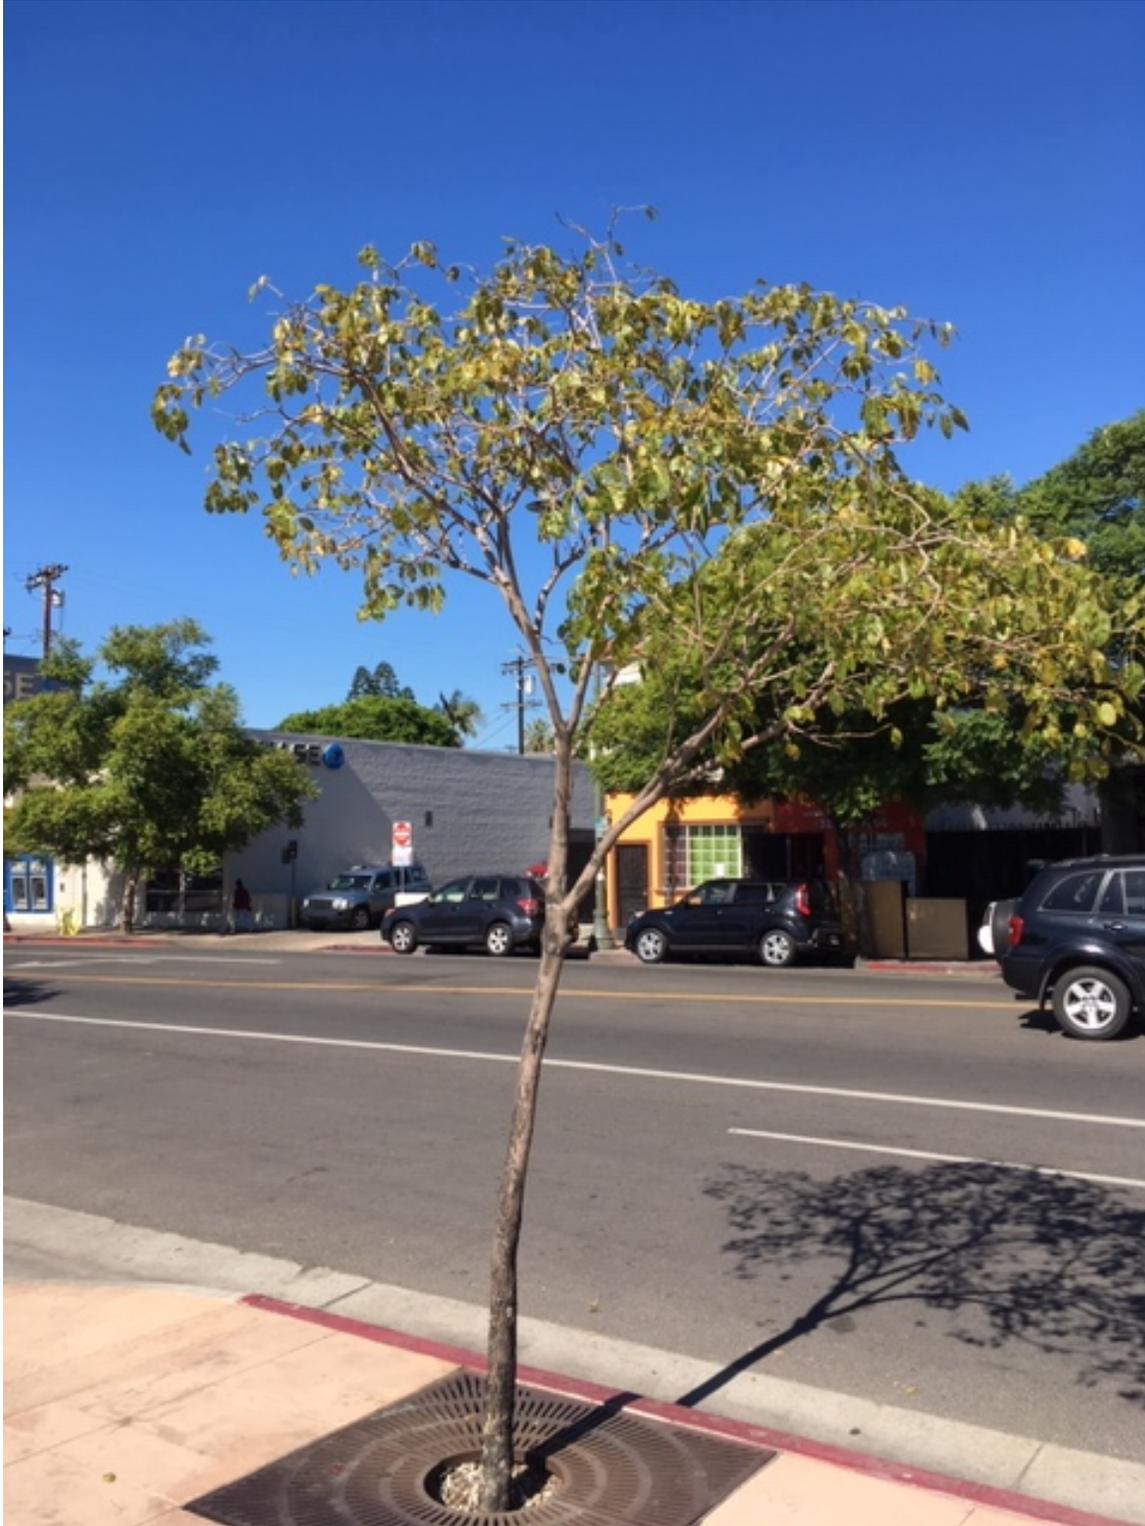
Figure 3 : Tree 2 is a street tree. It is not likely to be affected by the proposed construction.

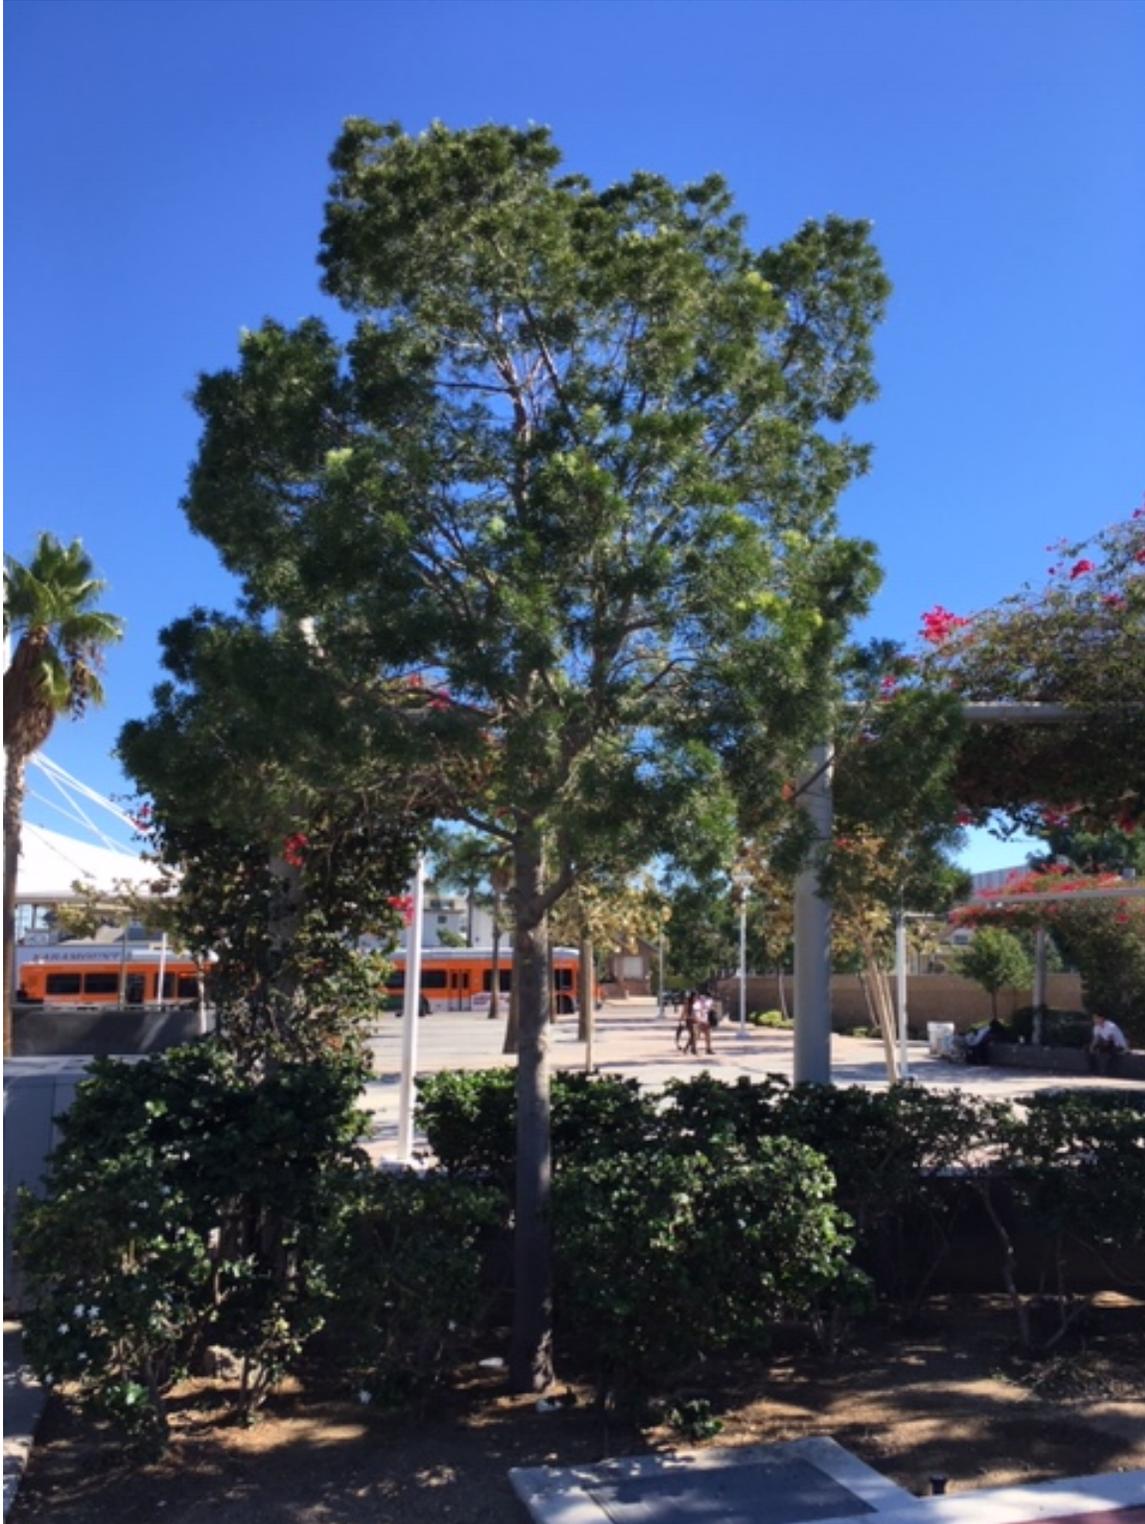
Figure 4: Tree 3 is not protected. It will be removed.

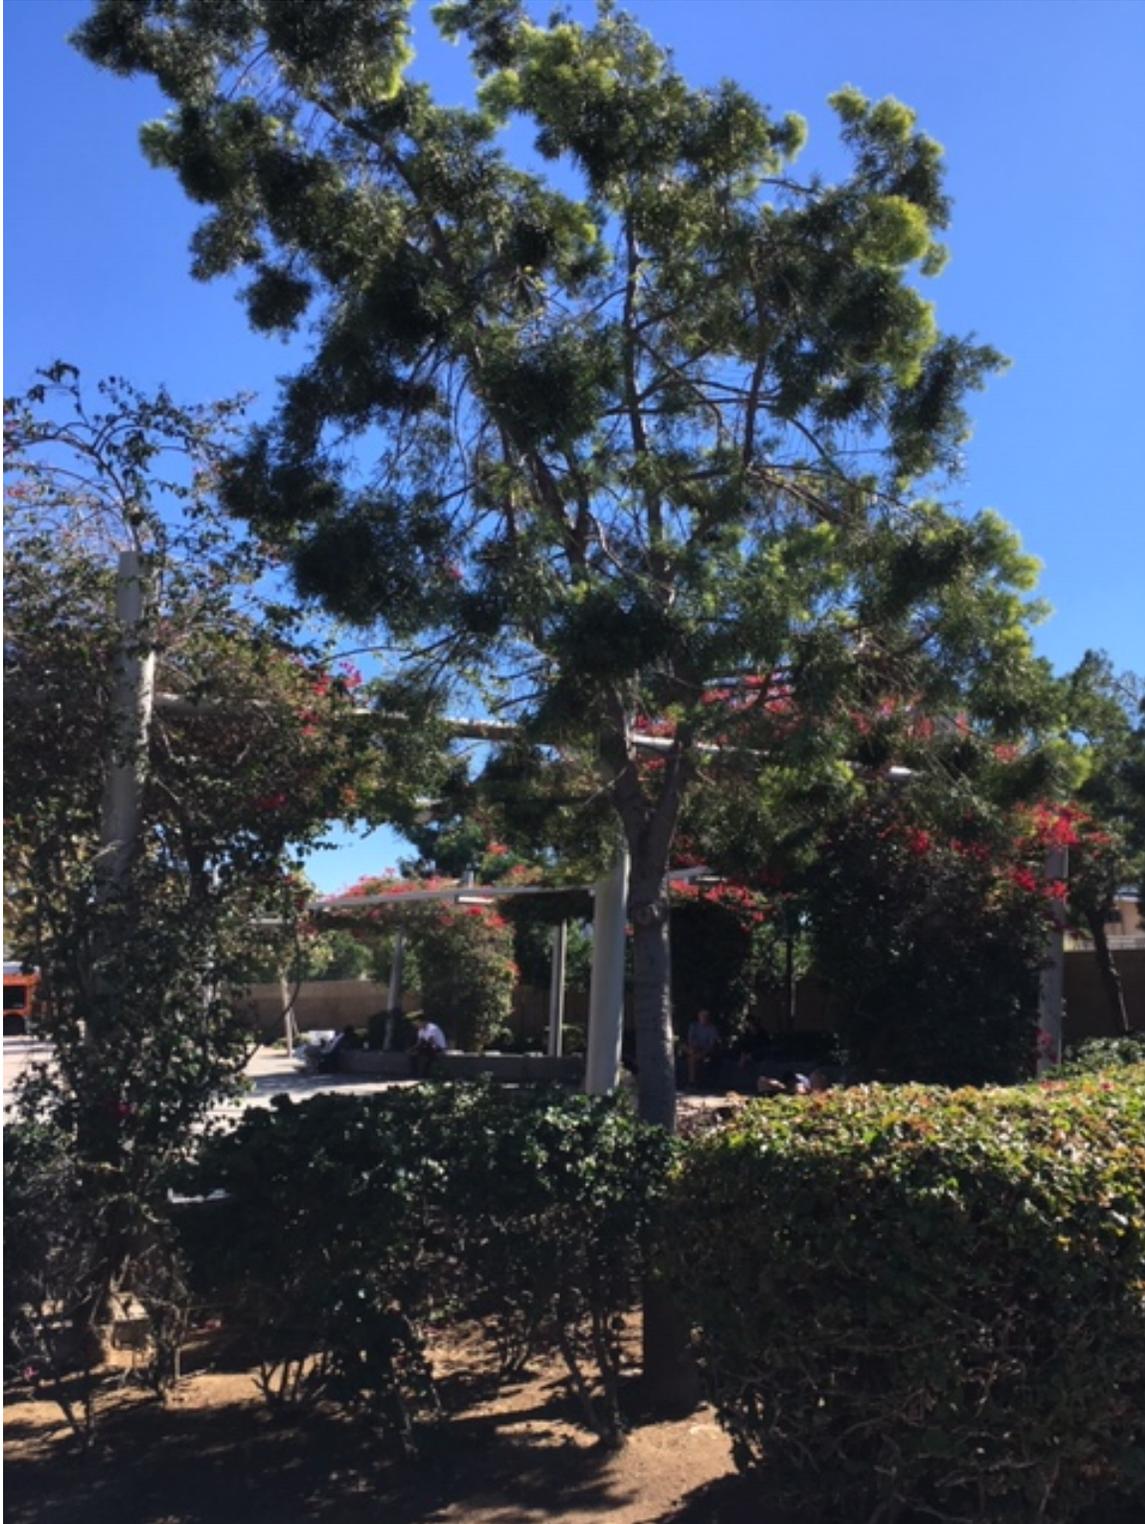
Figure 5: Tree 4 is not protected. It will be removed.

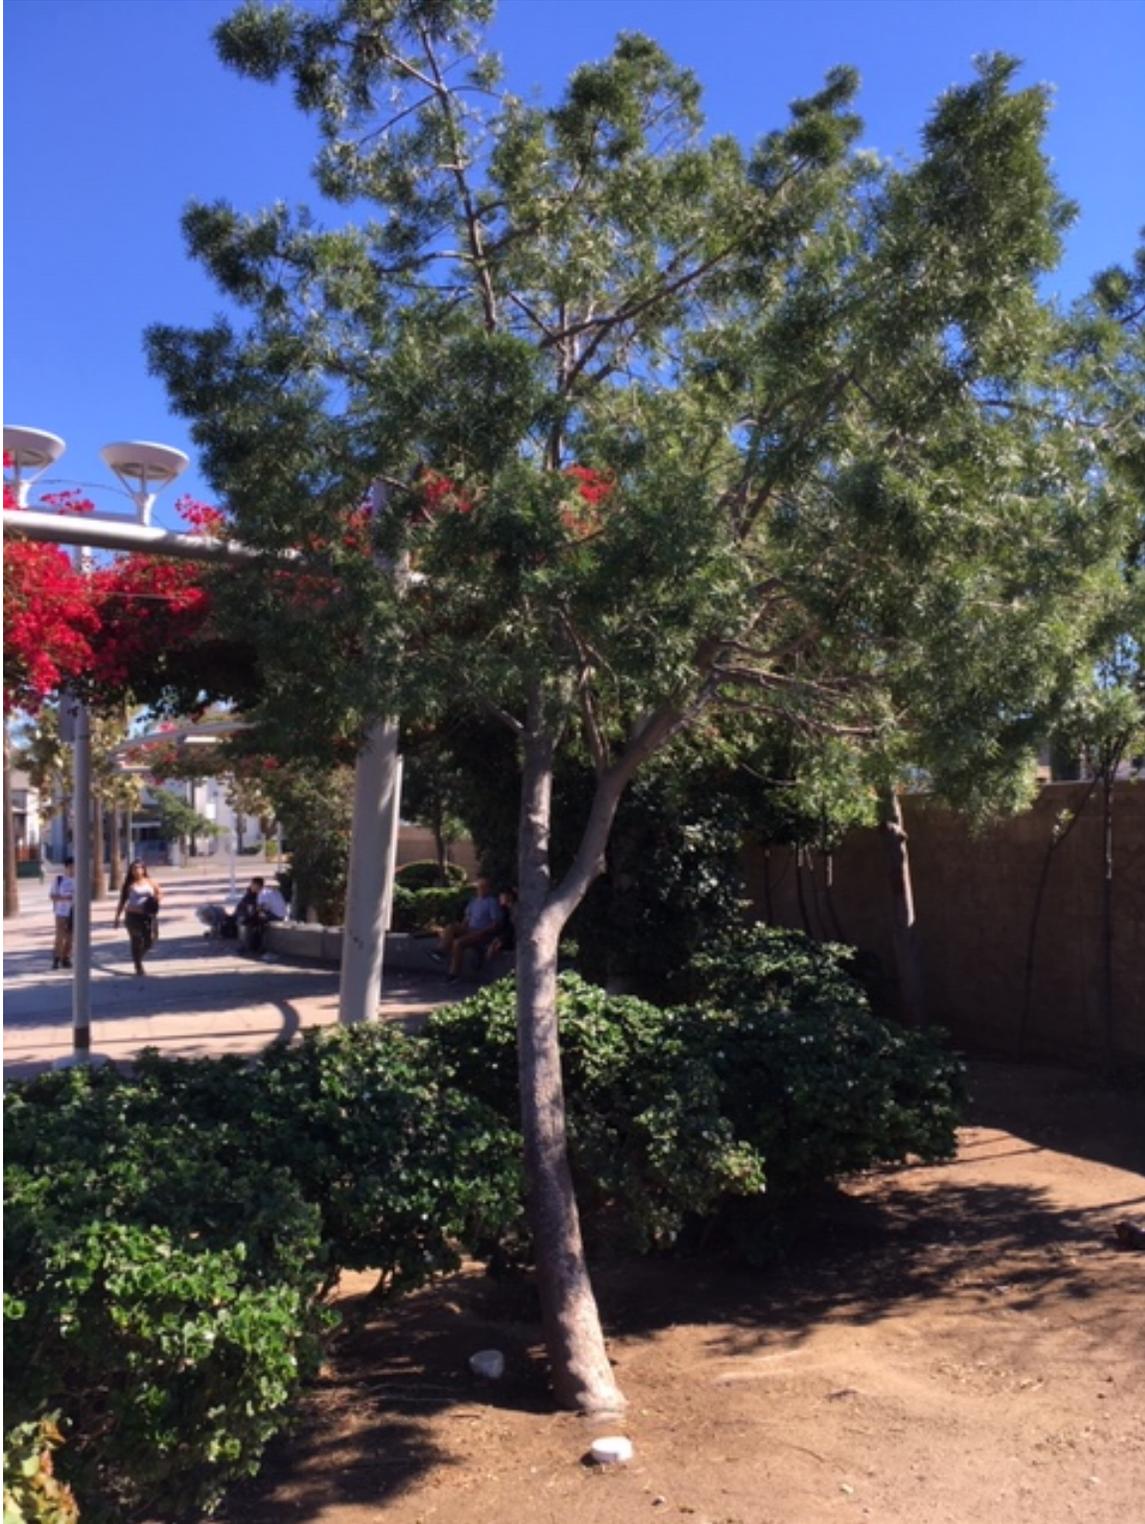
Figure 6: Tree 5 is not protected. It will be removed.

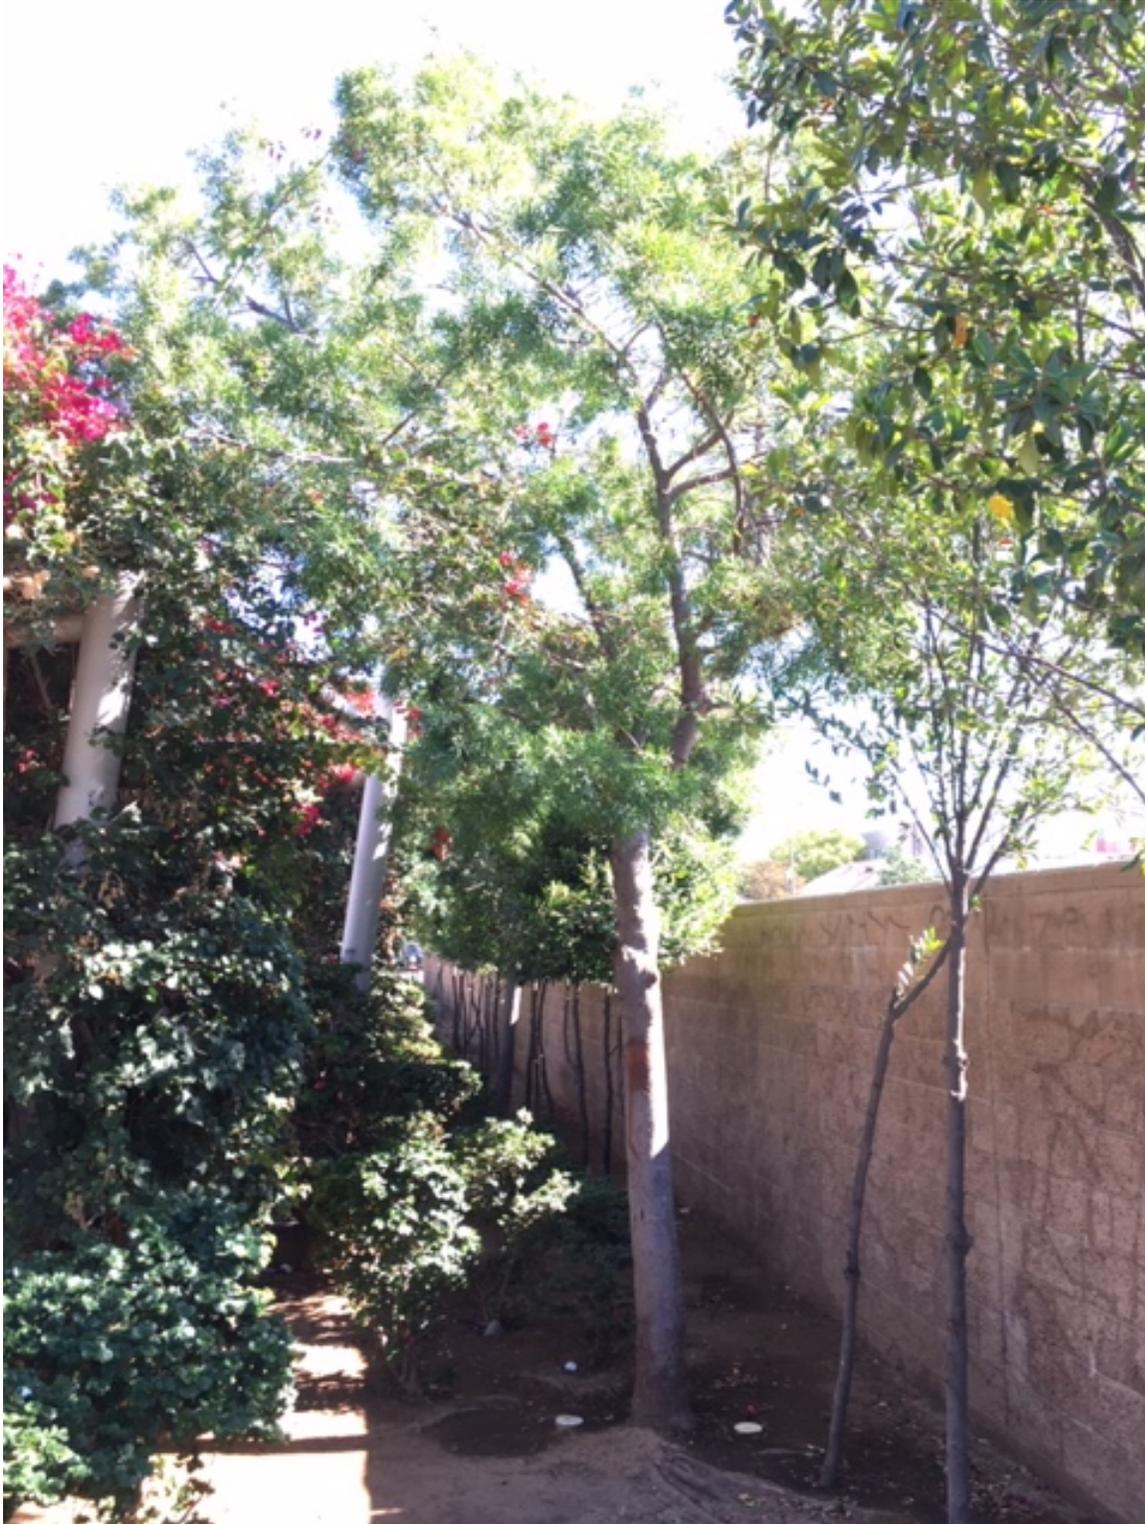
Figure 7: Tree 6 is not protected. It will be removed.

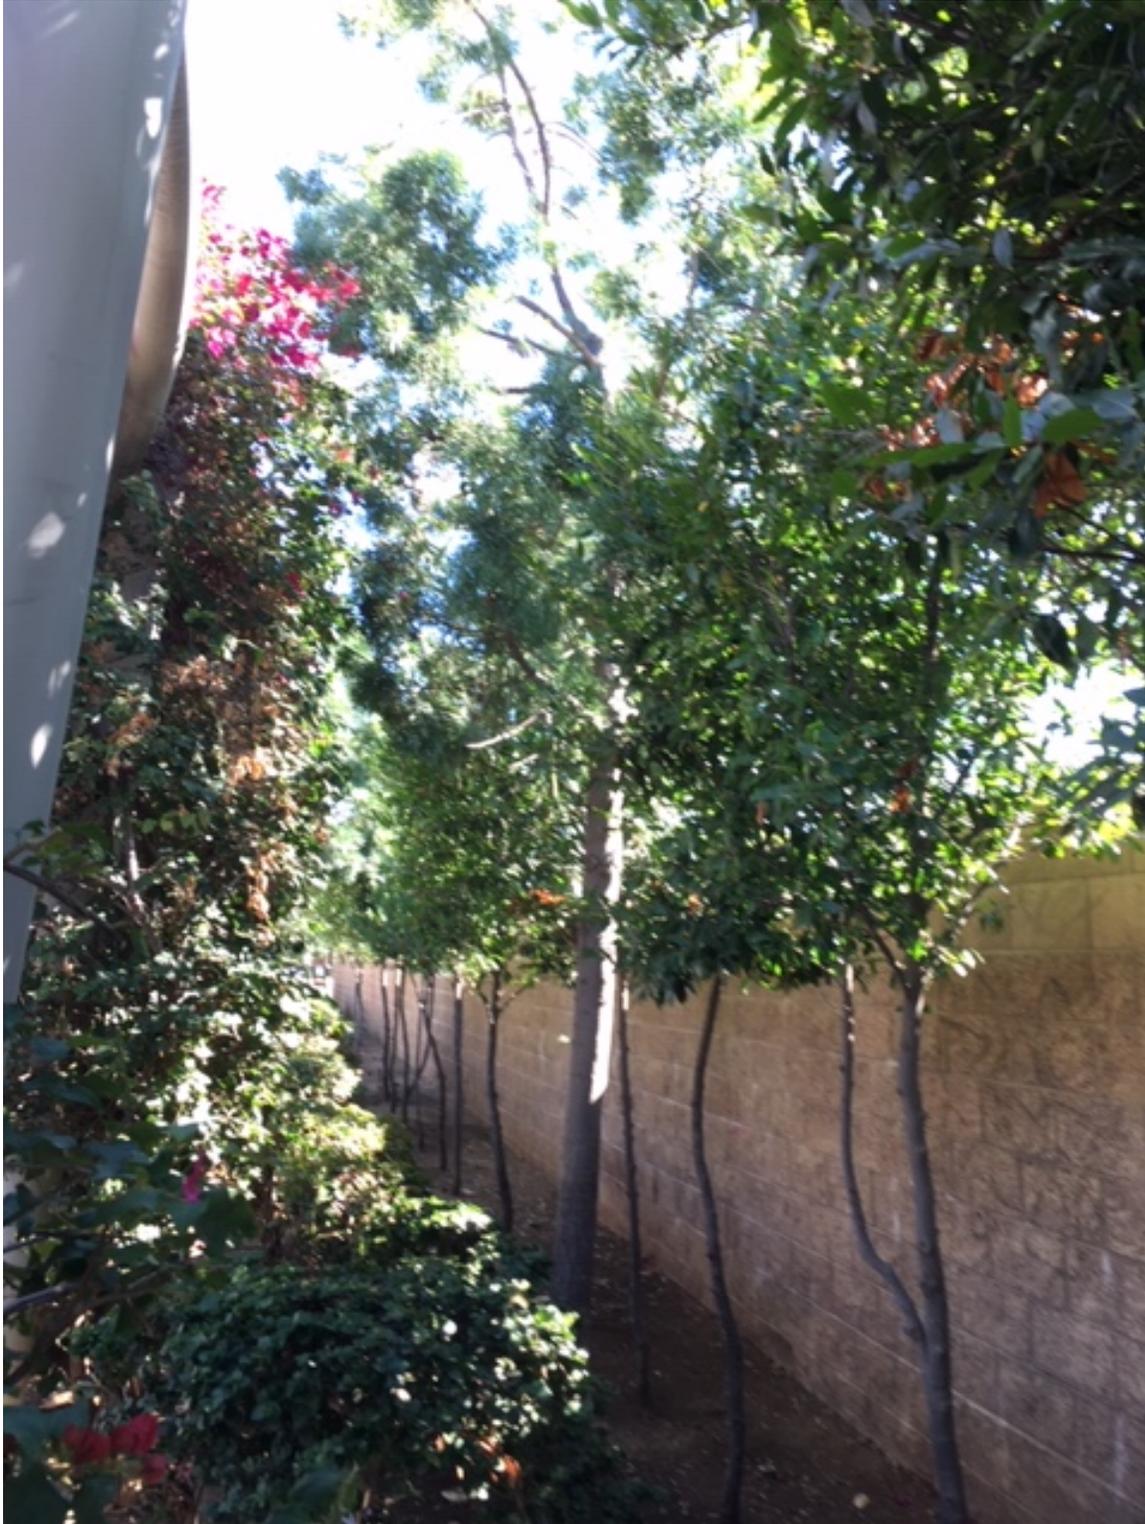
Figure 8: Tree 7 is not protected. It will be removed.

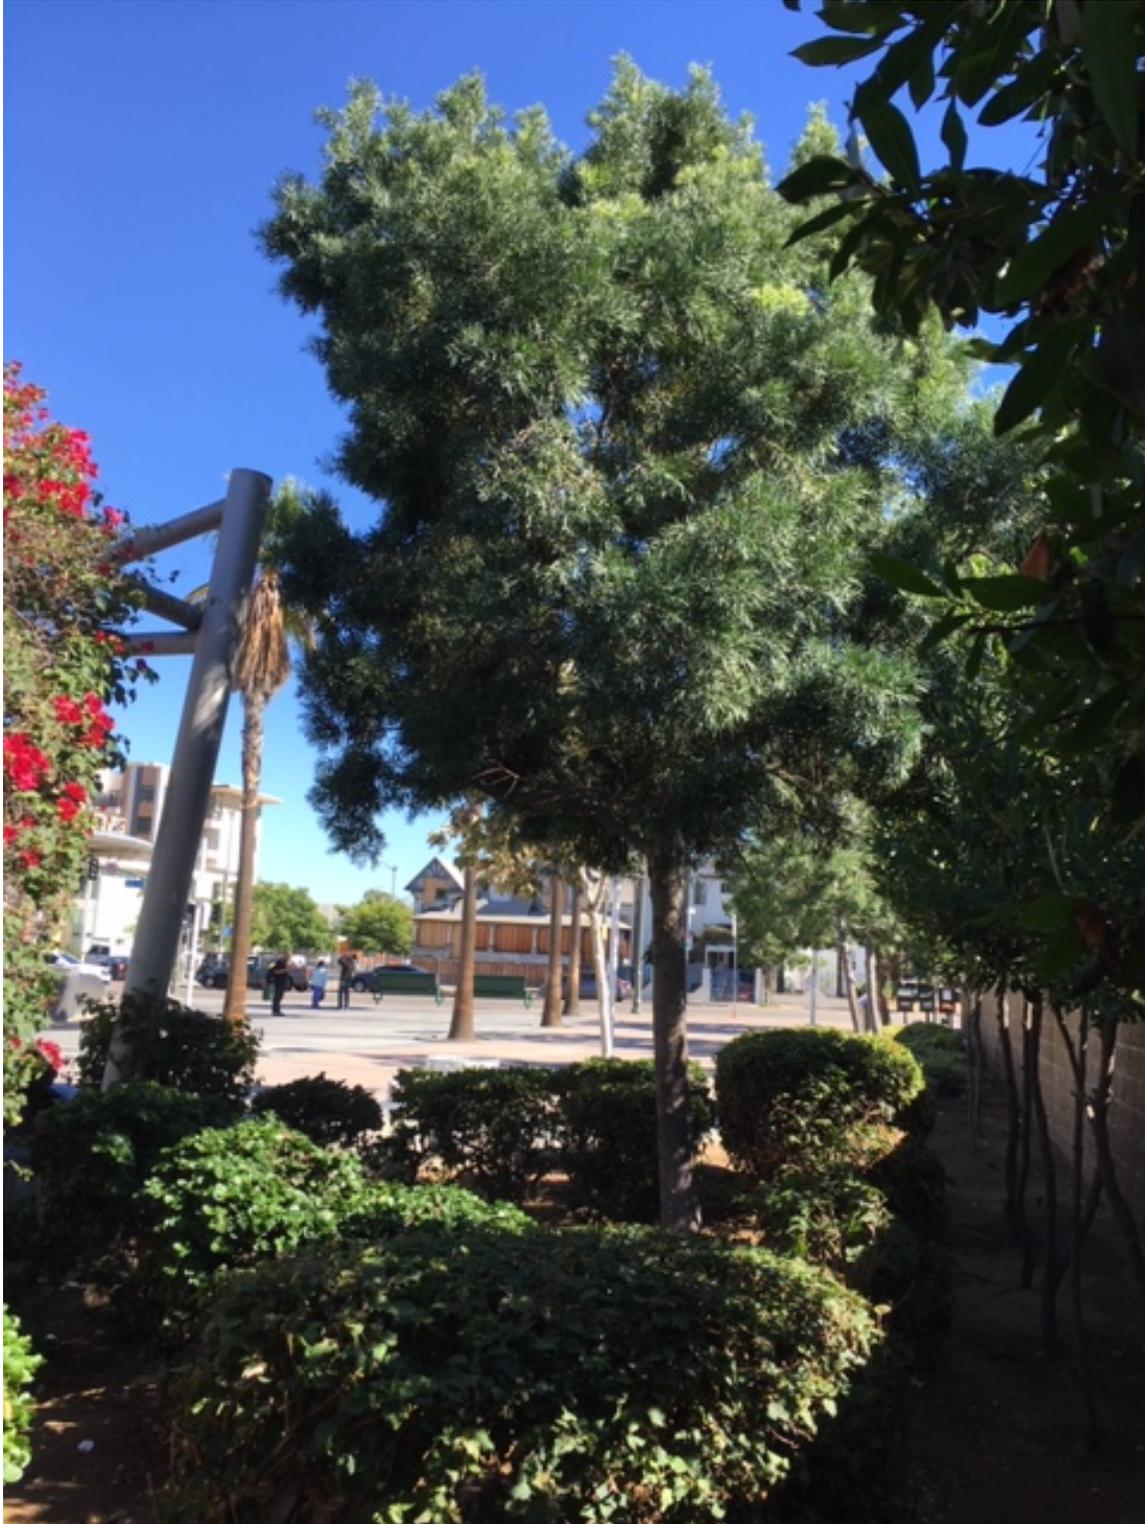
Figure 9: Tree 8 is not protected. It will be removed.
