Appendix A
Tree Report

Los Lirios Apartments Arborist Report

Prepared for East LA Community Corporation
Jacqueline Monterrosas
2917 E. 1st Street, Suite 101
Los Angeles, CA 90033

Prepared by James Komen
BCMA WE-9909B
RCA #555

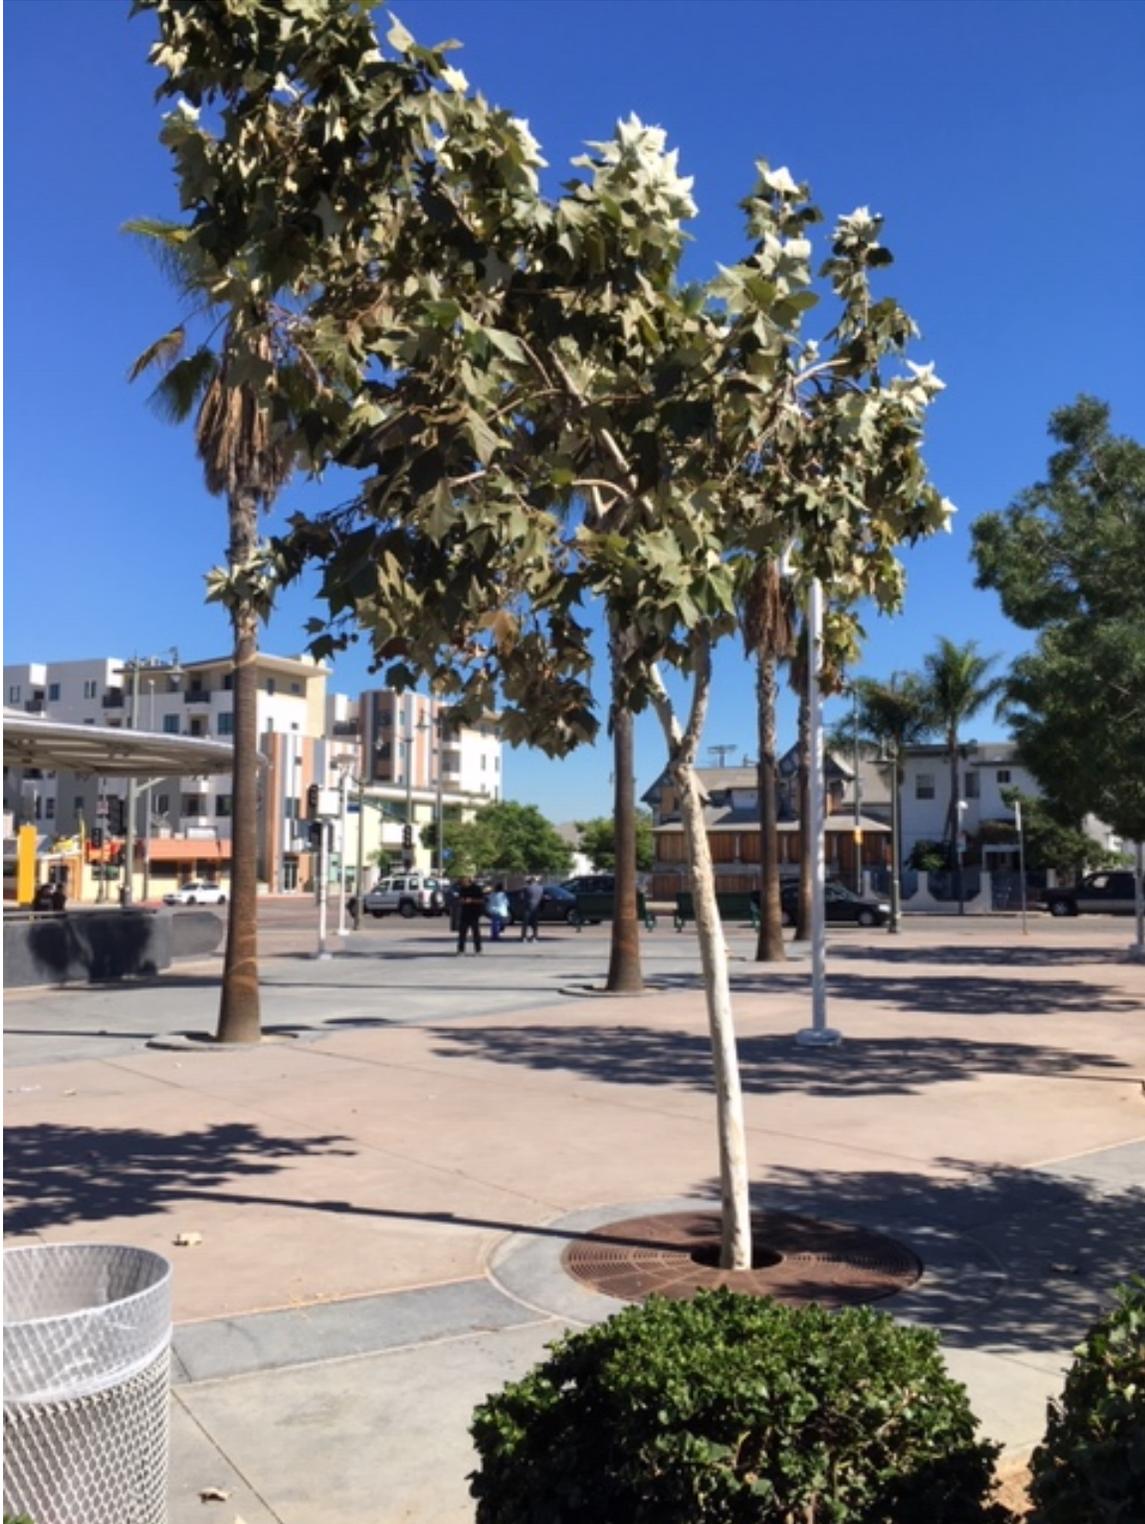
Figure 10: Tree 9 is not protected. It will be removed.

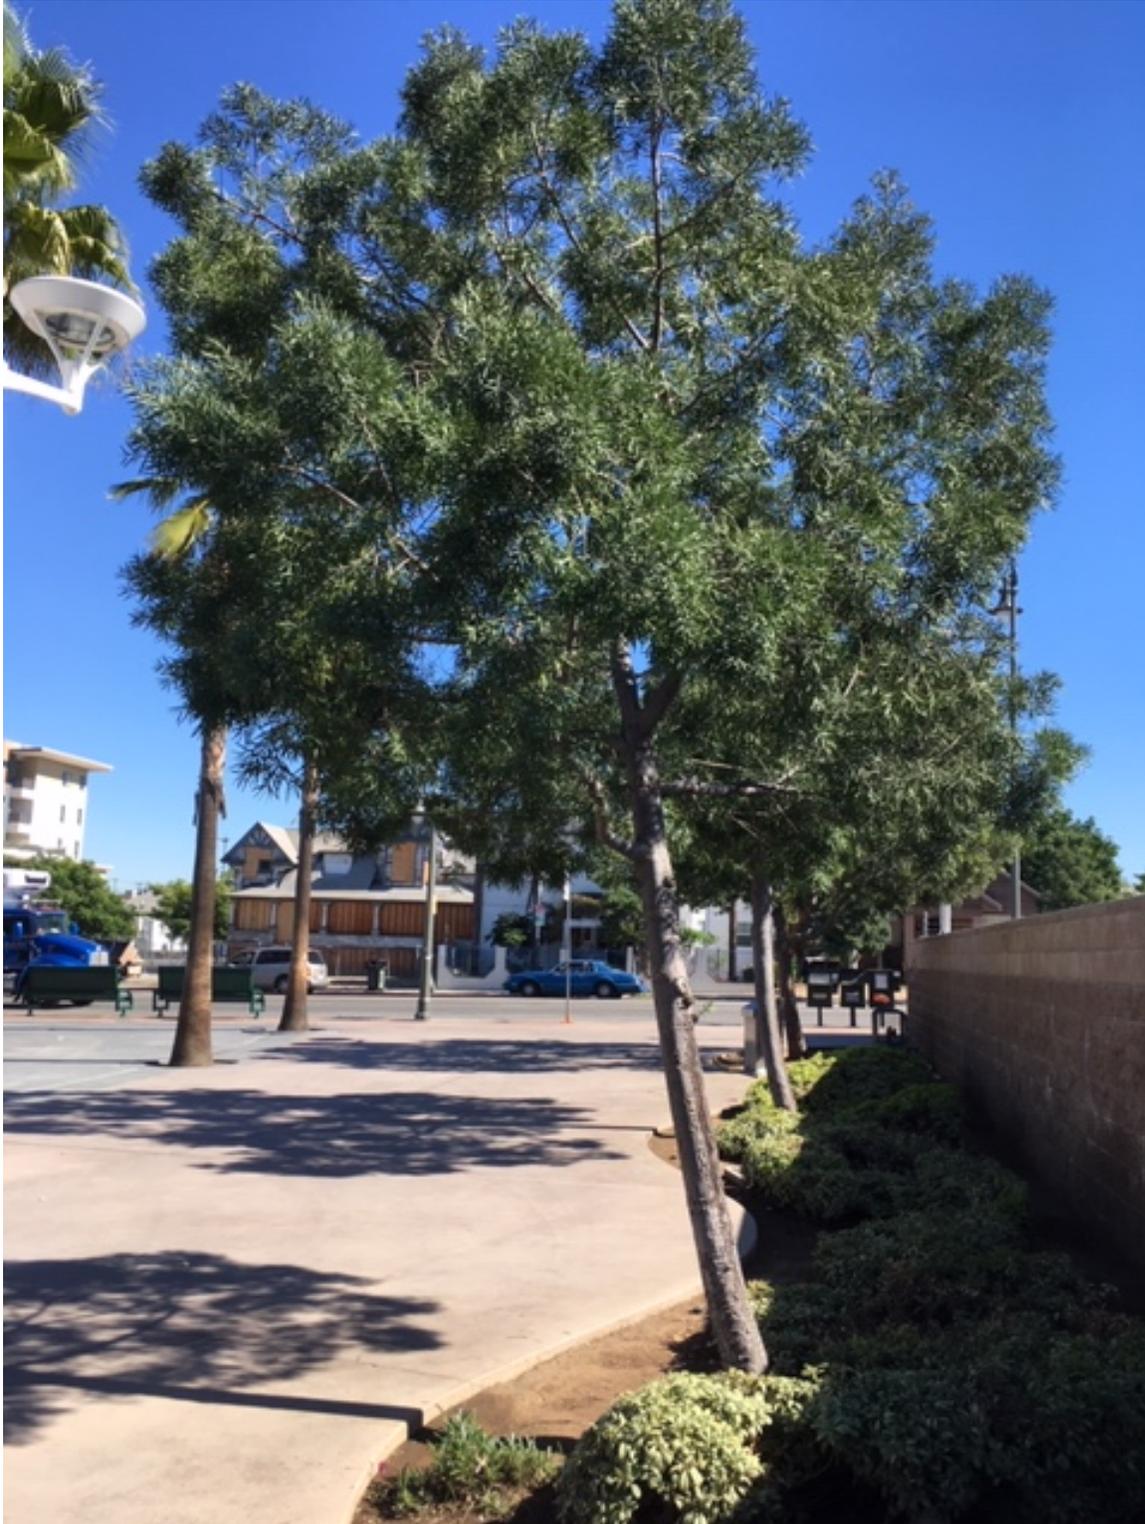
Figure 11: Tree 10 is not protected. It will be removed.

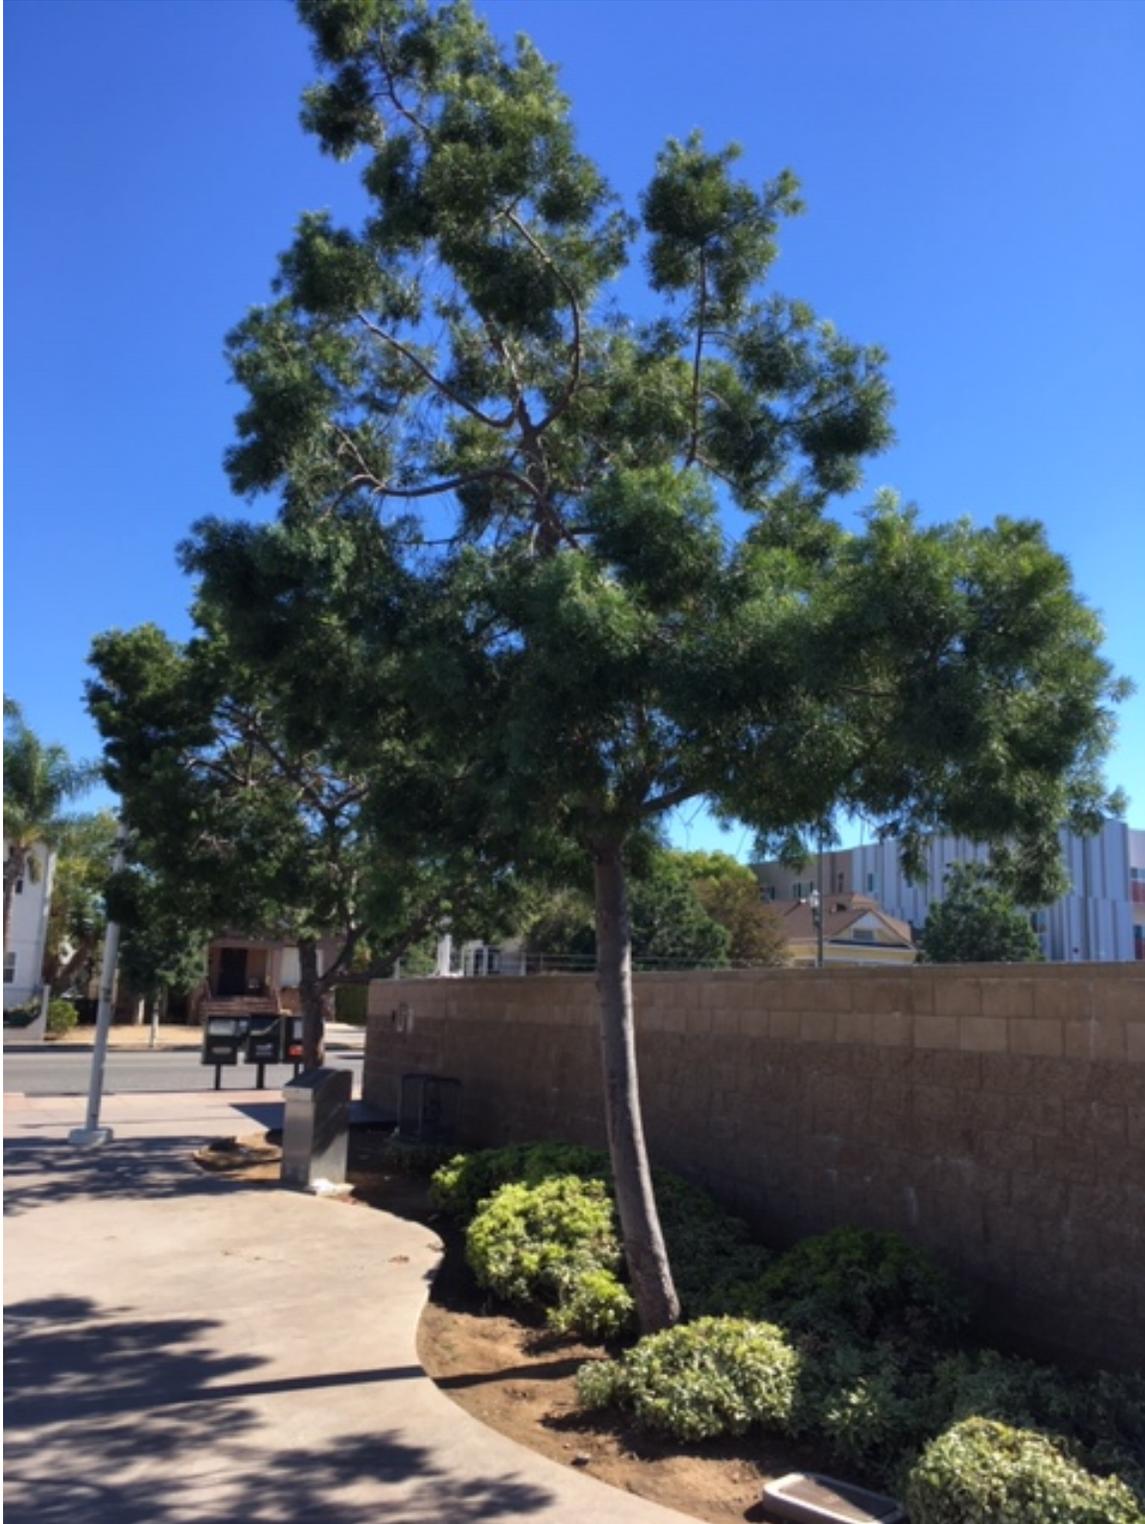
Figure 12: Tree 11 is not protected. It will be removed.

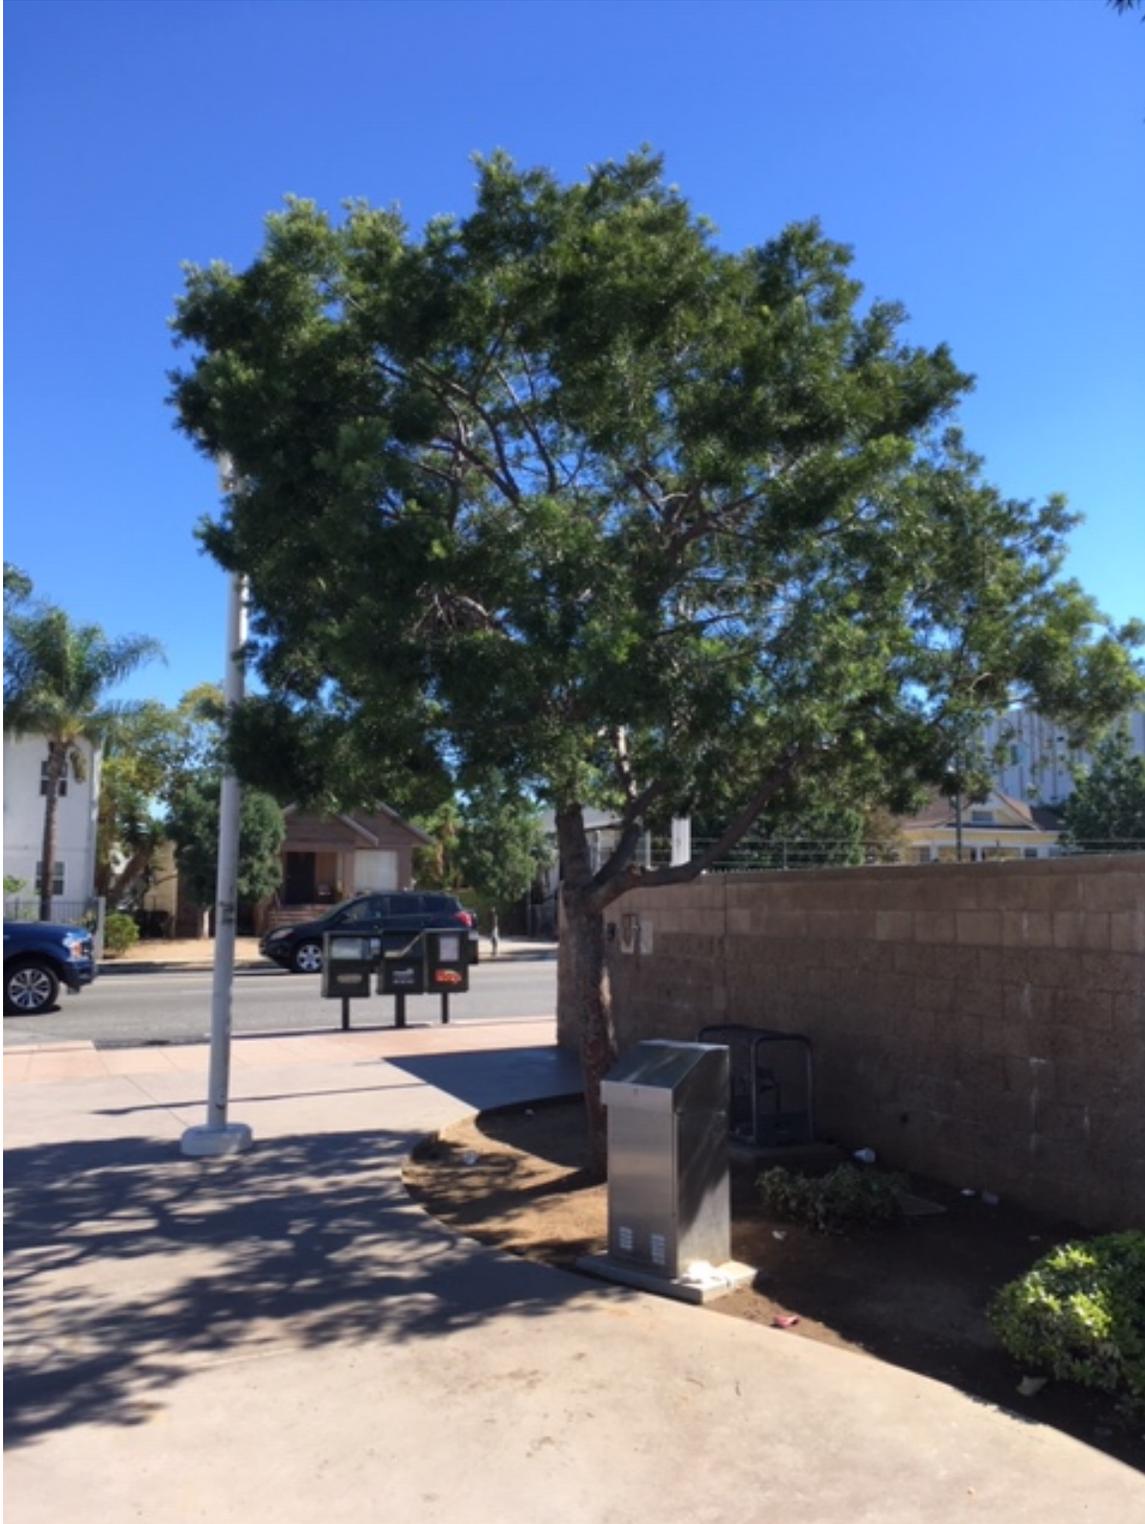
Figure 13: Tree 12 is not protected. It will be removed.

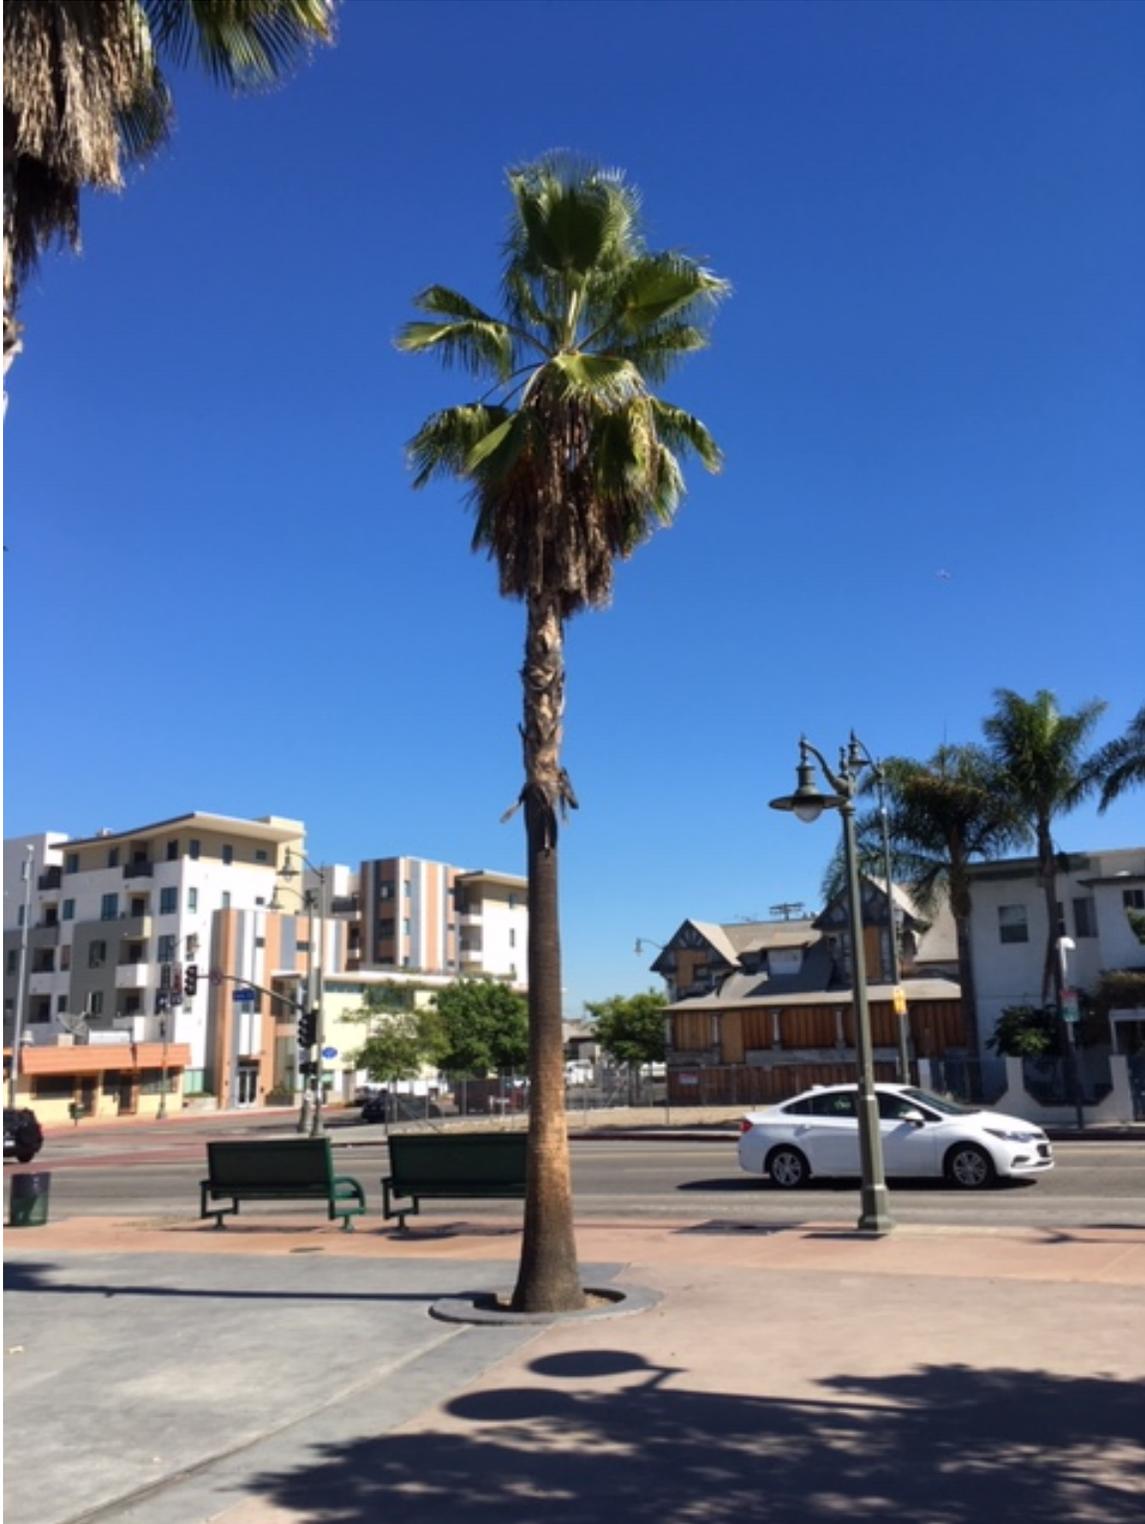
Figure 14: Tree 13 is not protected. It will be removed.

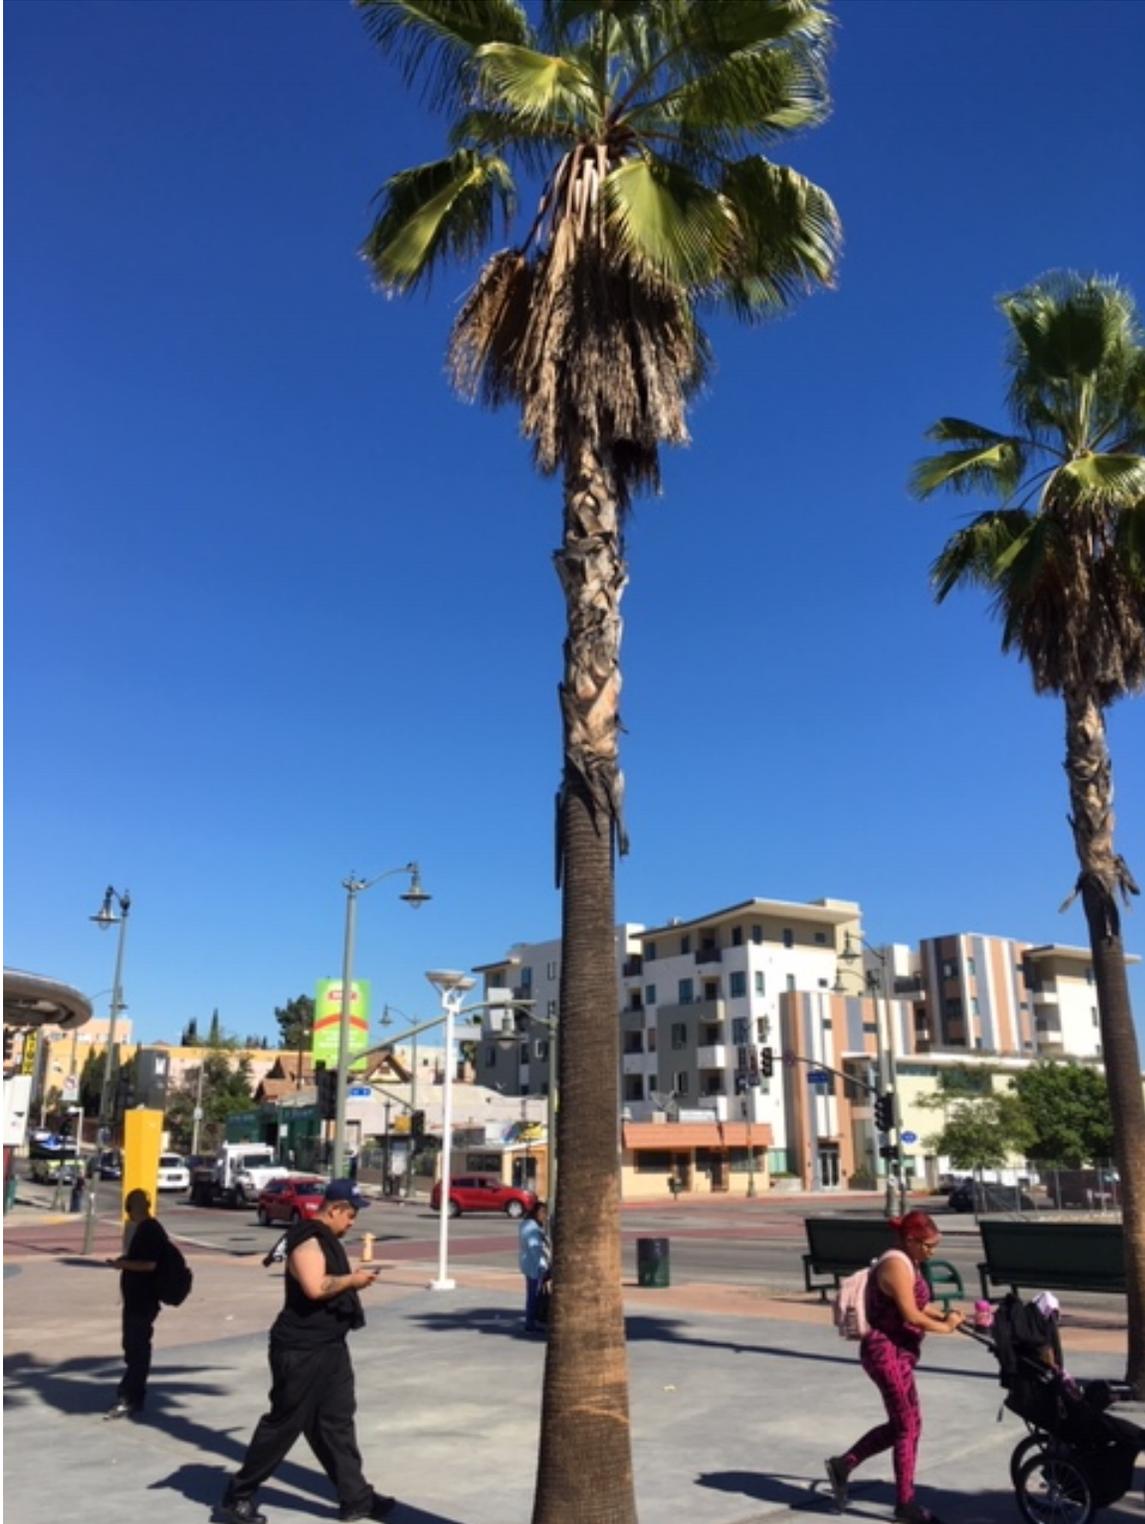
Figure 15: Tree 14 is not protected. It will be removed.

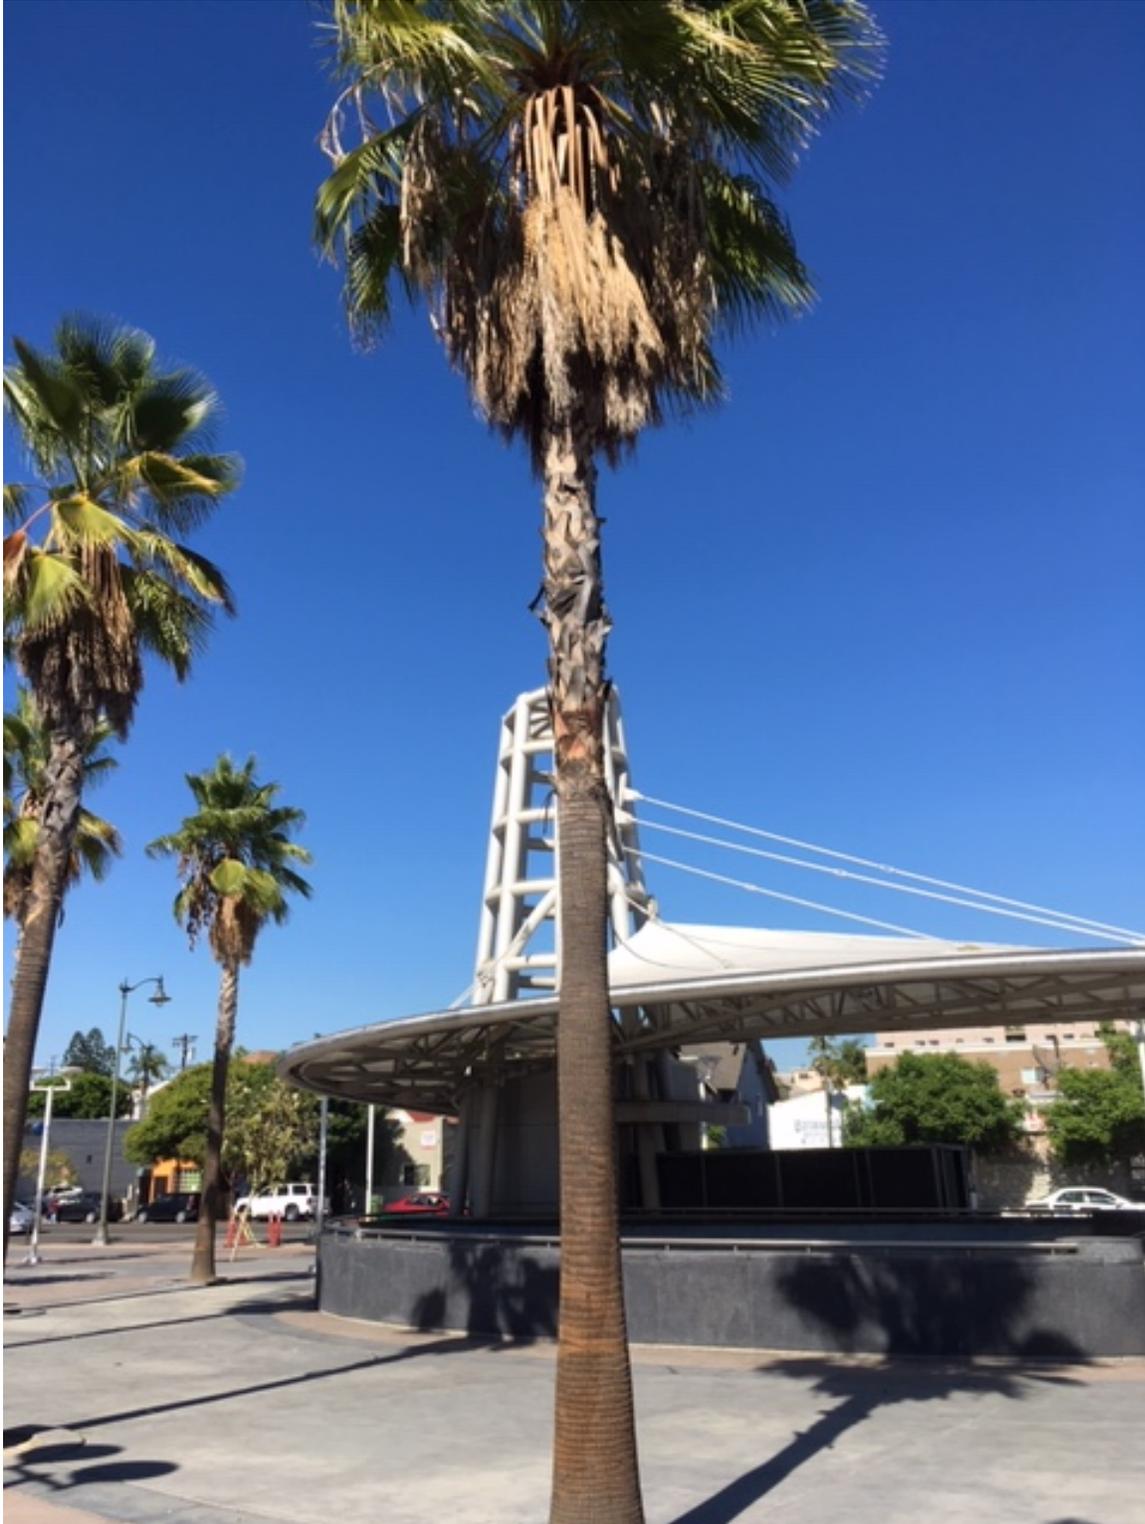
Figure 16: Tree 15 is not protected. It will be removed.

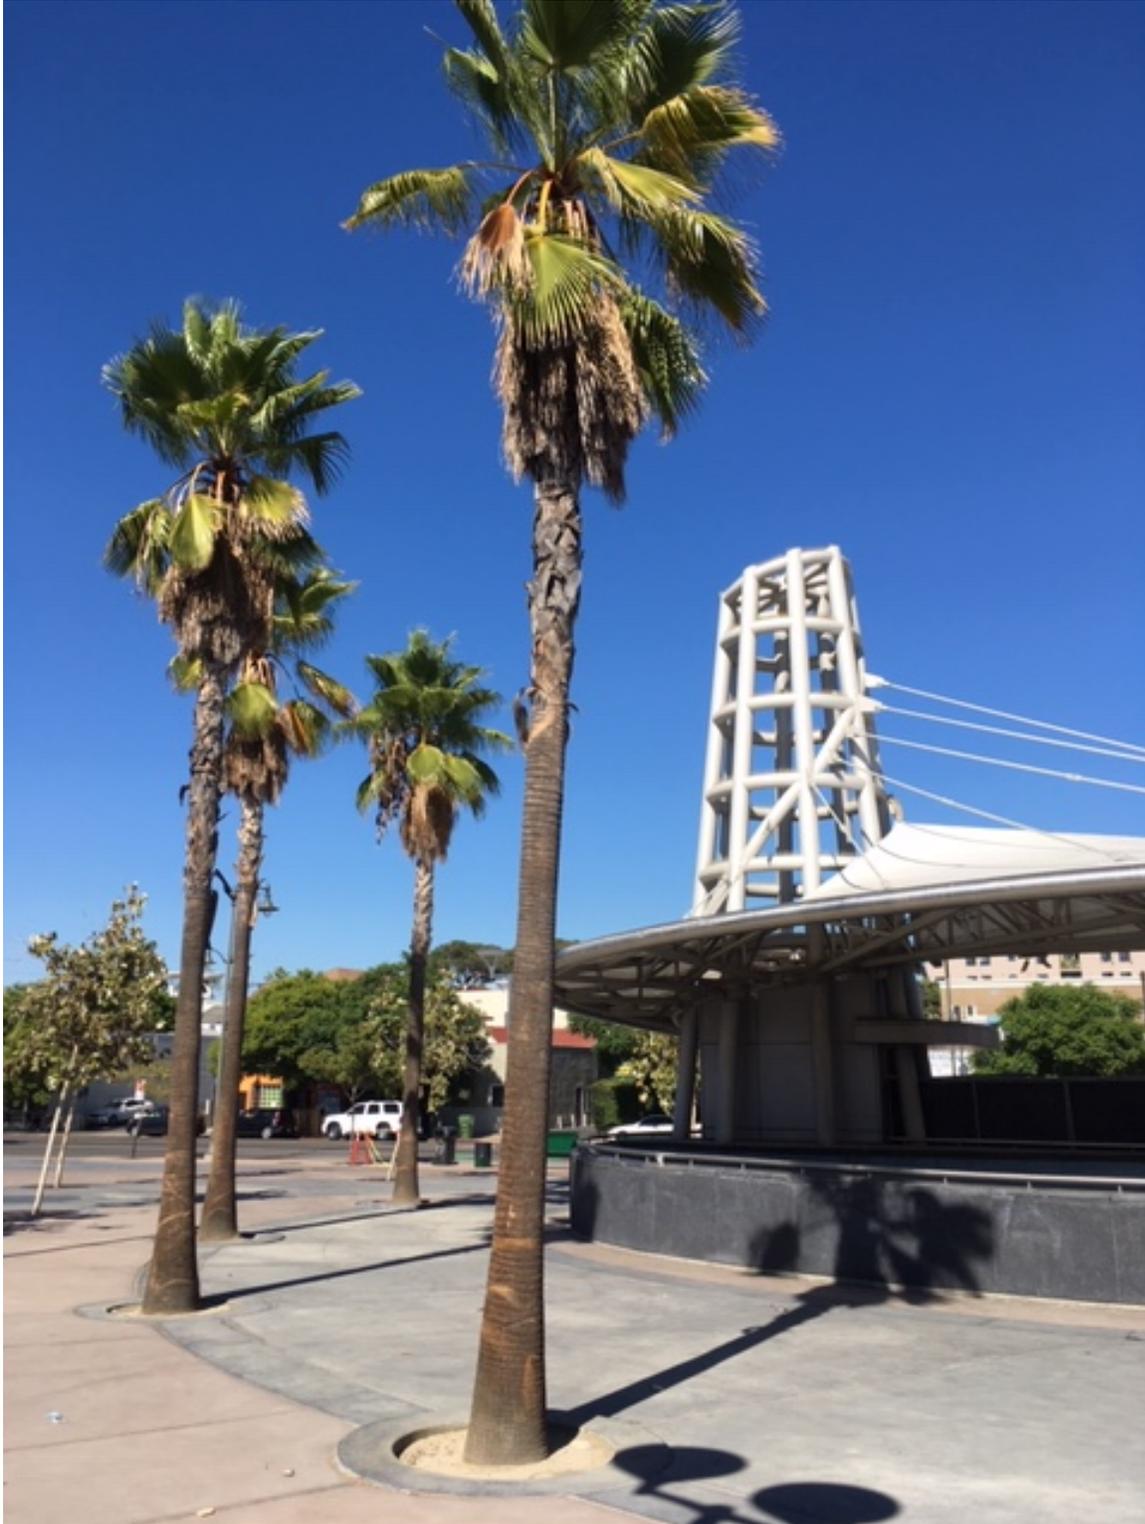
Figure 17: Tree 16 is not protected. It will be removed.

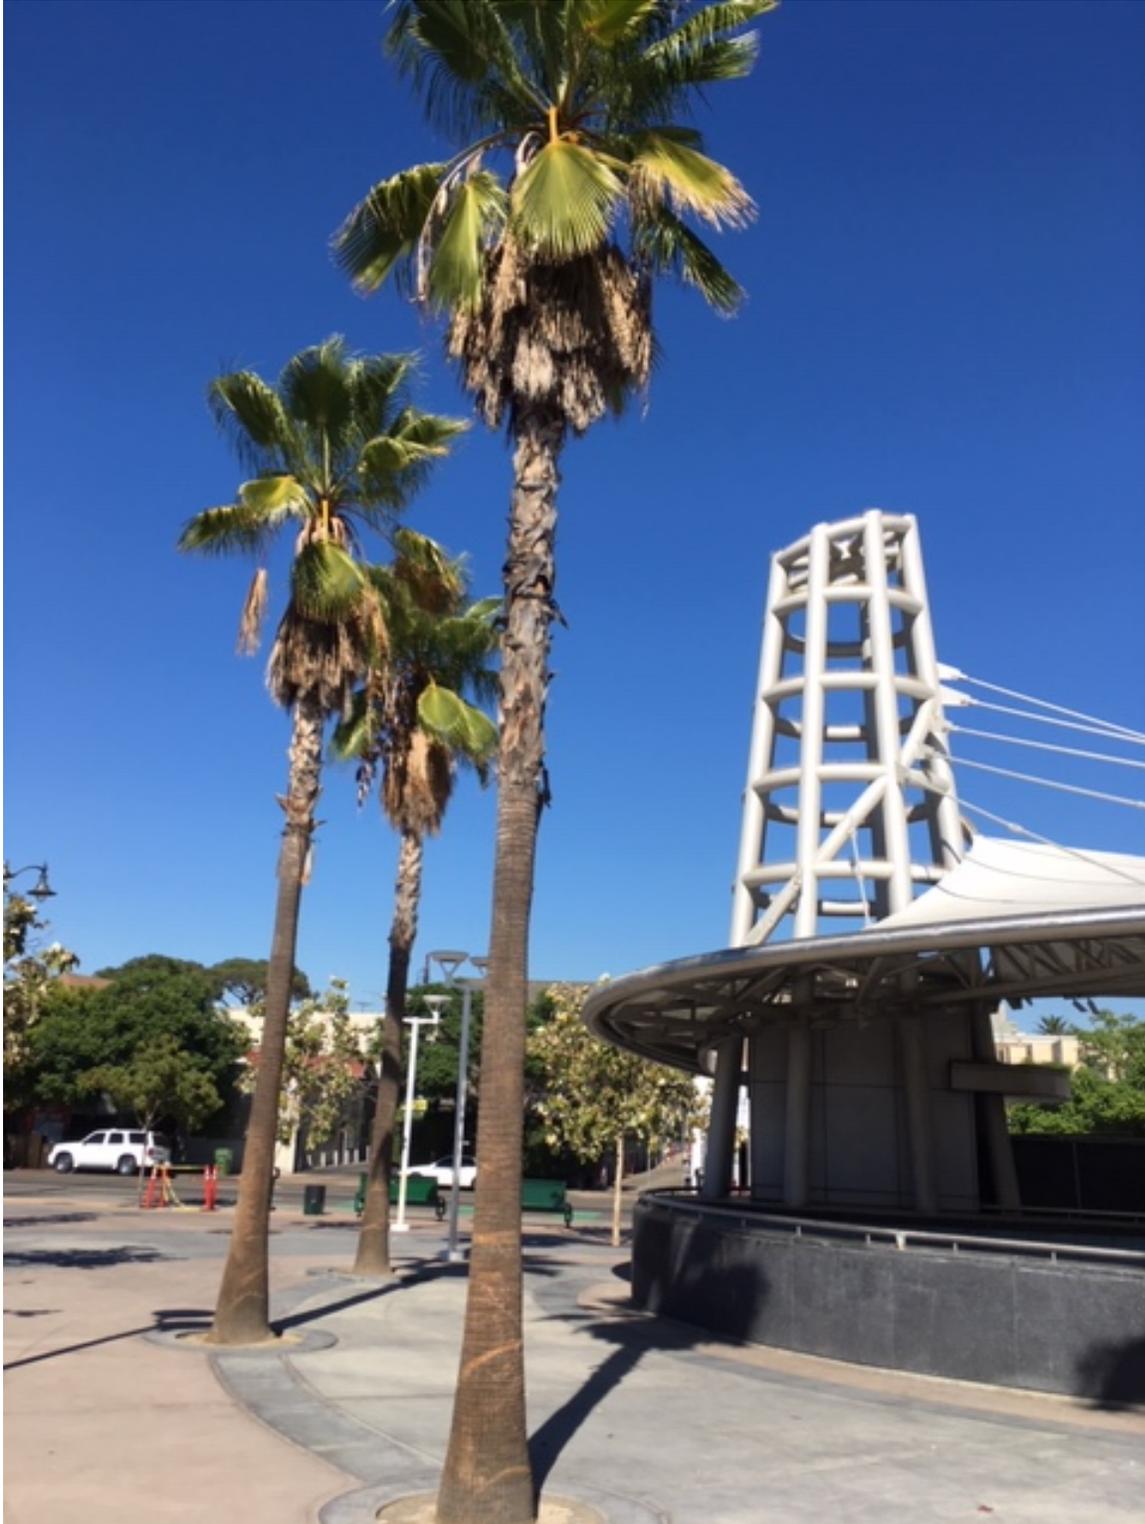
Figure 18: Tree 17 is not protected. It will be retained in the landscape.

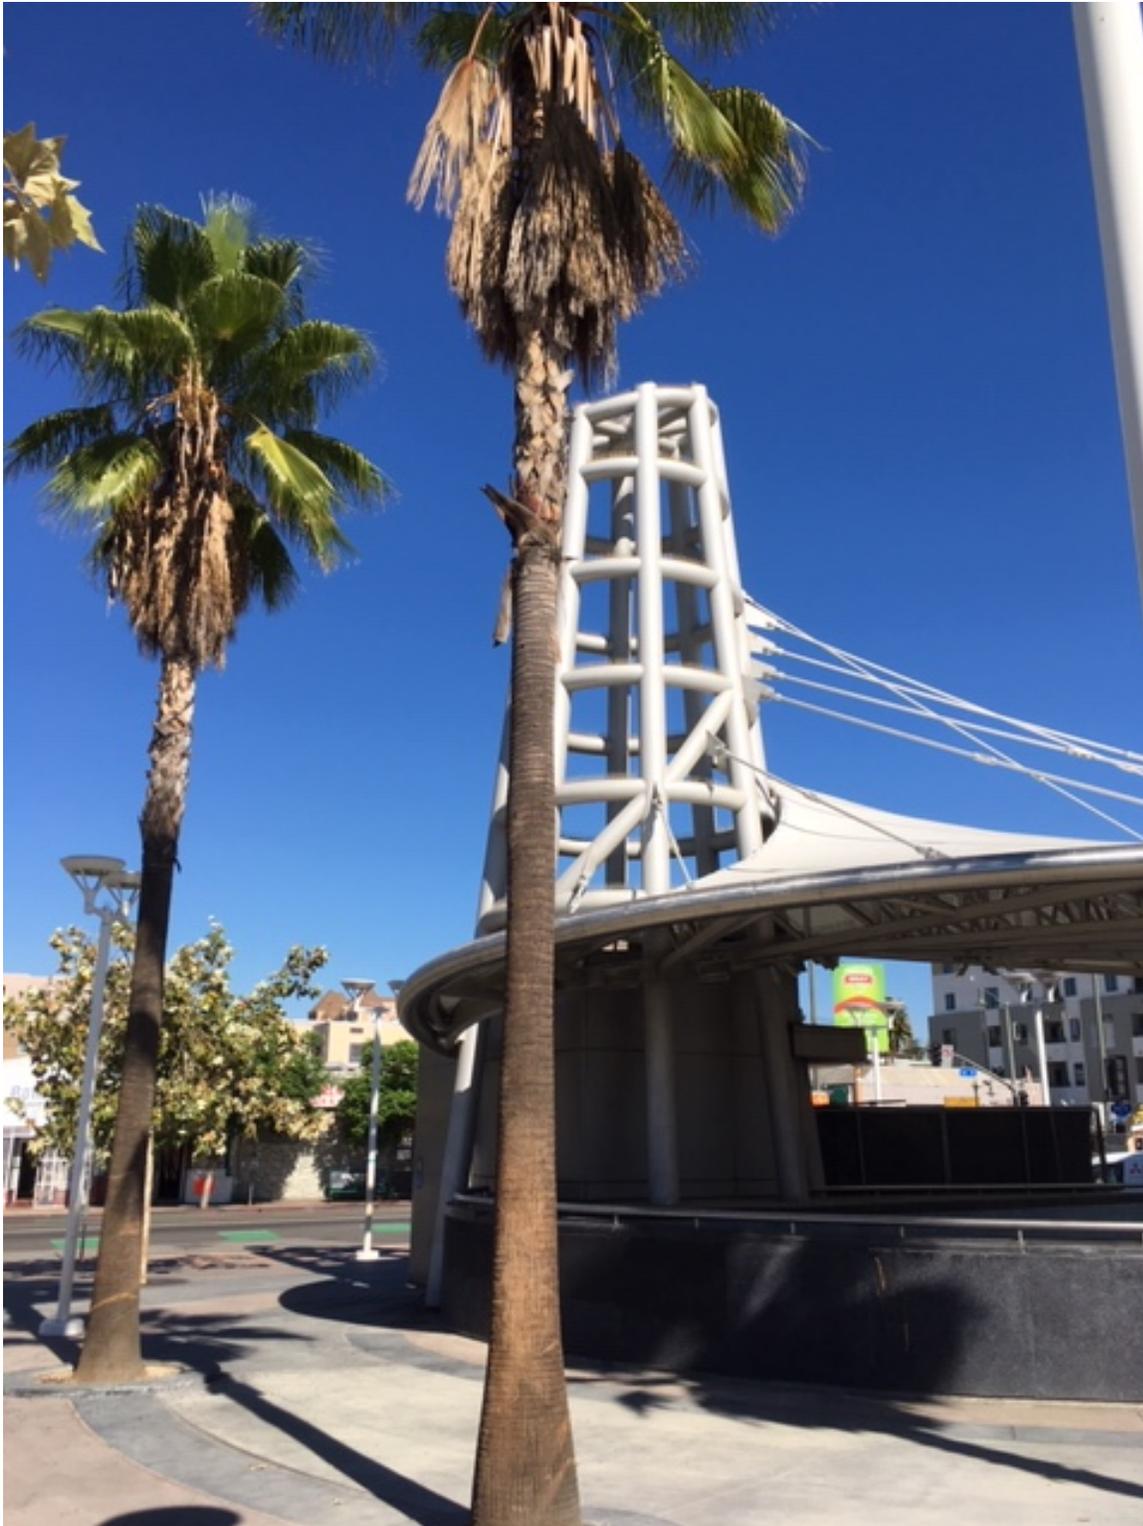
Figure 19: Tree 18 is not protected. It will be retained in the landscape.

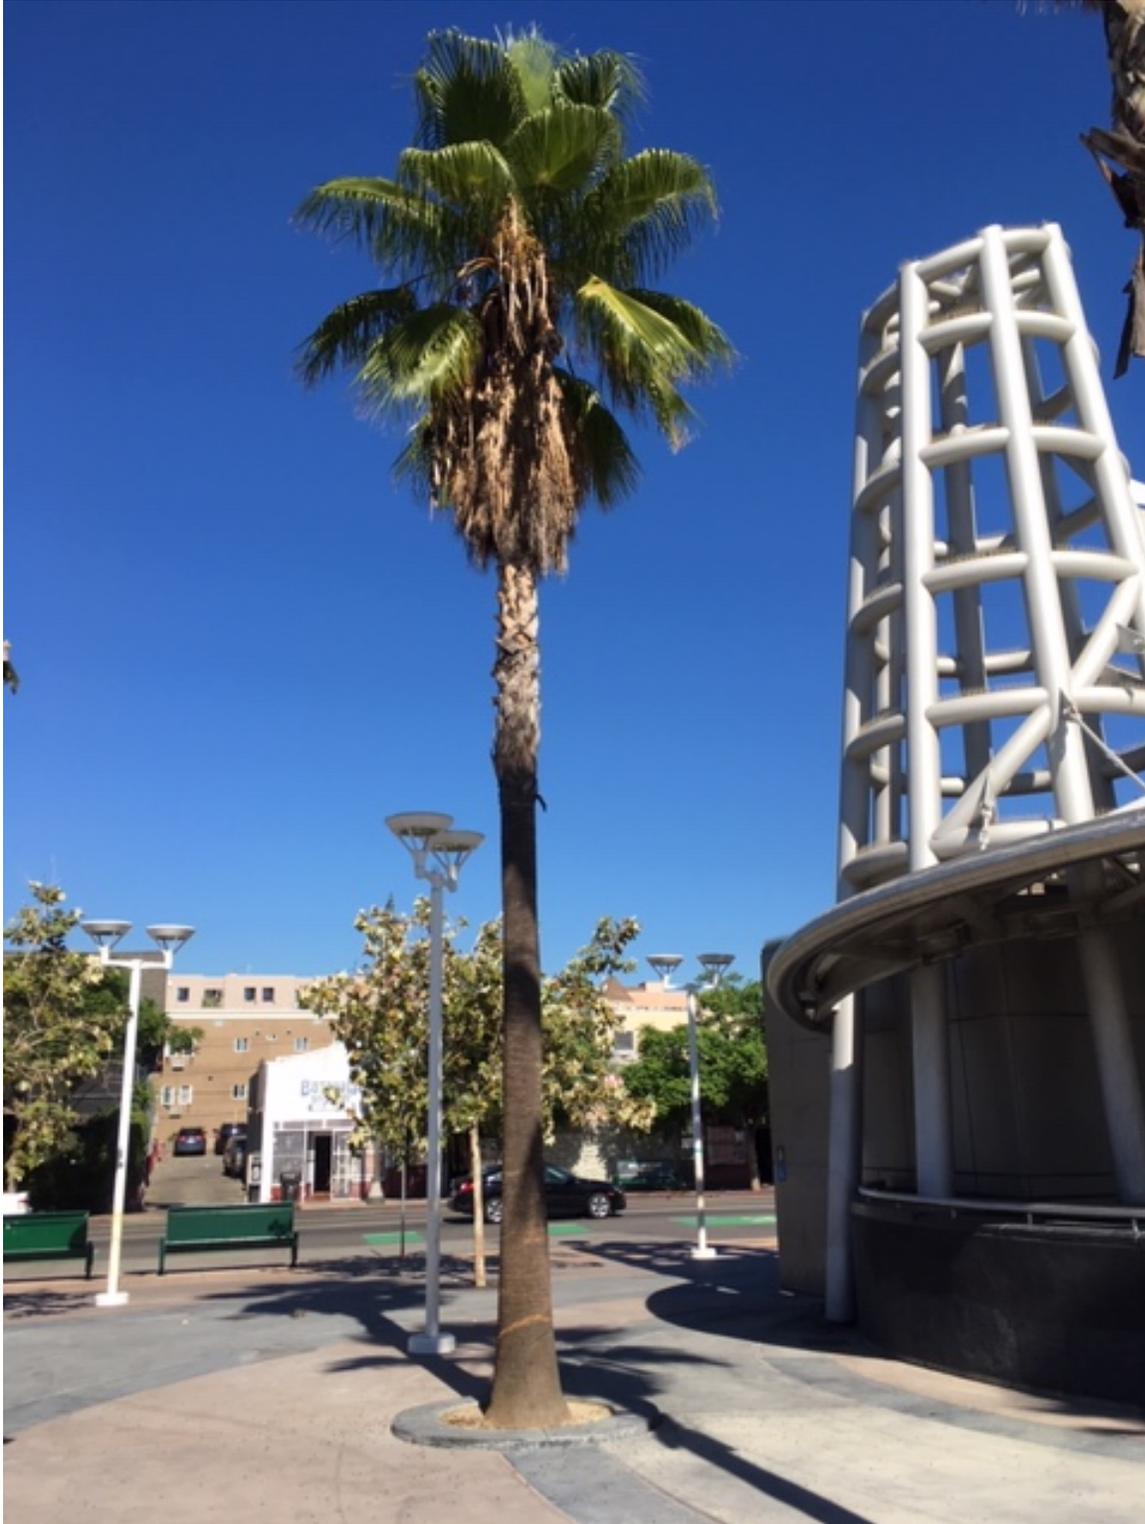
Figure 20: Tree 19 is not protected. It will be retained in the landscape.

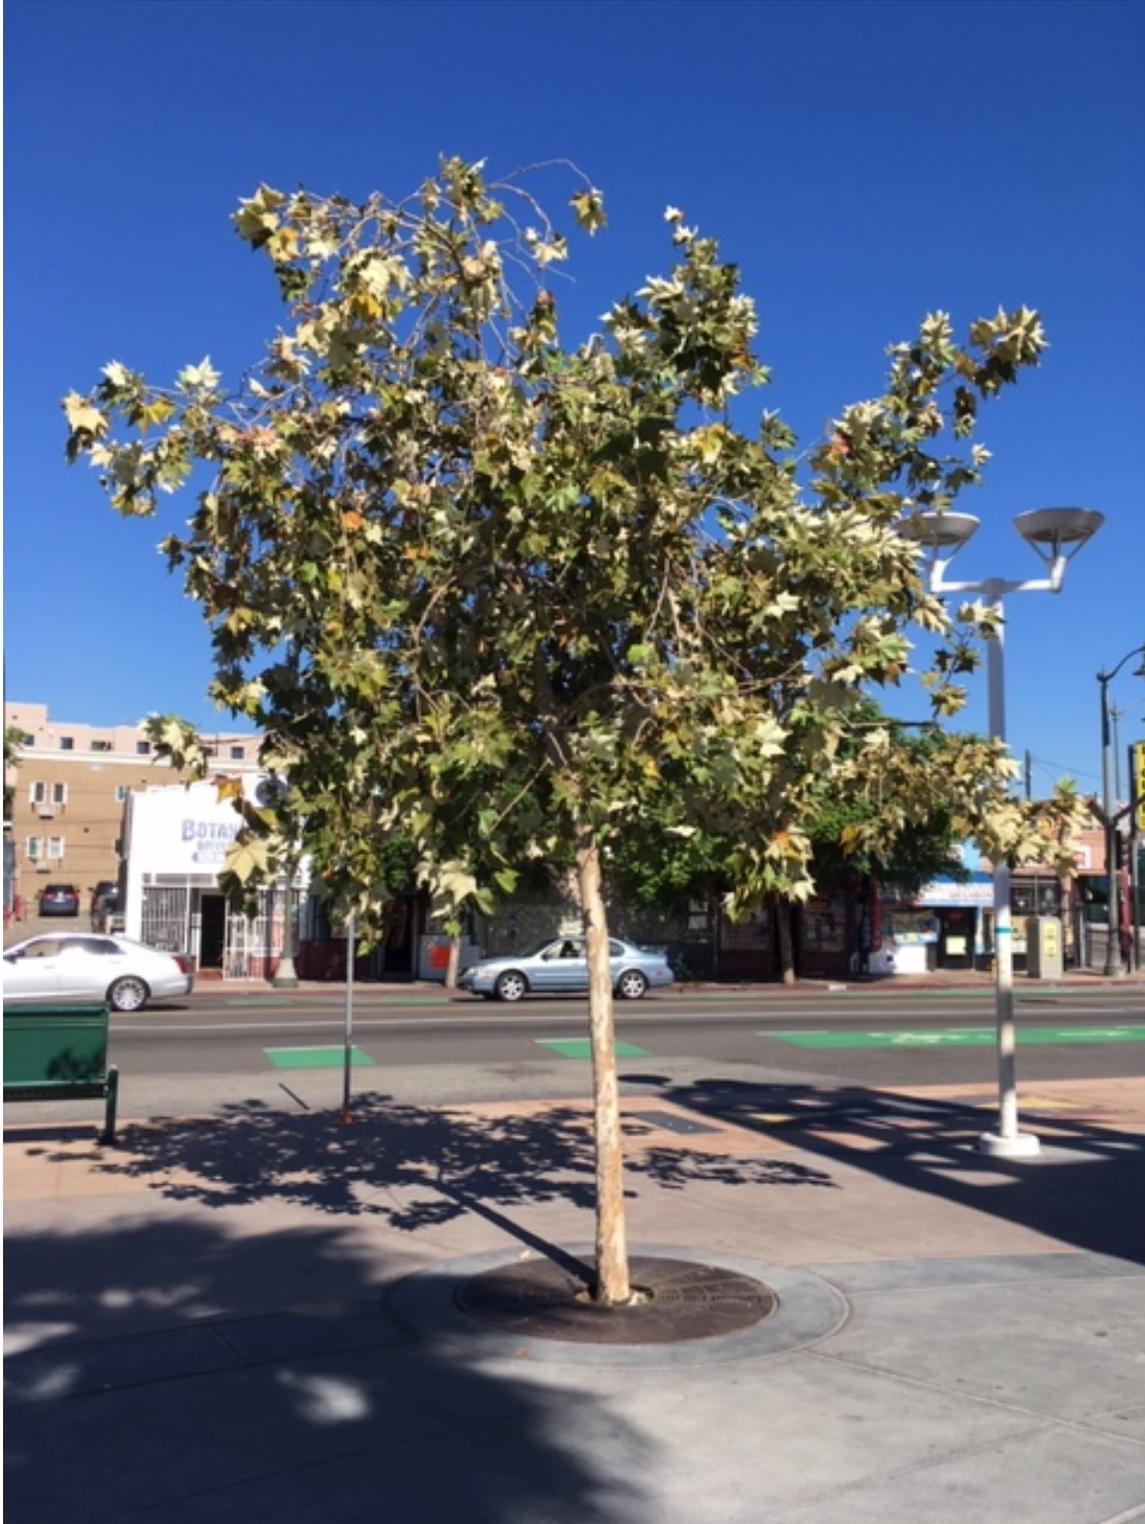
Figure 21: Tree 20 is not protected. It will be retained in the landscape.

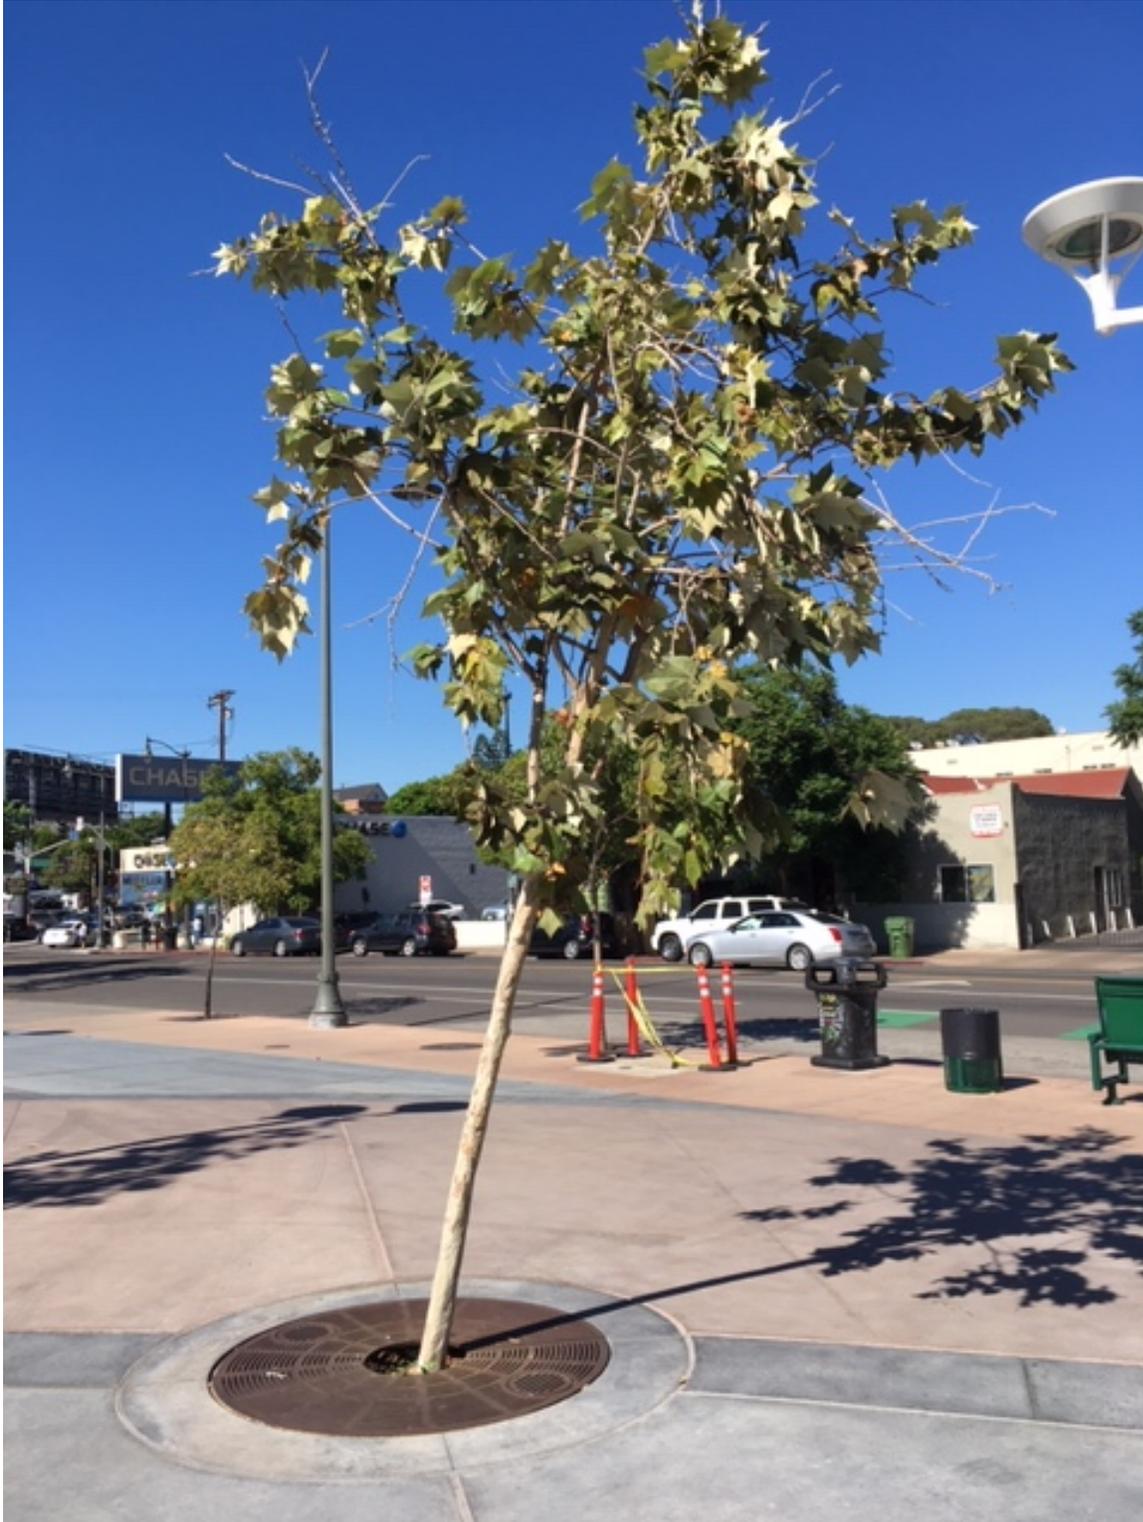
Figure 22: Tree 21 is not protected. It will be retained in the landscape.
