Appendix A
Tree Report

Los Lirios Apartments Arborist Report

Prepared for East LA Community Corporation
Jacqueline Monterrosas
2917 E. 1st Street, Suite 101
Los Angeles, CA 90033

Prepared by James Komen
BCMA WE-9909B
RCA #555

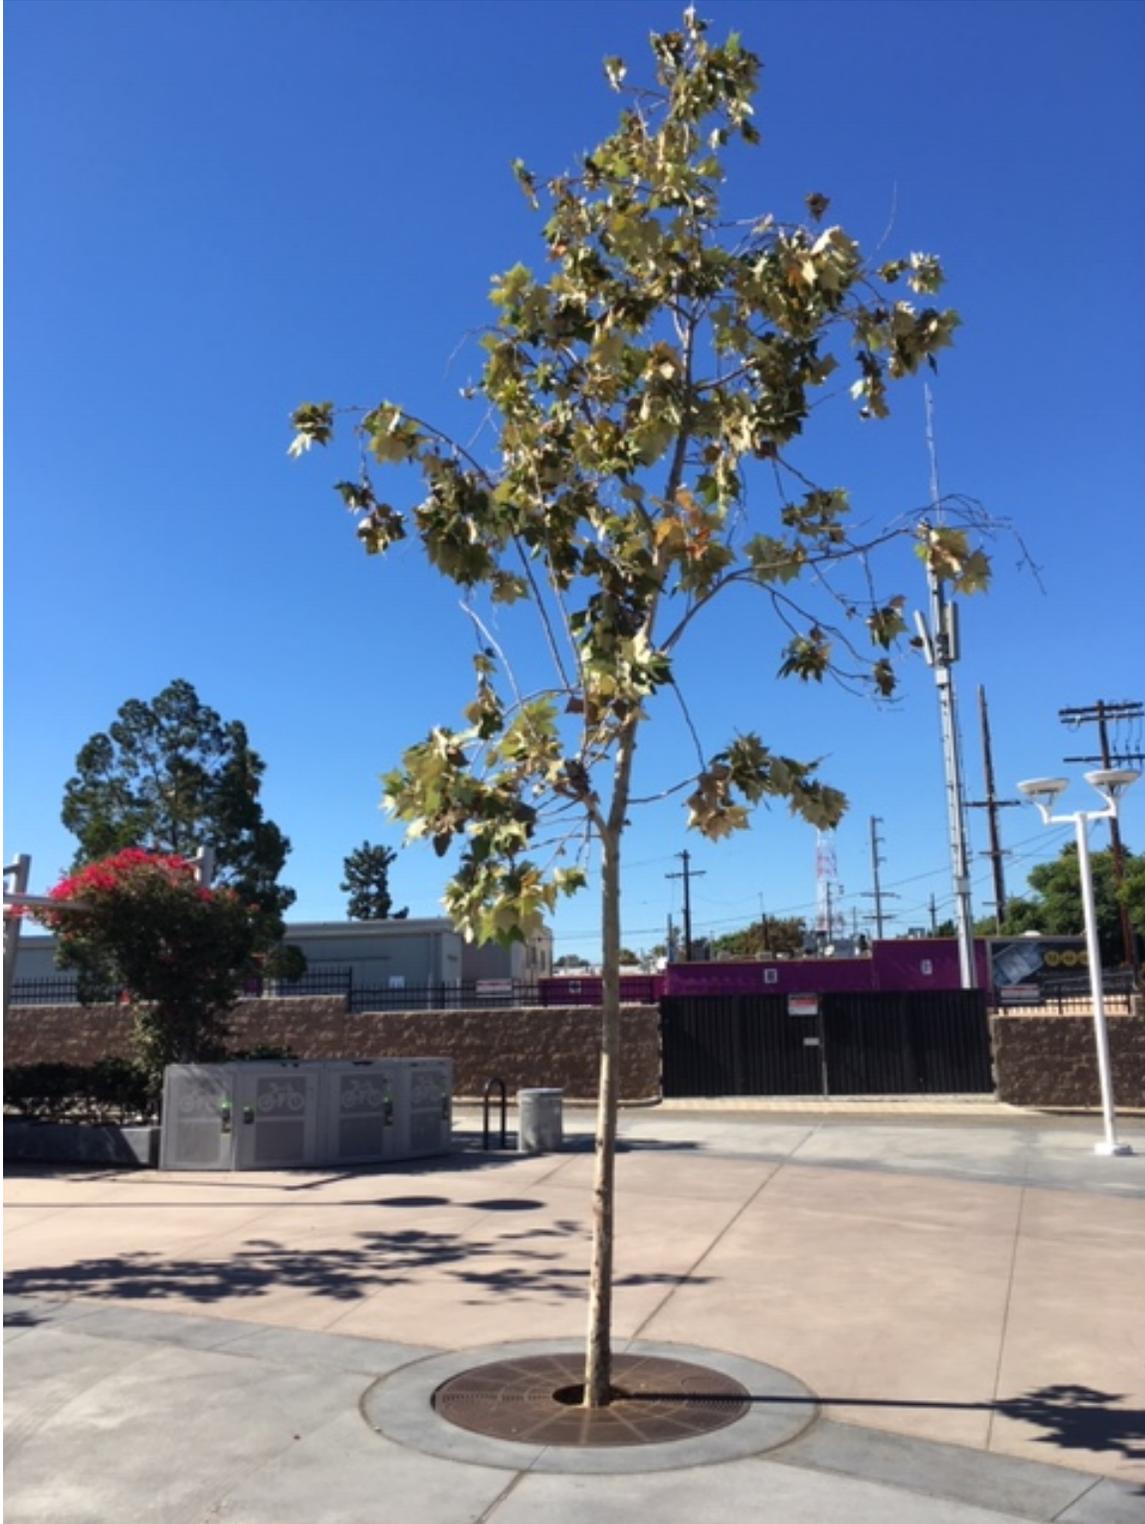
Figure 23: Tree 22 is not protected. It will be retained in the landscape.

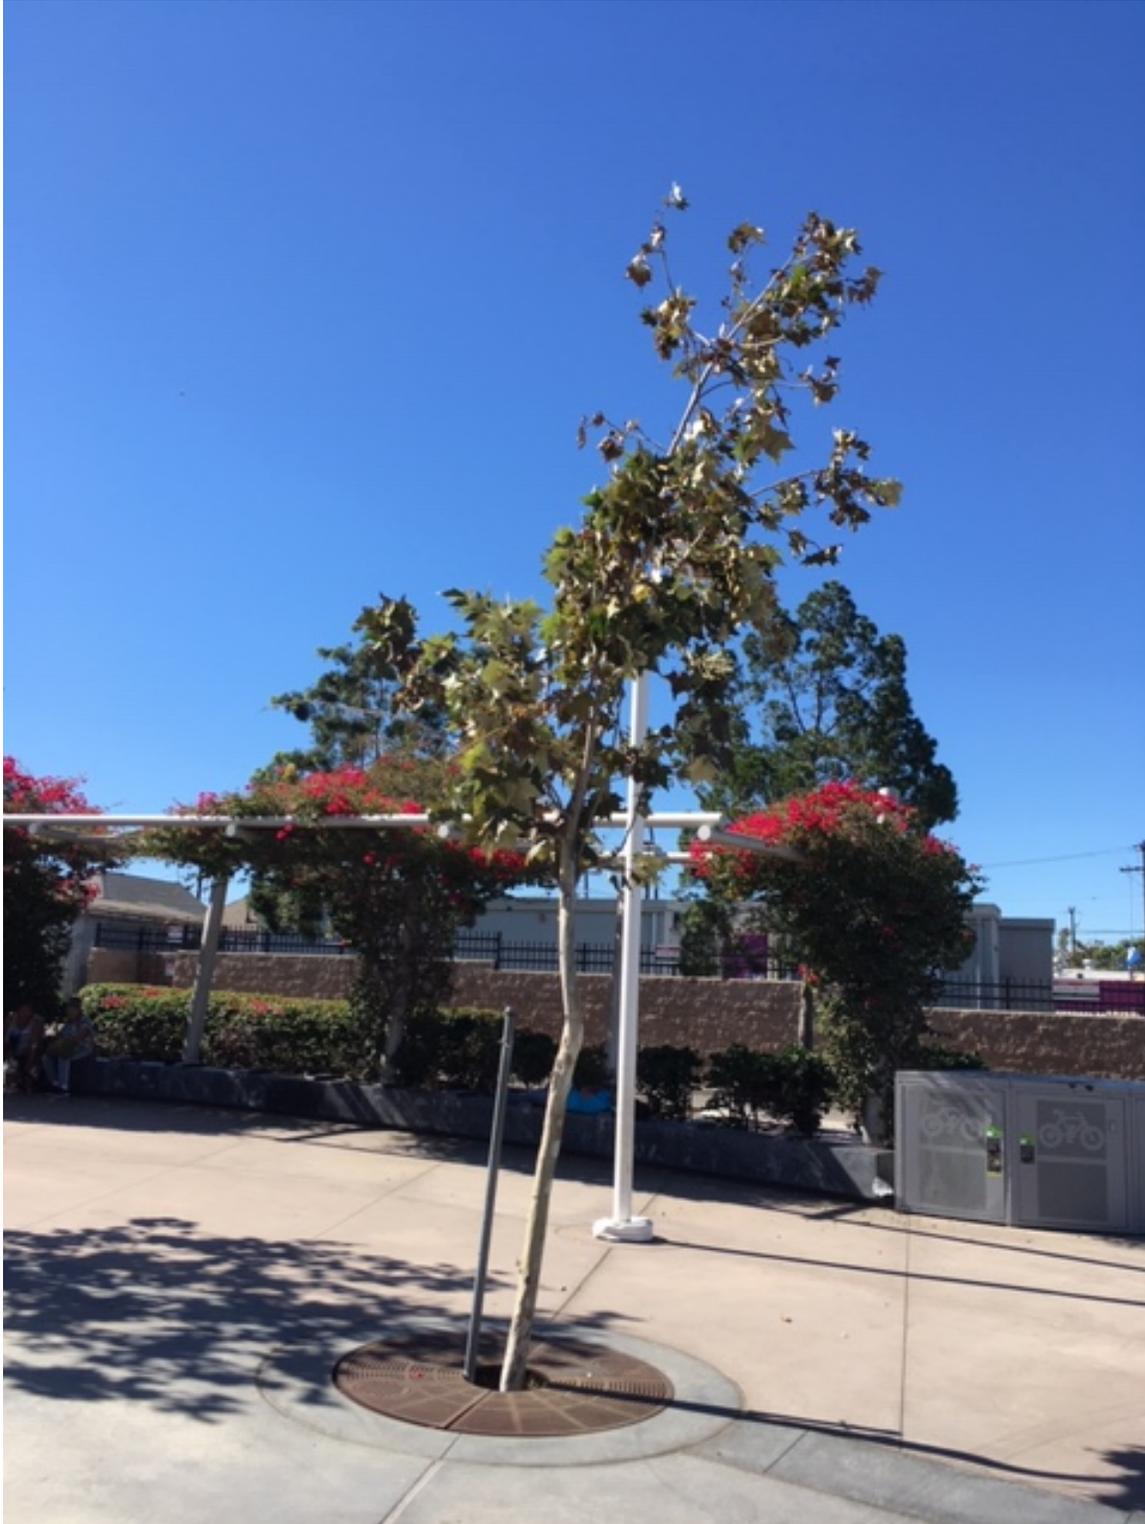
Figure 24: Tree 23 is not protected. It will be removed.

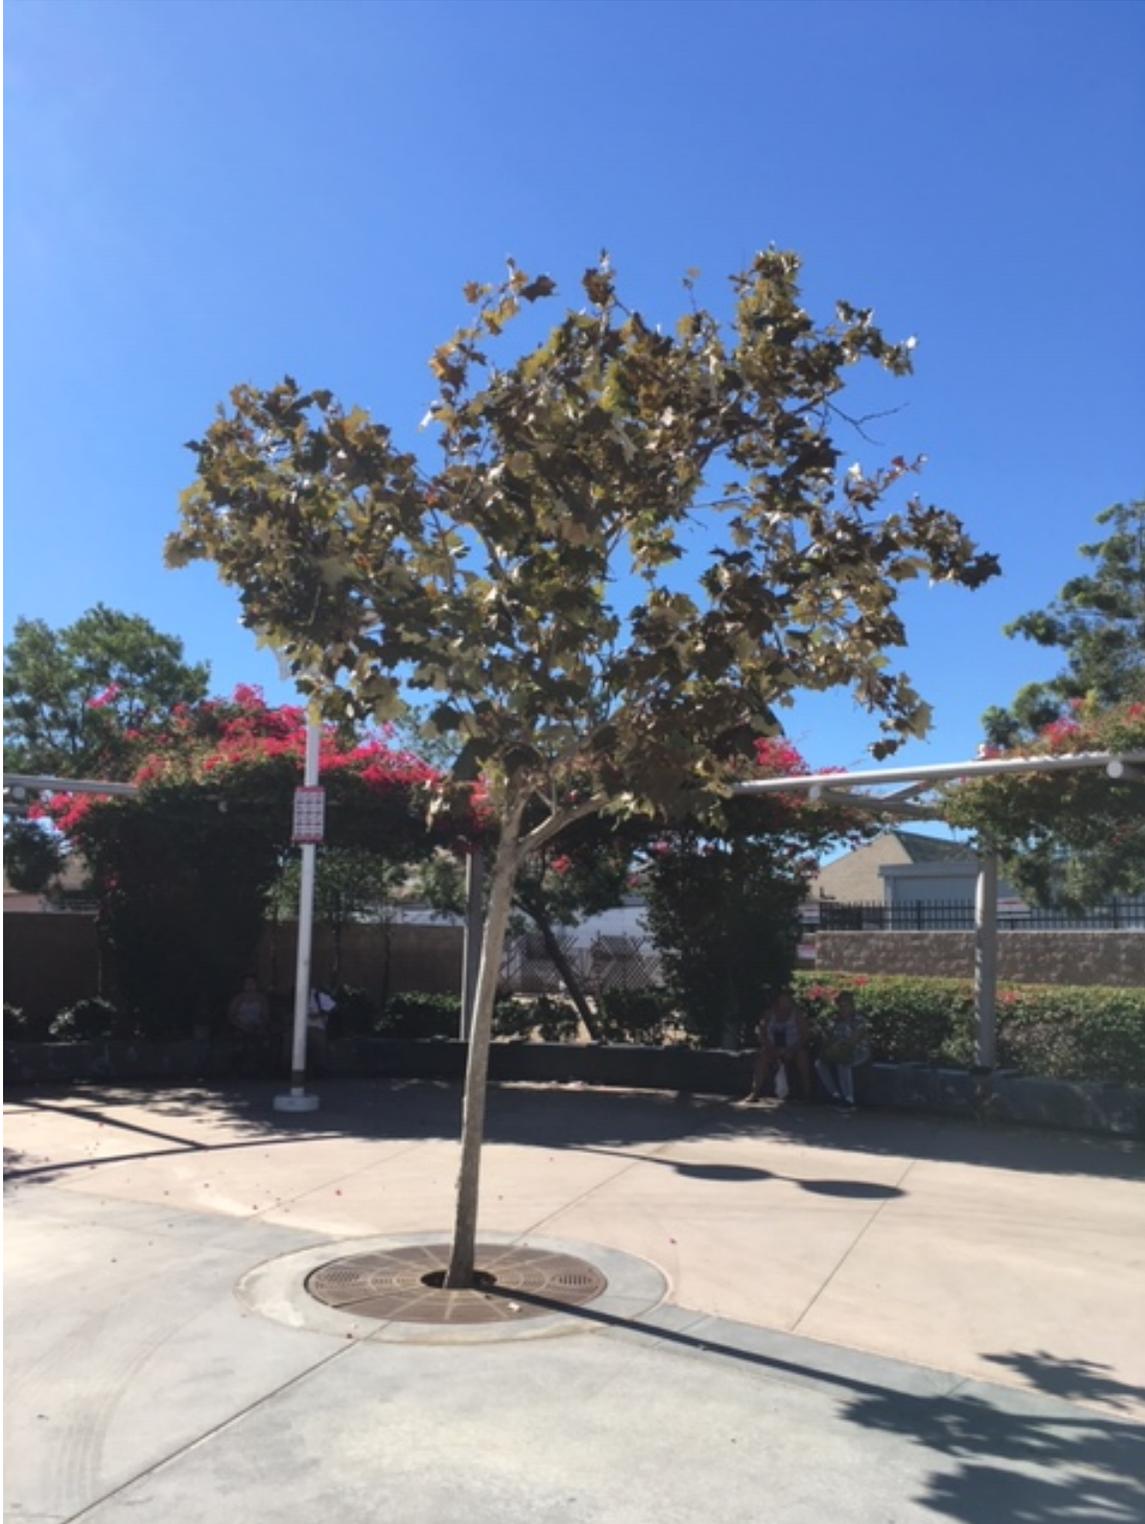
Figure 25: Tree 24 is not protected. It will be removed.

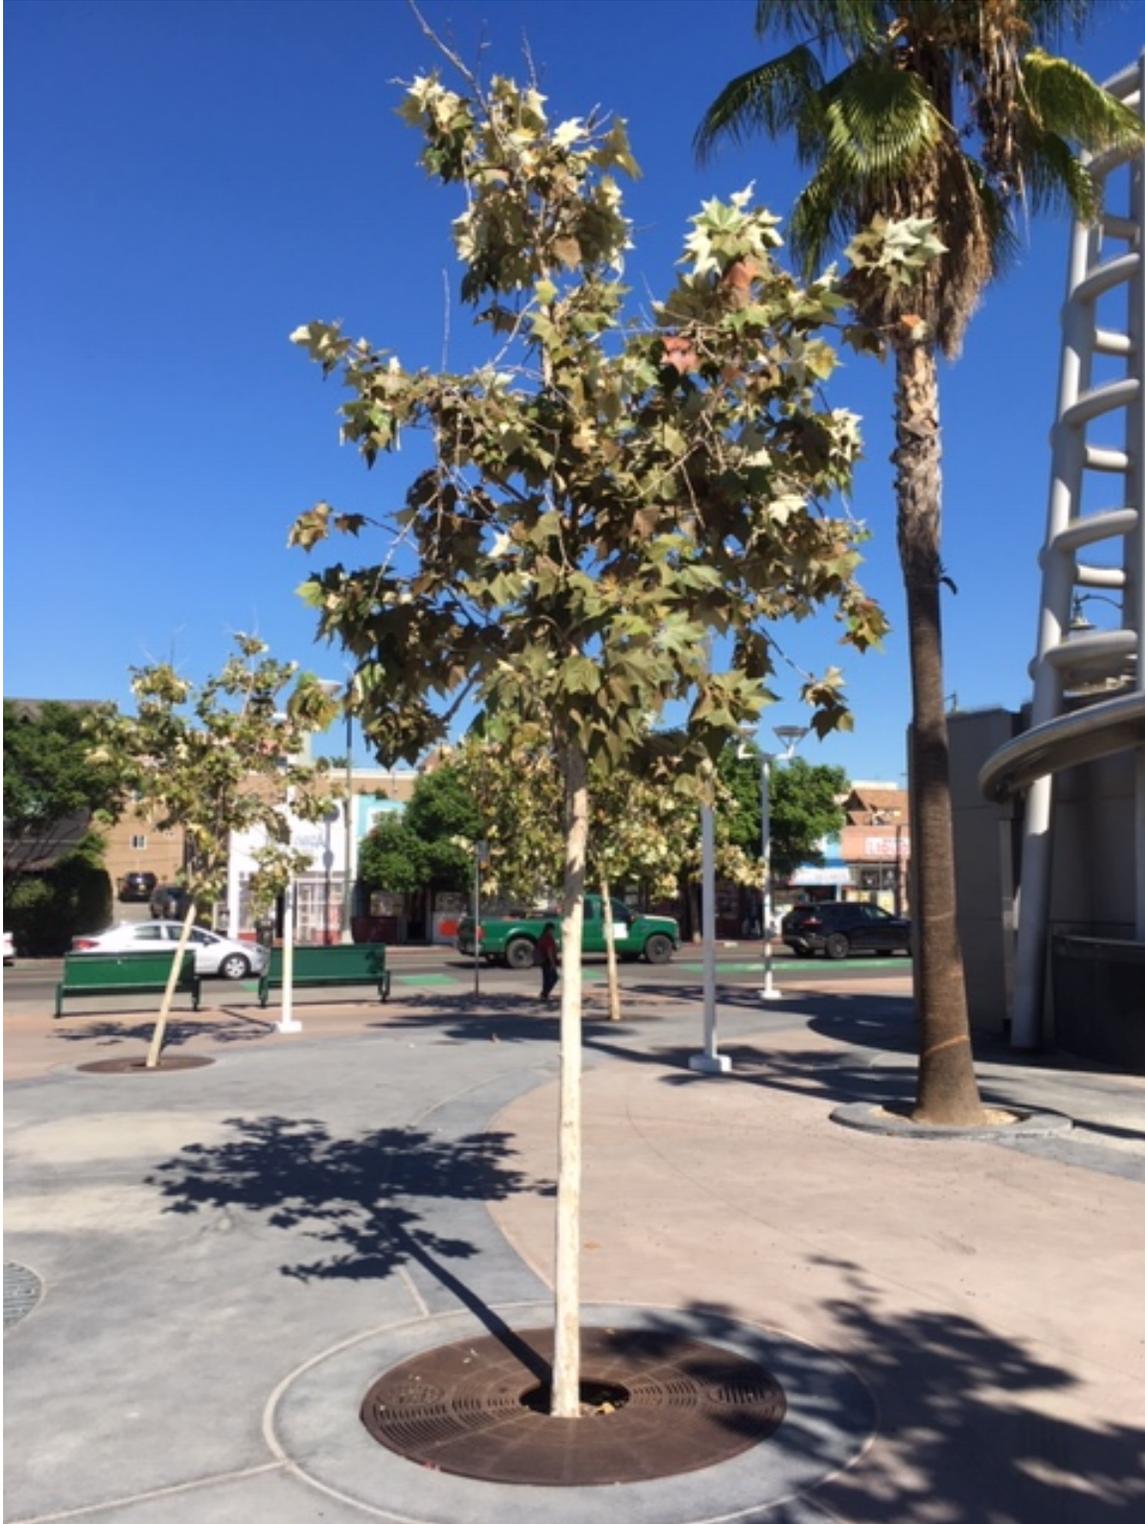
Figure 26: Tree 25 is not protected. It will be removed.

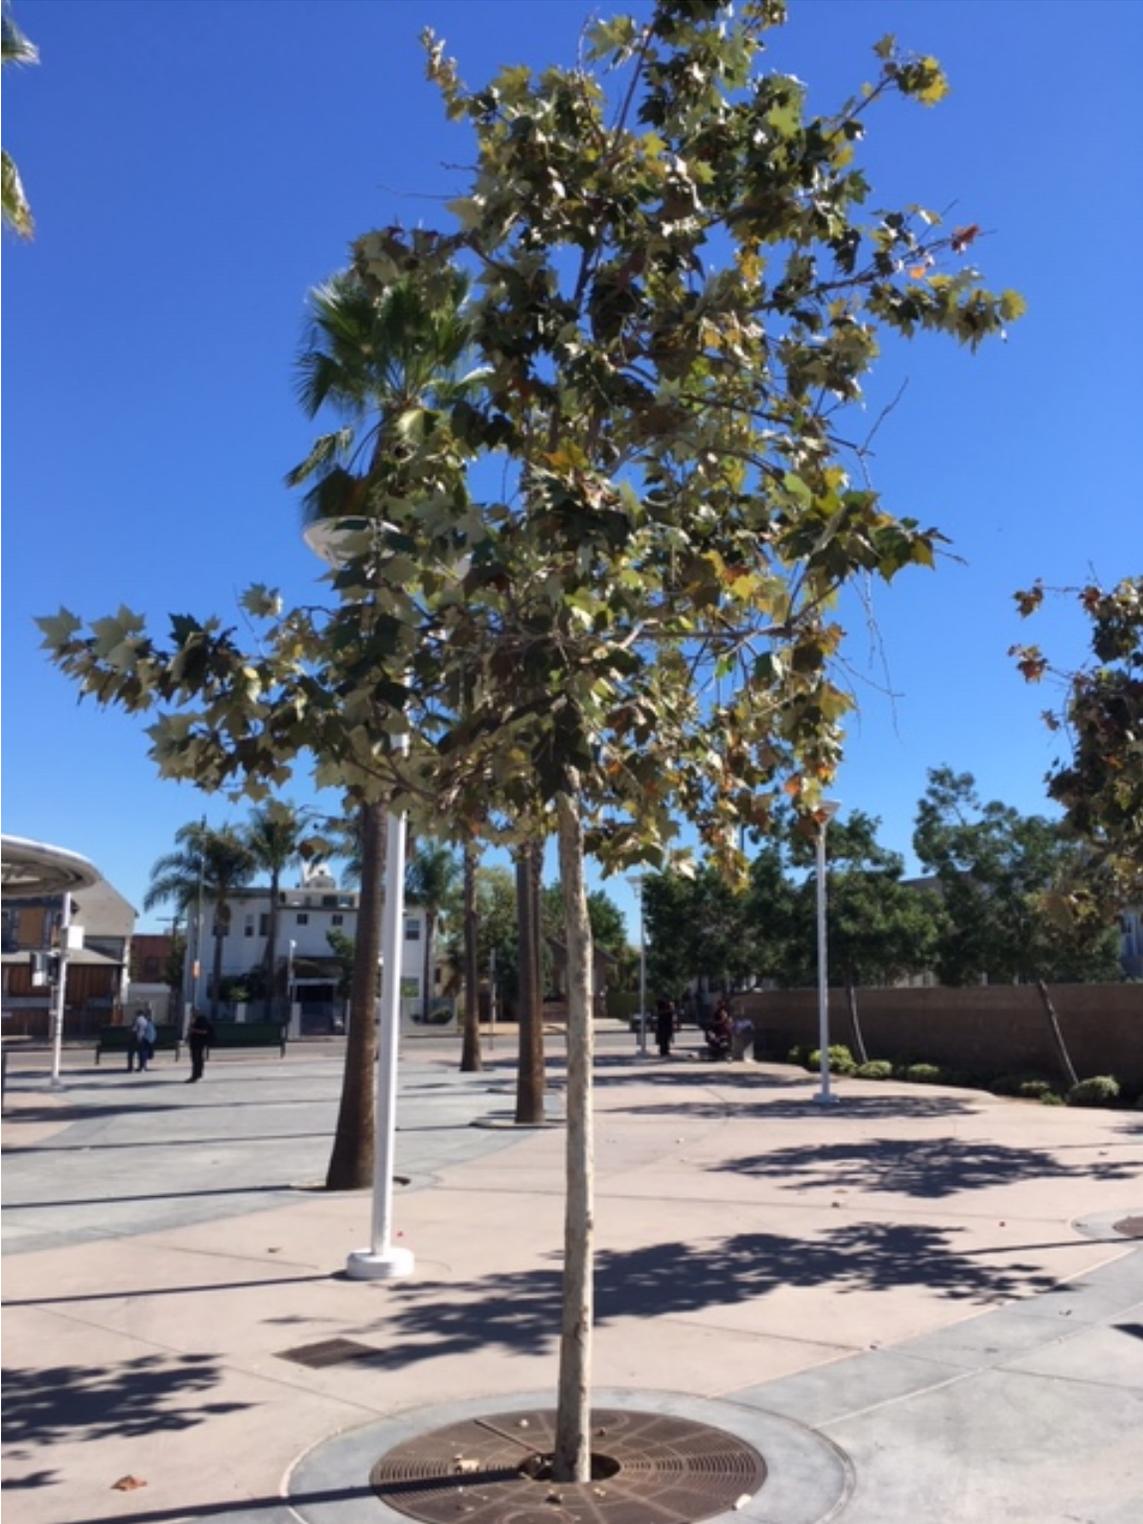
Figure 27: Tree 26 is not protected. It will be removed.

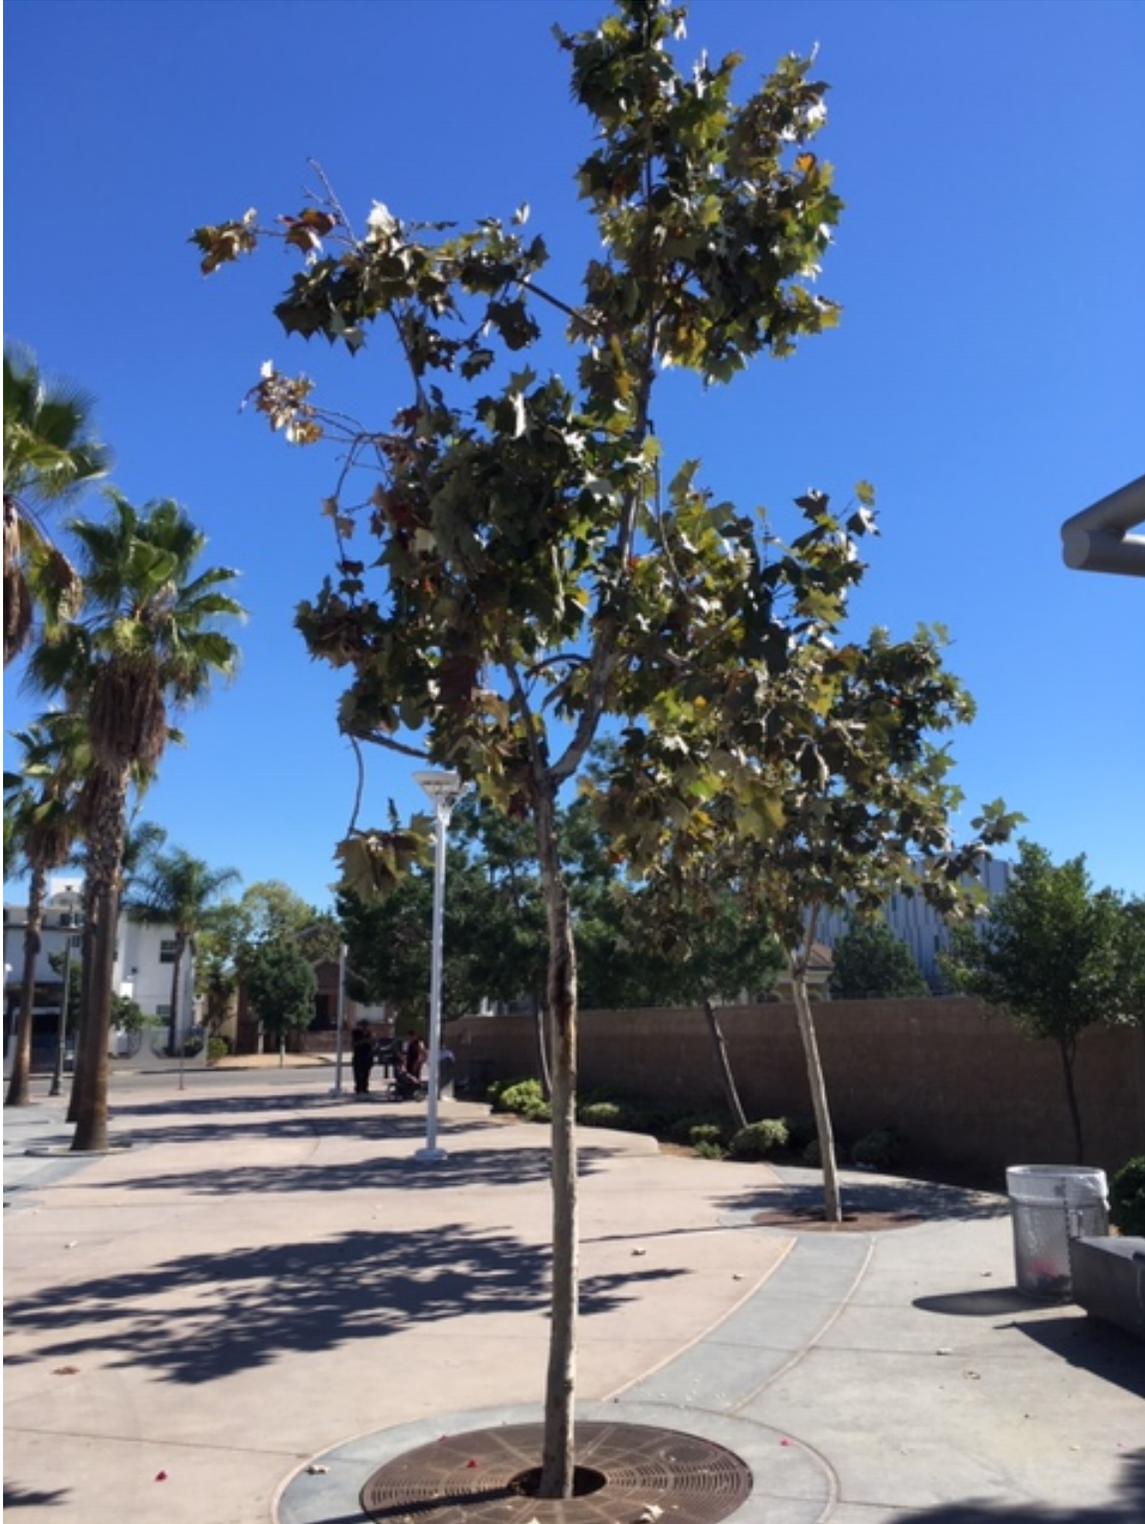
Figure 28: Tree 27 is not protected. It will be removed.

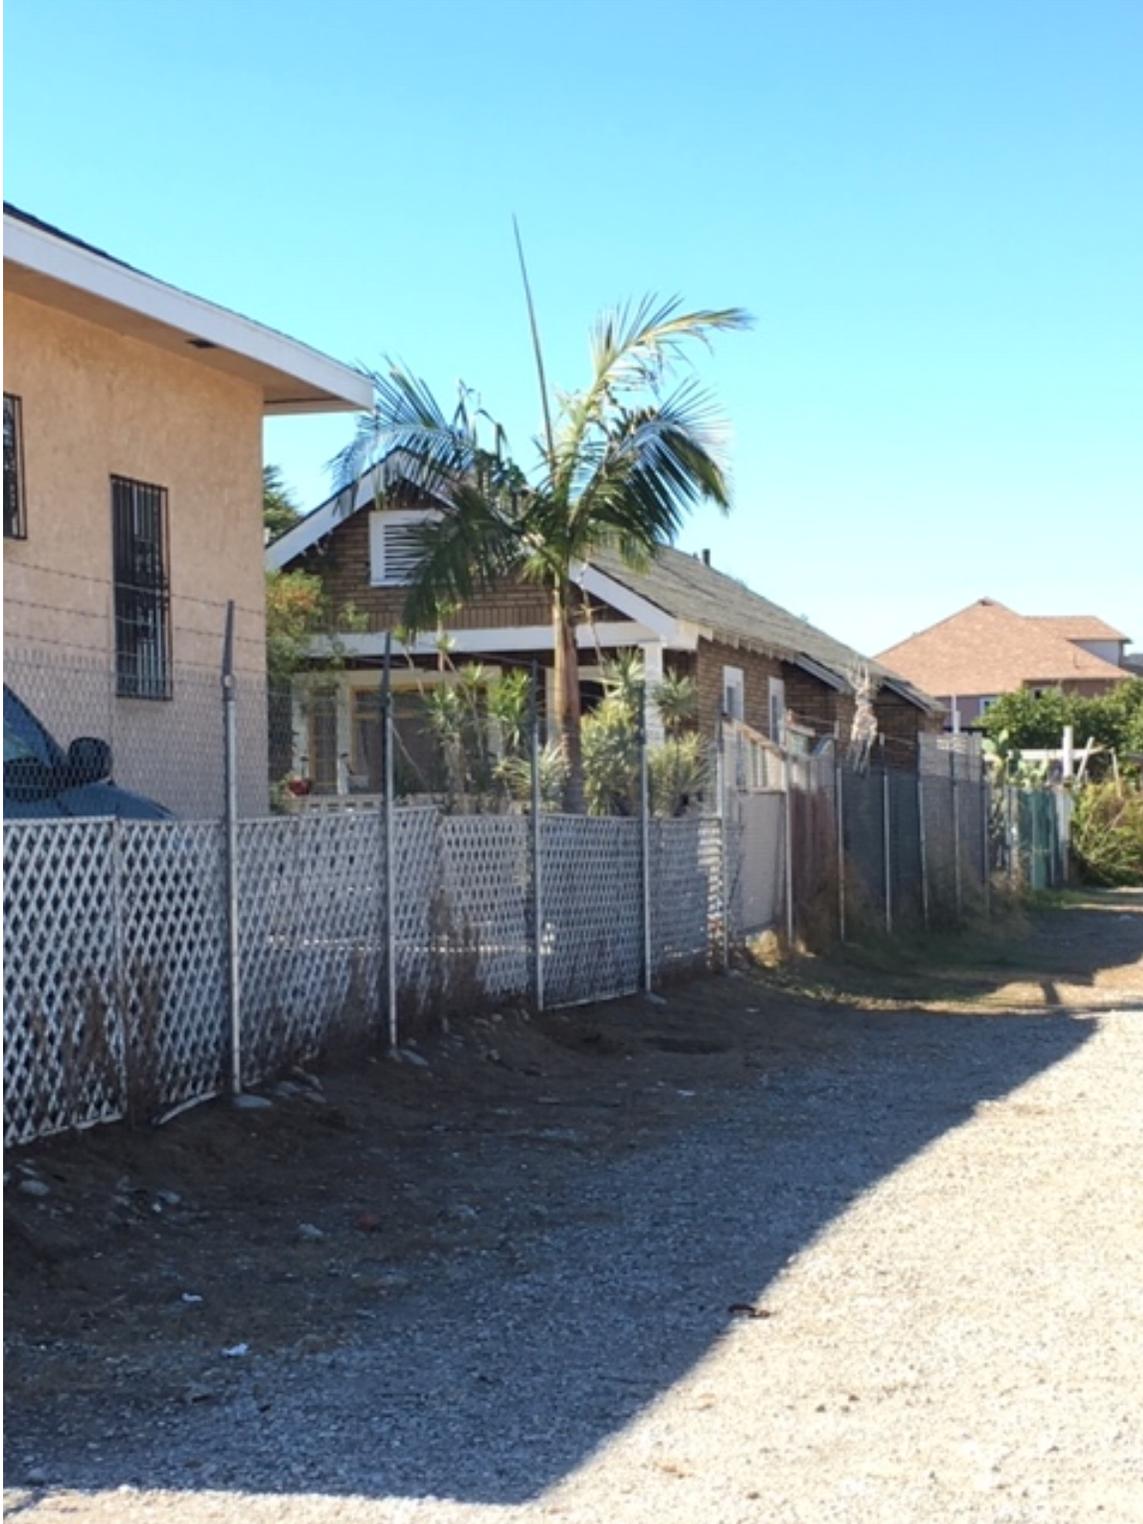
Figure 29: Tree OP28 is not protected. It is growing on a neighboring property. It is unlikely to be affected by the proposed construction.

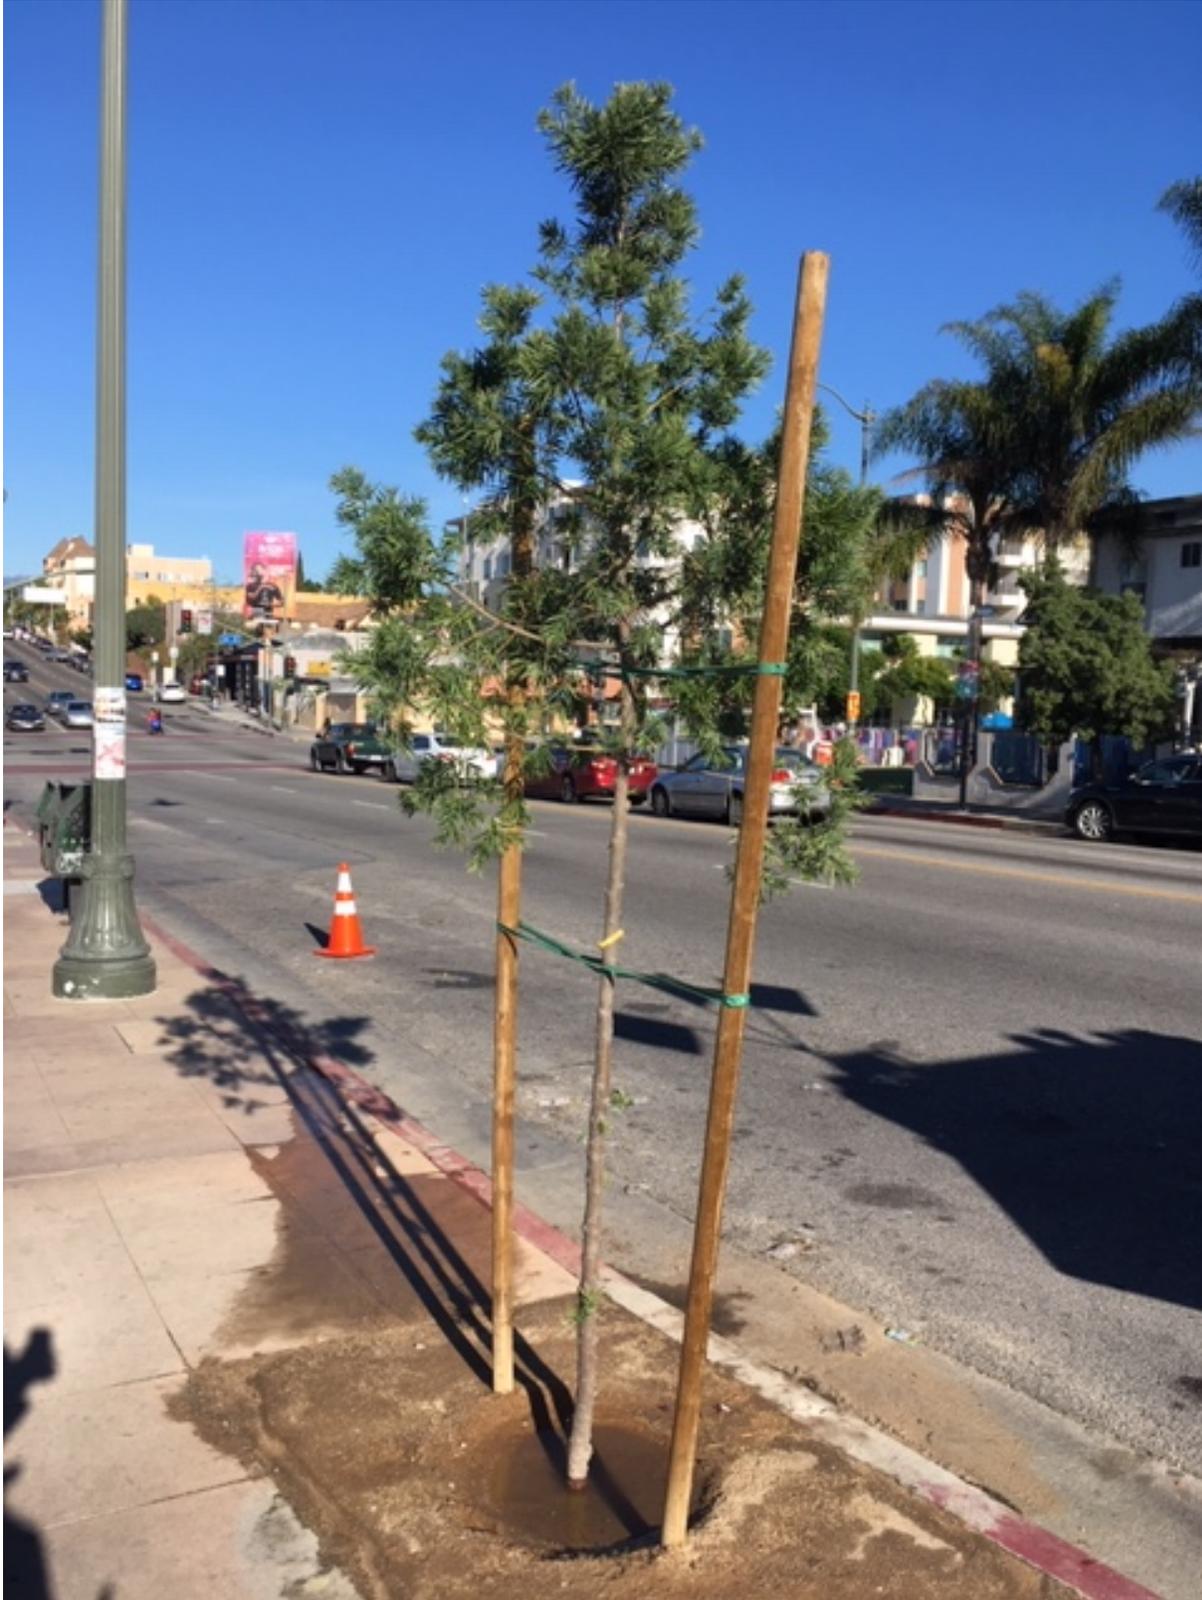
Figure 30: Tree 29 is a street tree. It will be preserved through construction.

- Erect construction fencing around the perimeter of the project footprint to exclude pedestrians at the Metro Station. This fencing will also exclude construction equipment from the publicly accessible side where the trees intended for preservation will be. There is already a fence at the property line near Tree OP28, so as long as the property line is not crossed, that tree is unlikely to be affected by construction as well. Also erect tree protection fencing around the perimeter of the drip lines of Trees 29 and 30.

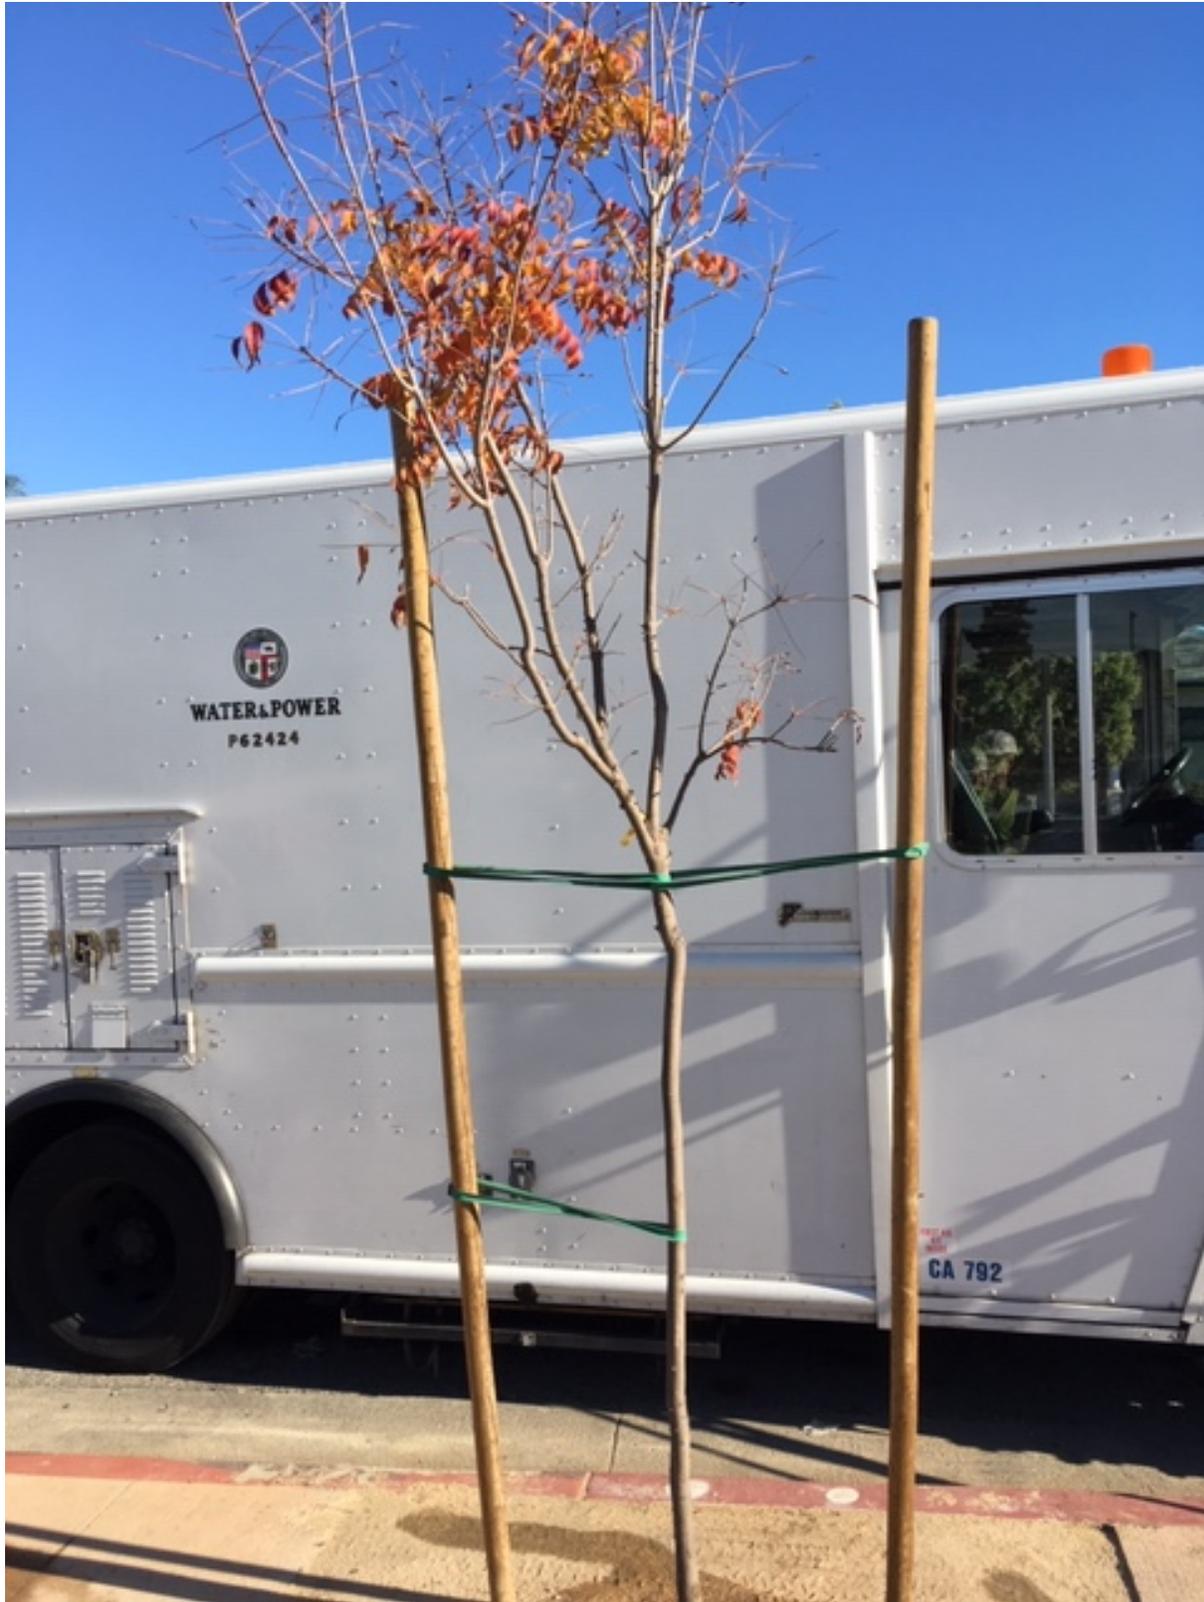
Figure 31: Tree 30 is a street tree. It will be preserved through construction.

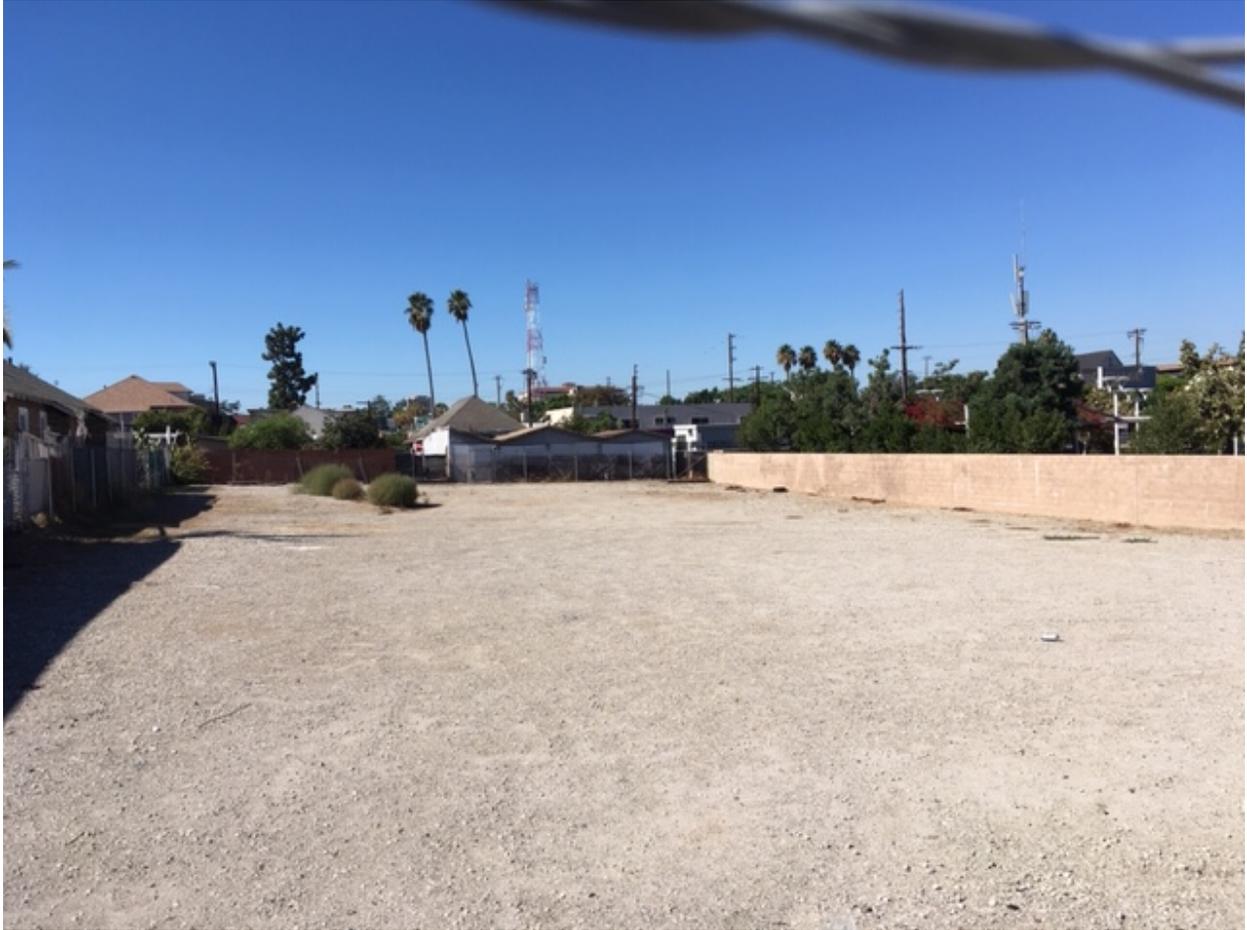
Figure 32: There are no trees on the southern lots.

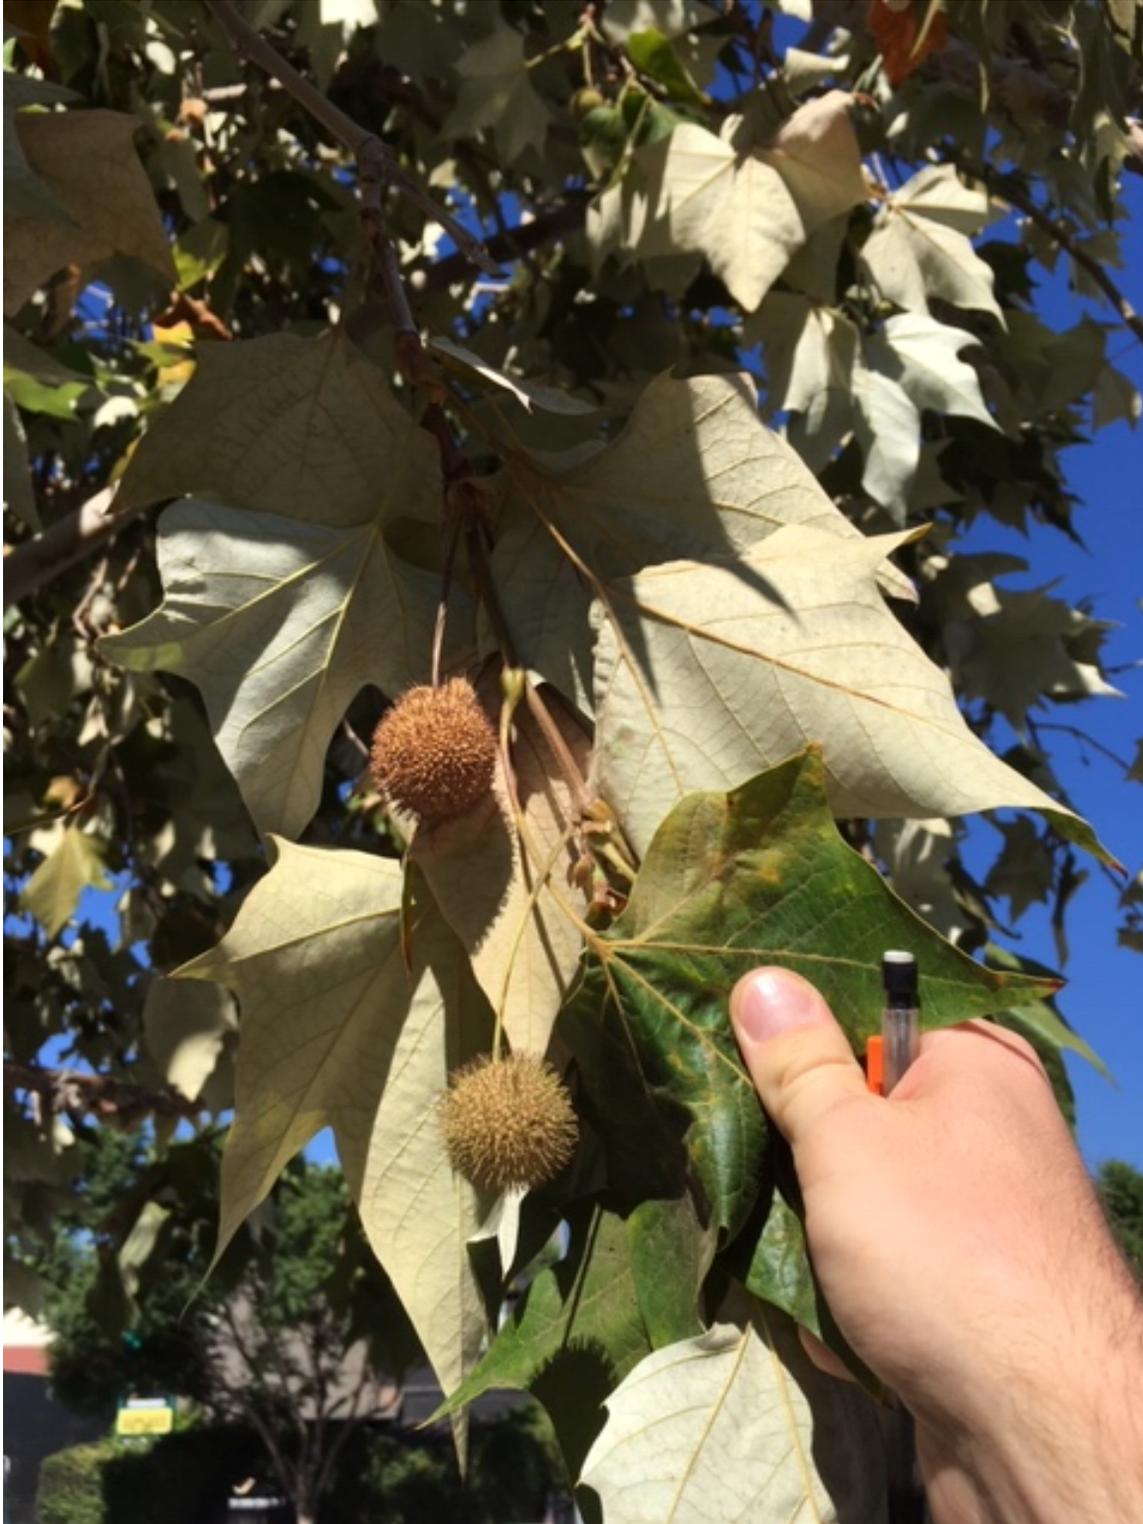
There are no protected trees on the subject property per Ordinance 177,404 covering native trees: Native Oaks (*Quercus sp.*), California Sycamore (*Platanus racemosa*), California Black Walnut (*Juglans californica*), and Bay Laurel (*Umbellularia californica*). There are nine London Planetrees (*Platanus x hispanica*) on the site. These trees share similar characteristics to the protected California Sycamore (*P. racemosa*), but their fruits are borne singly instead of in threes and fives, identifying them as the non-protected *P. x hispanica* and not the protected *P. racemosa* (See Figure 31).

Figure 33: The fruits on Tree 21 are born singly indicating London Plane Tree (*P. x hispanica*). The leaves have shallow lobes and the lobes are more angular than those of the protected *P. racemosa*.
