GEOTECHNICAL INVESTIGATION

THE AVALON INN
1201 NORTH MAIN STREET
FORT BRAGG, CALIFORNIA

Project Number 12122.01

December 4, 2015

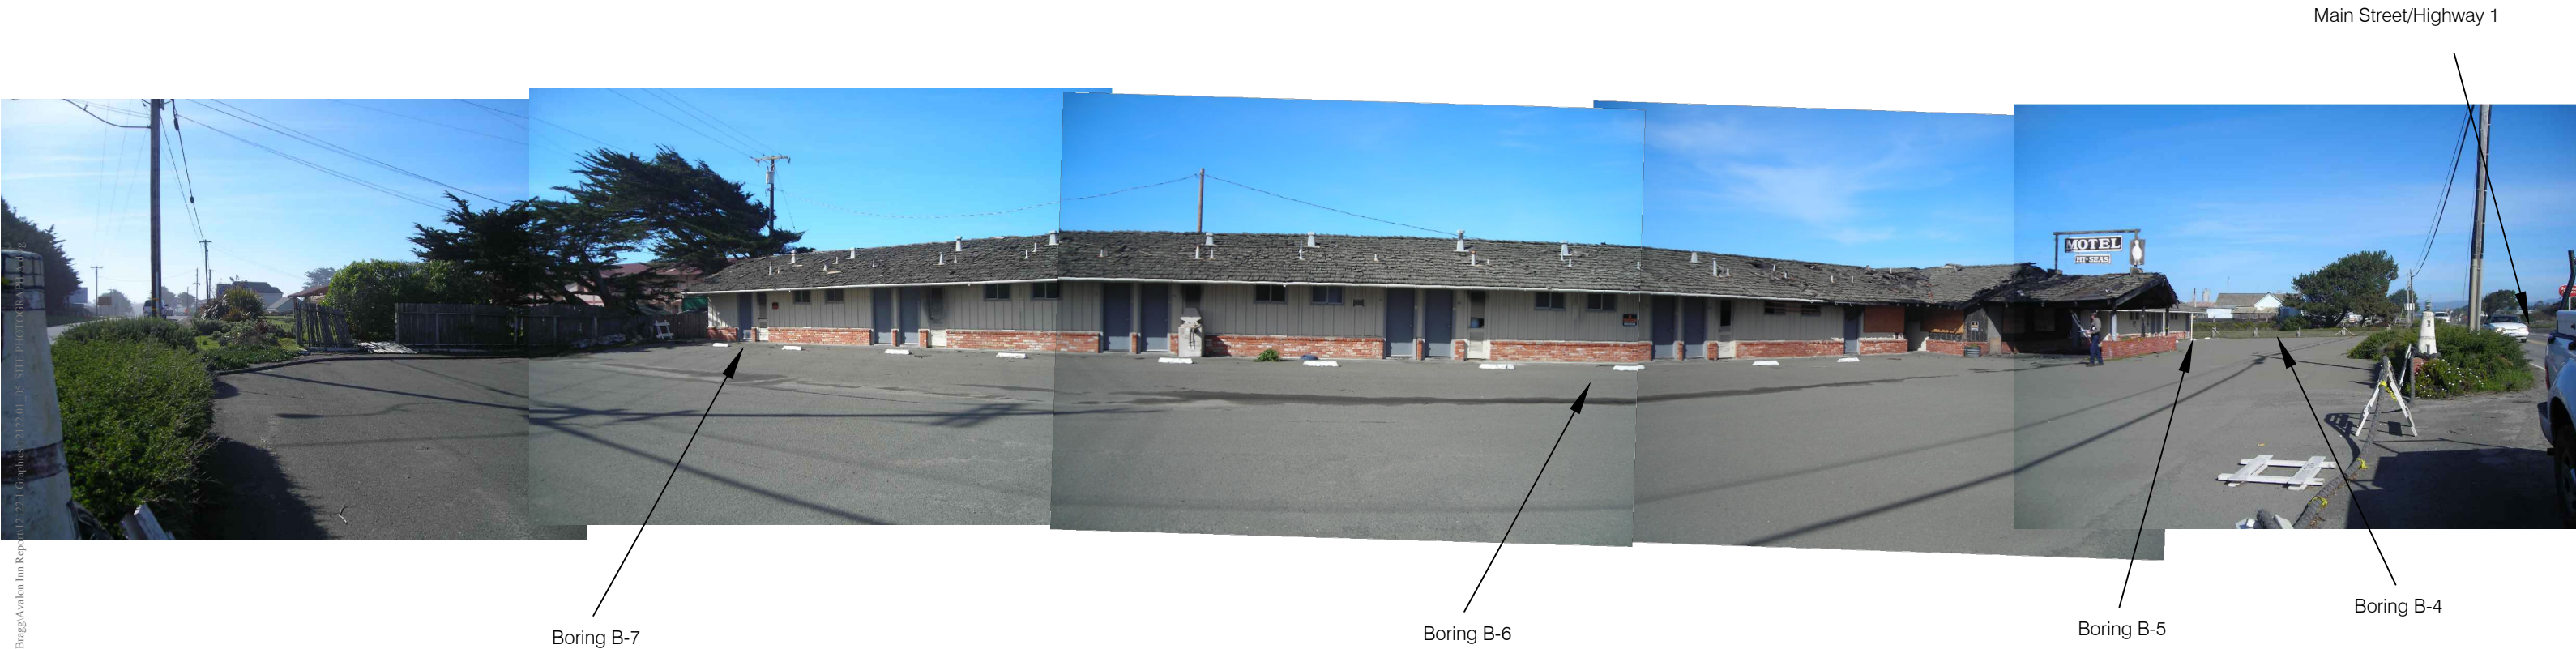
SITE PHOTOGRAPH A

Panoramic of hotel front, 2/8/08.

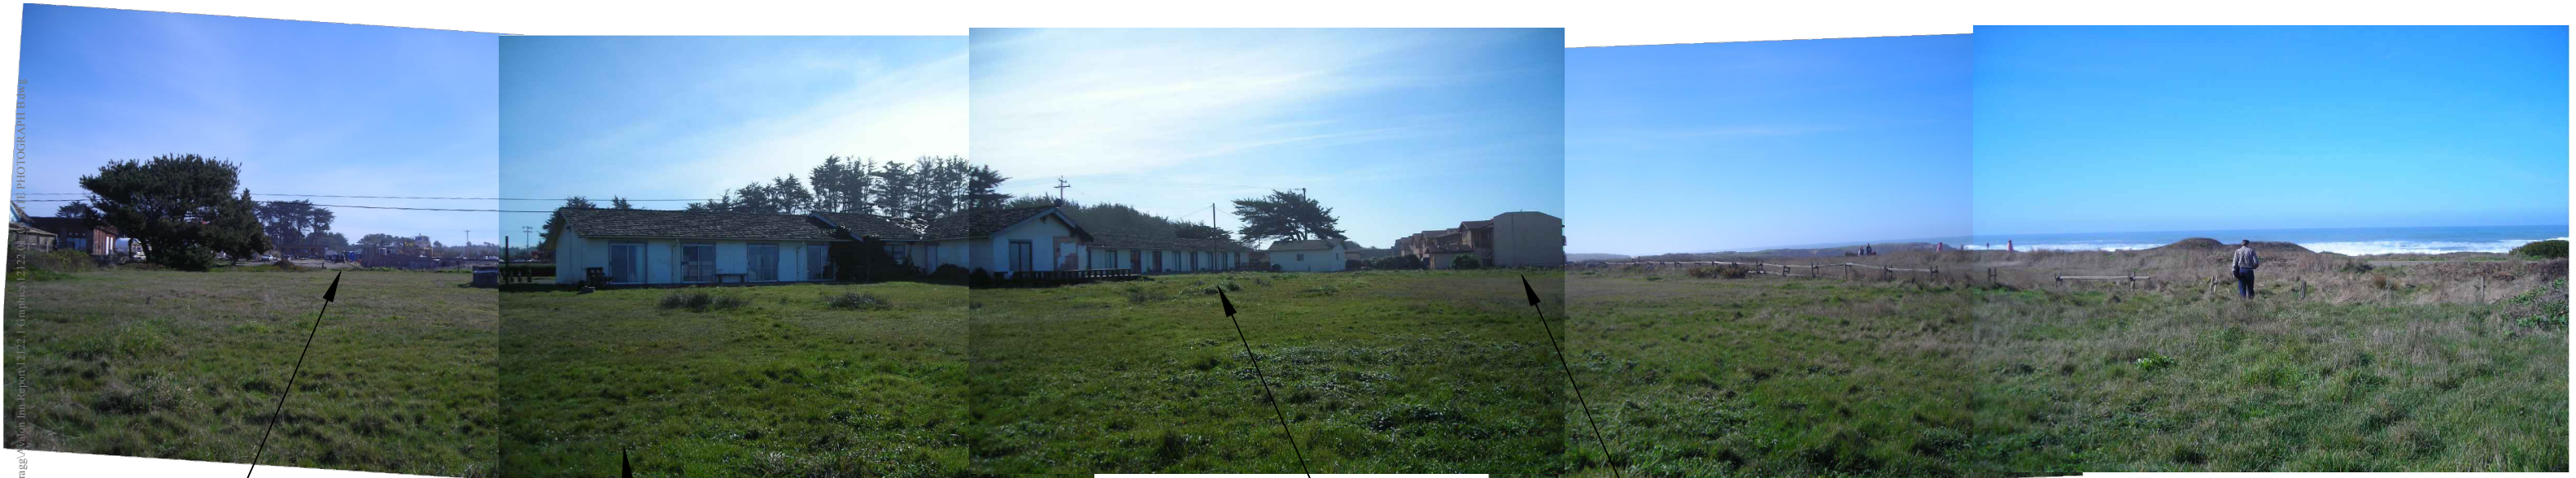
SITE PHOTOGRAPH B

Looking east, south, and west; panoramic of rear property, 2/8/08.

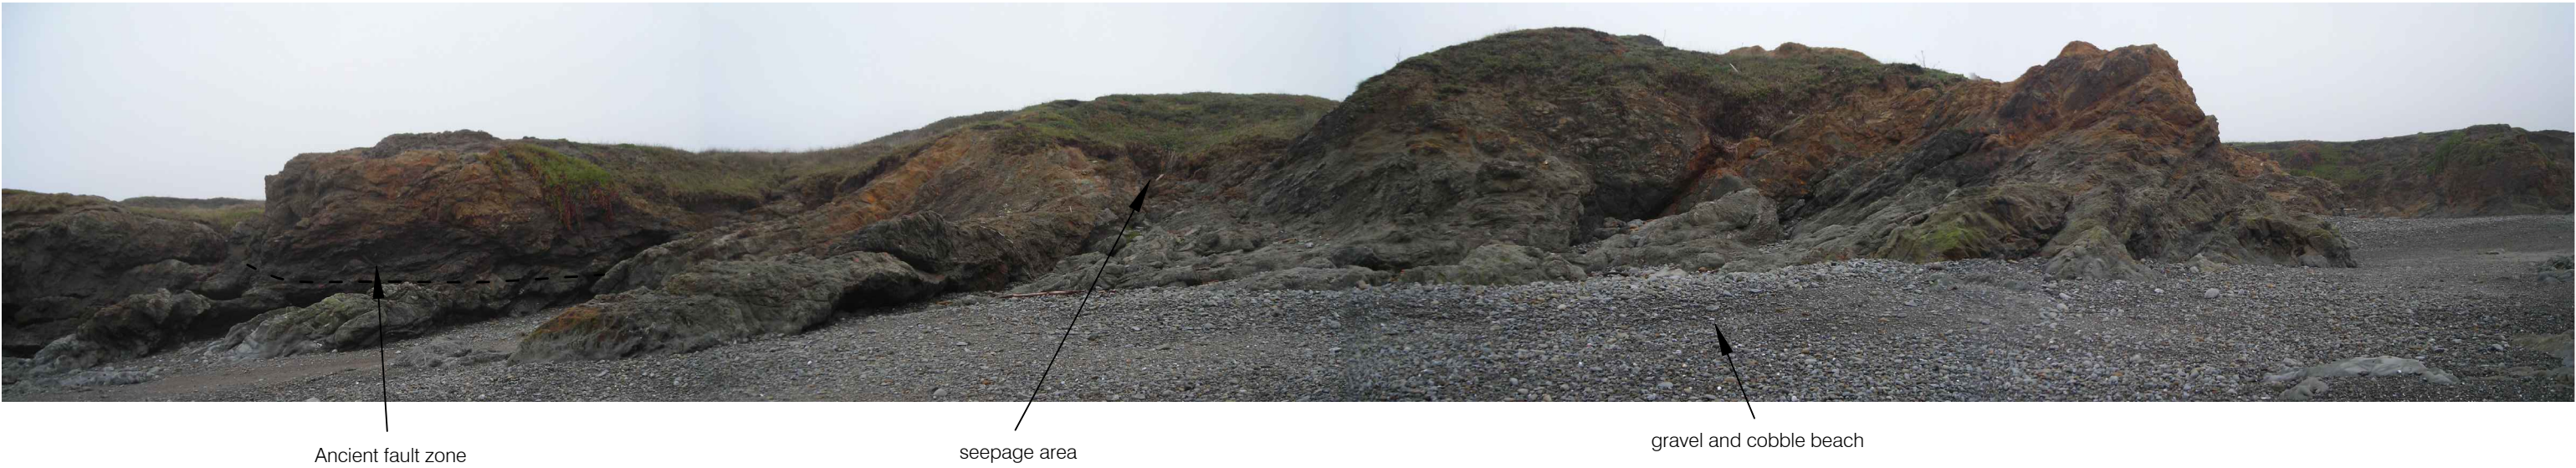
SITE PHOTOGRAPH C

As observed during our reconnaissance of the bluffs west of the property, the upper bedrock underlying the terrace deposits is comprised of orange-brown sandstone that is intensely fractured, low to moderate in hardness, and deeply weathered. The lower bluffs consist of dark gray sandstone that is intensely to closely fractured, hard, and little weathered. Many of the Franciscan rocks are poorly bedded. However, locally, the bedding orientation of the Franciscan rocks consists of a northwest to northeast trending strike with a moderately steep dip, about 40 degrees from horizontal, to the east. The bluffs as viewed from the beach are shown on Plates 7 through 9.

Bluffs and beach northwest of the site, 3-19-08.
See Plate 4 for photograph location.

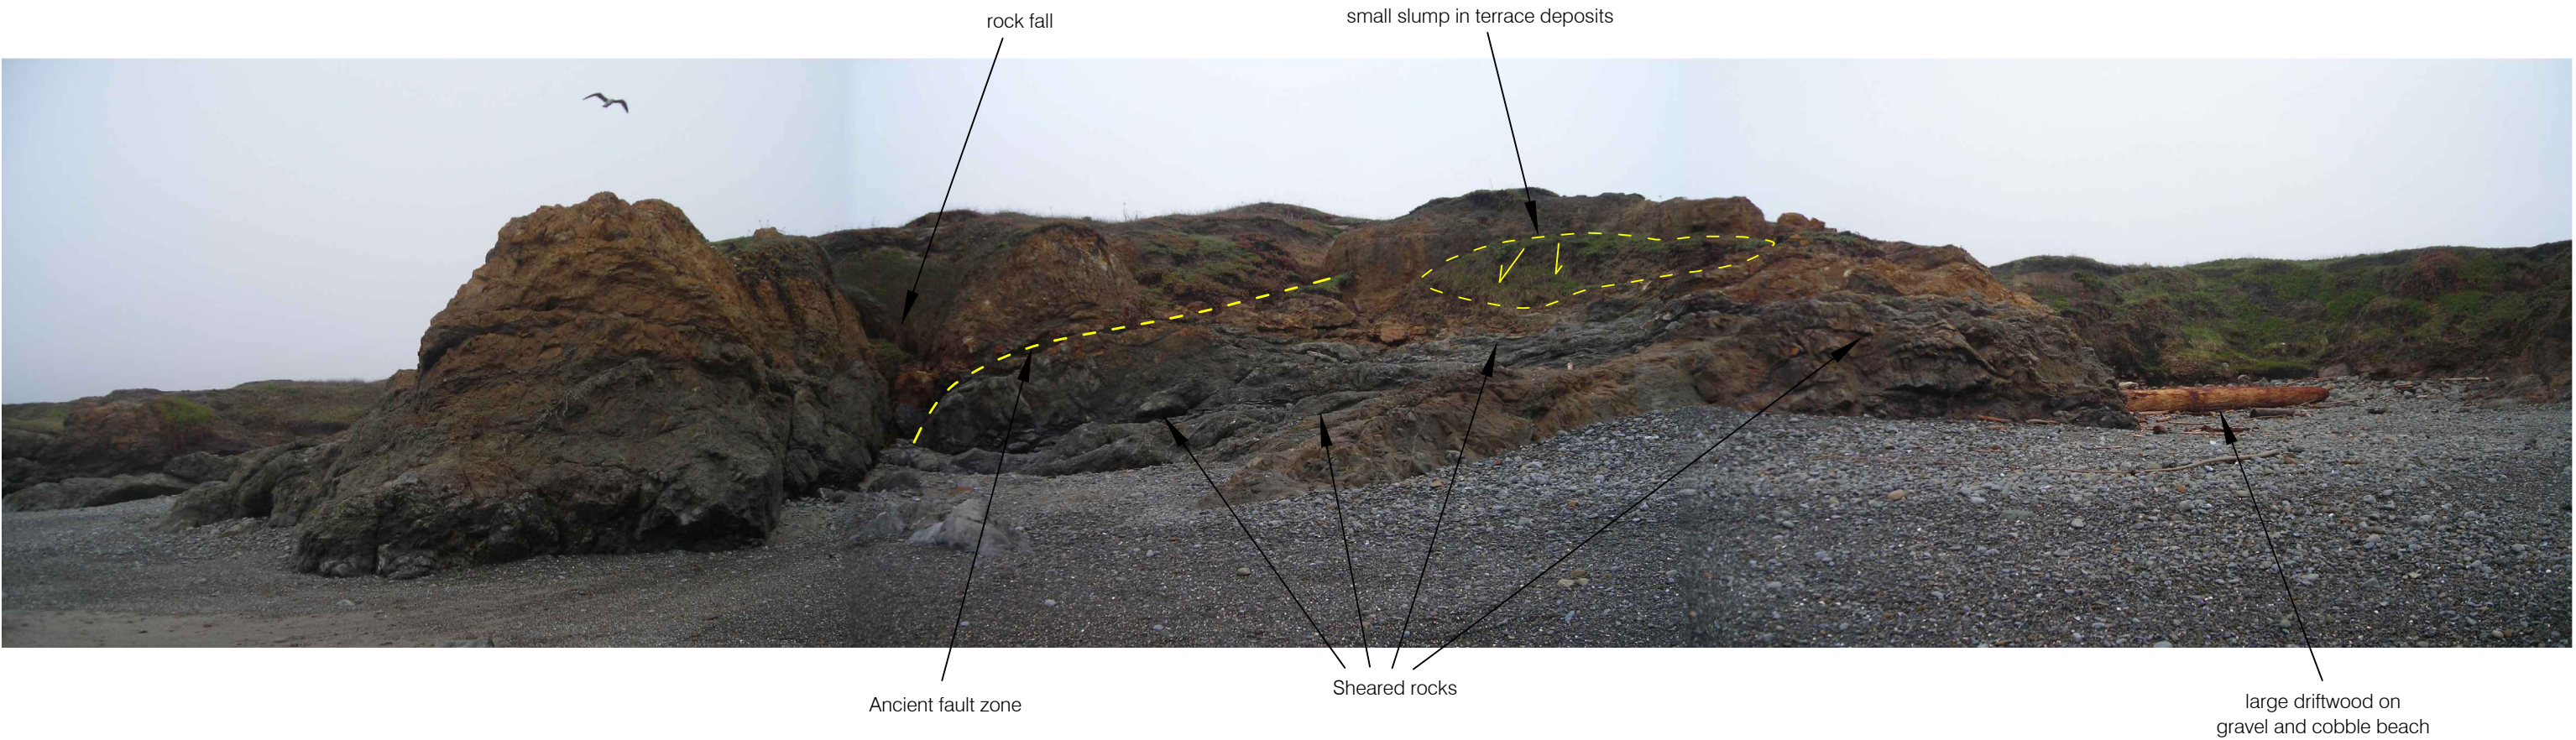
SITE PHOTOGRAPH D
Bluffs and beach west of the site, 3-19-08.
See Plate 4 for photograph location.

Two ancient (inactive) faults and associated narrow shear zones (a few feet wide) were observed within the bluffs (Plates 4 and 8). Some increased erosion has occurred along the faults due to the relatively weakened condition of the rocks and increased permeability along the fault plane. The faults do not appear to offset the overlying terrace deposits. No evidence of active faulting was observed by us nor is shown on the references we reviewed for this investigation. The active San Andreas fault is located approximately 7 miles offshore.

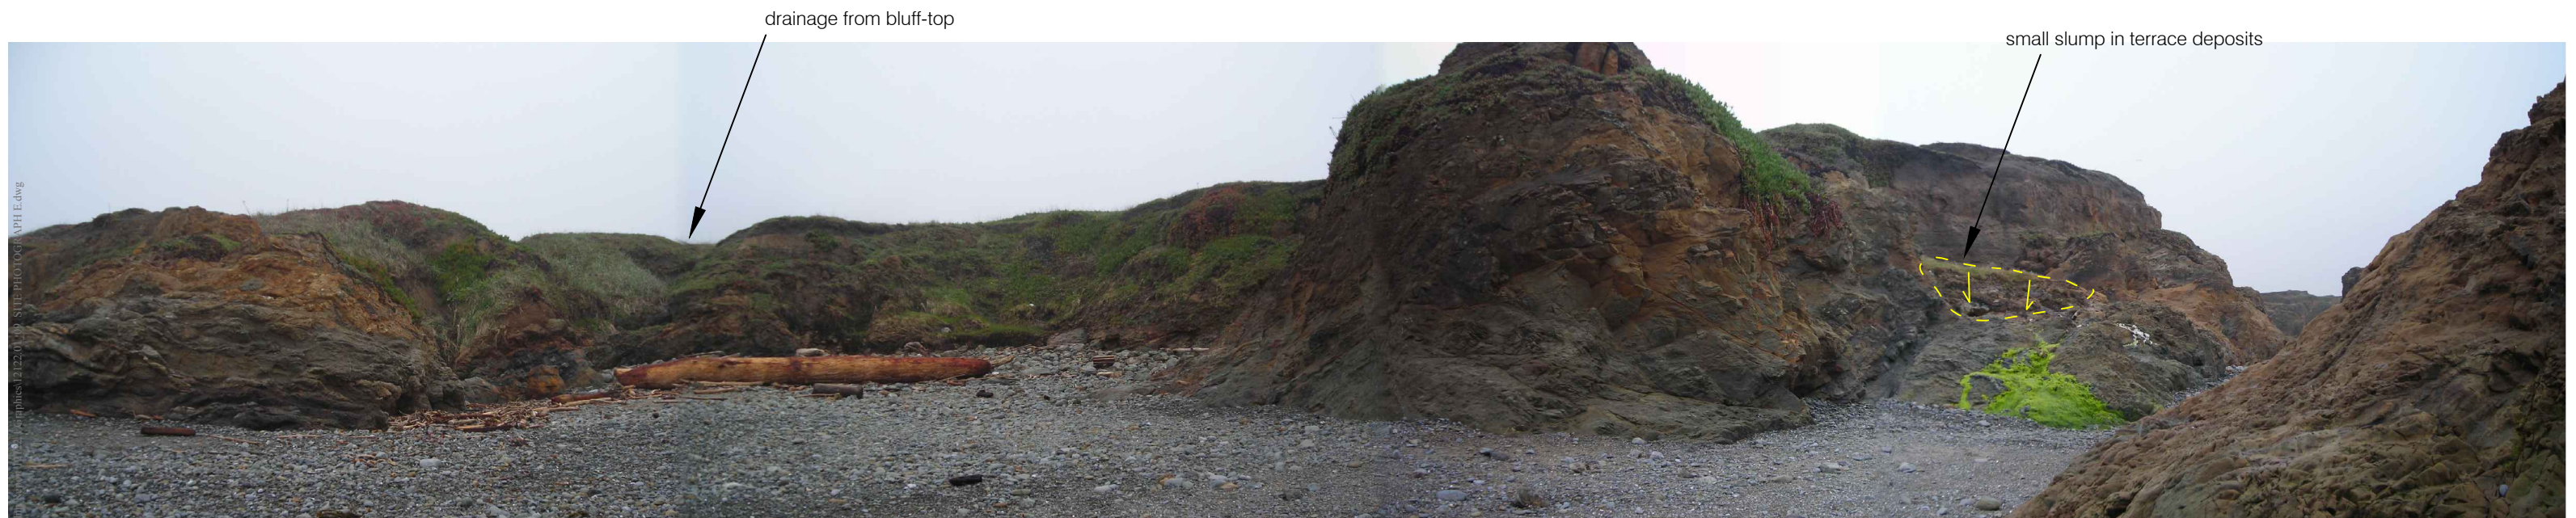
A few areas of accelerated erosion, small rockfalls, and small landslide deposits were observed along the bluff edge (Plates 4 and 9). The slides we observed are relatively small and do not appear to involve the bedrock.

Bluffs and beach southwest of the site, 3-19-08.
