**ARBORIST REPORT,  
TREE INVENTORY SUMMARY,  
CONSTRUCTION IMPACT ASSESSMENT  
AND  
TREE PROTECTION PLAN**

**6211 SANTA TERESA BLVD. PROJECT SITE  
(Job # 1042240)  
City of San Jose, California**

**November 25, 2019**

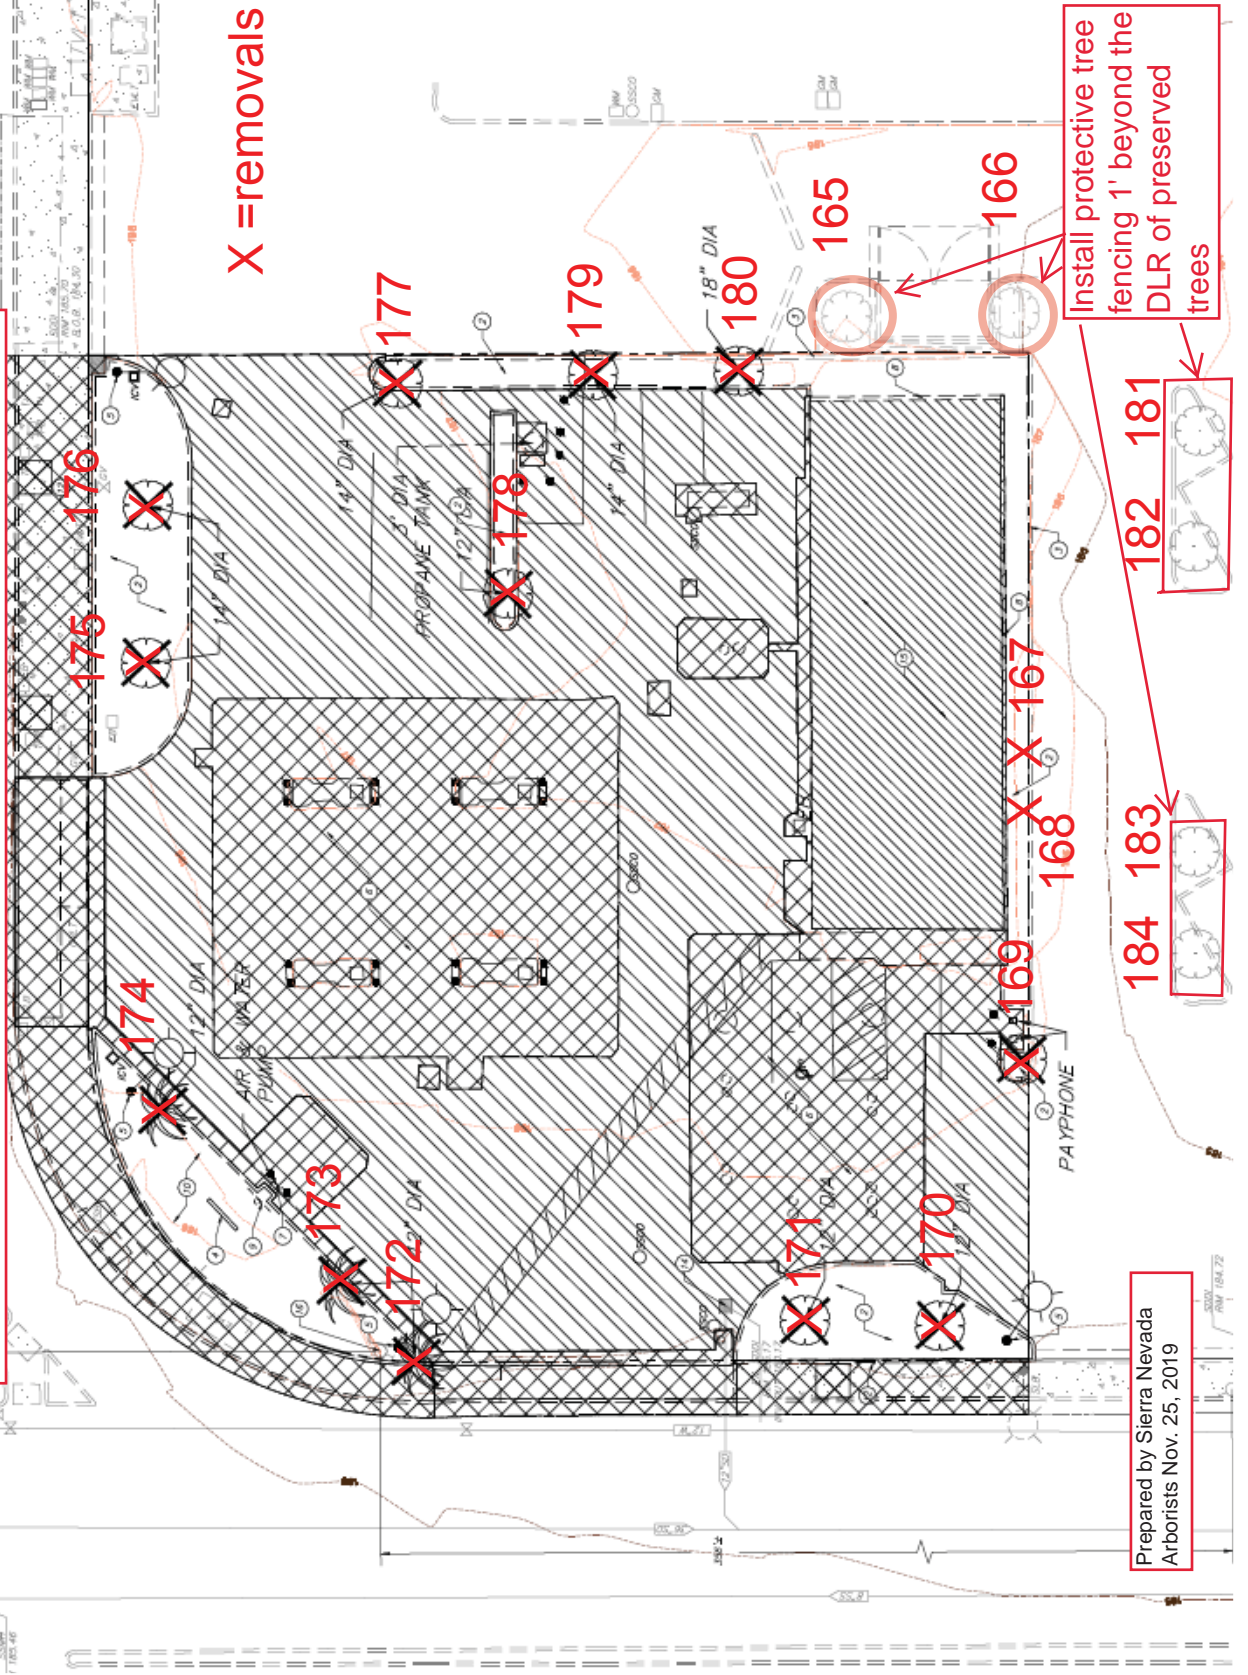
Smith DCC: 6211 Santa Teresa Blvd, San Jose, CA Project Site  
Tree Inventory, Removal and Tree Protection Plan Exhibit

X = removals

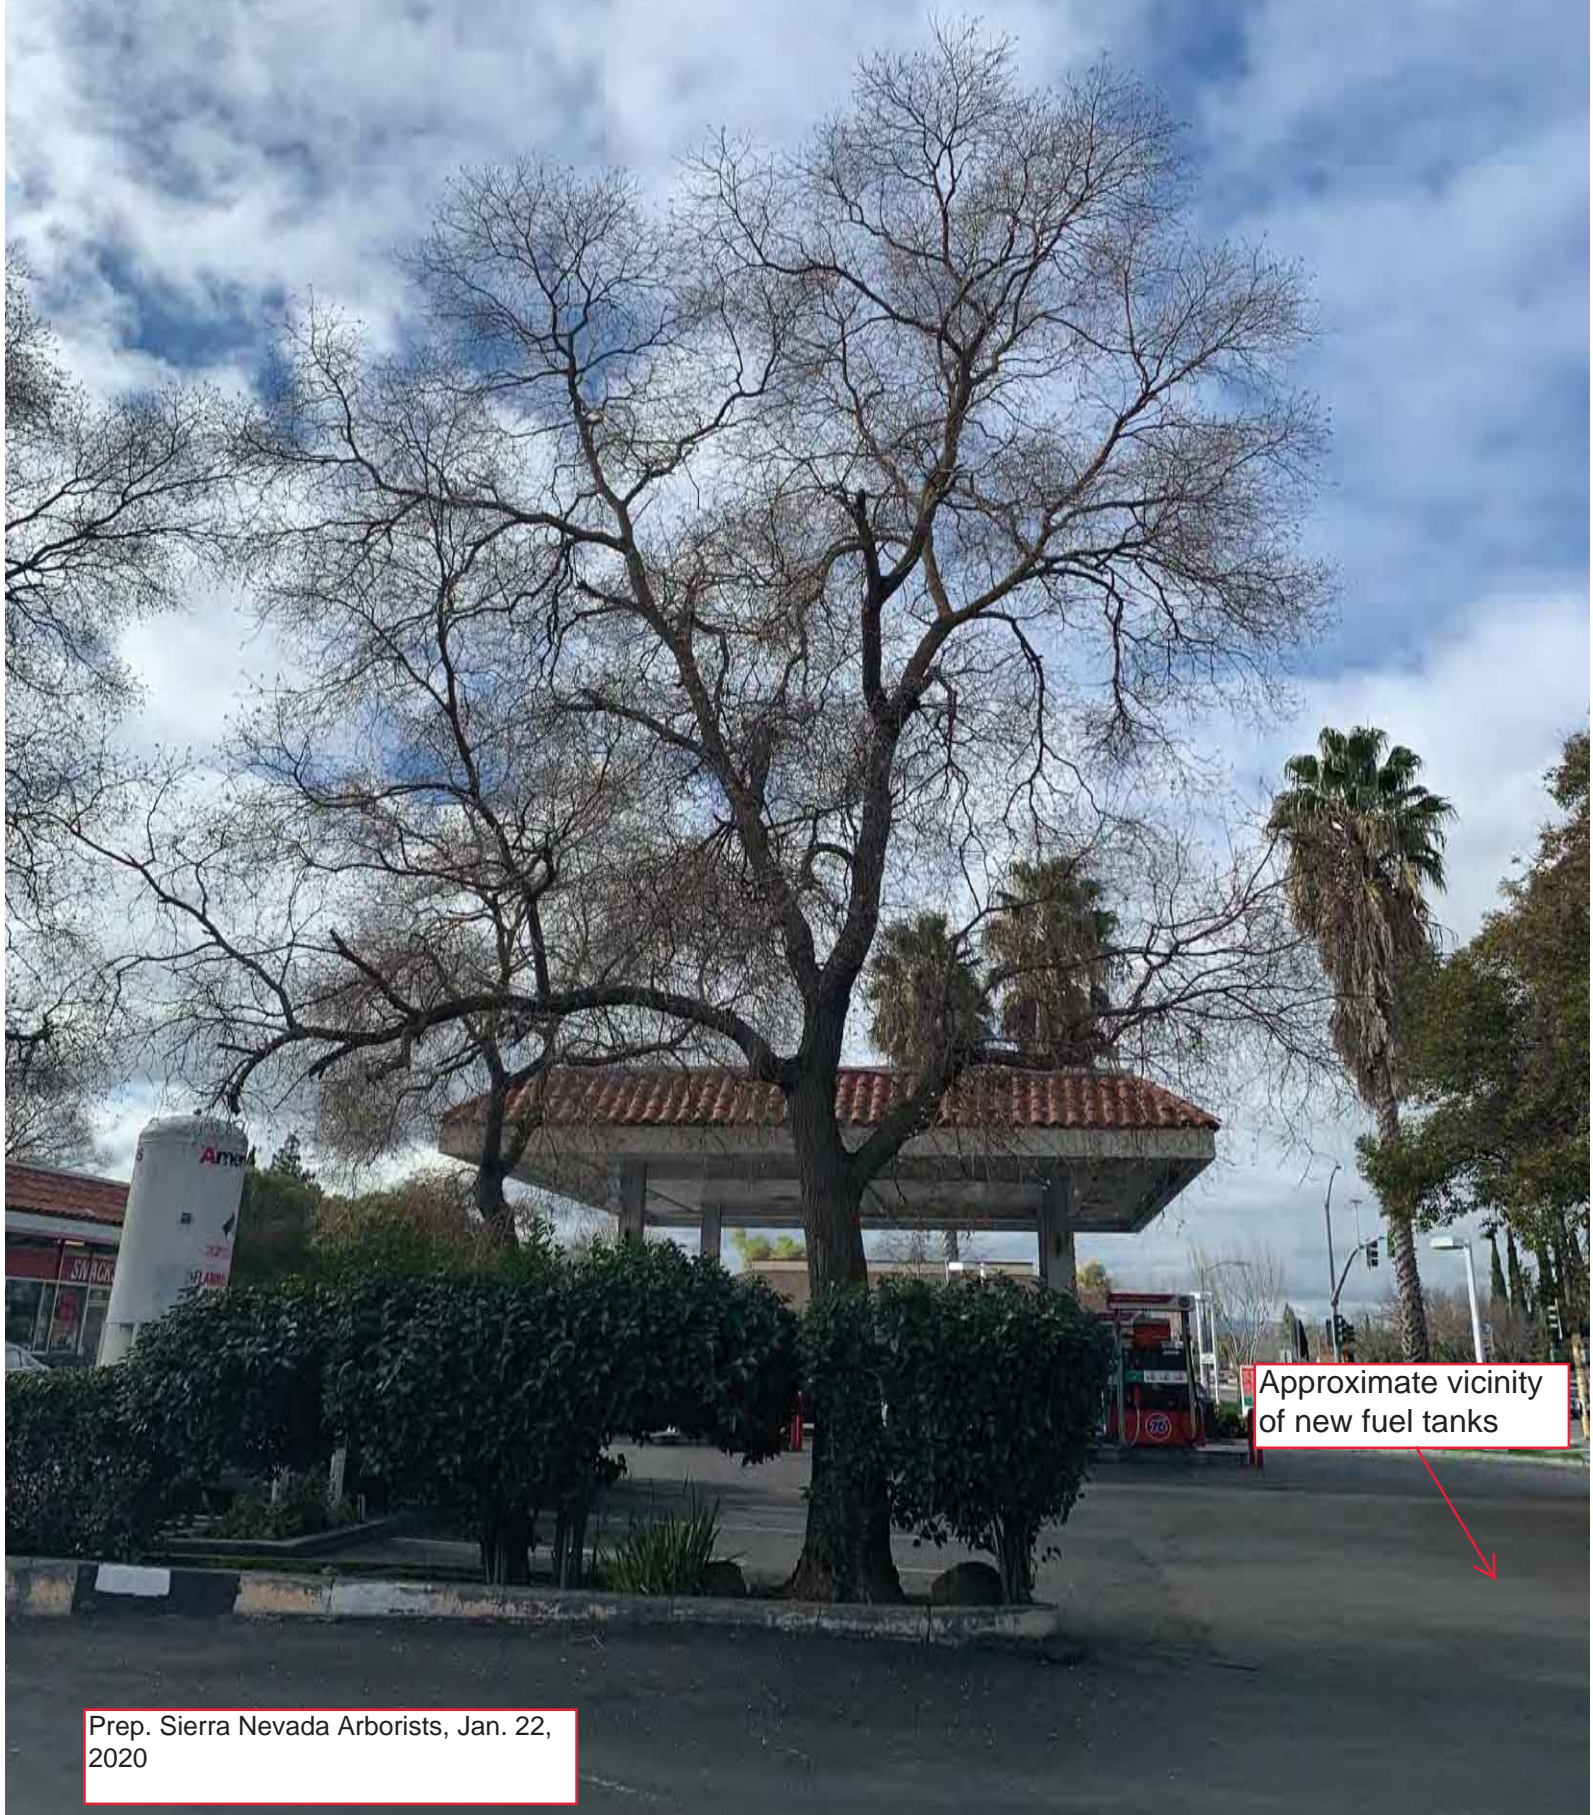
Smith DCC: 6211 Santa Tessa Blvd, San Jose,  
CA Project Site  
Tree # 177 West View

Tree 177 has been growing in a narrow landscape planter which is situated at grade with the surrounding parking lot. (Photos attached) Again, the planter area and resulting soil volume is too small for a medium or large stature tree. Tallow trees tend to be shallow rooting trees in many situations and in this case the roots are located just beneath the asphalt and within the planter. The demolition and reconstruction of the parking area surface will result in root damage, especially if the area is excavated to a depth of 18" for sub grade preparation. It is probable that root loss would be significant compromising both the stability and health of the tree. The replacement underground fuel tanks will fall within close proximity to the tree and well within the critical root zone. If there are any roots deeper than 18" (which is unlikely) the excavation for the tank pits would result in loss of those roots also. In order to preserve this tree it would be

necessary to stay out of the critical root zone and not create any disturbance for 15' to 20' from the trunk. The asphalt can not be removed and replaced without significant root loss unless the grade is raised around the tree to eliminate root loss from excavation. In my opinion the best course of action is to remove the trees and replace them with appropriate species in reasonably sized planters capable of sustaining trees.

The Palm trees numbered 172, 173 and 174 will be removed per the request from the city public works department. And as discussed above trees 167, 168 and 177 should be removed and replaced with appropriate species in appropriate sized planters.

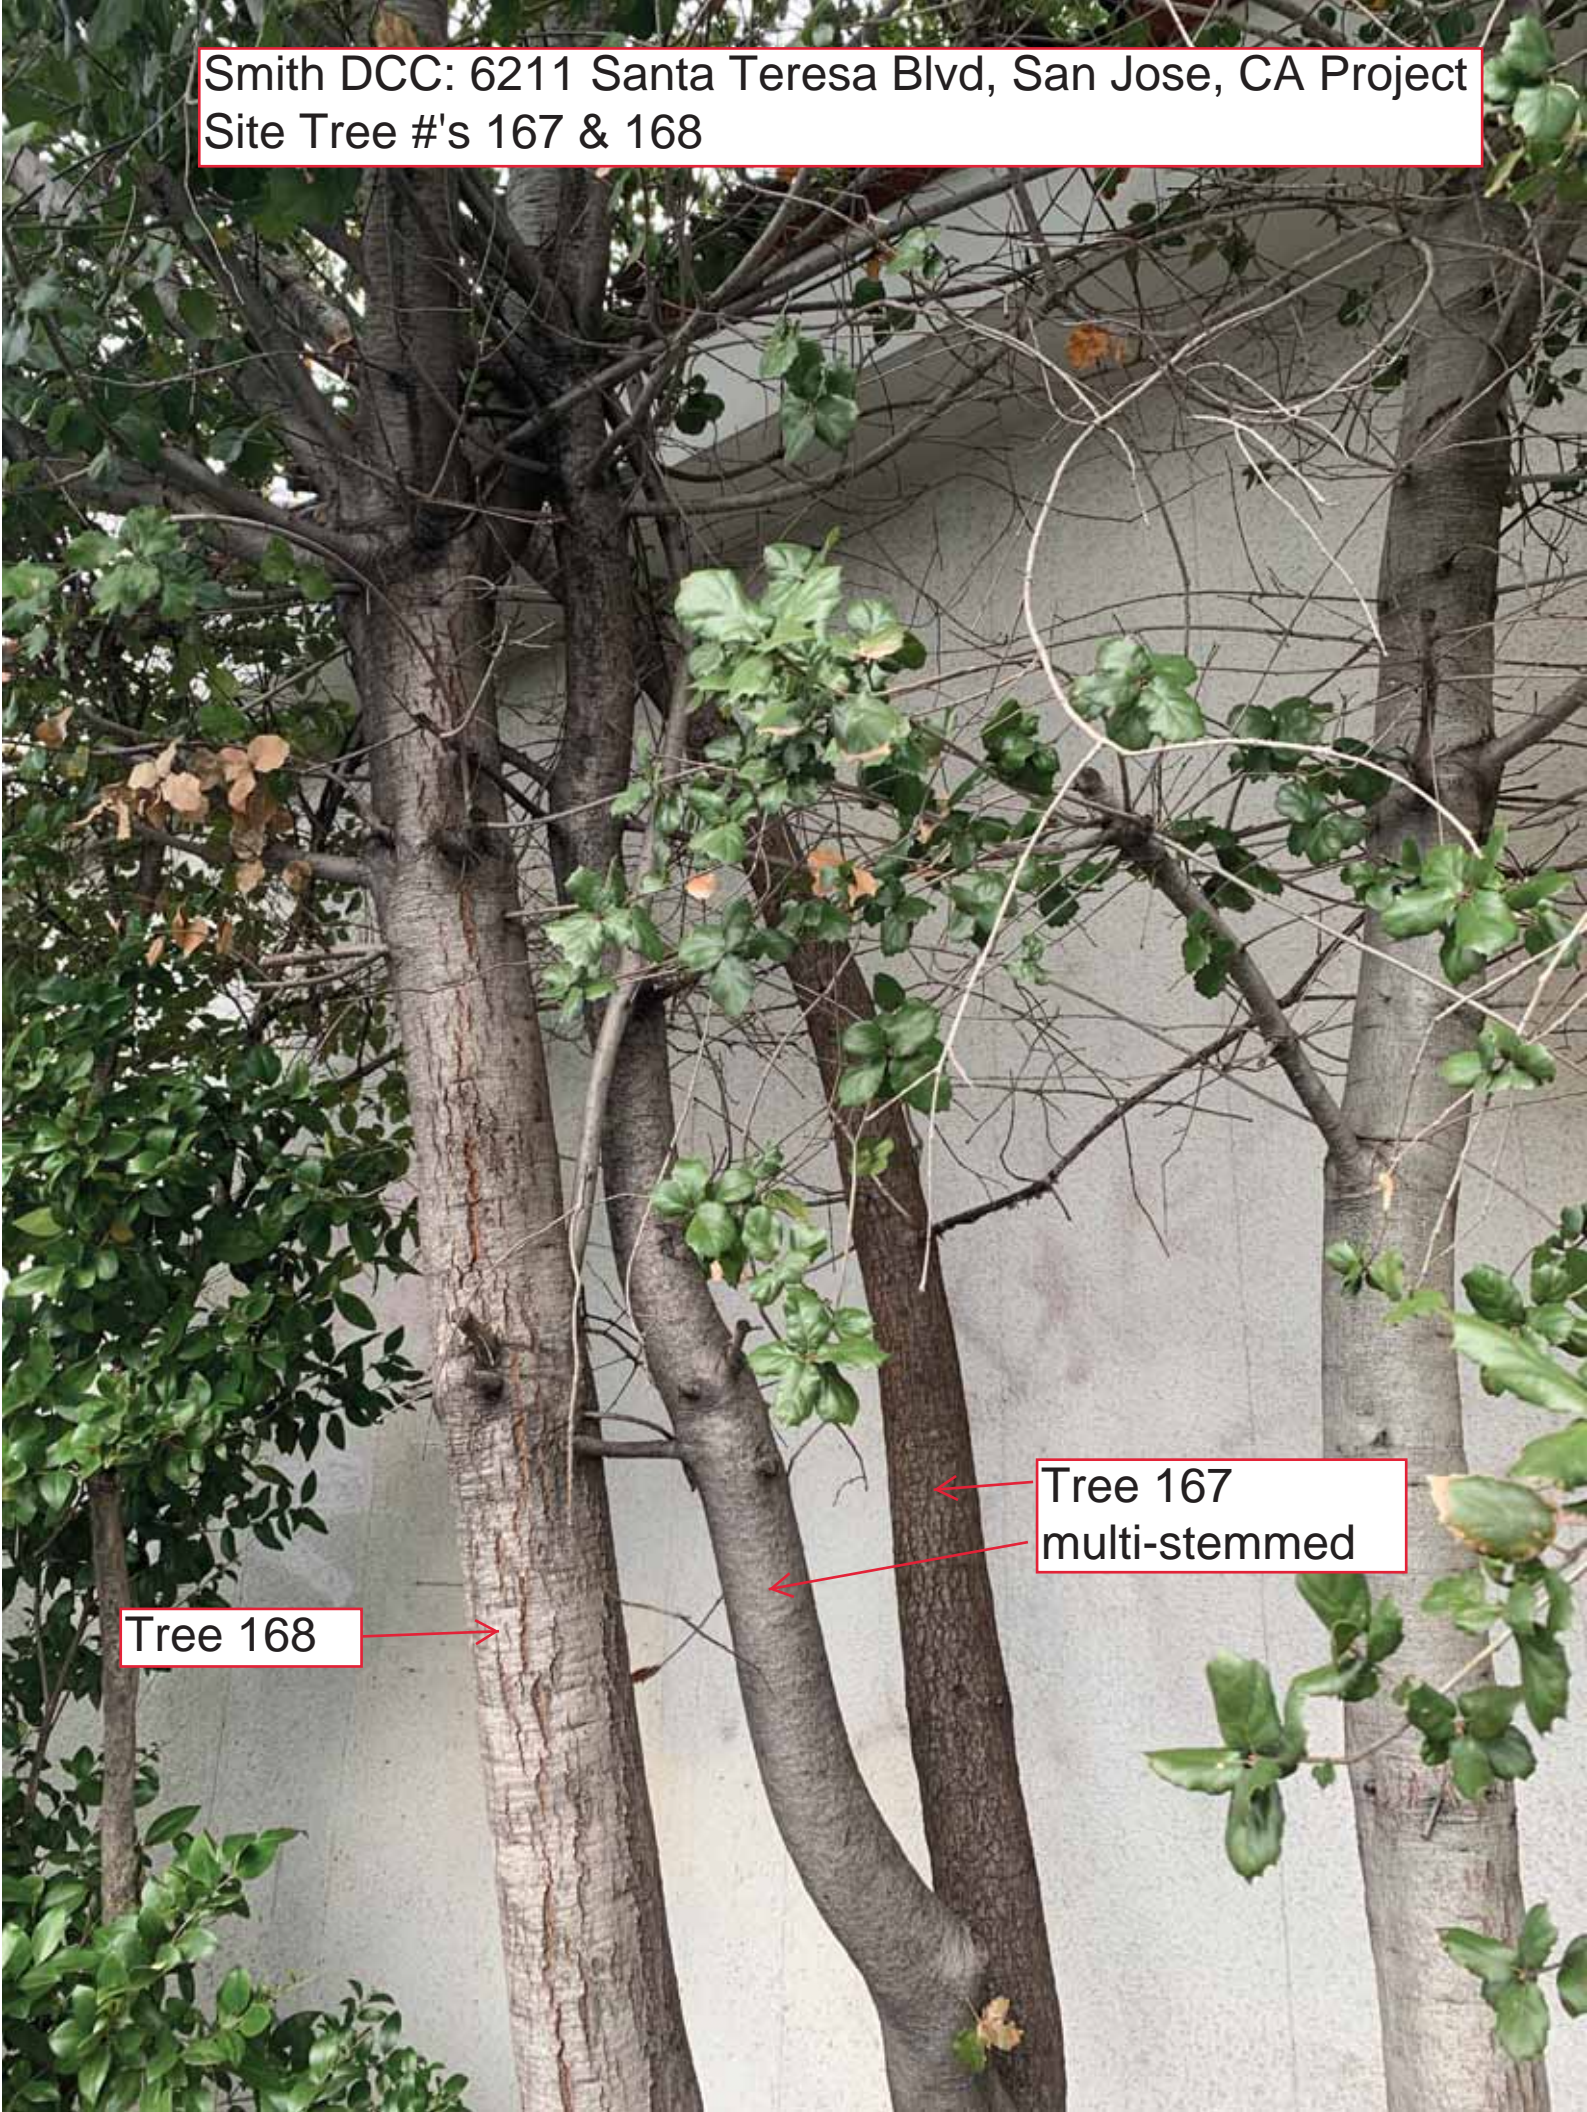
Smith DCC: 6211 Santa Teresa Blvd, San Jose, CA Project  
Site Tree #'s 167 & 168

Trees 167 & 168 – These trees have grown in a narrow, raised masonry planter with limited soil volume in close quarters to each other, other trees & the adjacent building (photos attached). The limited soil volume has prevented the trees from growing at a normal rate to a reasonable size. The trees are essentially containerized and this situation causes irregular root growth typically with limited root system development.

The proximity to other trees/plants and the building has caused the trees to lean away from the building, creating an out of balance situation. The trees are also growing through each other with intertwining branches. These trees are actually poor specimens from a structural standpoint and will not tolerate the encroachment that will occur during site demolition and reconstruction. The initial structure rating in the tree inventory was generous and the trees should have been rated lower.

After the existing, surrounding hardscape is removed the stability of the trees will be compromised and there will be an elevated risk of failure due to the disturbance. The existing planter is too small for any type of oak or any large stature tree. Considering the location and extent of proposed activities no protective measures will provide adequate protection for preservation of the trees.

Tree 168

Tree 167  
multi-stemmed
