PHASE I
ENVIRONMENTAL
SITE ASSESSMENT

2220 Fulton Road
Santa Rosa
California

March 21, 2019
19-ENV5373

Subject: Phase I Environmental Site Assessment Report
2220 Fulton Road
Santa Rosa, California 95403

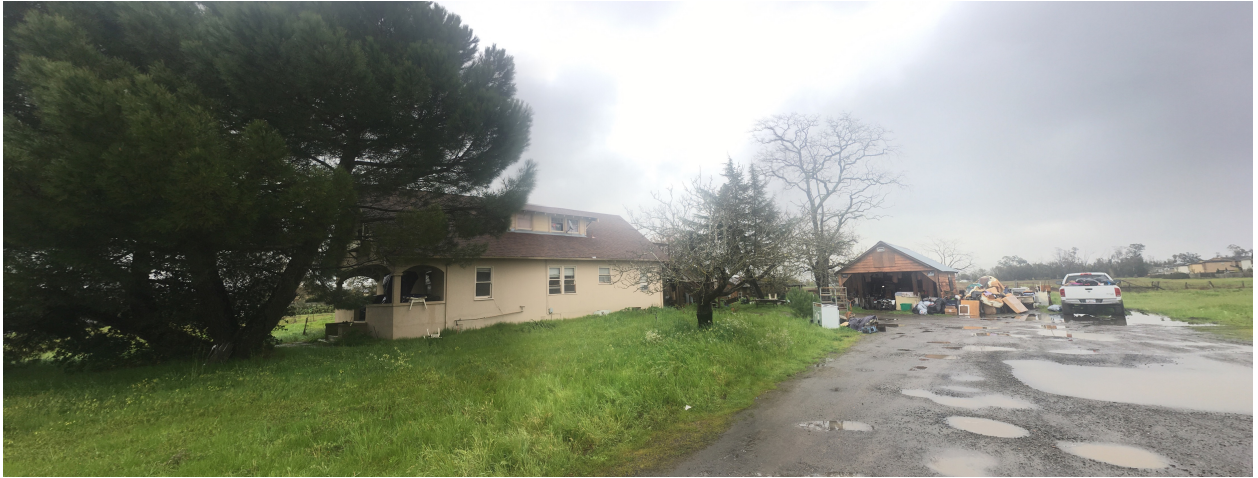
accessible via an exterior stairway and provides access to the second floor (See Photos 1-3). Discussions with Ms. Peterson indicated to her knowledge no hazardous materials, underground fuel storage, or heating oil tanks are utilized onsite. She stated that a roughly 80-year old couple has occupied the residential dwelling for a long time. Discussions with Mr. Jacobson indicated that a septic tank is currently utilized onsite. Due to private occupancy, visual observations were limited to the exterior areas. General observations of the exterior of the dwelling did not reveal any obvious signs of hazardous materials, stains and/or spills.

Photo 1: Subject Site (Facing Northeast)
Two-Story Residential Dwelling
And Associated Sheds

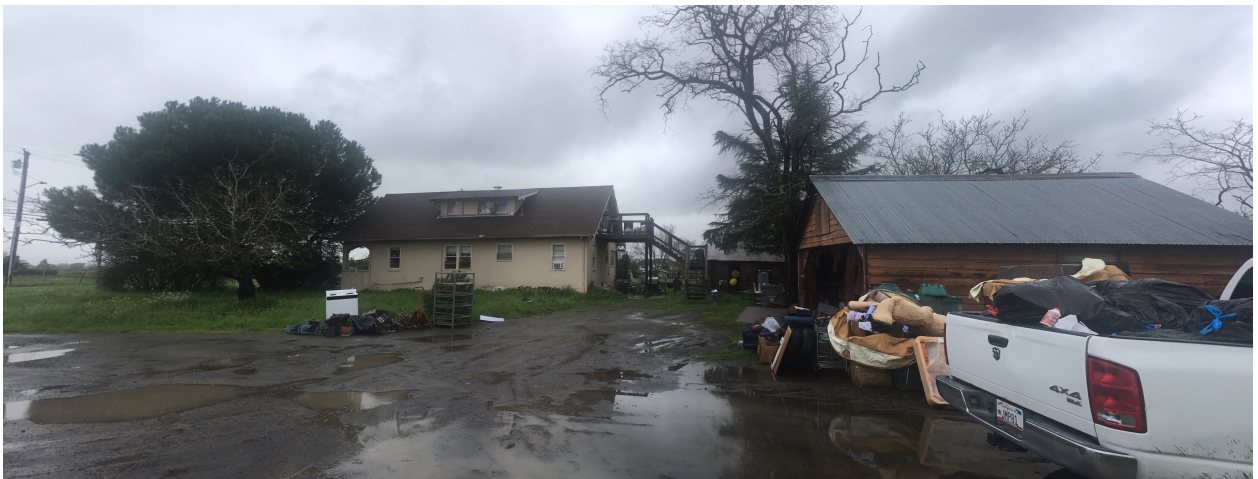
Photo 2: Subject Site (Facing Northwest)
Two-Story Residential Dwelling
And Associated Sheds

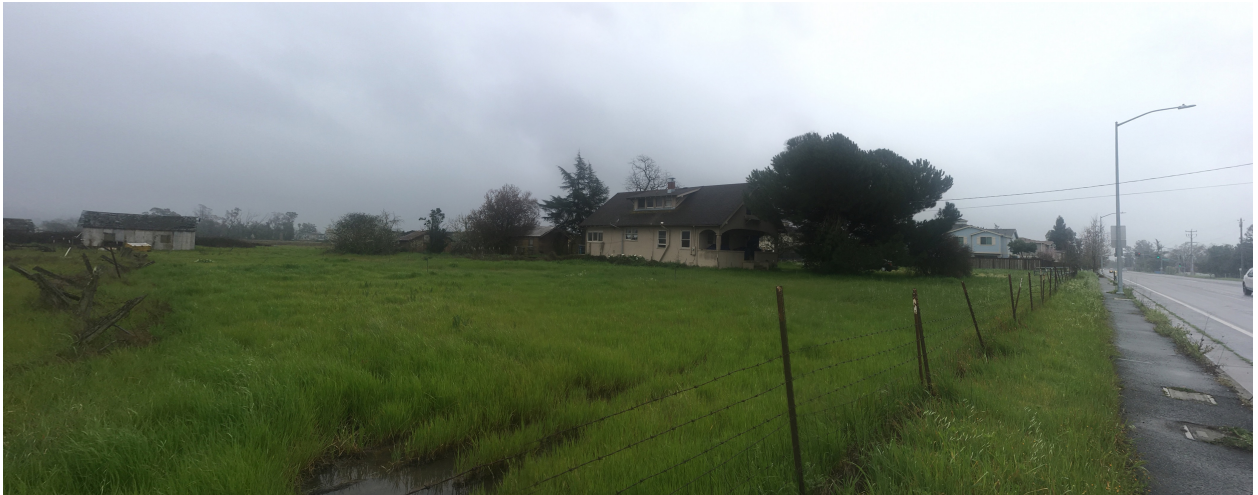
Photo 3: Subject Site (Facing Southeast)
Two-Story Residential Dwelling
And Associated Sheds

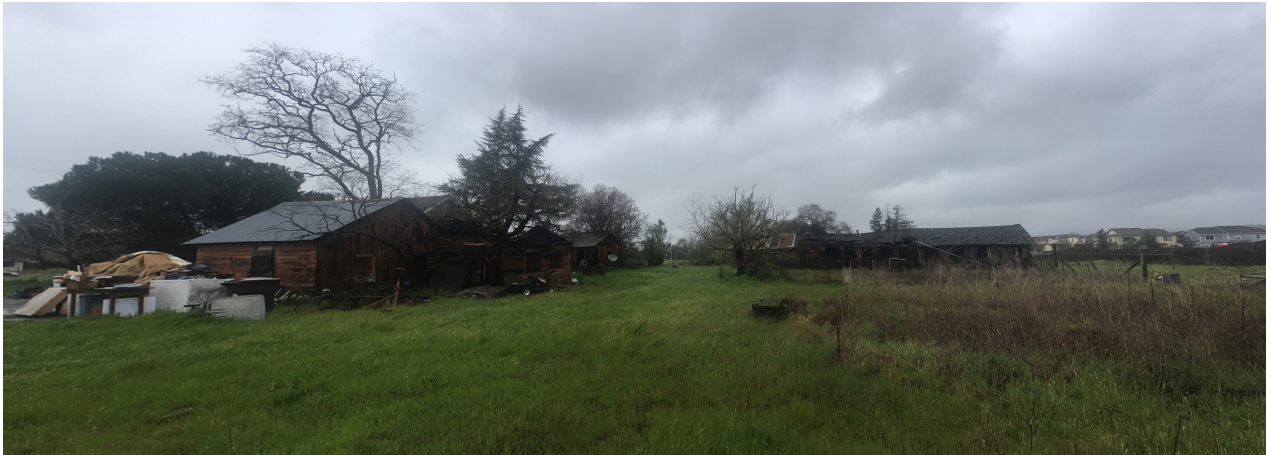
The two-story residential dwelling is bordered on the eastern portion with five (5) dilapidated sheds. All five sheds are constructed with wood framing and wood exterior walls, and most are extremely run-down with no doors or a crumbling frame. The sheds are utilized to store common household items and supplies (bikes, tools, storage, etc.) (See Photos 1-4). General observations of the sheds did not reveal any obvious signs of hazardous materials, stains and/or spills.

Photo 4: Subject Site (Facing Northwest)
Associated Sheds and Landscaped Area

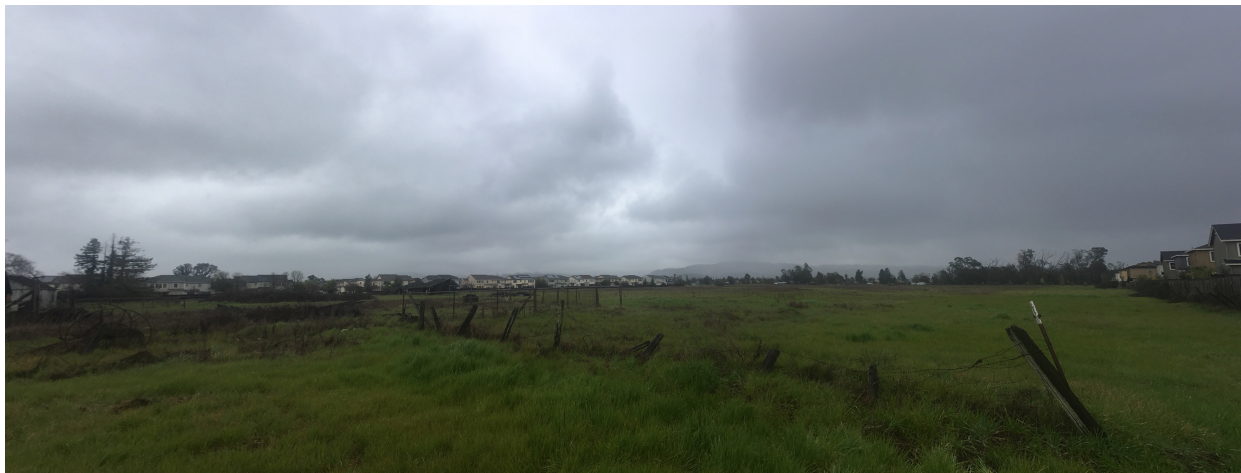
Wetlands – Occupying the eastern portion of the subject site are federally protected wetlands. Throughout this area are several surface water ponds and vernal pools supporting biodiversity in the Santa Rosa plain (See Photos 5-11). General observations of the wetlands area did not reveal any obvious evidence of hazardous materials. Visual observations of the wetlands area did not reveal any other obvious evidence of drains, sumps of other conduits to the subsurface.

Photo 5: Subject Site (Facing Northwest)
Wetlands Area

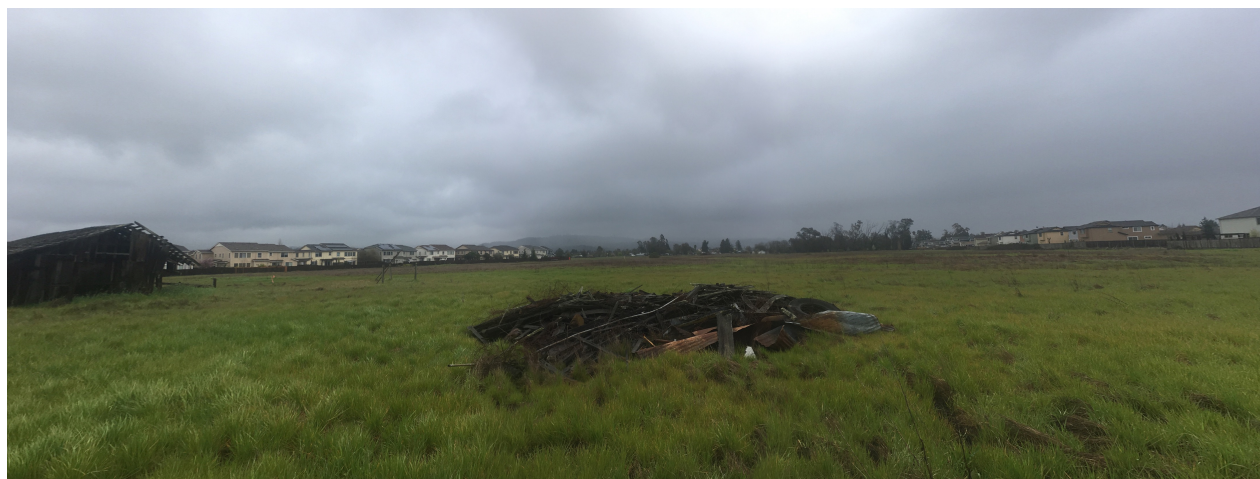
Photo 6: Subject Site (Facing West)
Wetlands Area

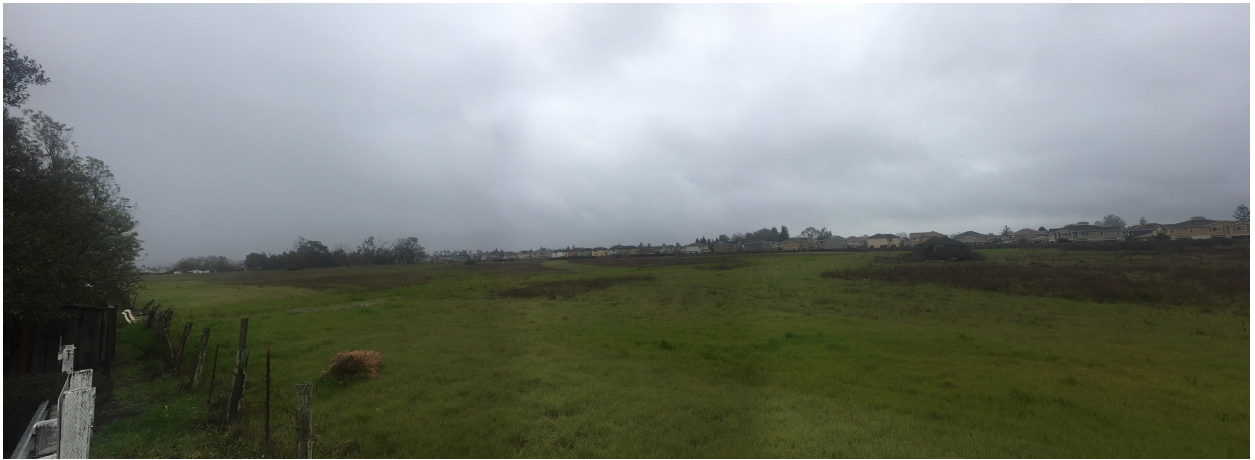
Photo 7: Subject Site (Facing Southeast)
Wetlands Area

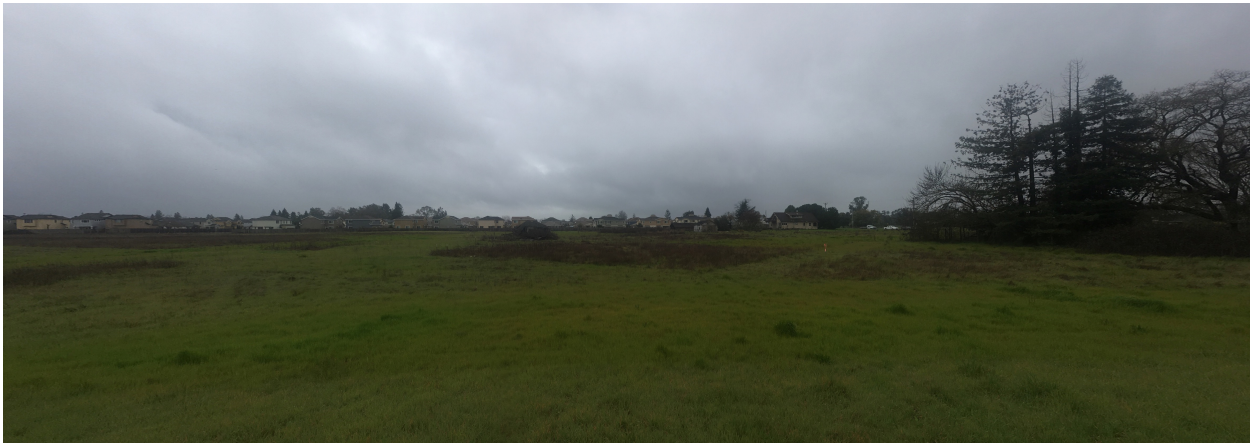
Photo 8: Subject Site (Facing Southwest)
Wetlands Area

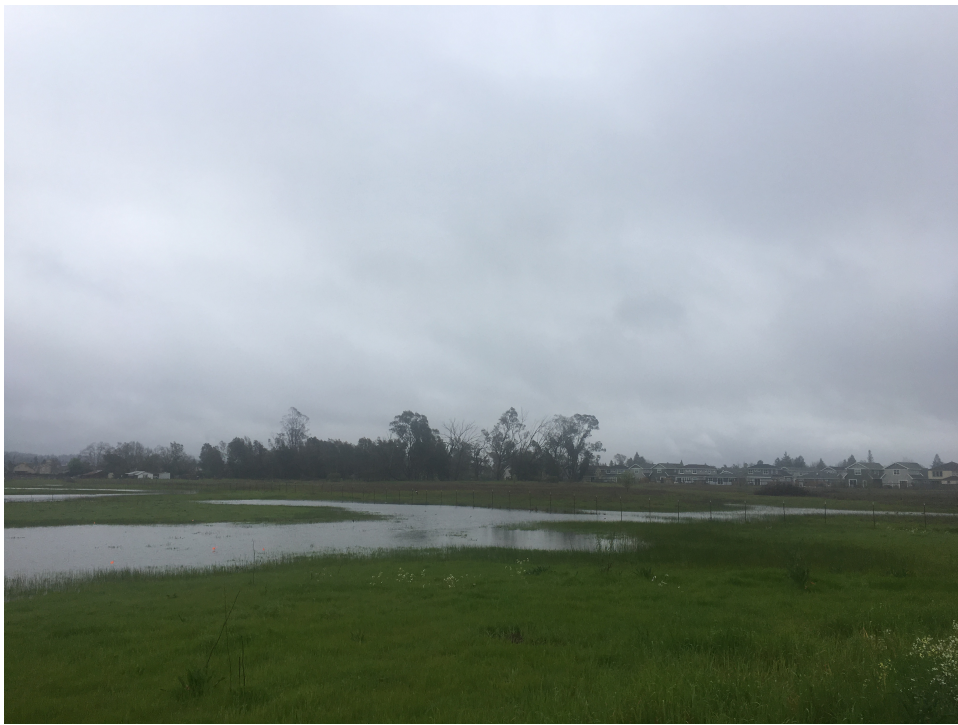
Photo 9: Subject Site (Facing Southeast)
Wetlands Area

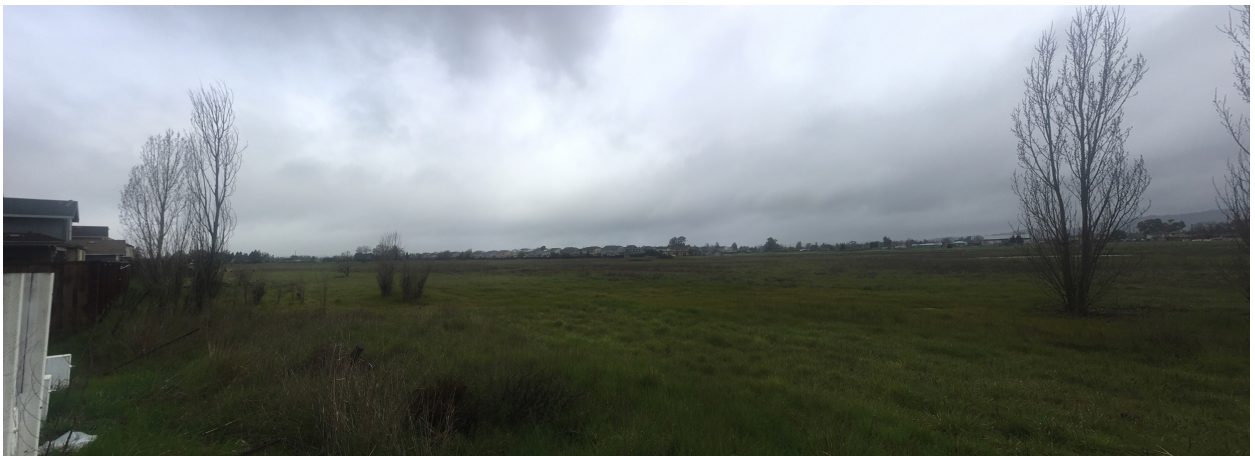
Photo 10: Subject Site (Facing Northwest)
Wetlands Area

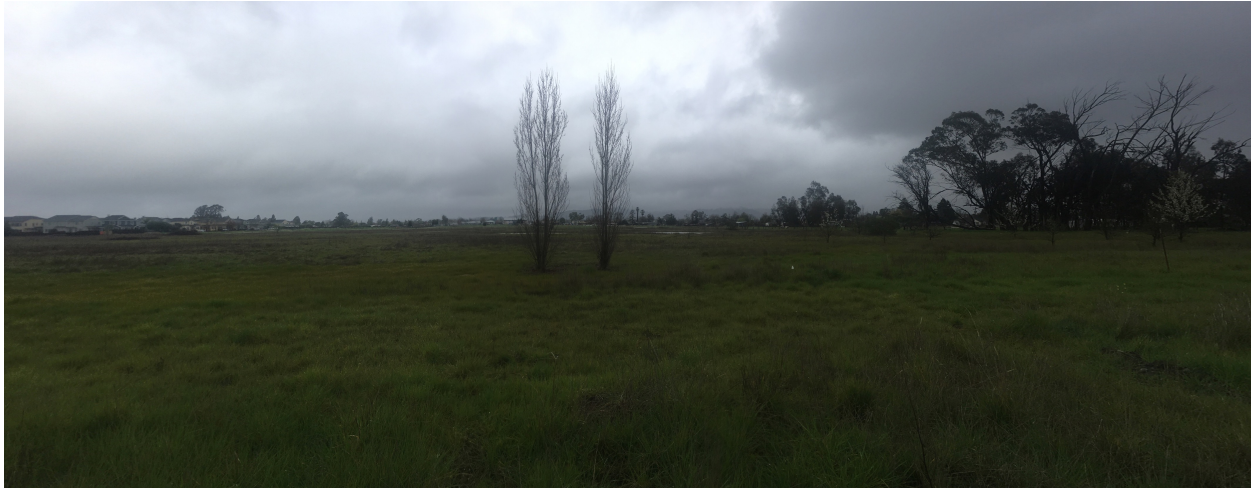
Photo 11: Subject Site (Facing Northeast)
Wetlands Area
