ARBORIST REPORT

TREE IMPACT ASSESSMENT

JANUARY 10, 2020

MITZI PLACE, 4146 MITZI DRIVE, SAN JOSE

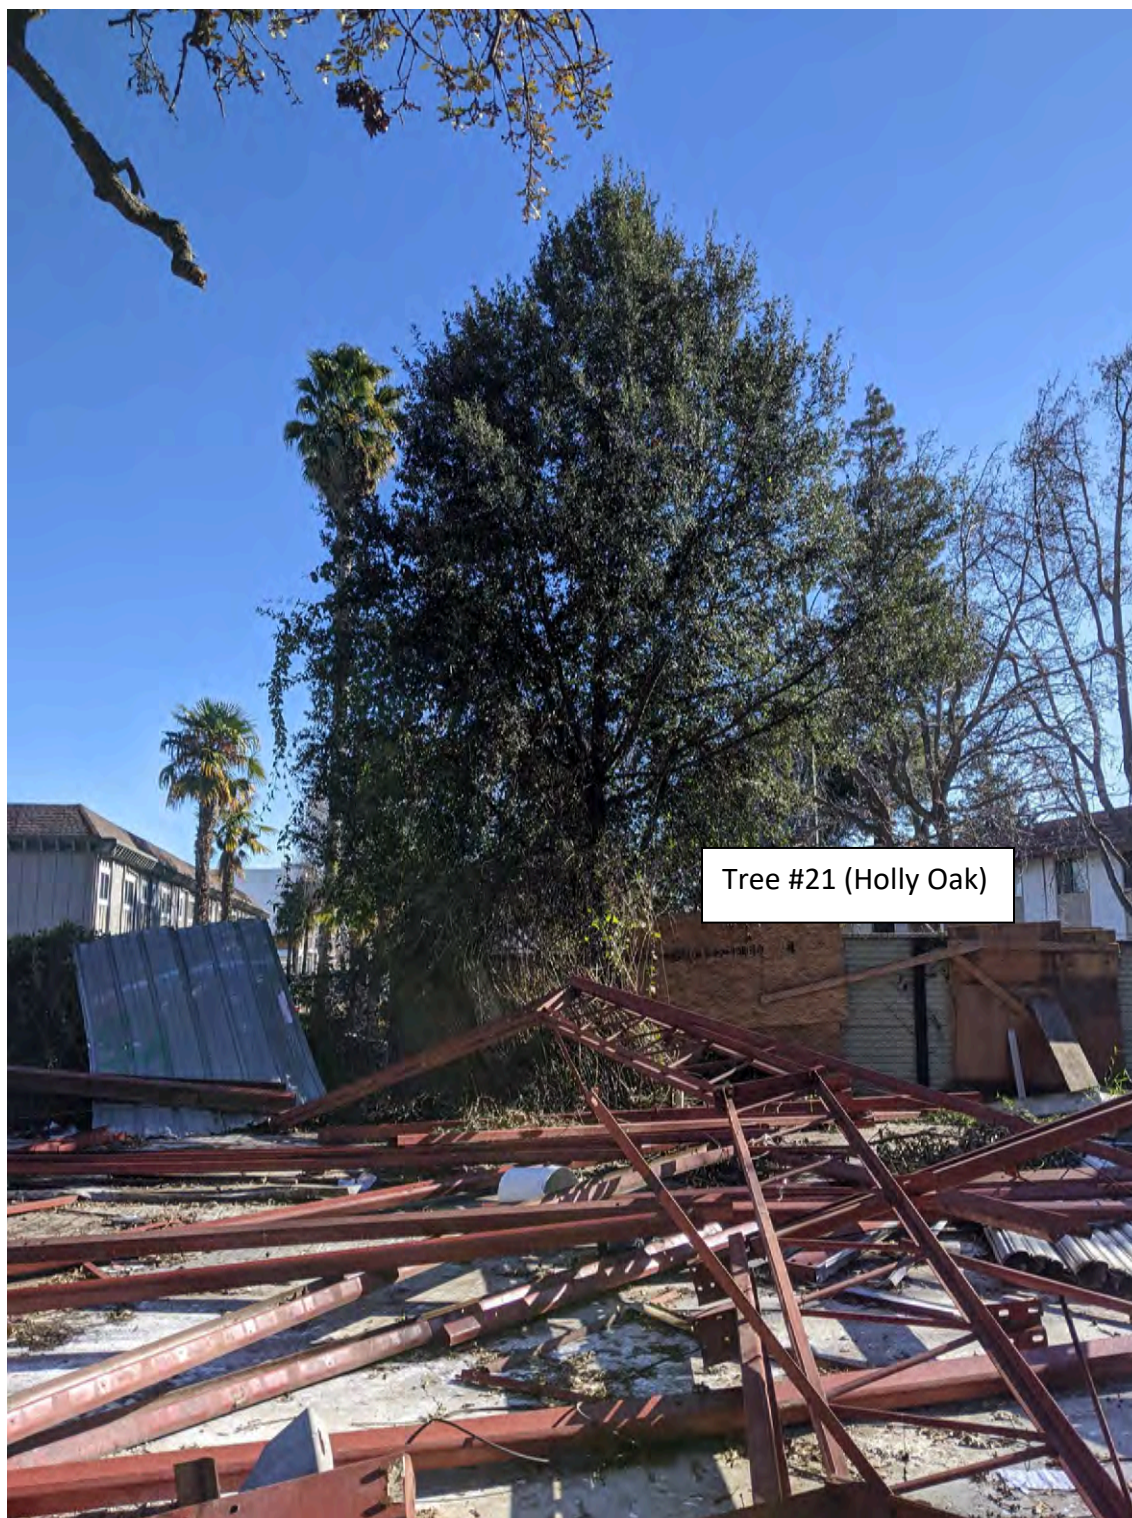
Tree #21 (Holly Oak)

Most trees were low-value species or were in poor condition. The exceptions were trees #21 and #24, young holly oak in good condition along the back-property line. However, these trees were within the footprint of the underground parking area and would be uprooted by the excavation. Even if they were somehow retained, they would be too close to the multi-story building than appropriate for their mature canopy spread.

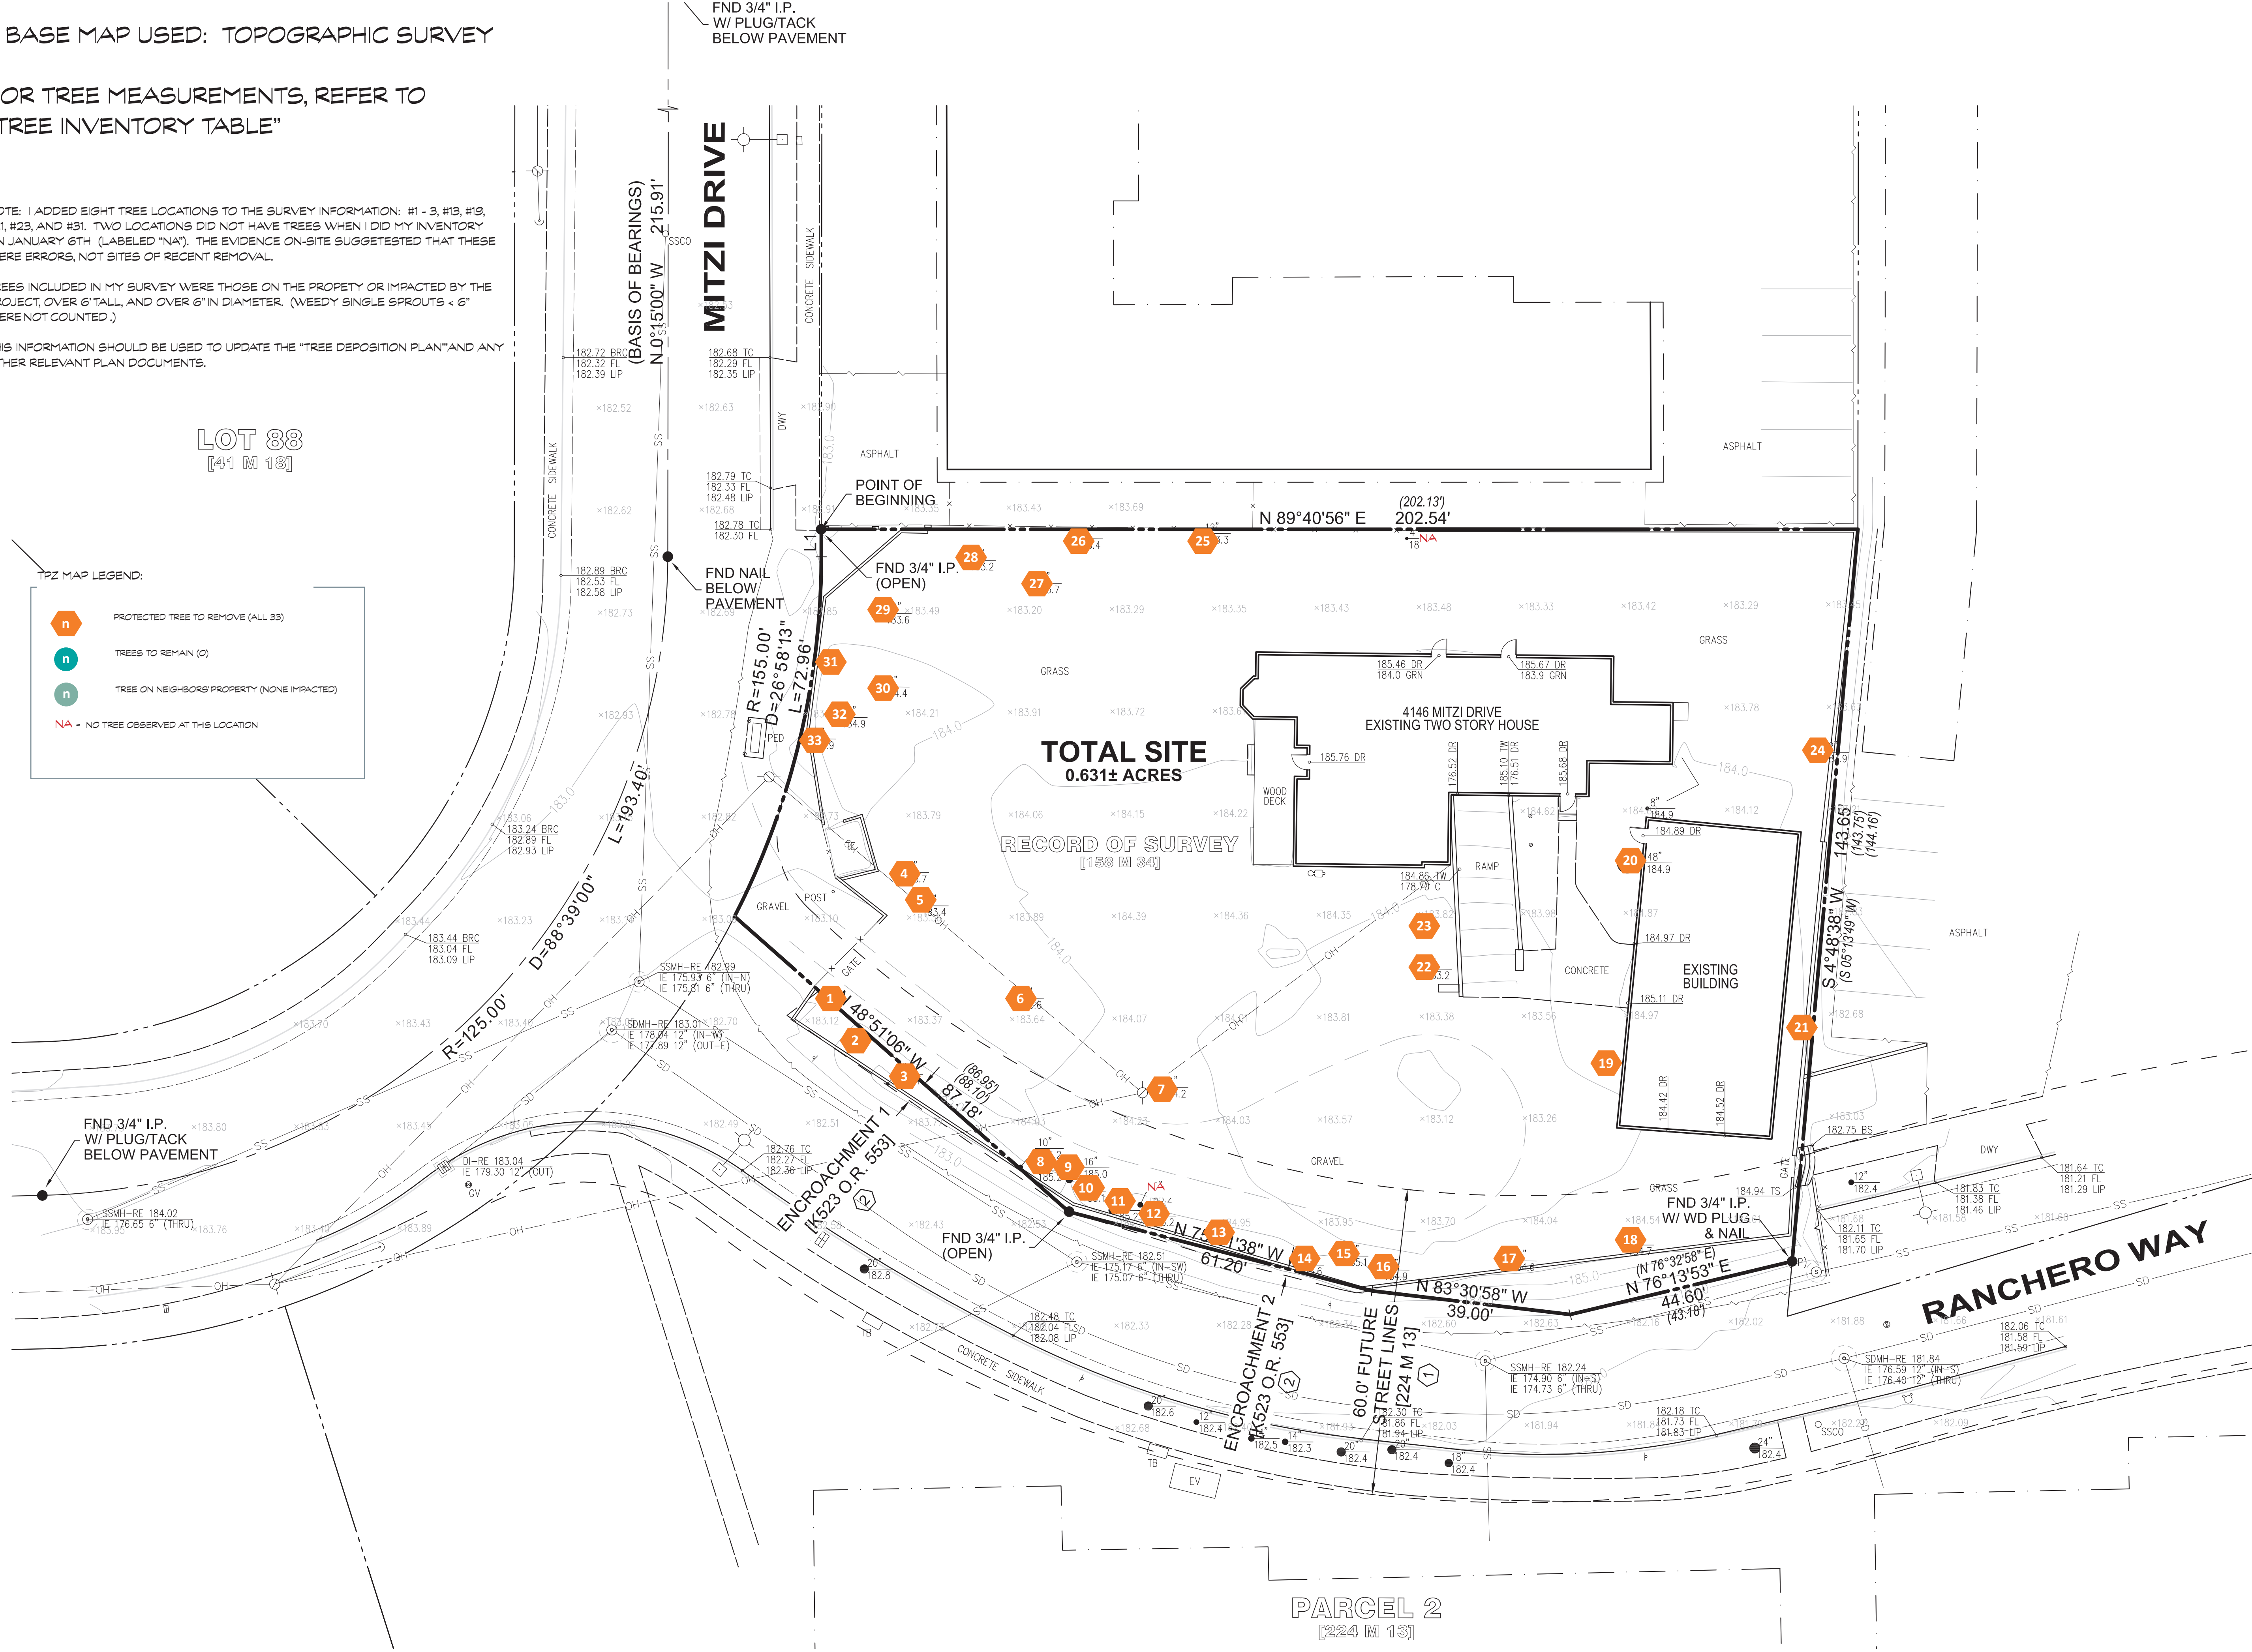
TREE MAP

NOTE: I ADDED EIGHT TREE LOCATIONS TO THE SURVEY INFORMATION: #1 - 3, #13, #19, #21, #23, AND #31. TWO LOCATIONS DID NOT HAVE TREES WHEN I DID MY INVENTORY ON JANUARY 6TH (LABELED "NA"). THE EVIDENCE ON-SITE SUGGESTED THAT THESE WERE ERRORS, NOT SITES OF RECENT REMOVAL.

THIS INFORMATION SHOULD BE USED TO UPDATE THE "TREE DEPOSITION PLAN" AND ANY OTHER RELEVANT PLAN DOCUMENTS.
