Site Management Plan

WDID-1_12CC415333

Humboldt County

9/18/2019

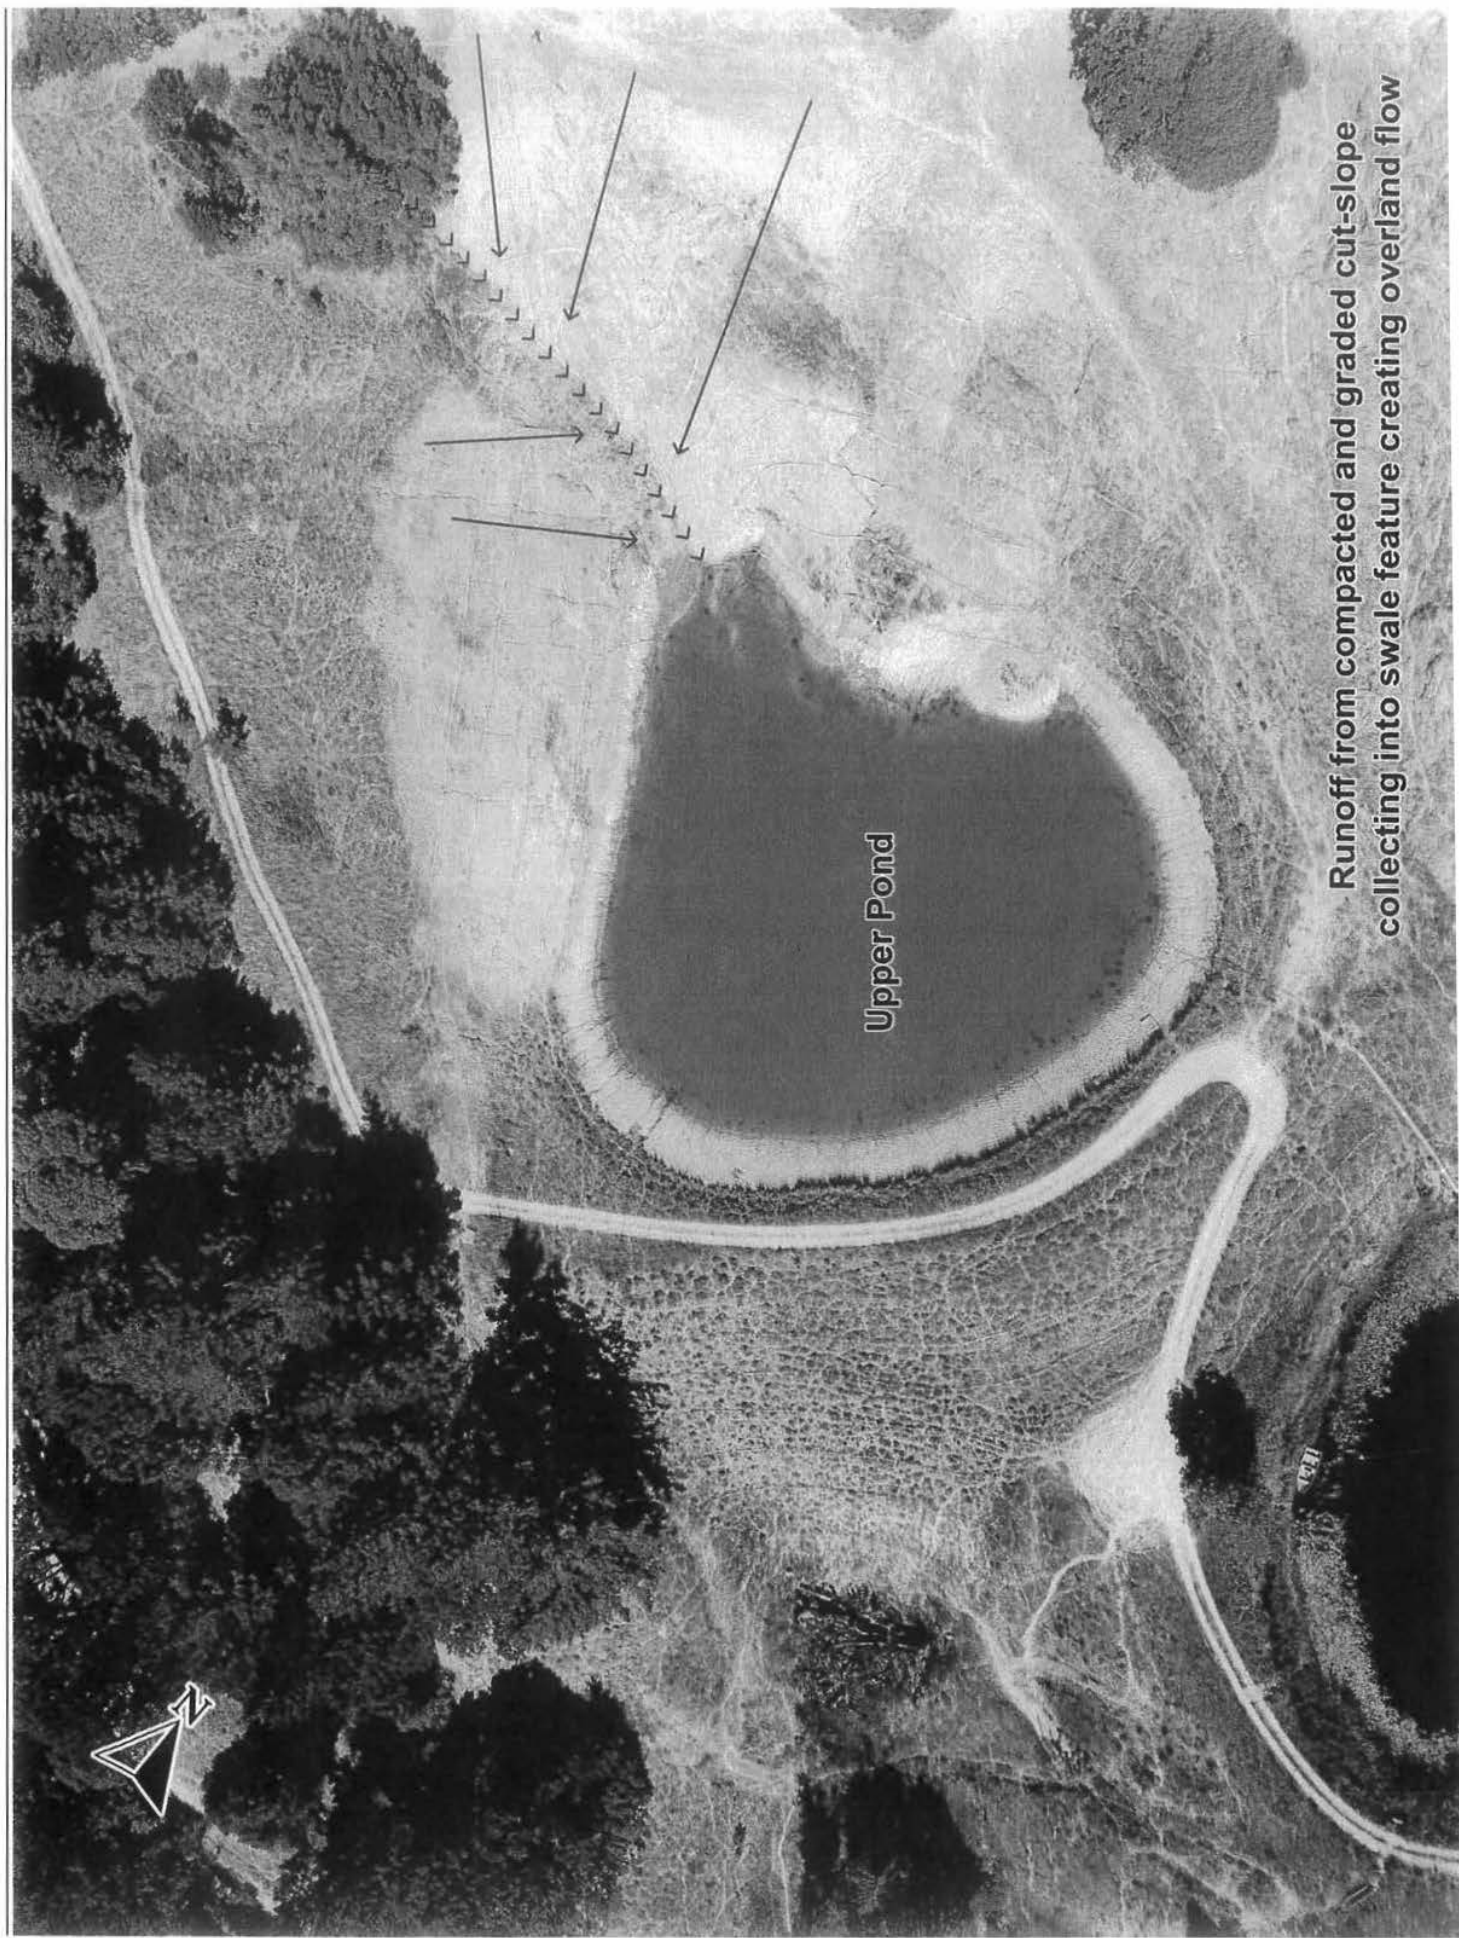
Runoff from compacted and graded cut-slope
collecting into swale feature creating overland flow

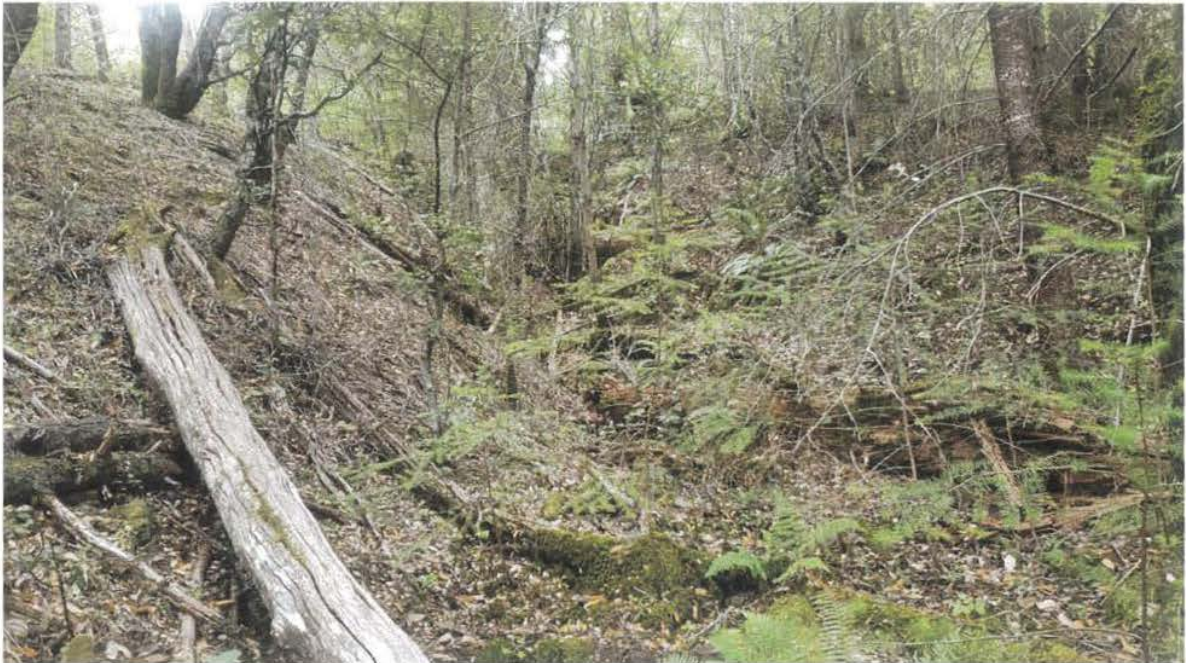
Undefined watercourse at Site 13 looking up stream.

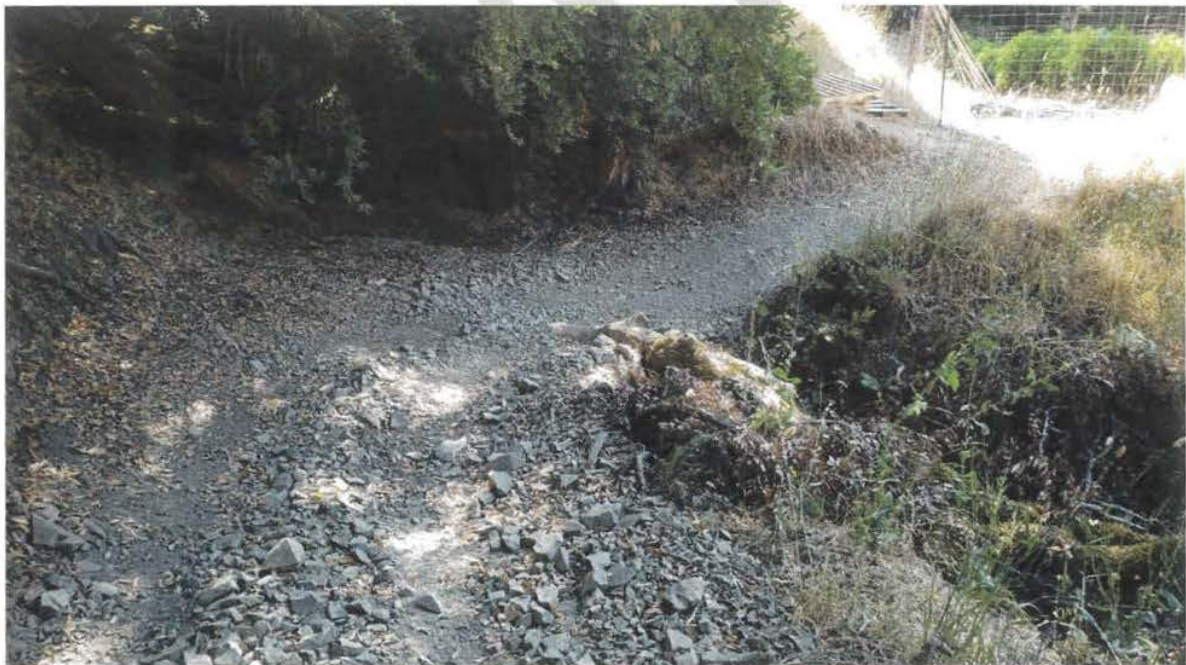
Photograph of the watercourse crossing at Site 16. This crossing is to be upgraded to a culverted crossing and the road approaches rocked to the garden parking area immediately to the left out of frame of this photograph.

Photograph of the watercourse crossing at Site 16 looking southeast.

Unique Point	Lat-Long NAD 83	Road Type	Mitigation Planned	Monitor	1600	Treatment Priority	Date Completed
Site 16	-123.762341 40.095568	Seasonal	X	X	X	Prior to 10/15/20	
Current Condition: Class III watercourse crossing consisting of a dirt ford. The outboard edge of the ford crossing is down cutting the road fill at the outlet.						Prescribed Action: Rock surface the approaches to the crossing and upgrade the existing crossing by installing an 18" D x 30' - 40' L culvert per the specifications outlined in the attached BMPs: See Permanent Culvert Crossing, Permanent Culvert Crossing Design: Critical Dip and Hydrologic Disconnect Placement, Critical Dip, Culvert Orientation, Inlet and Outlet Armoring, General Operations BMPs, and General Erosion Control specifications.

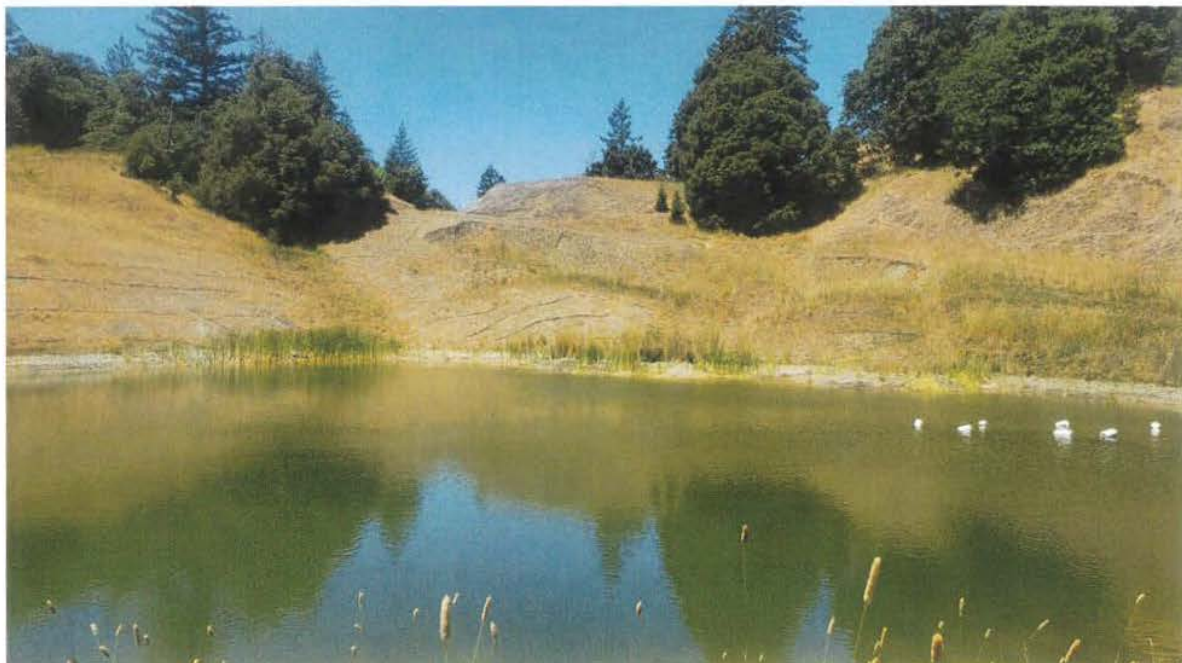
Photograph of the Upper Pond (off-stream rain catchment) look up grade towards the road fillslope failure at Site 36 taken from the pond embankment.

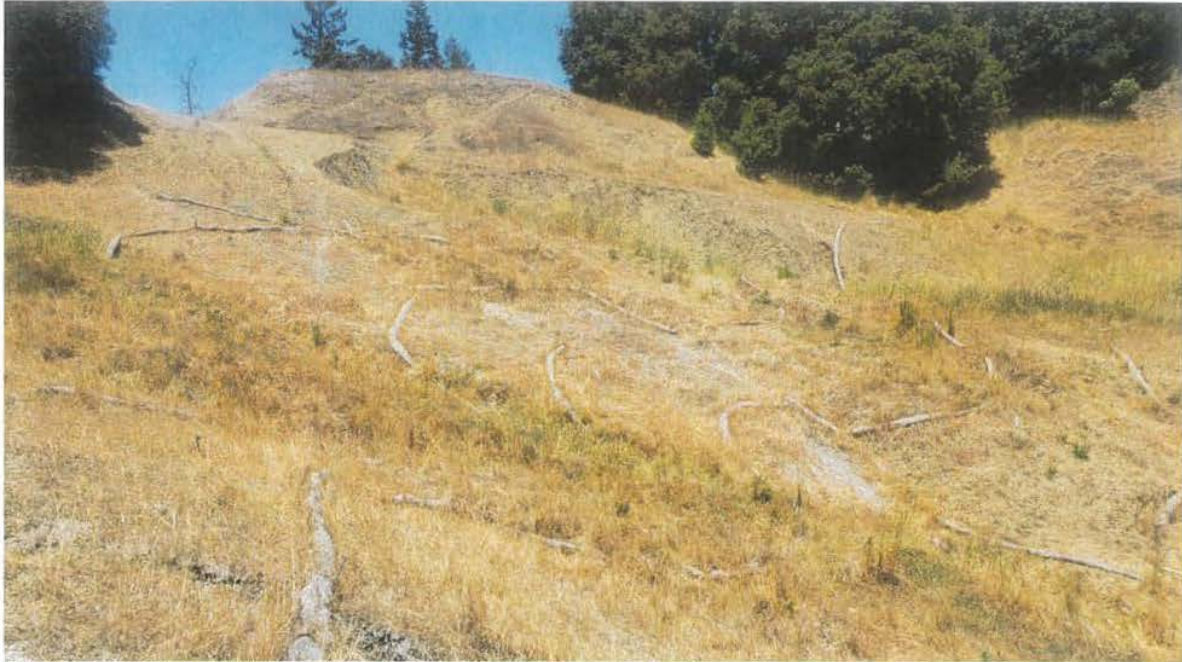
Photograph of the road fillslope failure at Site 36 taken from the west.

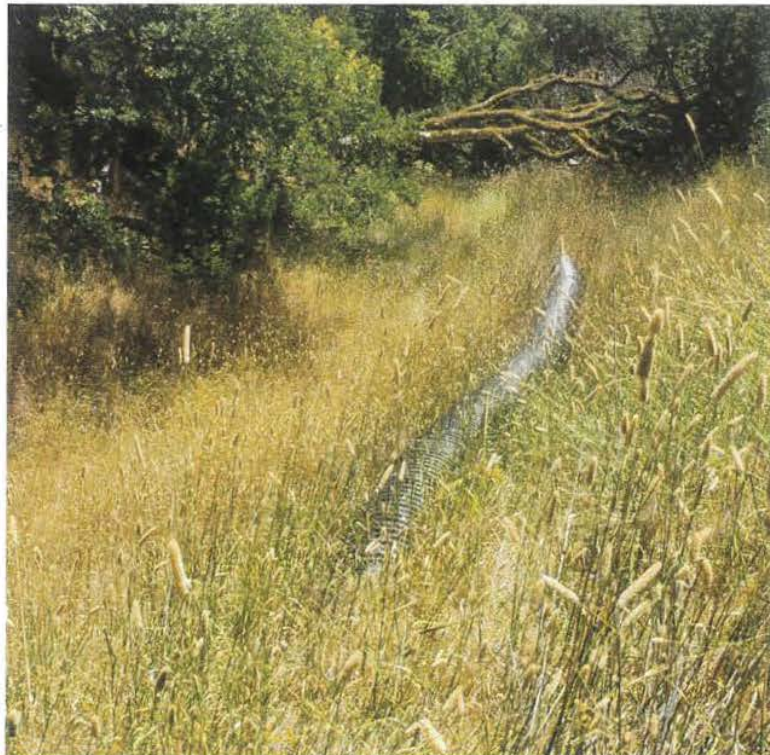
Photograph of the primary spillway (Site 38) on the Lower Pond to be removed.

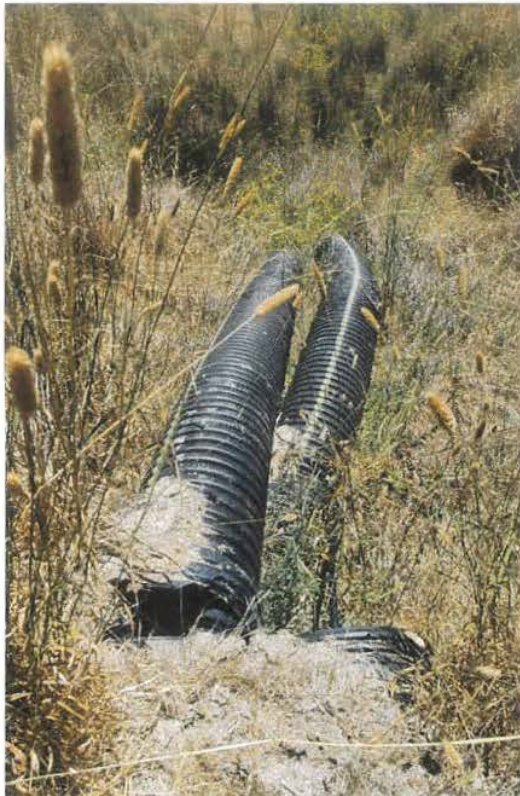
Photograph of the failing secondary spillway at Site 39. This spillway is to become the primary spillway after reconstructing of the pond embankment and installation of an anchored 24" culvert spillway.

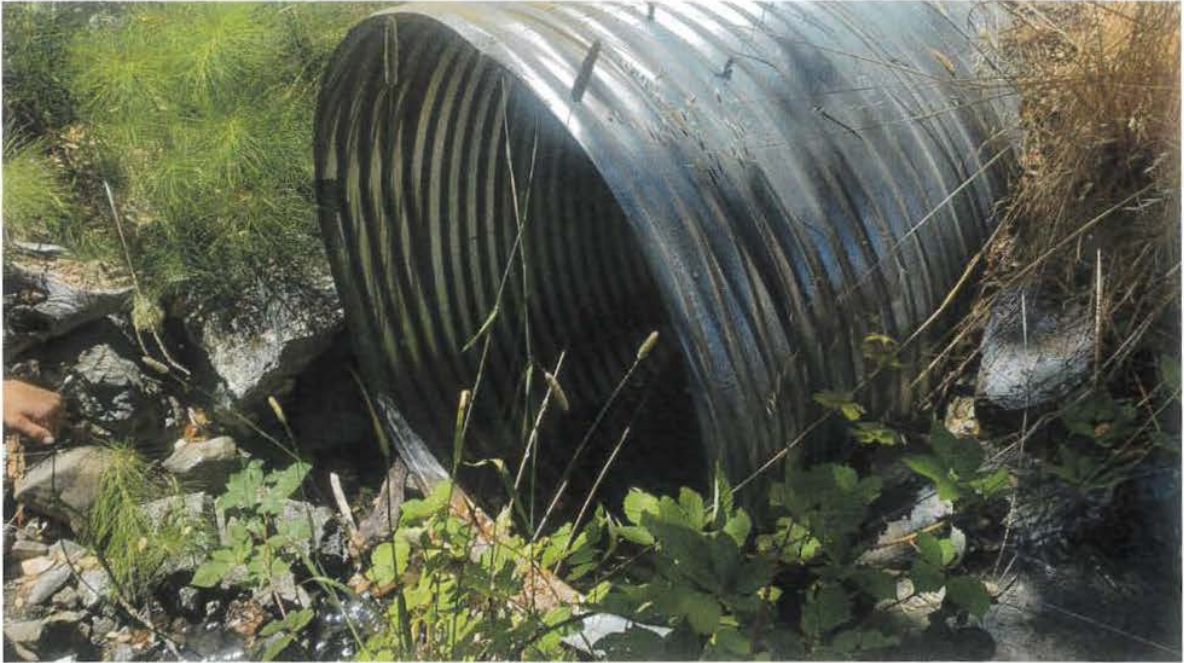
Photograph of the inlet of the watercourse crossing at Site 61.

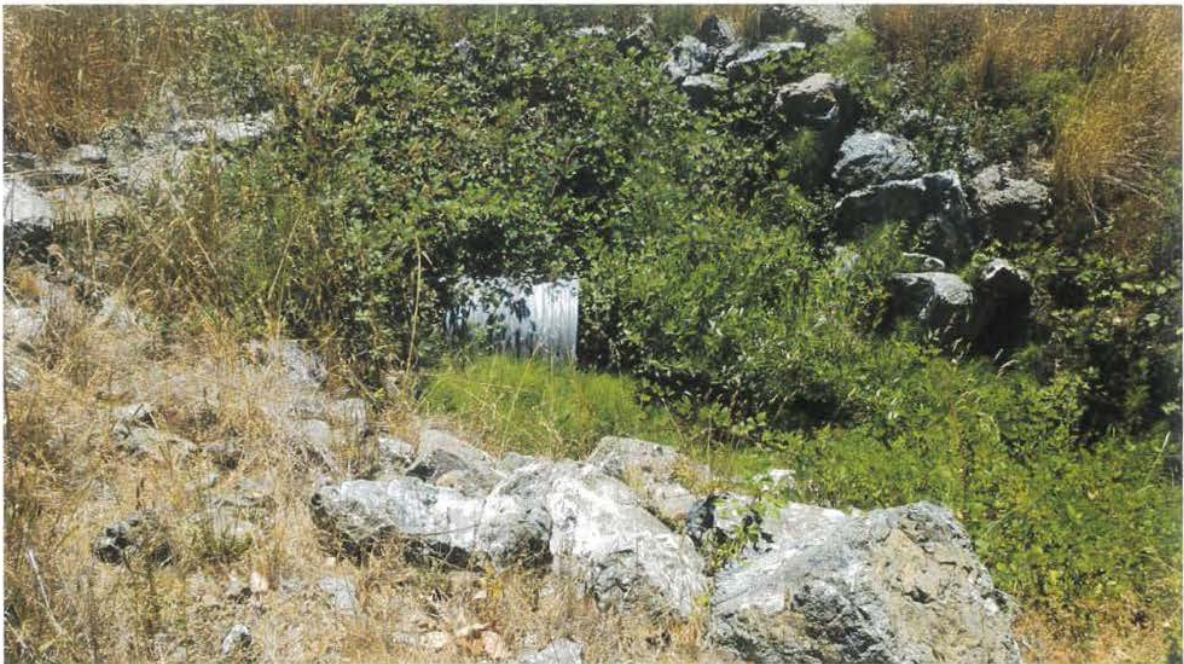
Photograph of the outlet of the watercourse crossing at Site 61.

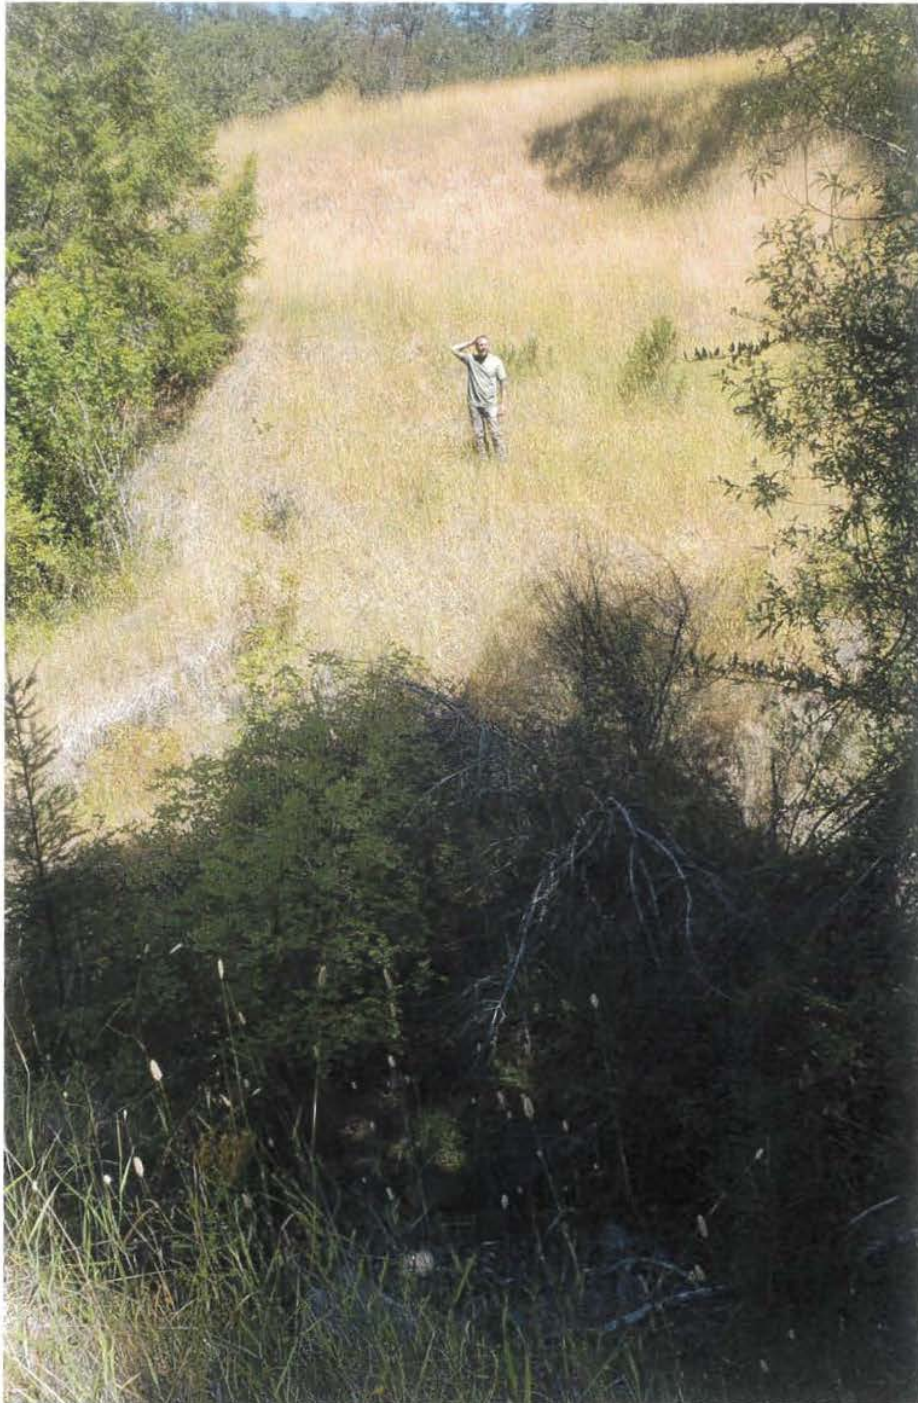
Photograph of the either removed or failed watercourse crossing at Site 70 looking north.

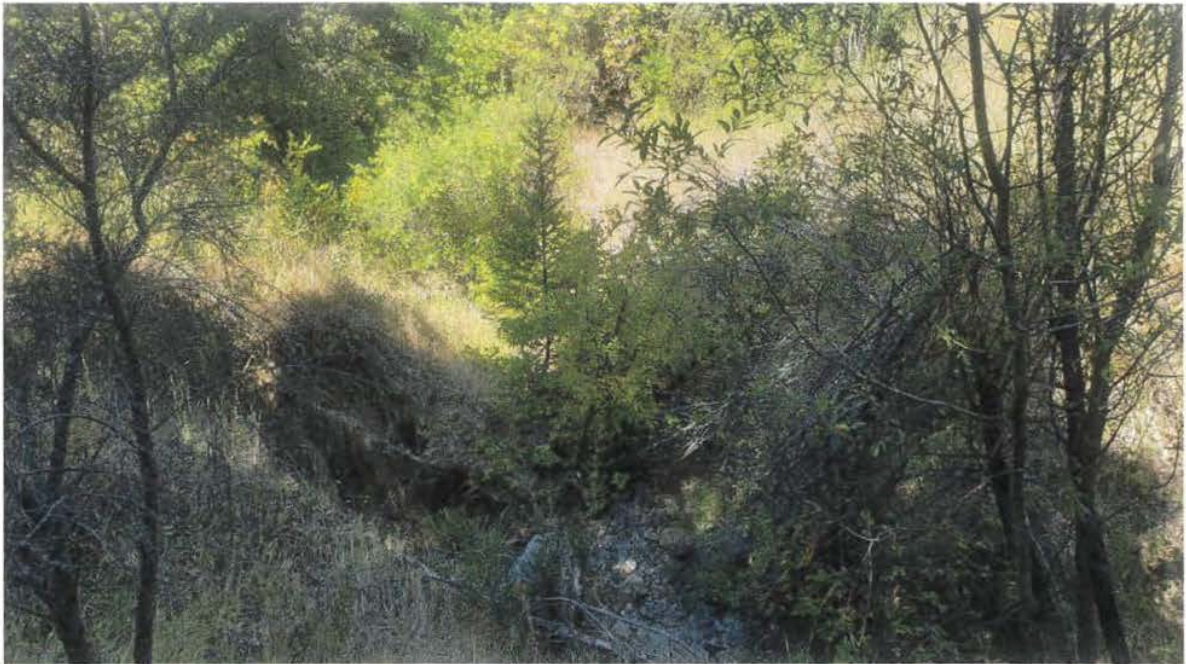
Photograph of the either removed or failed watercourse crossing at Site 70 looking west.

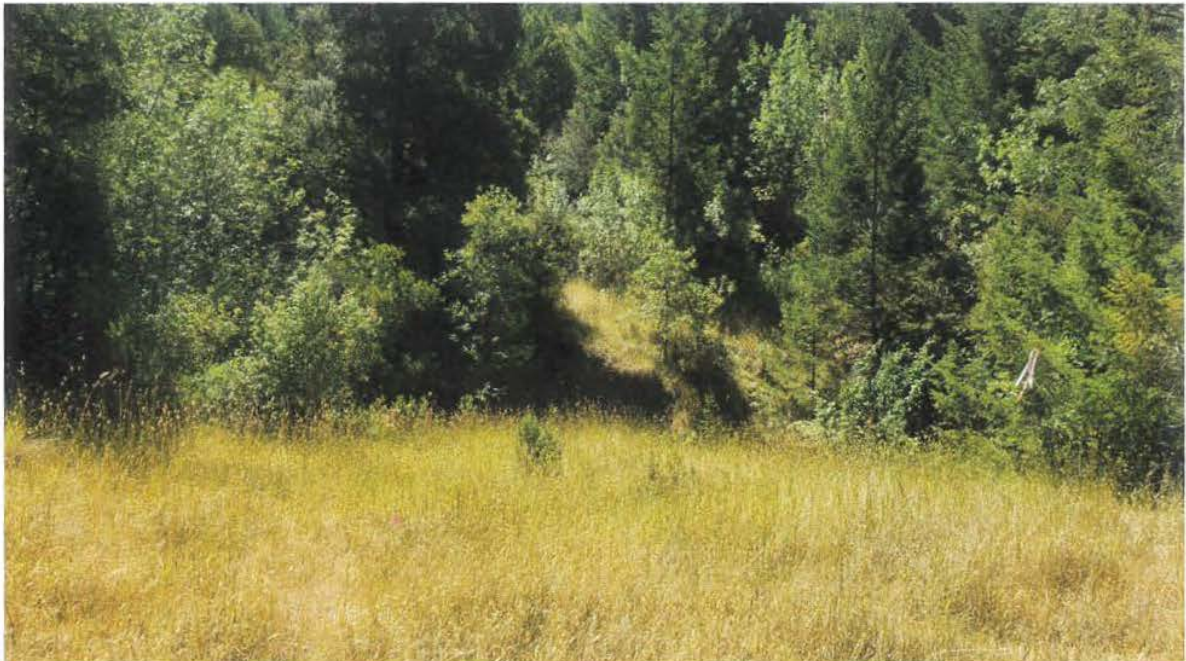
Photograph of the either removed or failed watercourse crossing at Site 70 looking south.

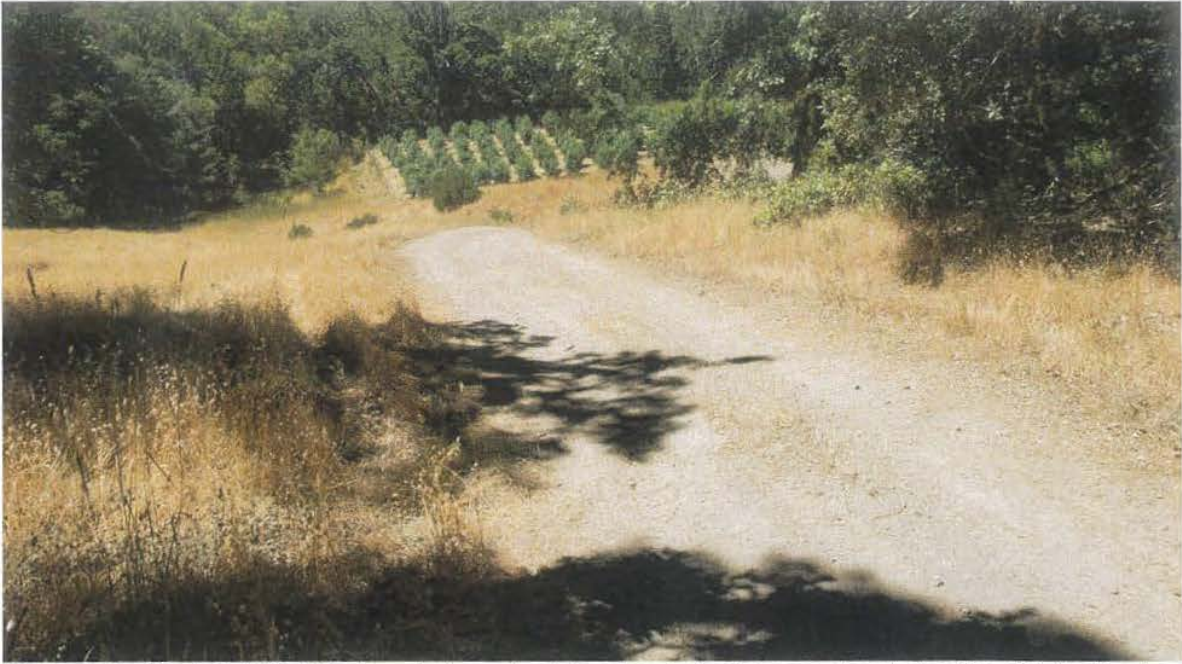
Photograph of the trail at Site 71 to be water barred and abandoned after the removal and relocation of Cultivation Area F.
