**TREE INVENTORY REPORT
DISTRICT NOHO
5430 NORTH LANKERSHIM BOULEVARD
LOS ANGELES, CALIFORNIA 91601**

**NOVEMBER 14, 2019
(REV. JUNE 4, 2020)**

Re: District NOHO Project, North Hollywood, California – Tree Inventory Report

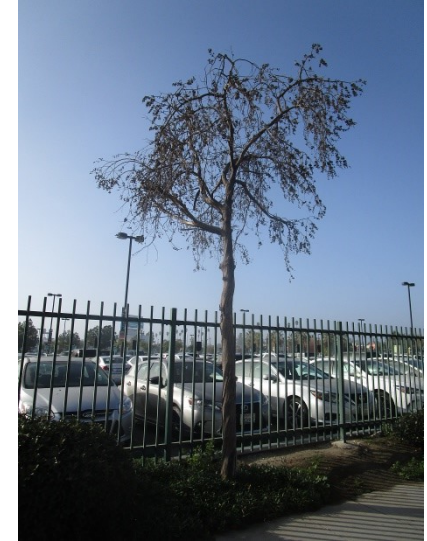
Tree 9

9	Brisbane box	<i>Lophostemon confertus</i>	6	15	N/A	F	F	No	No	DEAD; fence holding tree upright; recommend remove immediately
10	Brisbane box	<i>Lophostemon confertus</i>	6.8	15	N/A	F	F	No	No	DEAD

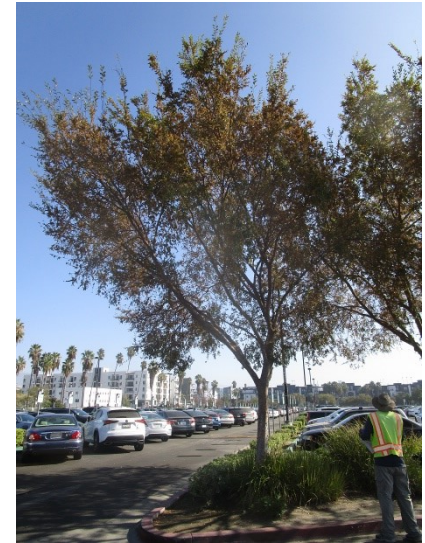
Tree 43

42	Chinese elm	<i>Ulmus parvifolia</i>	9.1	20	27 / 33	A-	B	No	Significant	HOB; MPE; thin canopy
43	Chinese elm	<i>Ulmus parvifolia</i>	7.5	20	23 / 27	A-	B+	Yes	No	MPE
44	Chinese elm	<i>Ulmus parvifolia</i>	8.5	20	25 / 30	A-	B+	No	Significant	MPE; electrical vault to east
45	Mediterranean fan palm	<i>Chamaerops humilis</i>	BT-4,6,6,6,6'	10	10 / 10	A	A	Yes	No	nice specimen

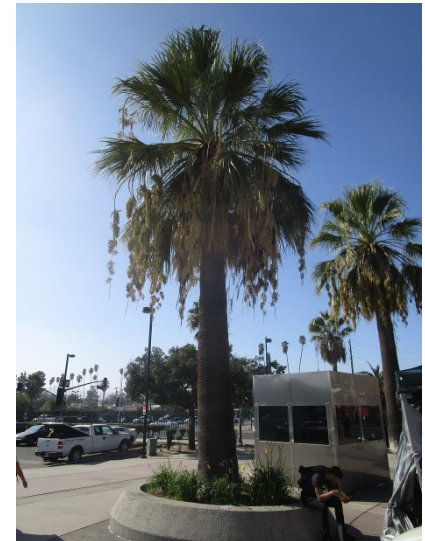
Tree 54

53	California fan palm	<i>Washingtonia filifera</i>	BT- 20'	30	15 / 15	A	A-	Yes	No	irrigation damage at base
54	California fan palm	<i>Washingtonia filifera</i>	BT- 20'	30	15 / 15	A	A-	Yes	No	irrigation damage at base
55	California fan palm	<i>Washingtonia filifera</i>	BT- 20'	30	15 / 15	A	A-	Yes	No	irrigation damage at base
56	California fan palm	<i>Washingtonia filifera</i>	BT- 20'	30	15 / 15	A	A-	Yes	No	irrigation damage at base
57	California fan palm	<i>Washingtonia filifera</i>	BT- 20'	30	15 / 15	A	A-	Yes	No	irrigation damage at base

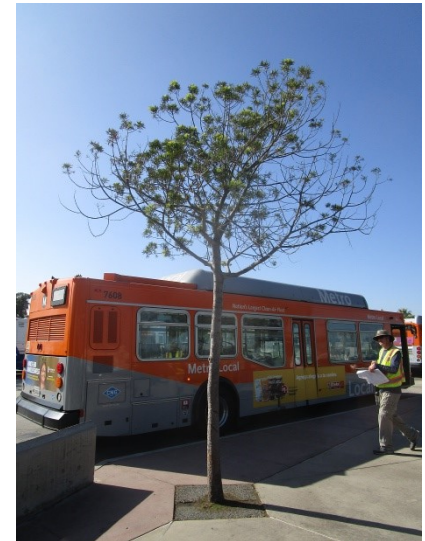
Tree 66

66	fern pine	<i>Afrocarpus gracilior</i>	4.8	15	10 / 10	B-	B-	No	No	sunburn on west trunk; bark peeling; sparse; MPE; drought stress
67	fern pine	<i>Afrocarpus gracilior</i>	12.2	25	21 / 21	A	A	Yes	Significant	MPE
68	fern pine	<i>Afrocarpus gracilior</i>	5.2	10	10 / 10	B	B	No	No	drought stress; sparse; sunburn on trunk on west; MPE
69	fern pine	<i>Afrocarpus gracilior</i>	9.5	15	25 / 27	A	A	Yes	Significant	MPE

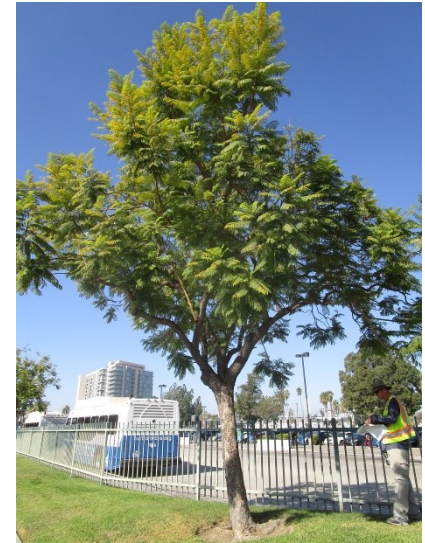
Tree 77

76	jacaranda	<i>Jacaranda mimosifolia</i>	4.8	10	12 / 12	B-	B-	No	No	leans north; sparse; MPE; sunburn on southwest trunk
77	jacaranda	<i>Jacaranda mimosifolia</i>	9.5	15	21 / 21	B	B	No	Significant	MPE; MBA; exposed roots
78	jacaranda	<i>Jacaranda mimosifolia</i>	9.3	20	21 / 21	B+	B+	No	Significant	MPE; MBA
79	jacaranda	<i>Jacaranda mimosifolia</i>	7.4	15	21 / 21	B	B	No	No	slight lean west; MPE; MBA
80	jacaranda	<i>Jacaranda mimosifolia</i>	6.7	15	21 / 21	B	B	No	No	leans southeast; MPE; MBA

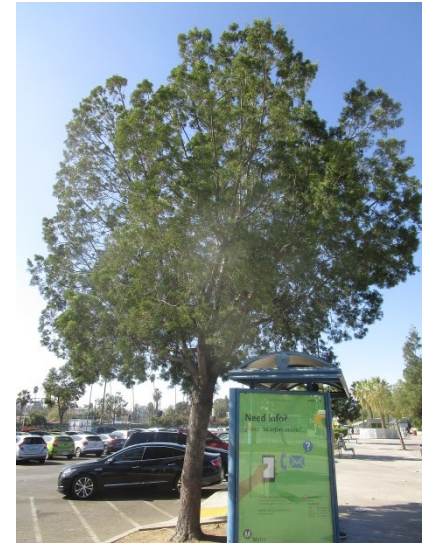
Tree 89

89	fern pine	<i>Afrocarpus gracilior</i>	13	30	20 / 27	A	A	Yes	Significant	MPE
90	fern pine	<i>Afrocarpus gracilior</i>	7.3	10	12 / 12	B+	B+	No	No	sunburn on west; drought stress
91	fern pine	<i>Afrocarpus gracilior</i>	11	25	22 / 27	A	A	Yes	Significant	MPE
92	fern pine	<i>Afrocarpus gracilior</i>	3.8	10	10 / 12	B+	B+	Yes	No	stakes still attached; drought stress

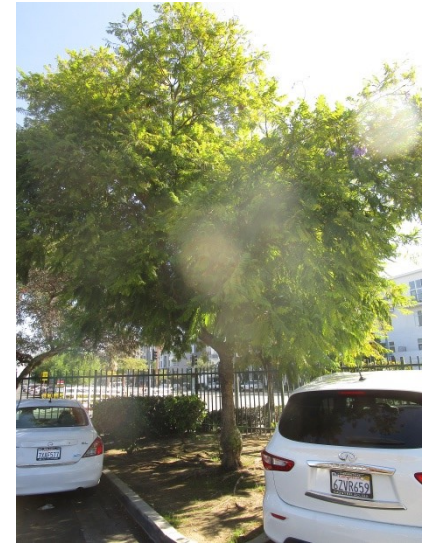
Tree 101

101	jacaranda	<i>Jacaranda mimosifolia</i>	9.3	20	30 / 36	B+	B-	No	Significant	exposed roots; epicormic growth; MPE
102	mimosa tree	<i>Albizia julibrissin</i>	9.3	15	21 / 27	B	B-	No	Significant	exposed roots; epicormic growth; MPE; moderate dieback
103	Brisbane box	<i>Lophostemon confertus</i>	6	25	21 / 17	A-	A	Yes	No	
104	Brisbane box	<i>Lophostemon confertus</i>	6.6	25	20 / 15	A-	A	Yes	No

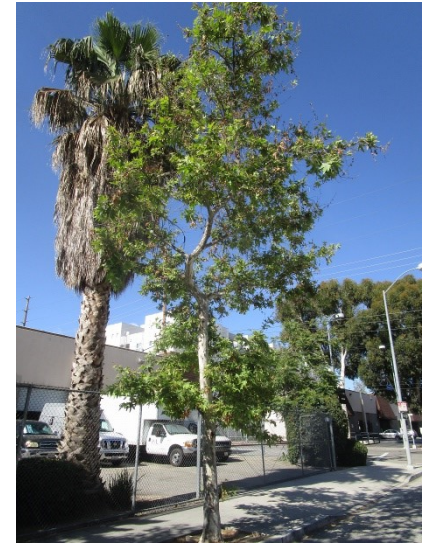
Tree ST57

ST56	crape myrtle	<i>Lagerstroemia indica</i>	4	10	12 / 12	A	B+	Yes	Protected - ROW	basal sprouts; multiple pruning events
ST57	California sycamore	<i>Platanus racemosa</i>	8.5	20	20 / 25	B	B	No	Protected - ROW	minor dieback; epicormic growth; multiple pruning events; in small planting space
ST58	California sycamore	<i>Platanus racemosa</i>	11	25	20 / 27	A	B+	No	Protected - ROW	leans east; mechanical damage on trunk; in small planting space
ST59	California sycamore	<i>Platanus racemosa</i>	15	30	30 / 30	B	B+	No	Protected - ROW	sparse; moderate dieback; in small planting space
ST60	California sycamore	<i>Platanus racemosa</i>	17	40	40 / 35	A	B+	No	Protected - ROW	minor dieback; in small planting space
ST61	California sycamore	<i>Platanus racemosa</i>	14.5	30	30 / 30	B+	B+	No	Protected - ROW	minor dieback; in small planting space
