GEOTECHNICAL ENGINEERING INVESTIGATION

PROPOSED MULTI-FAMILY RESIDENTIAL DEVELOPMENT

THE RESIDENCE AT CASA LOMA

Project Number: G57101.01-01

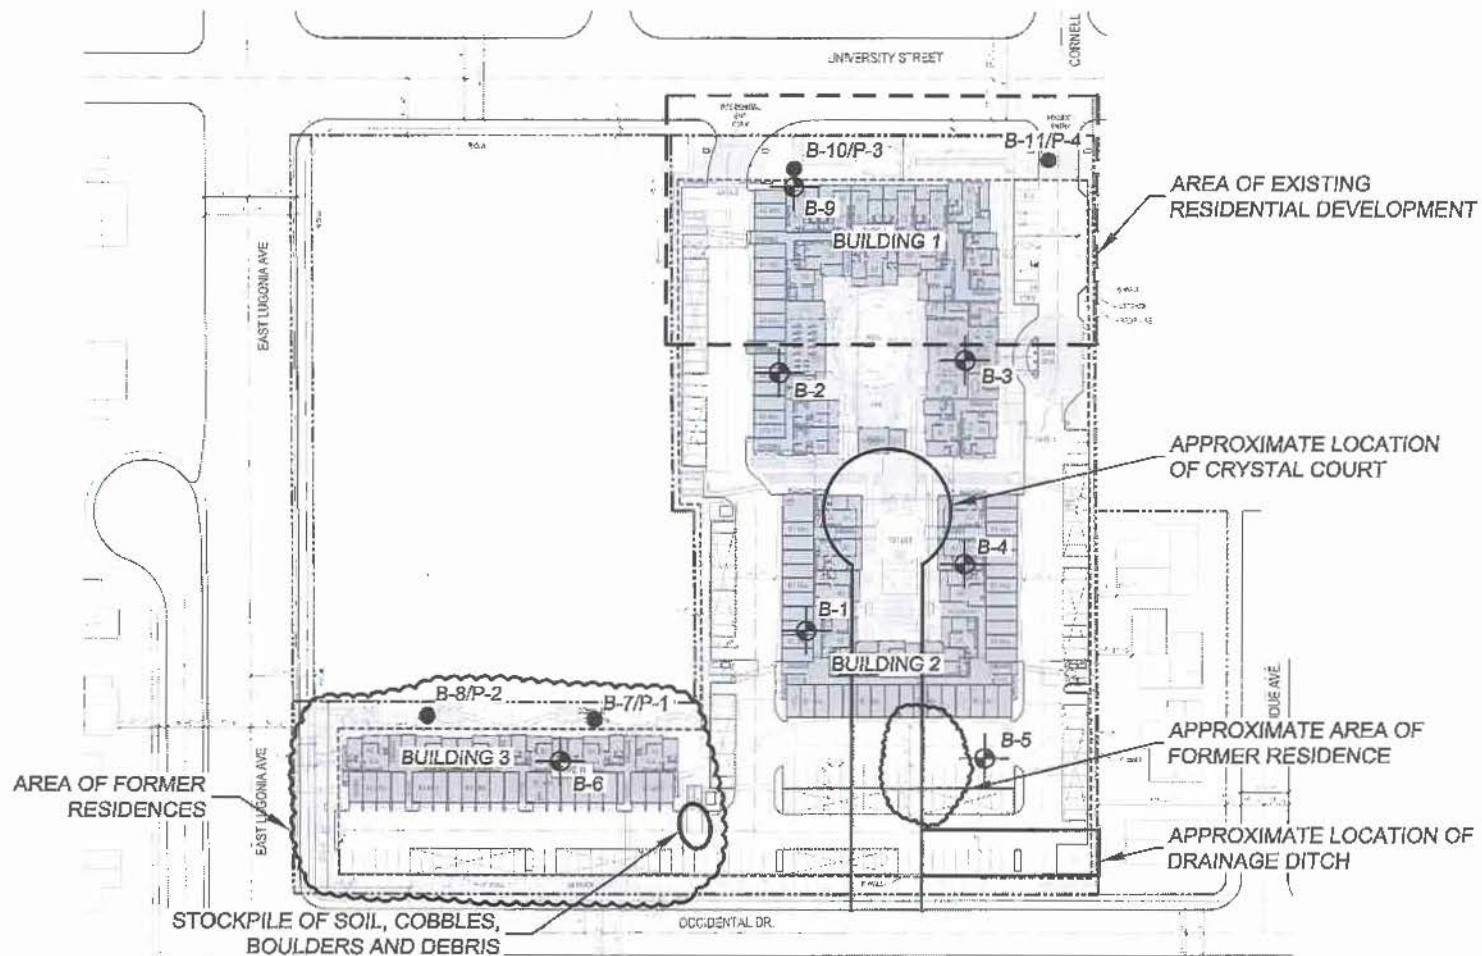
| Drawing No. 2 - | Test Boring Location Map |

Test boring locations were determined with reference to existing site features shown on the site plan. The locations, as described, should be considered approximate. The locations of the test borings are shown on Drawing No. 2 in Appendix A. The test borings were loosely backfilled with material excavated during the drilling operations; thus, some settlement should be anticipated at the boring locations.

4.1.4 Percolation Testing: Percolation tests were conducted in the four (4) borings (B-7/P-1, B-8/P-2, B-10/P-3 and B-11/P-4) where shown on Drawing No. 2 in Appendix A of this report. The percolation test borings were drilled to depths of approximately 3 to 5 feet below site grade with a truck-mounted CME-75 drill rig equipped with 8-inch outside diameter (O.D.) hollow-stem augers. The percolation tests were conducted within the boreholes and infiltration rates were estimated using the percolation test data.

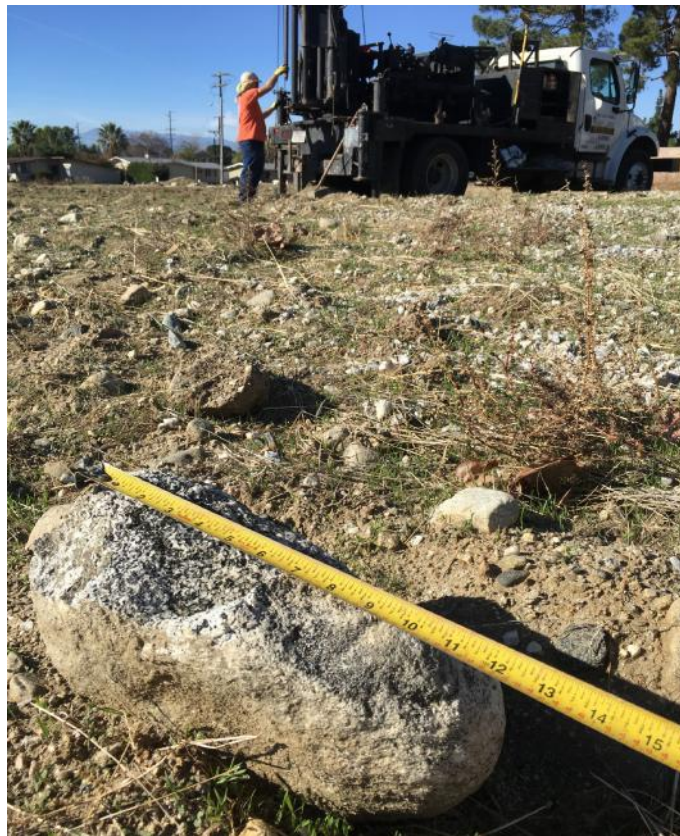
Photograph No. 2: Typical conditions of vacant lot with gravel, cobbles, boulders, grasses and weeds at ground surface

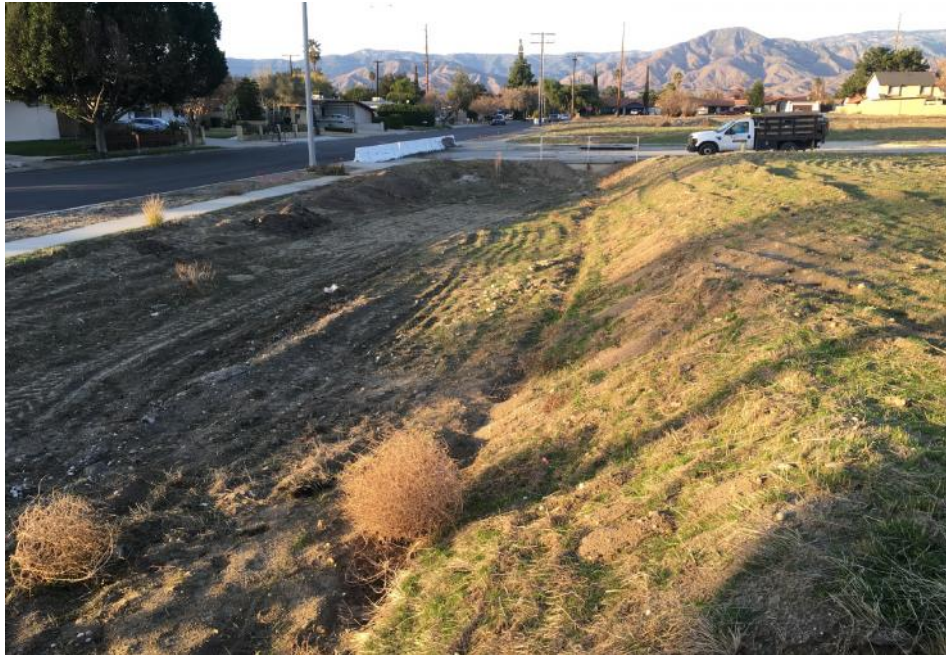
A man-made earthen drainage ditch is located in the southwest portion of the site, on the south side of Crystal Court (see photograph No. 3 in Appendix A). It appears that it was made to collect and infiltrate runoff from Crystal Court. A storm water inlet was noted along the south side of Crystal Court and an outlet was noted on the north side of the earthen drainage ditch which was completed filled with soil. The earthen drainage ditch has a five (5) foot tall slope on the east side with an inclination of approximately 1 Horizontal to 1 Vertical (1H:1V) and a two (2) foot tall slope on the west side with an inclination of approximately 1.5H:1V.

Photograph No. 3: Viewing north at drainage ditch in western portion of vacant lot, south of Crystal Court

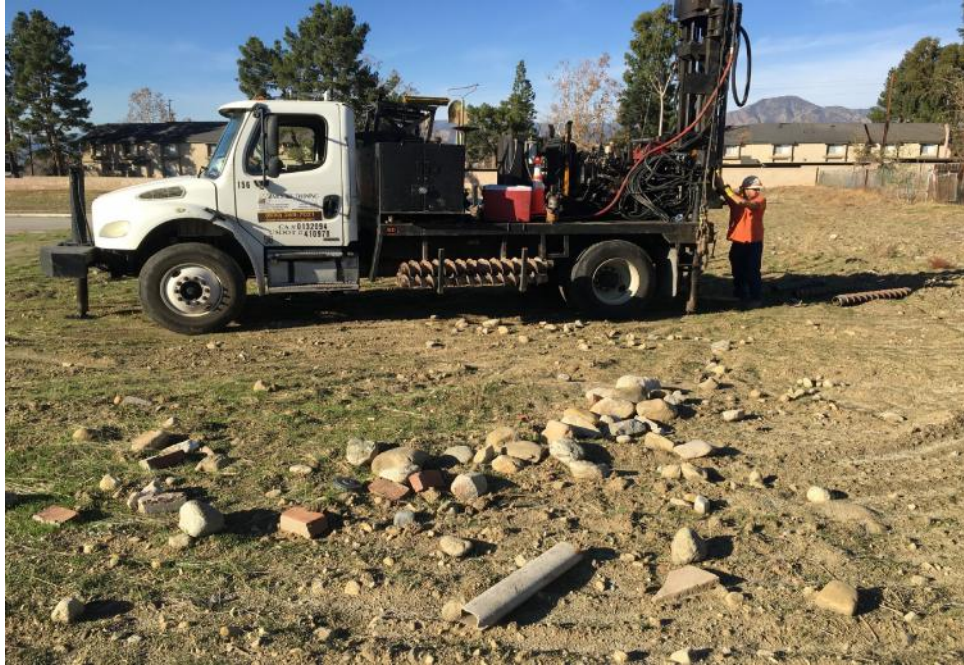
Photograph No. 5: Viewing north at asbestos pipe and nested cobbles and boulders in eastern portion of vacant lot

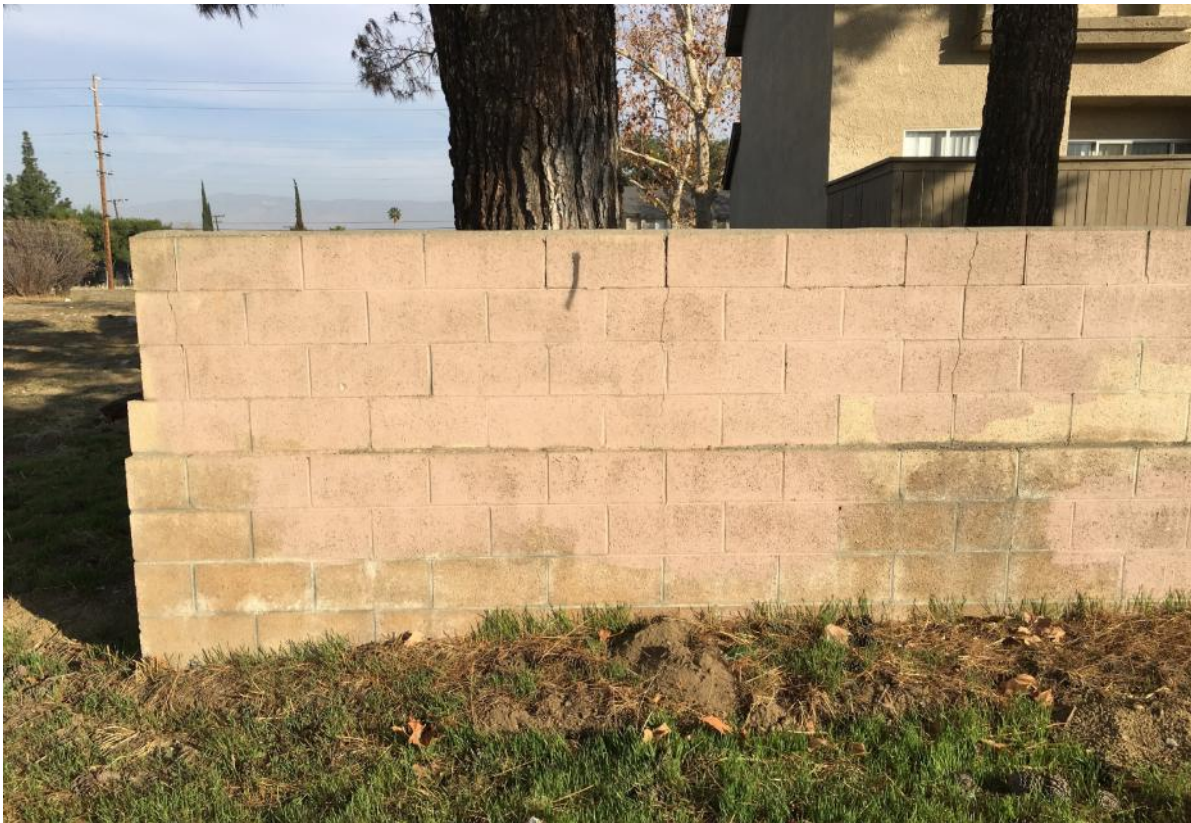
A concrete masonry unit screen wall (see photograph No. 6 in Appendix A) was noted on the west and south sides of the existing apartment complex that borders the subject site (vacant lot and three (3) single-family residential properties).

Photograph No. 6: Viewing north at screen wall exhibiting distress in the form of cracks. Screen wall divides the site from an existing apartment complex located north of the site.

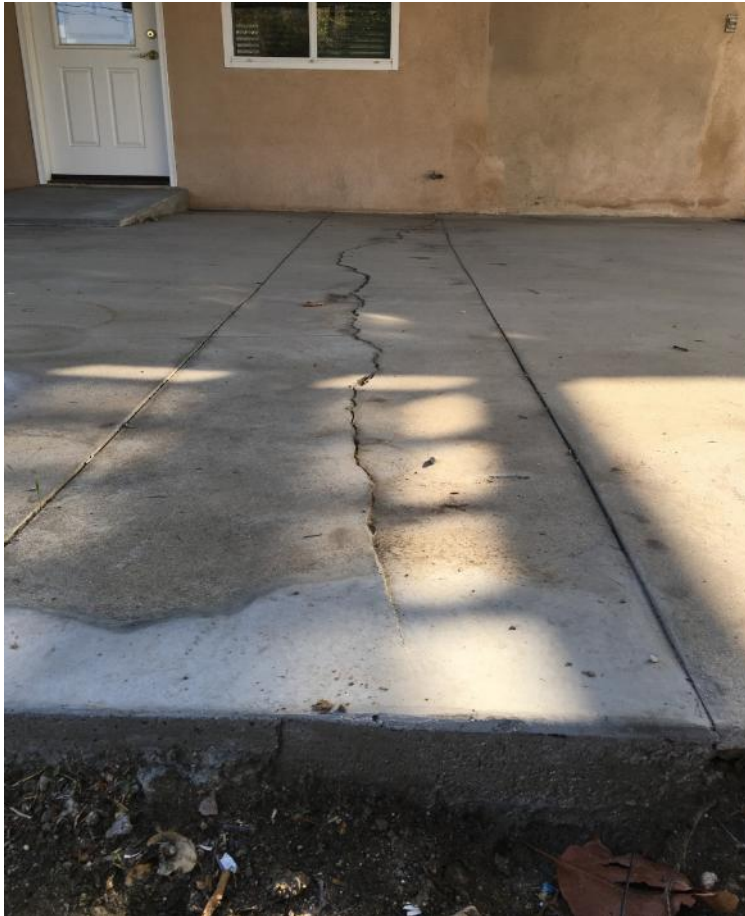
Photograph No. 10: Cracked patio slab on west side of residence at 1205 University Street
