# PROTECTED TREE REPORT

434 W. James Street  
Los Angeles, CA 90065

January 1, 2021

LISA SMITH, THE TREE RESOURCE  
REGISTERED CONSULTING ARBORIST #464  
ISA BOARD CERTIFIED MASTER ARBORIST #WE3782  
ISA TREE RISK ASSESSOR QUALIFIED  
MEMBER OF AMERICAN SOCIETY OF CONSULTING ARBORISTS  
P.O. BOX 49314, LOS ANGELES, CA 90049  
T 310-663-2290 E queenpalm@earthlink.net

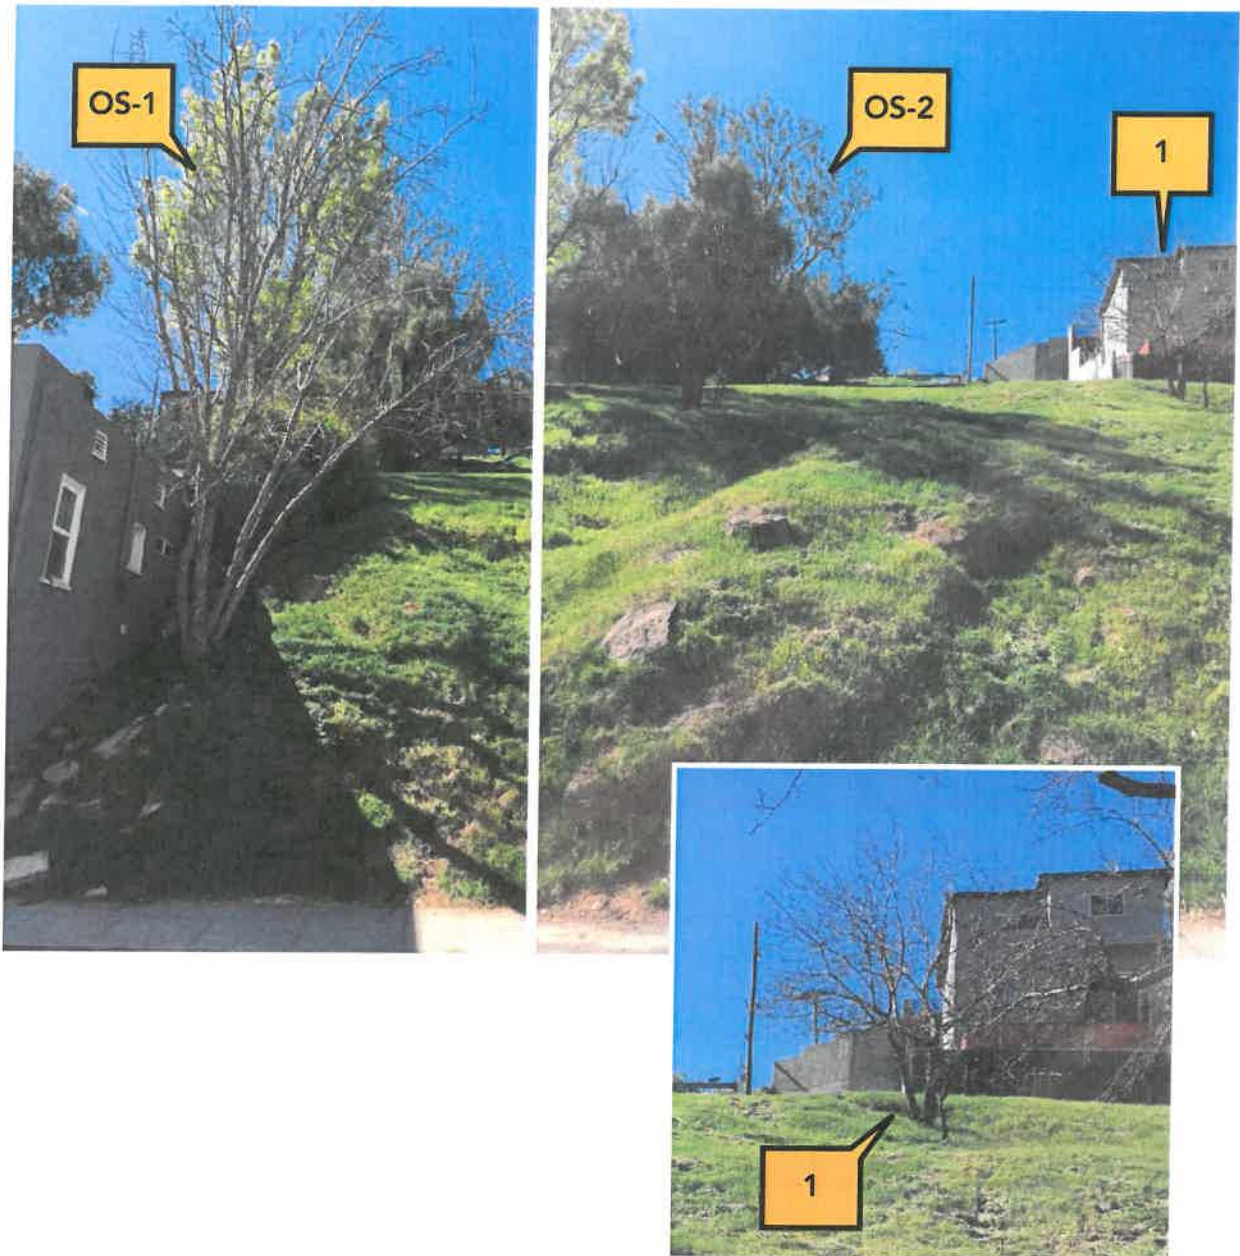
**PHOTO 1** - Shows a view of OFF-SITE black walnut trees #OS-1 and #OS-2 and a portion of the vacant lot 434 James Street, including black walnut tree #1. Black walnut tree #1 is above the construction zone of the proposed new residence and will be retained and protected in place.

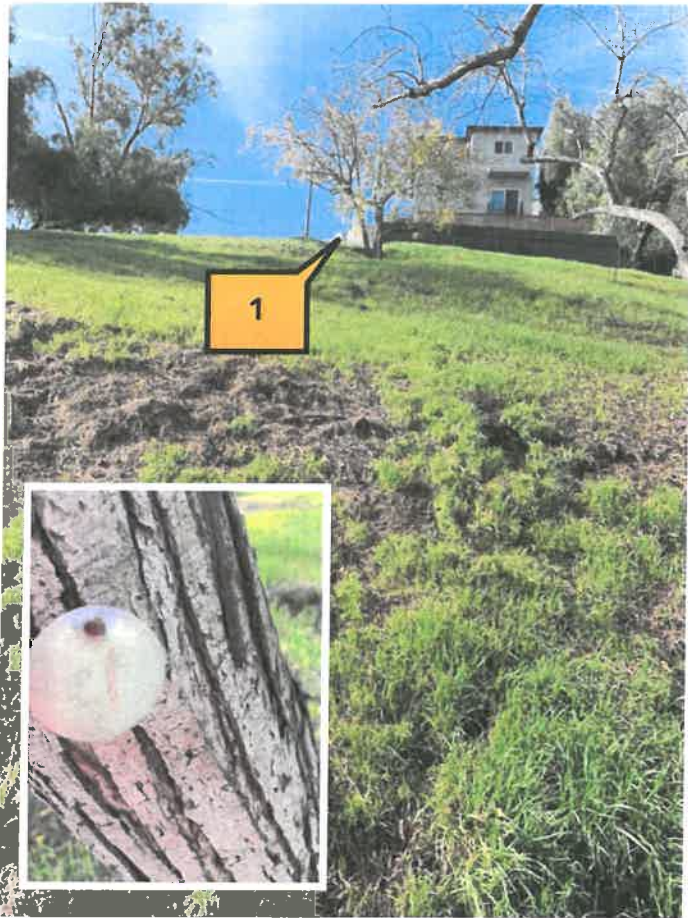
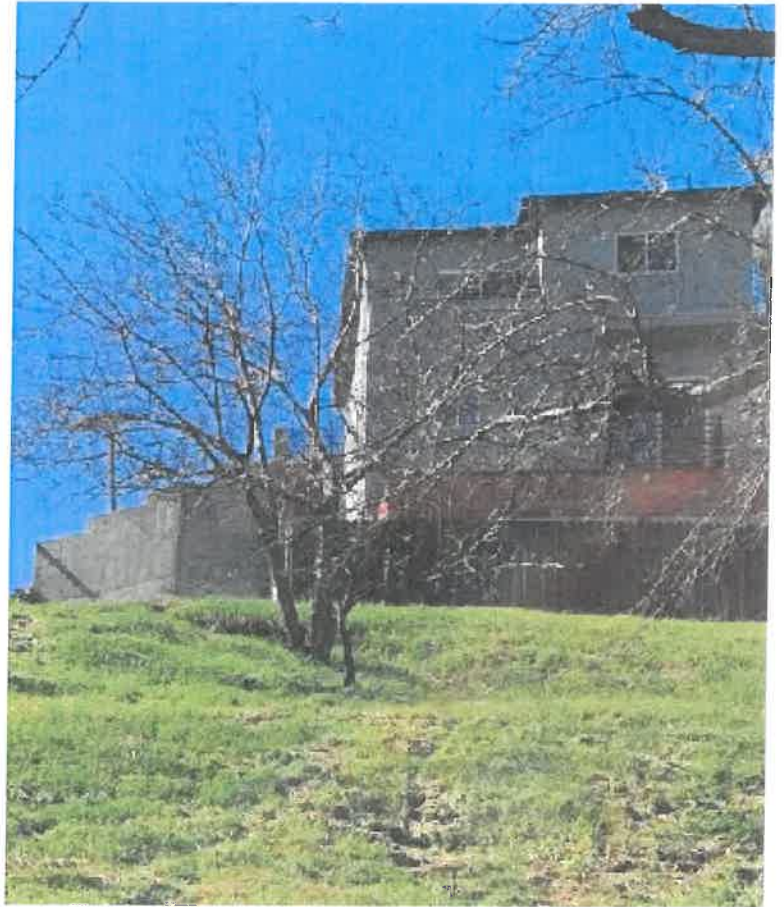
**PHOTO 2** - Shows Black walnut tree #1's protective fencing. This tree is above the construction zone of the proposed new residence and will be retained and protected in place.

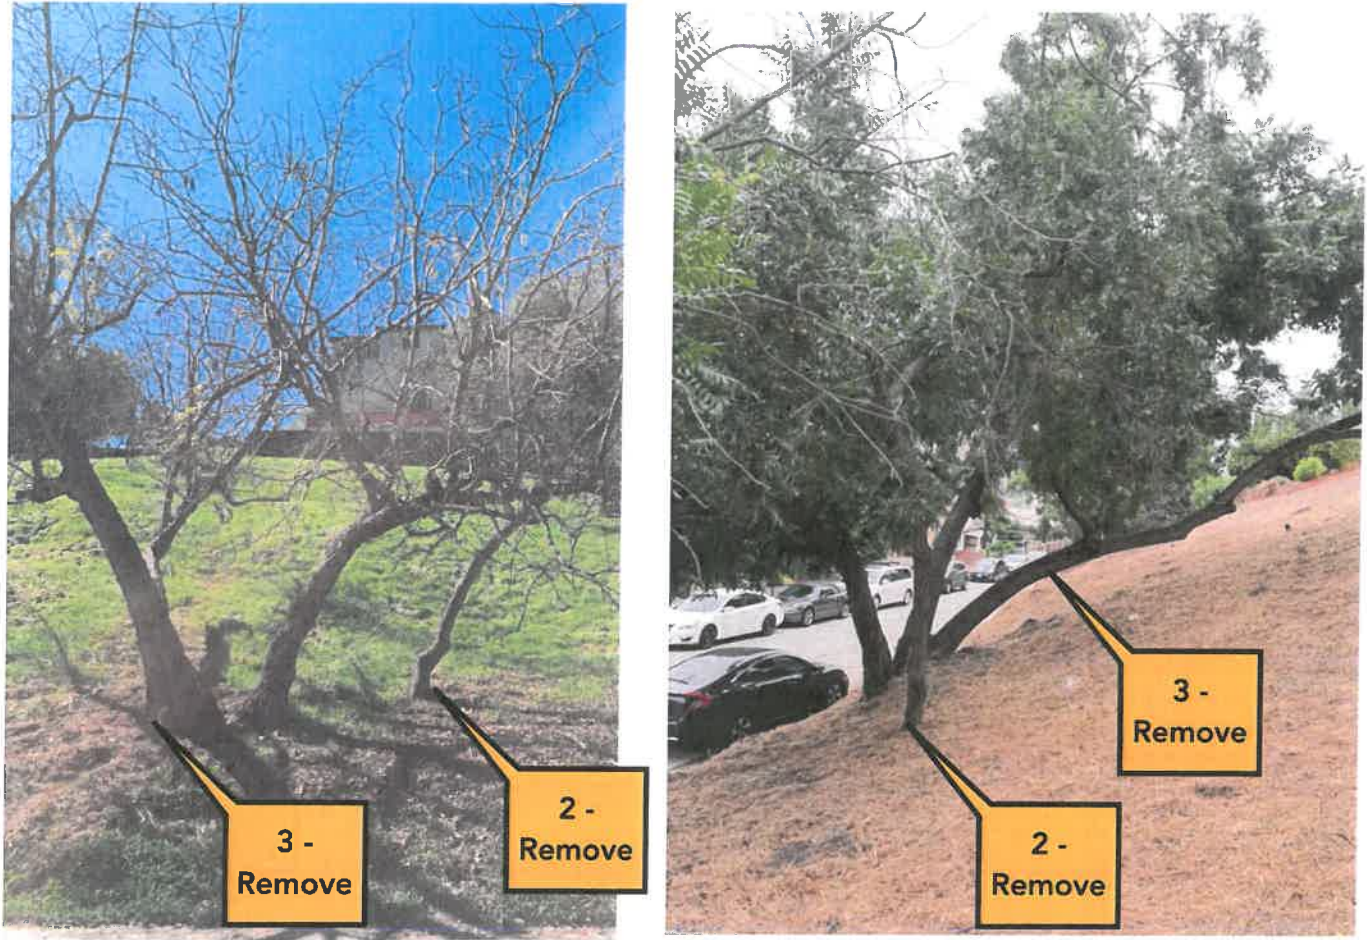
Black walnut trees #2 and #3 will be impacted by grading, soil removal, and recompaction and are recommended for removal. These trees are located at the bottom of the sloping property, and directly adjacent to the street. Any required grading would immediately impact these trees regardless of project size. Additionally, due to the small lot sizes, narrow width, there is no way to feasibly retain these trees as they are on the lowest portion of the lot. Tree #3 is decayed at the bottom and could easily fail into the street anytime. This tree was previously requested as a hazard tree removal permit from UFD. UFD then requested this tree be submitted for removal as part of the package. The clients are willingly replacing this decayed and hazardous tree at the typical 4:1 ratio to the satisfaction of the UFD.

**PHOTO 3** - Shows black walnut trees #2 and #3 which are recommended for removal and replacement to the satisfaction of the Urban Forestry Division.

Black walnut trees #2 and #3 will be replaced to the satisfaction of the Urban Forestry Division. Eight (8) new Southern California black walnut trees, 5-gallon size, and will be planted upon completion of construction, for a total of eight (8) replacement trees. New black walnut trees will be spaced between 7ft to 25ft between each tree and the proposed SFD to provide the desired spacing. Please see landscaping plan for exact measurements.

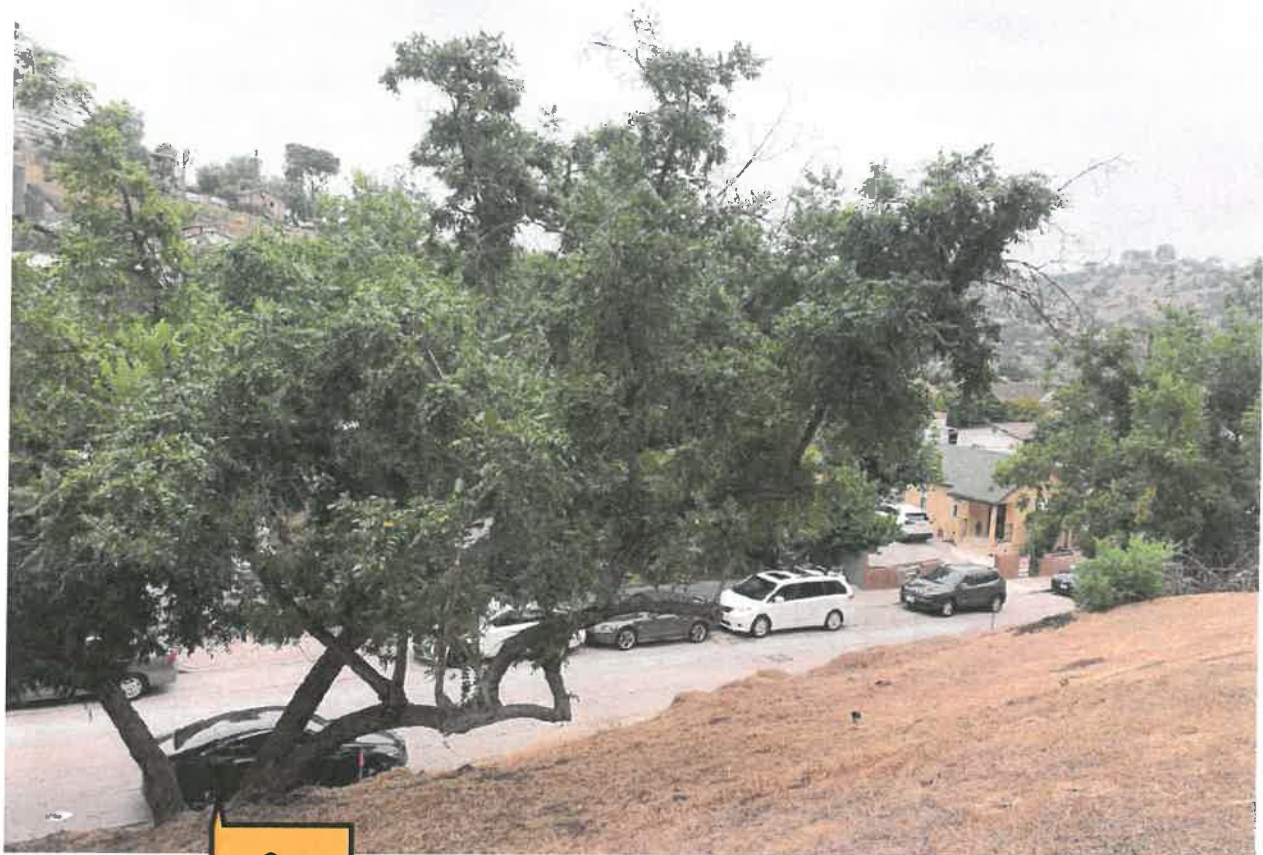
**3 -  
Remove**

**PHOTO 4** - Shows black walnut tree #3. This tree is decaying inside the base. As the decay advances through the lower portion of the trunk and into the main lateral roots, the tree will continue to have an even greater potential for complete root plate failure.

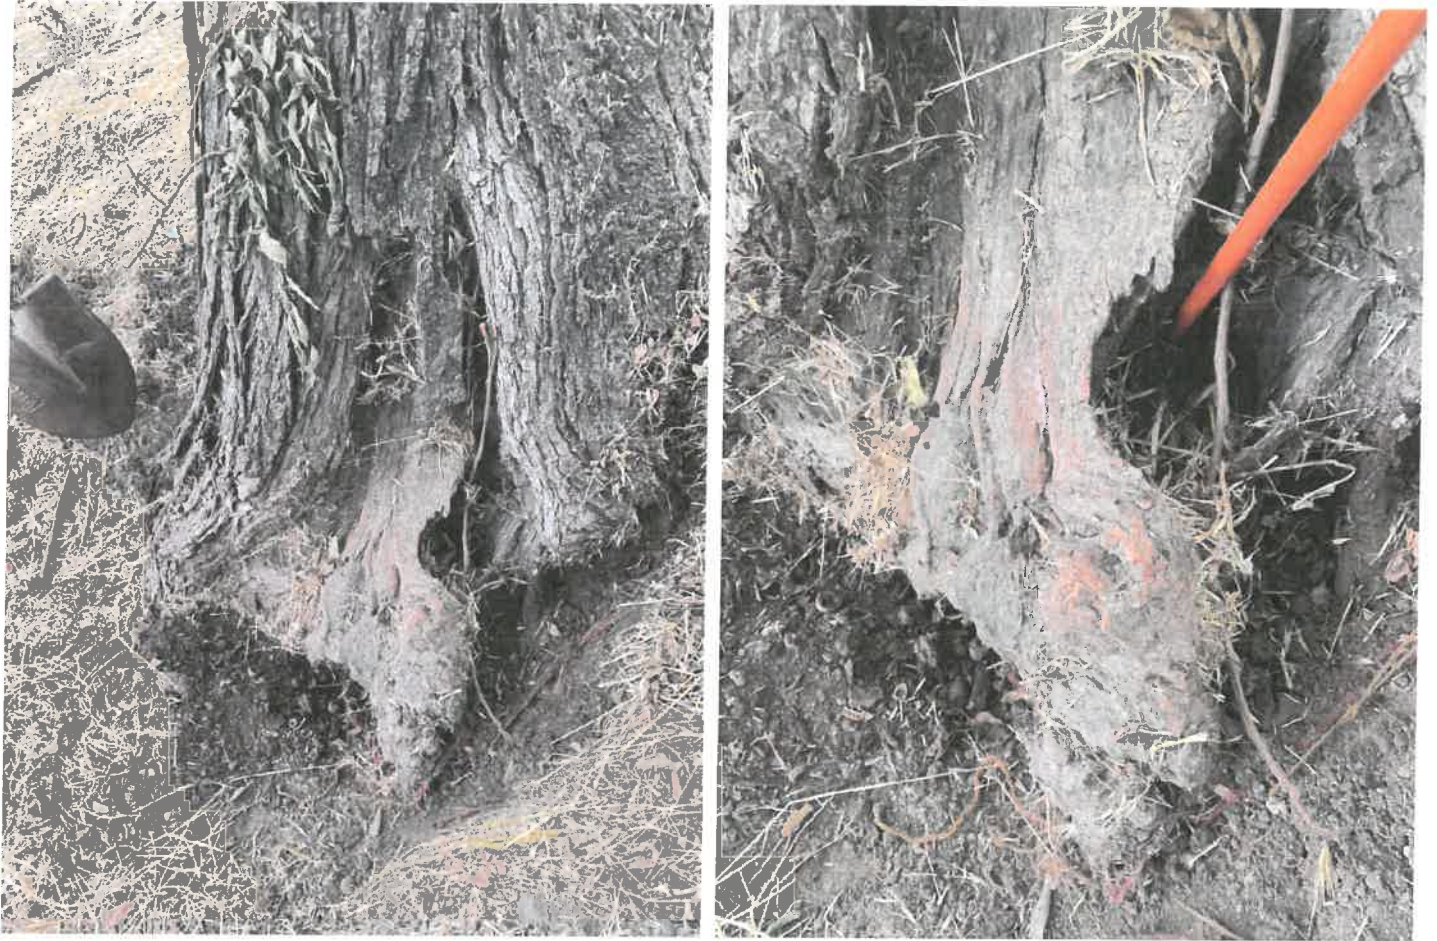
**PHOTO 5** - Shows extensive decay at the base of black walnut #3. This tree has multiple large decay pockets that are making the root plate unstable.

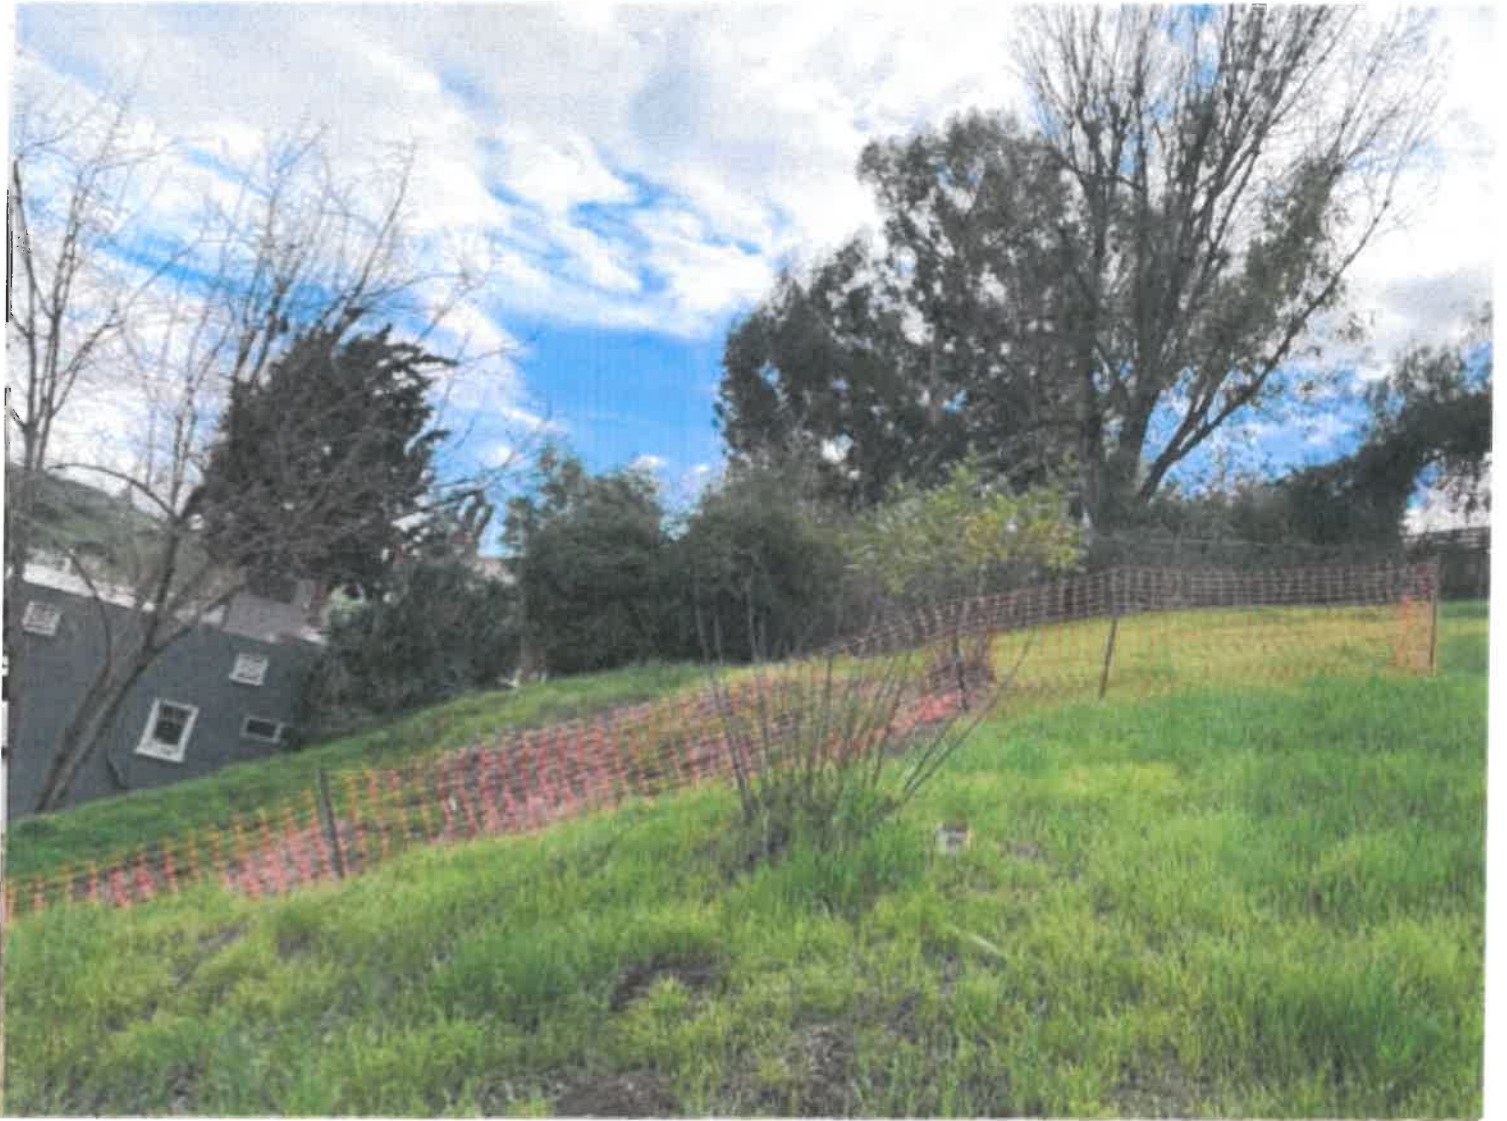
**PHOTO 6** - Shows protective fencing for Off-Site protected trees.

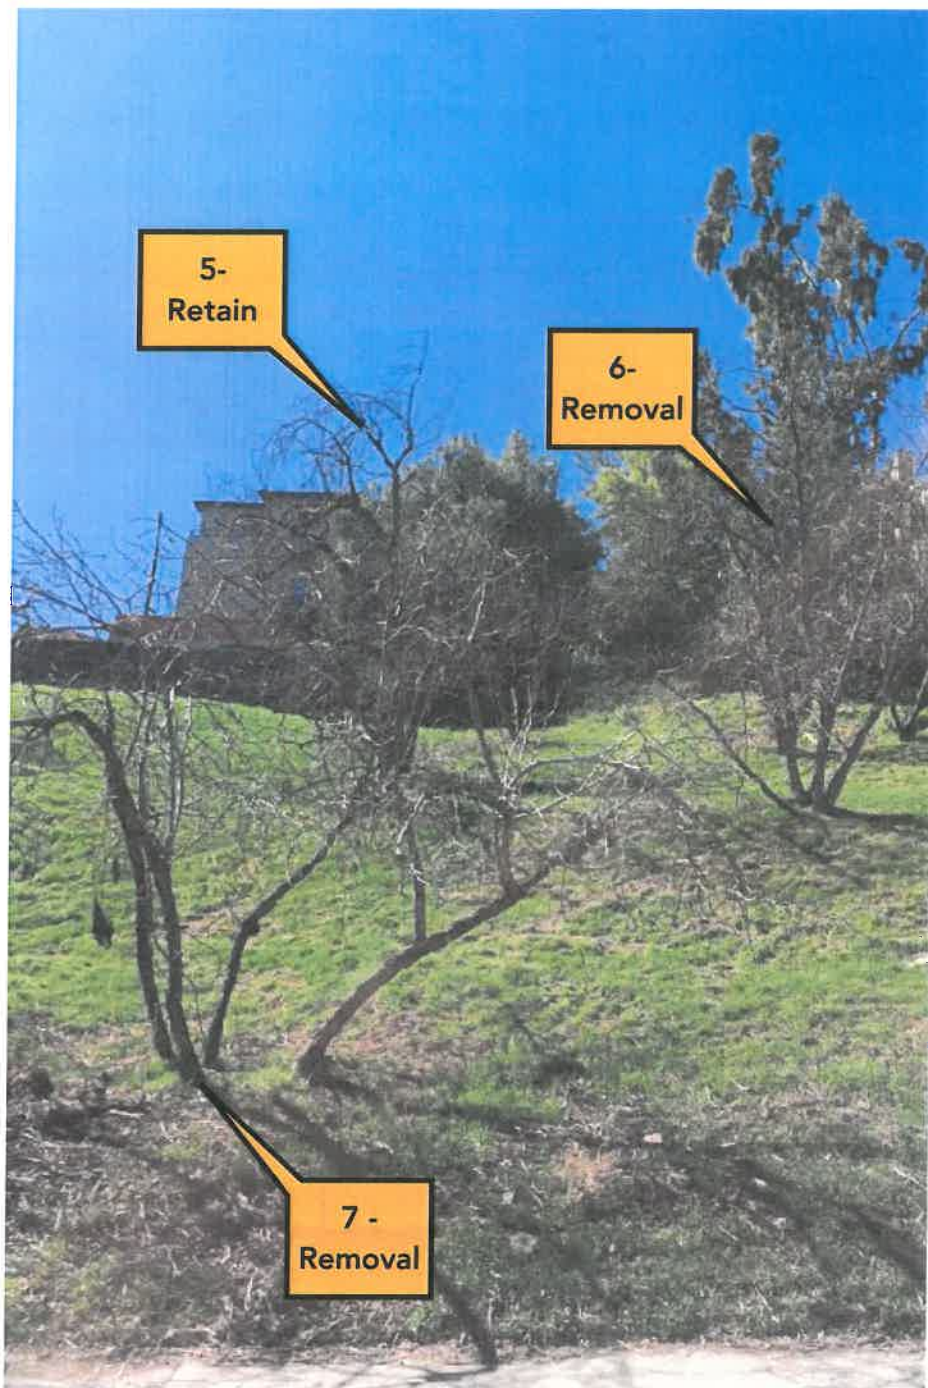
**PHOTO 1** - Shows black walnut trees #6 and #7 which are recommended for removal and replacement to the satisfaction of the Urban Forestry Division. Tree #5 will receive no impact and will be retained and protected in place.

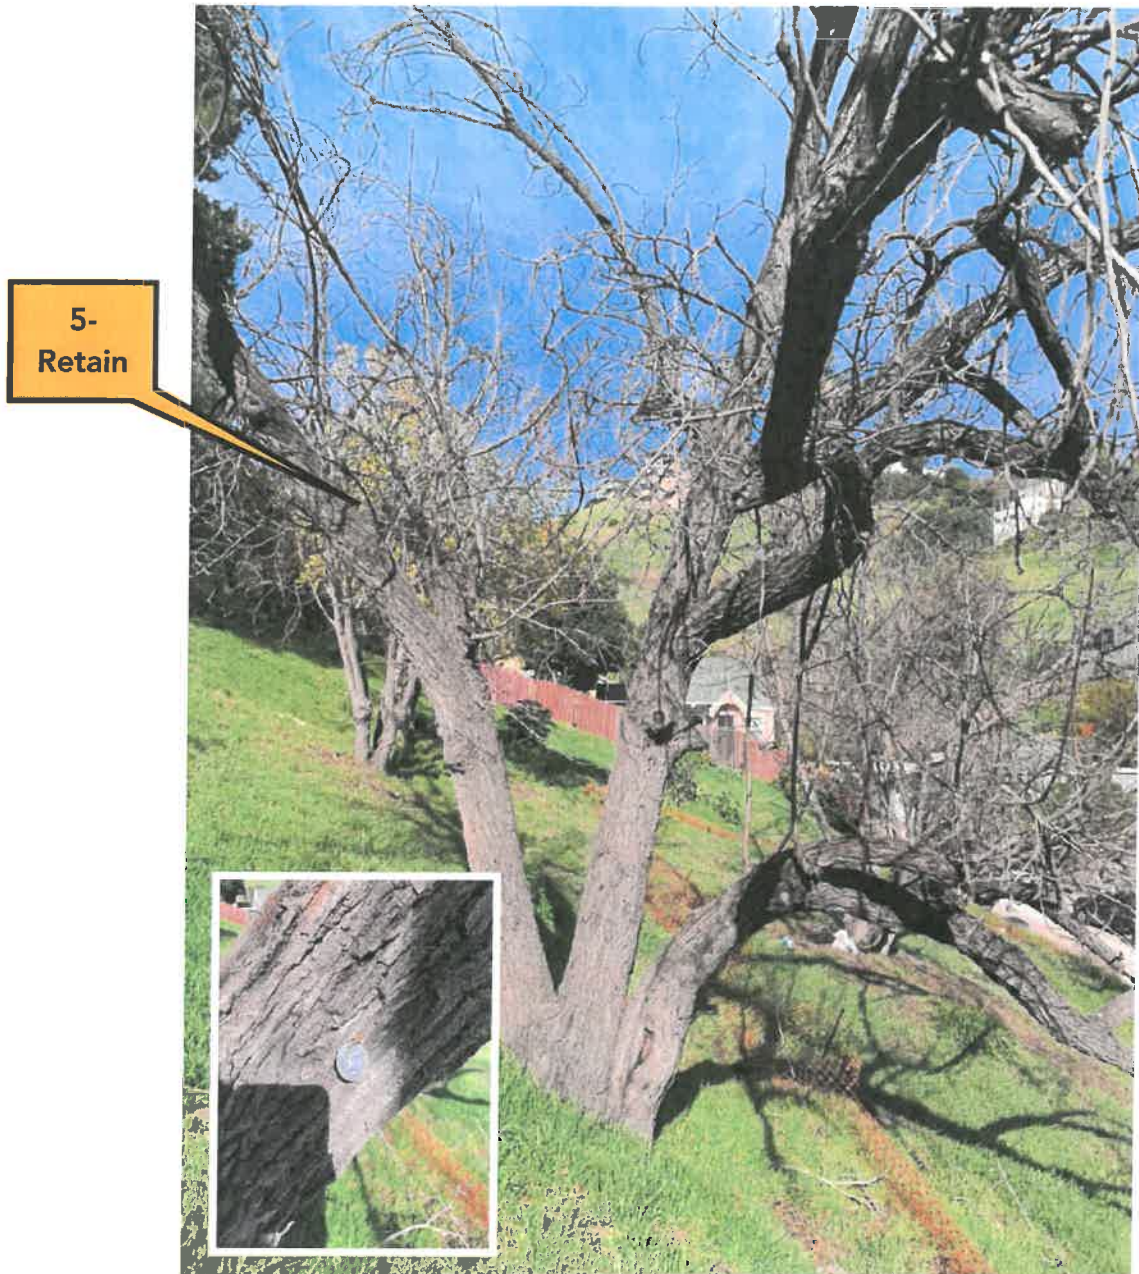
**PHOTO 2** - Shows protective fencing for black walnut tree #5. This tree will receive no impact and will be retained and protected in place.

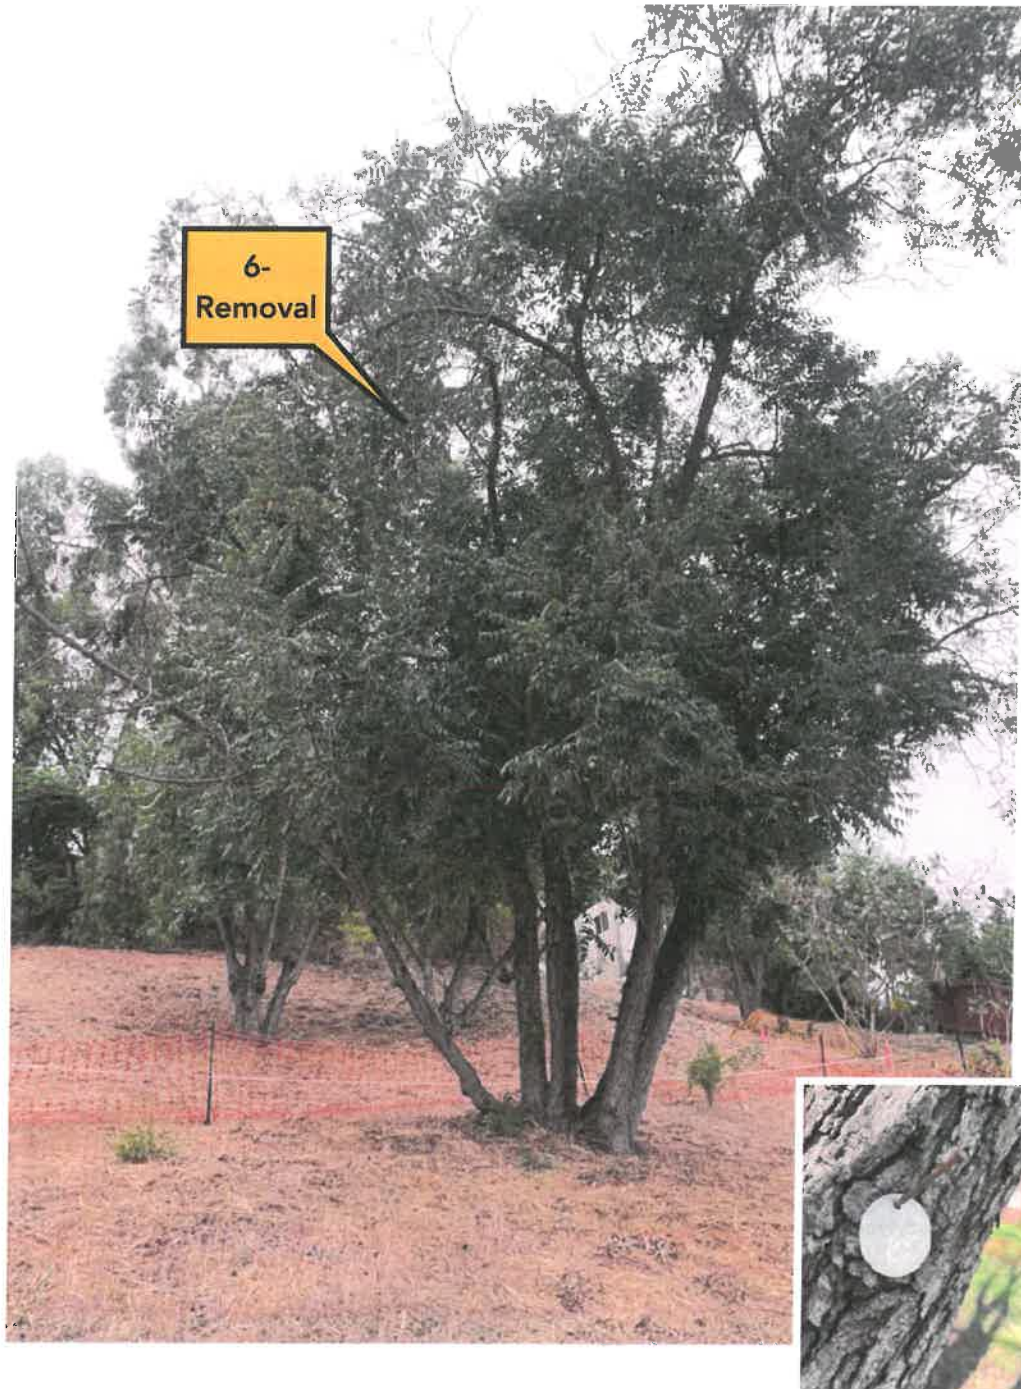
**PHOTO 3** - Shows tree #6. This tree will be removed and replaced to the satisfaction of the Urban Forestry Division.

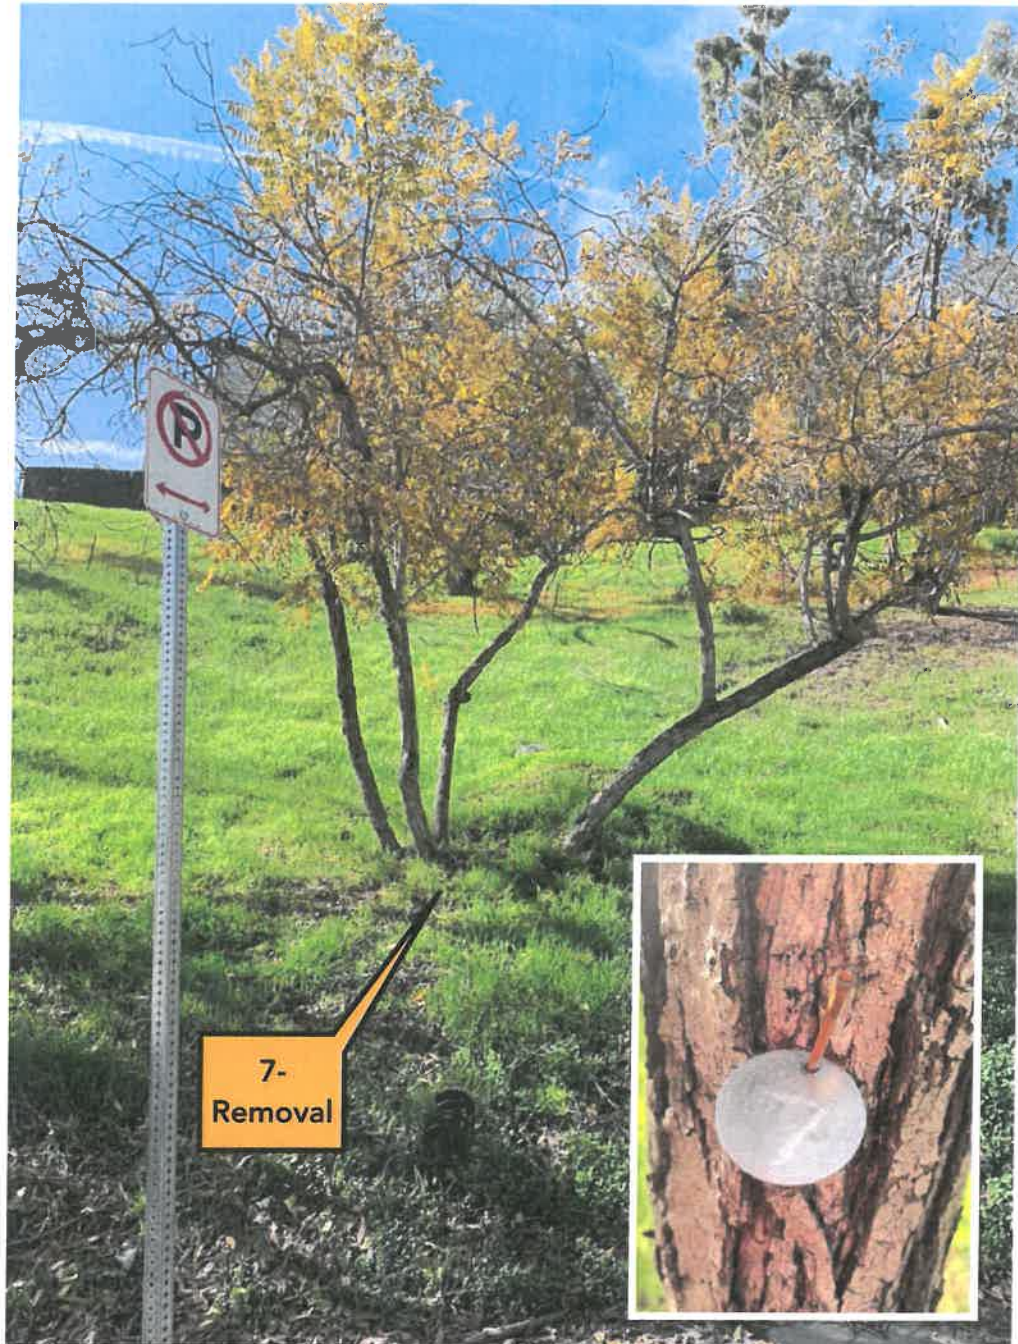
**PHOTO 4** - Shows tree #7. This tree will be removed and replaced to the satisfaction of the Urban Forestry Division.

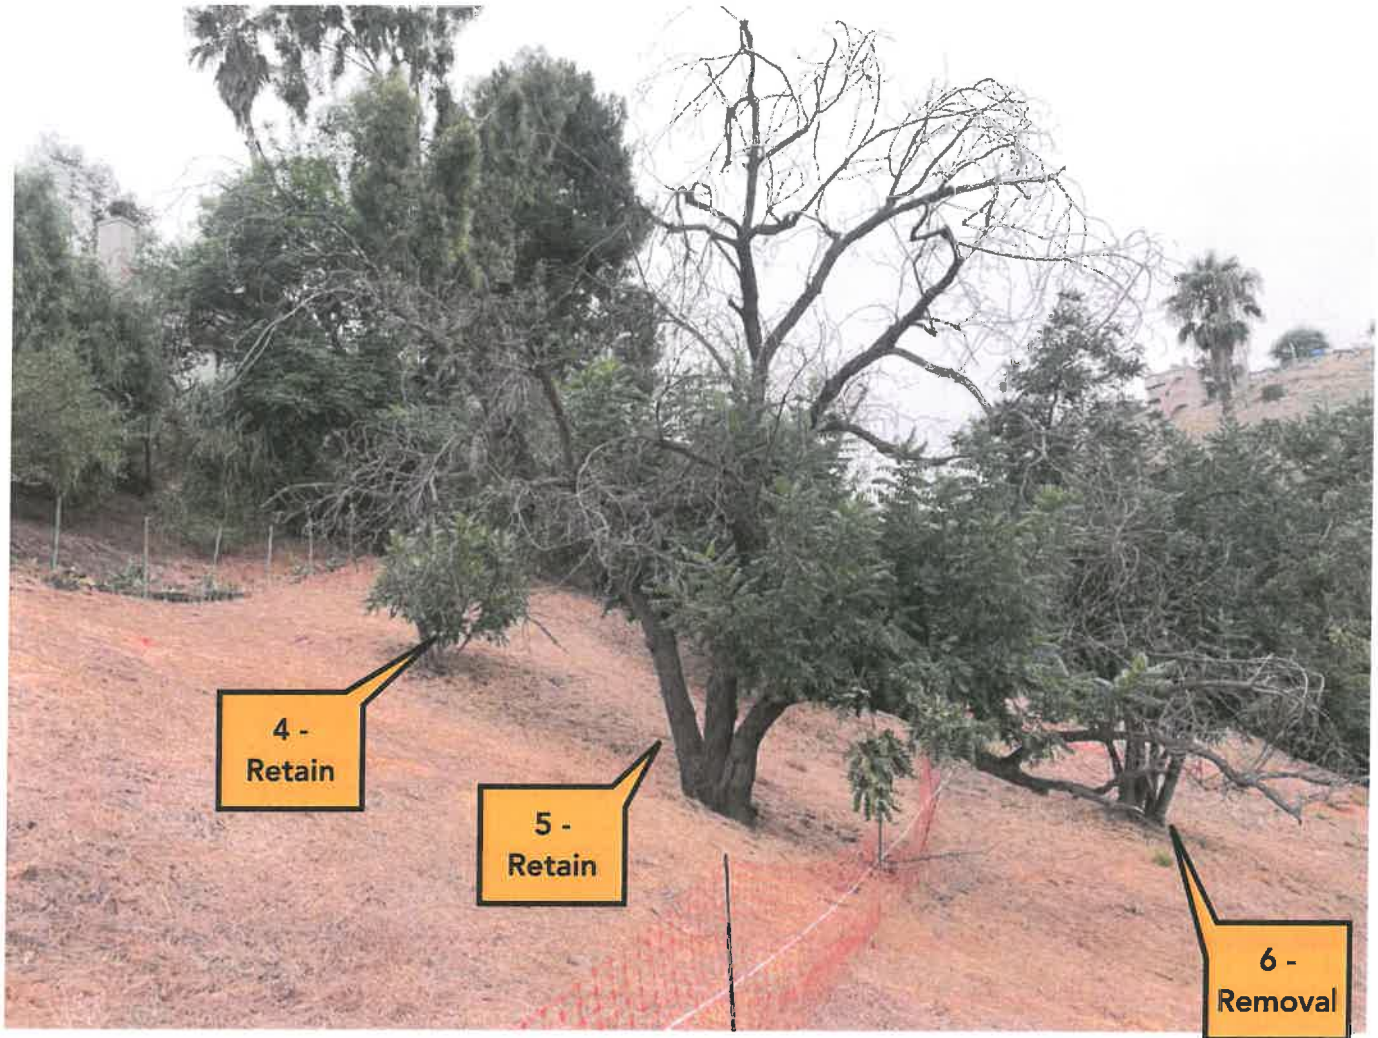
**PHOTO 5** - Shows protective fencing for tree #4 and tree #5. These trees will be retained and protected in place. Tree #6 will be removed and replaced to the satisfaction of the Urban Forestry Division.

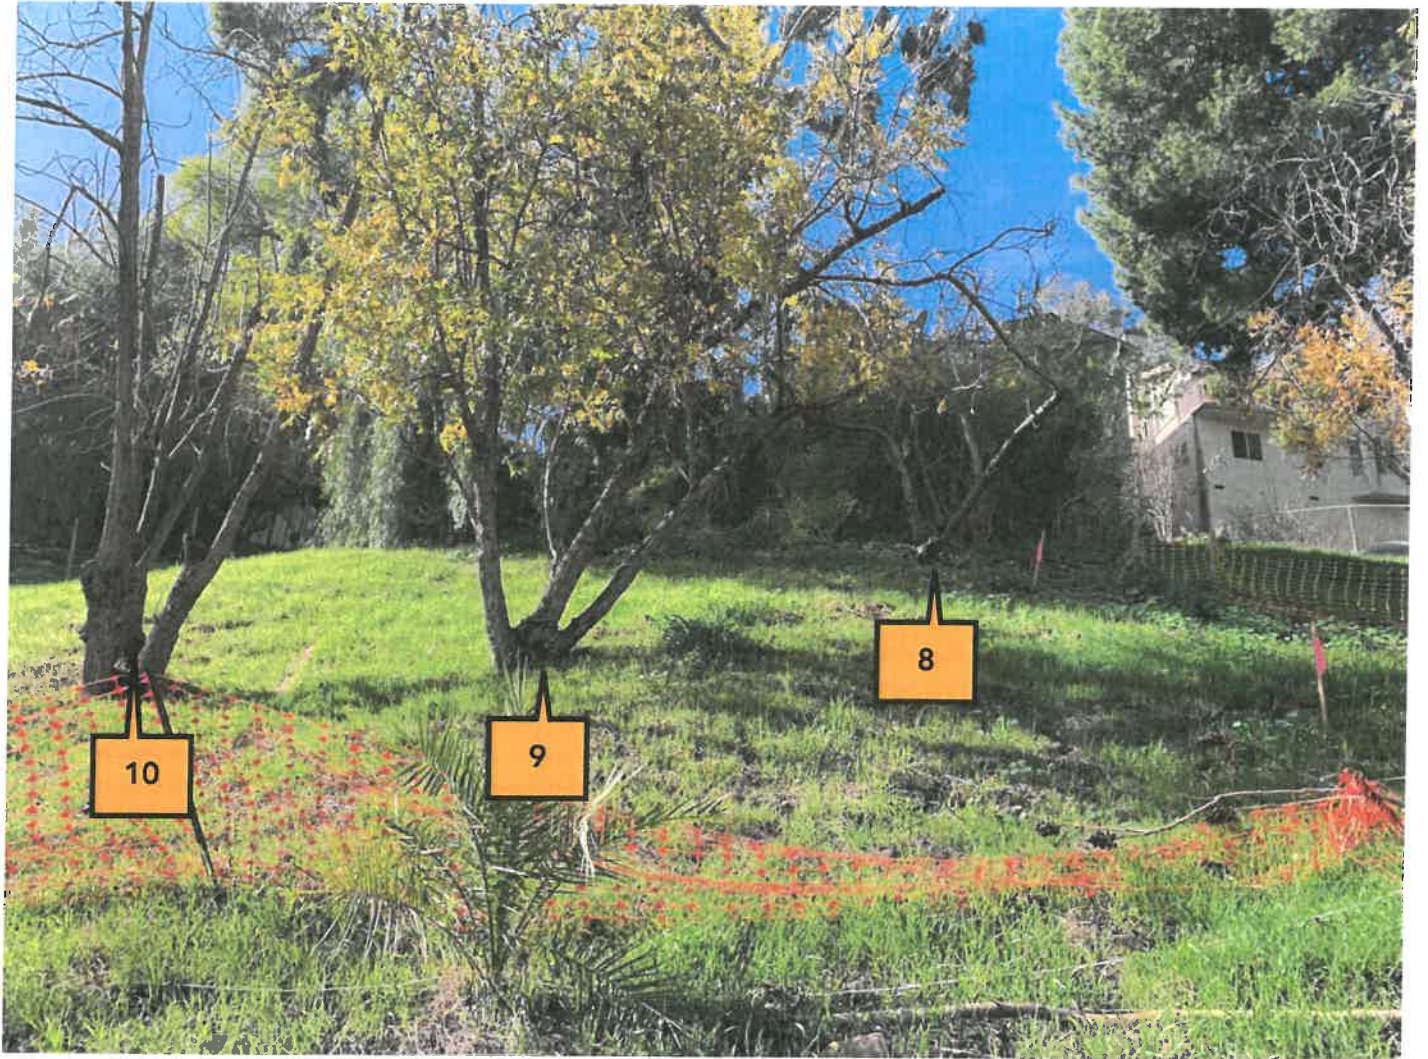
**PHOTO 1** - Shows protective fencing for black walnut trees #8, #9, and #10. These trees will be retained and protected in place.

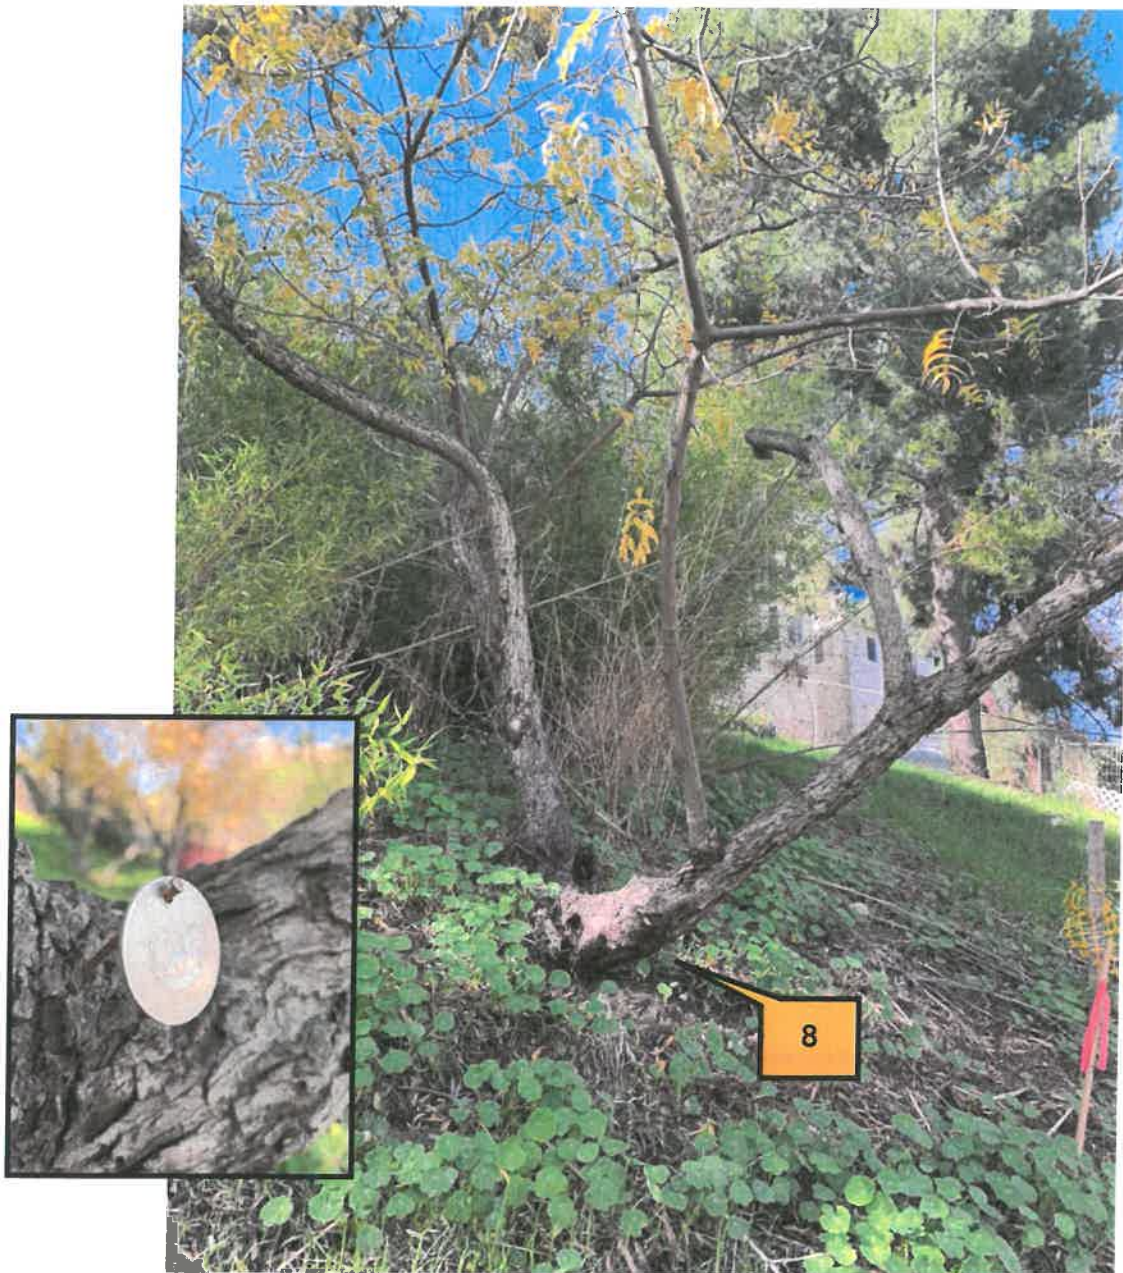
**PHOTO 2** - Shows black walnut trees #8. This tree will be retained and protected in place.

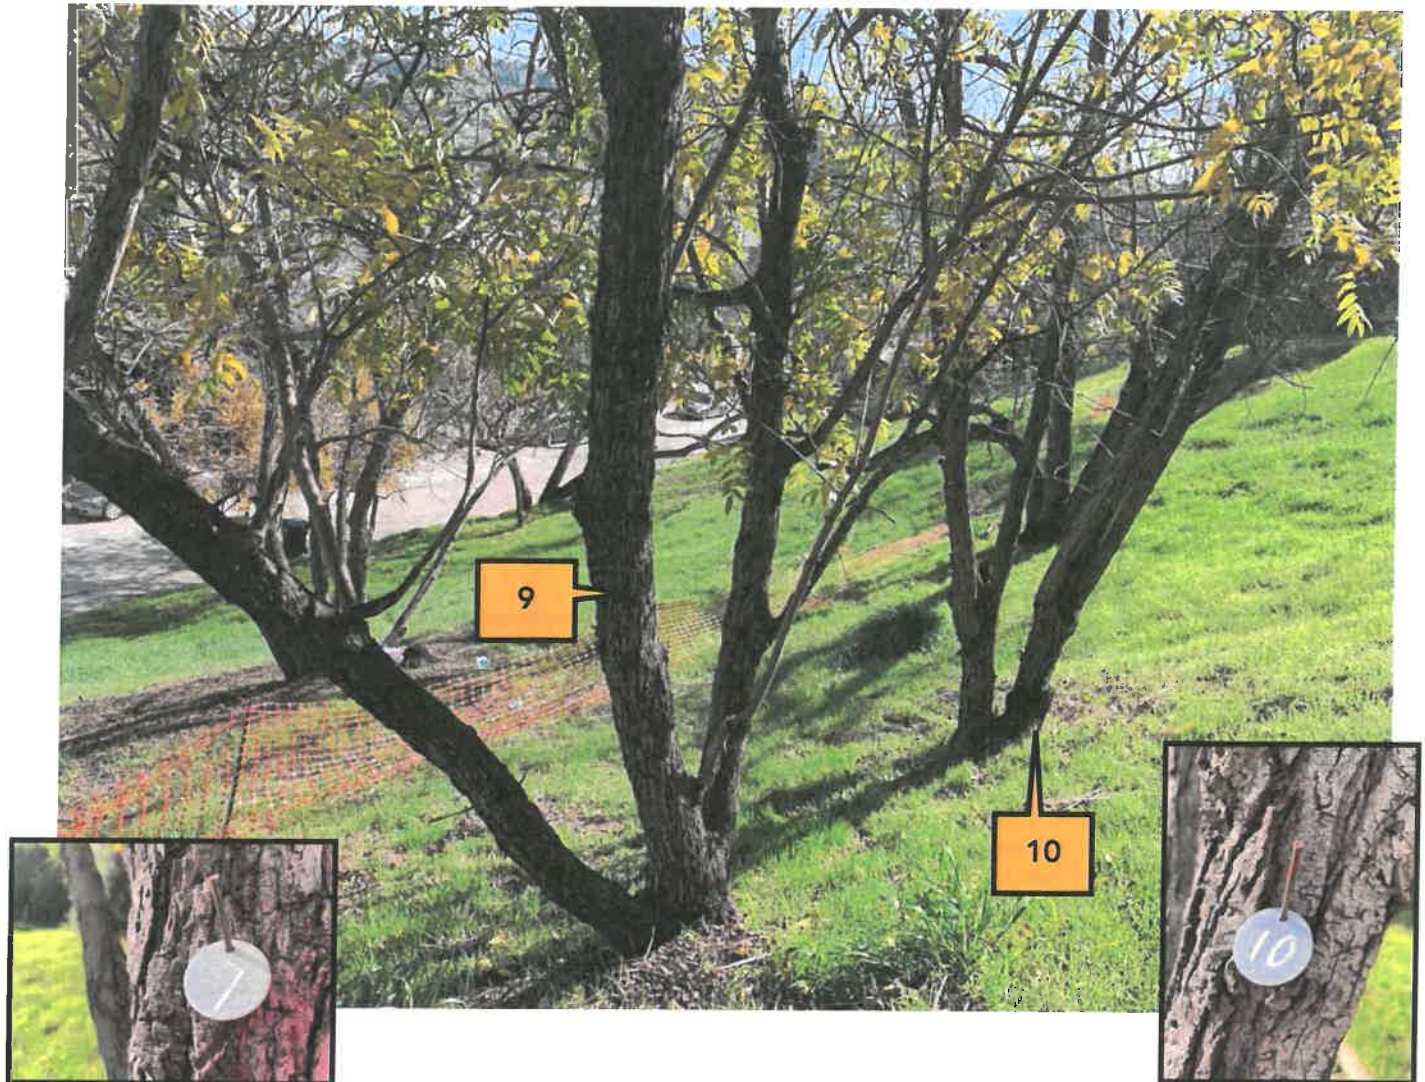
**PHOTO 3** - Shows black walnut trees #9 and #10. These trees will be retained and protected in place.

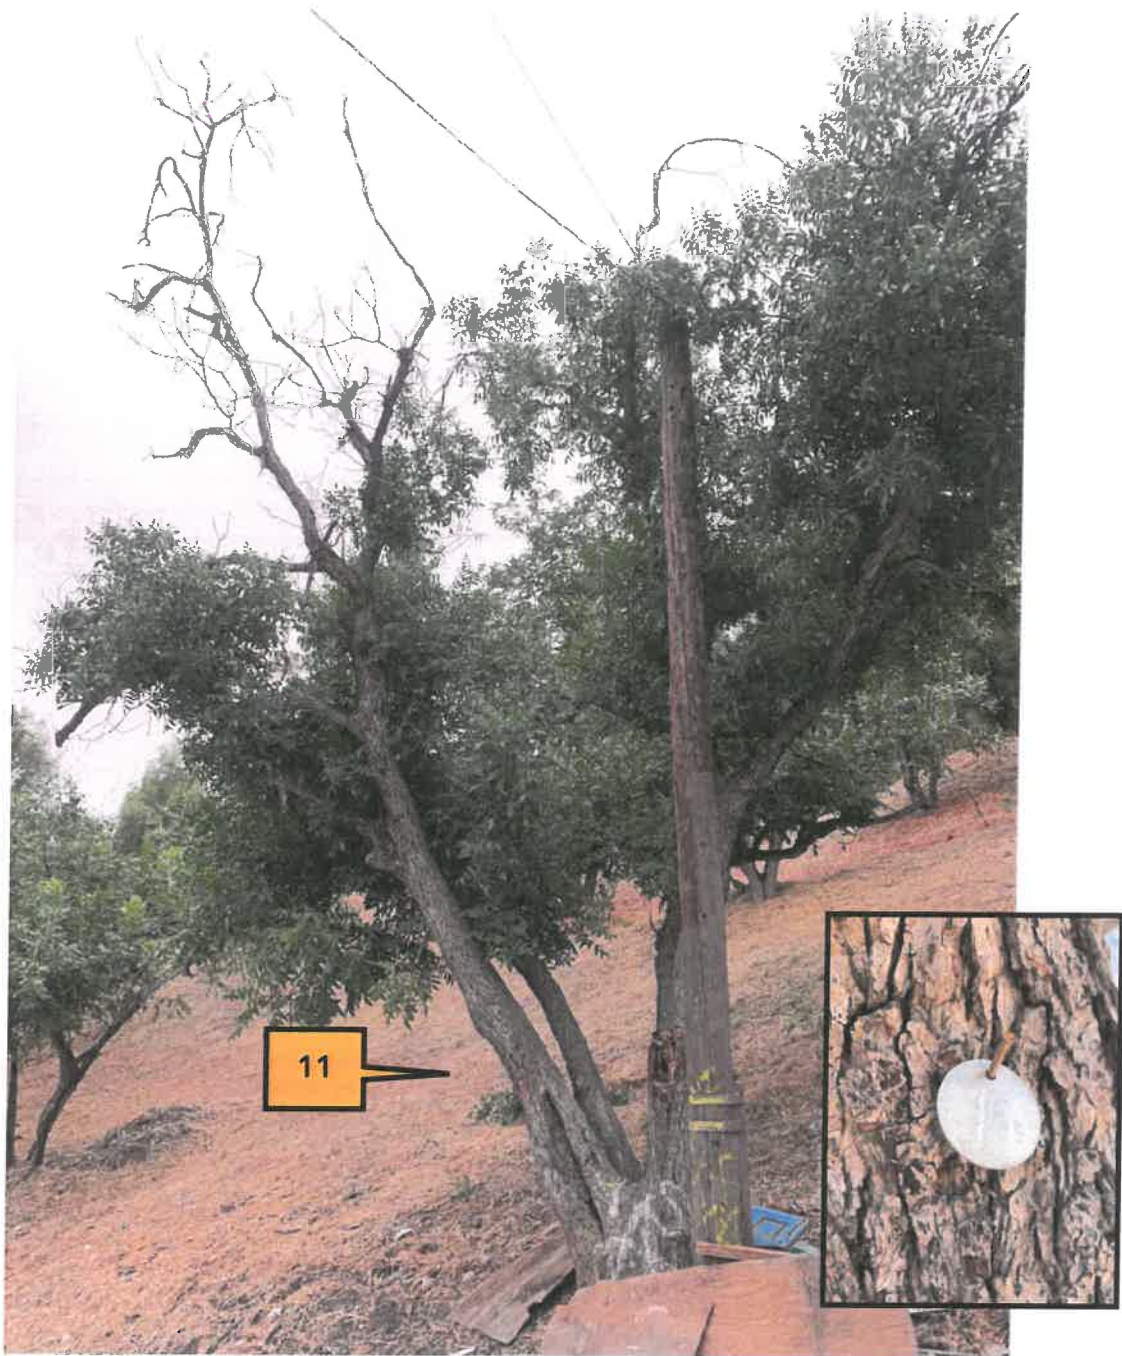
**PHOTO 4** - Shows Black walnut tree #11. This tree is completely hollow and rotted inside the base. This tree is in severe decline and will fail. This tree is recommended for removal and replacement to the satisfaction of the Urban Forestry Division.
