# PROTECTED TREE REPORT

434 W. James Street  
Los Angeles, CA 90065

January 1, 2021

LISA SMITH, THE TREE RESOURCE  
REGISTERED CONSULTING ARBORIST #464  
ISA BOARD CERTIFIED MASTER ARBORIST #WE3782  
ISA TREE RISK ASSESSOR QUALIFIED  
MEMBER OF AMERICAN SOCIETY OF CONSULTING ARBORISTS  
P.O. BOX 49314, LOS ANGELES, CA 90049  
T 310-663-2290 E queenpalm@earthlink.net

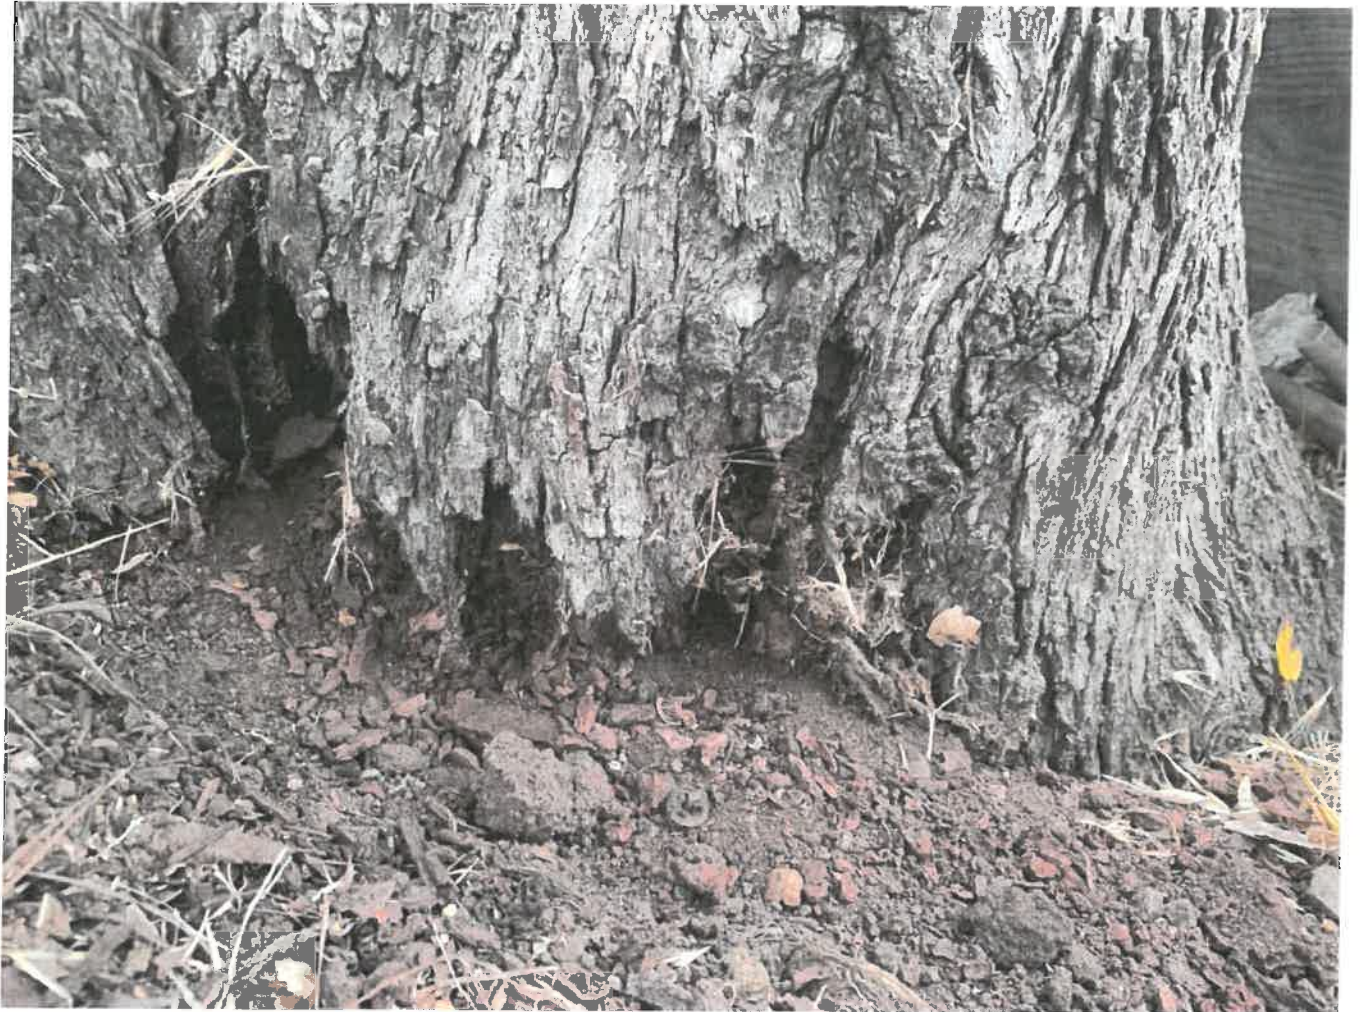
**PHOTO 5** - Shows Black walnut tree #11's defects and instability in its current condition. This large tree has the potential to inflict serious damage to cars or people walking nearby. This tree is recommended for removal and replacement.

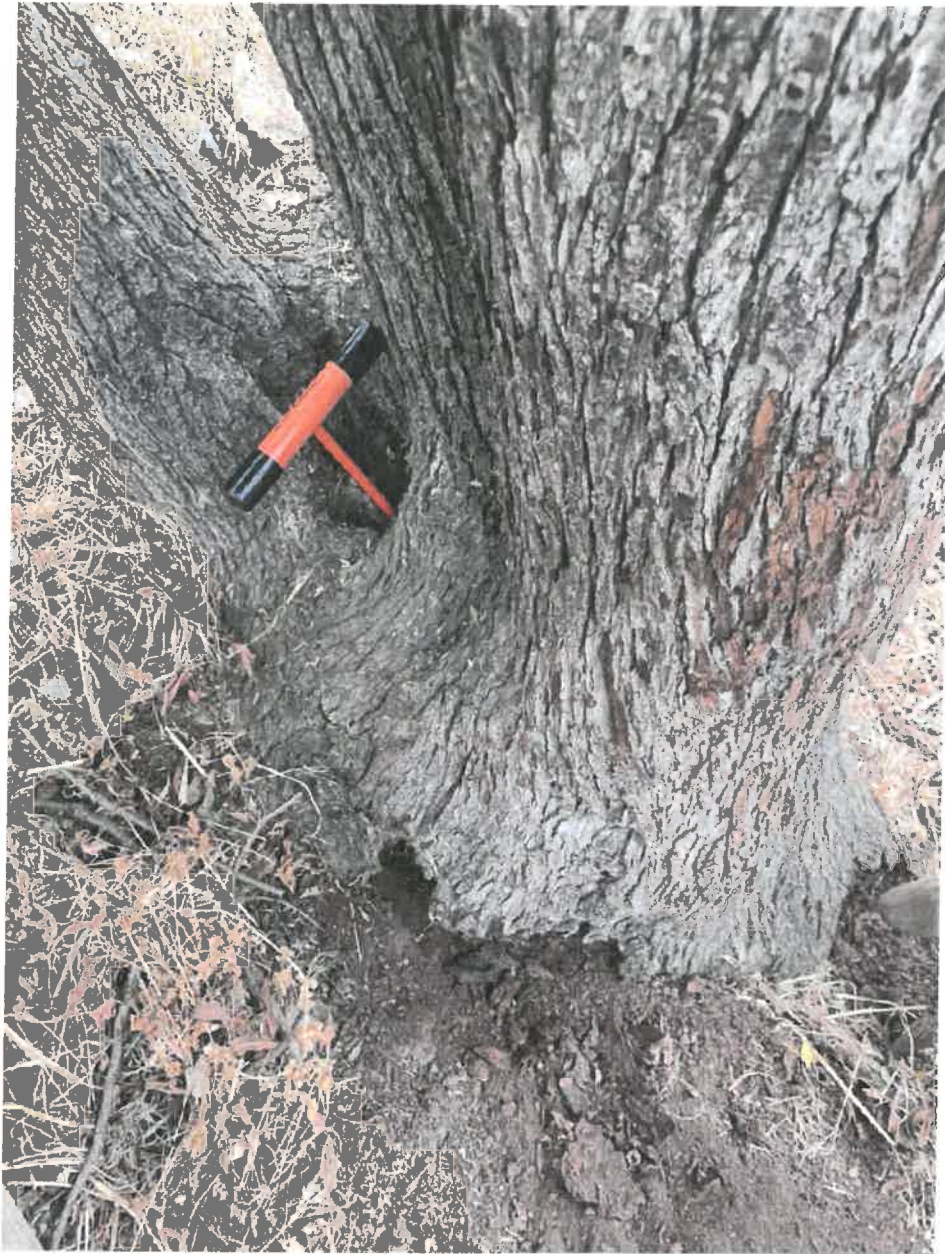
**PHOTO 6** - The base of the Black Walnut Tree #11 is hollow with a large decay pocket. A probe inserted from the top of the opening to the cavity's furthest interior point reached all the way in. There are no mitigation options that would inhibit this rot from continuing to degrade the entire buttress and trunk. As the decay advances through the lower portion of the trunk and into the main lateral roots, the tree will continue to have even greater potential for complete root plate failure.

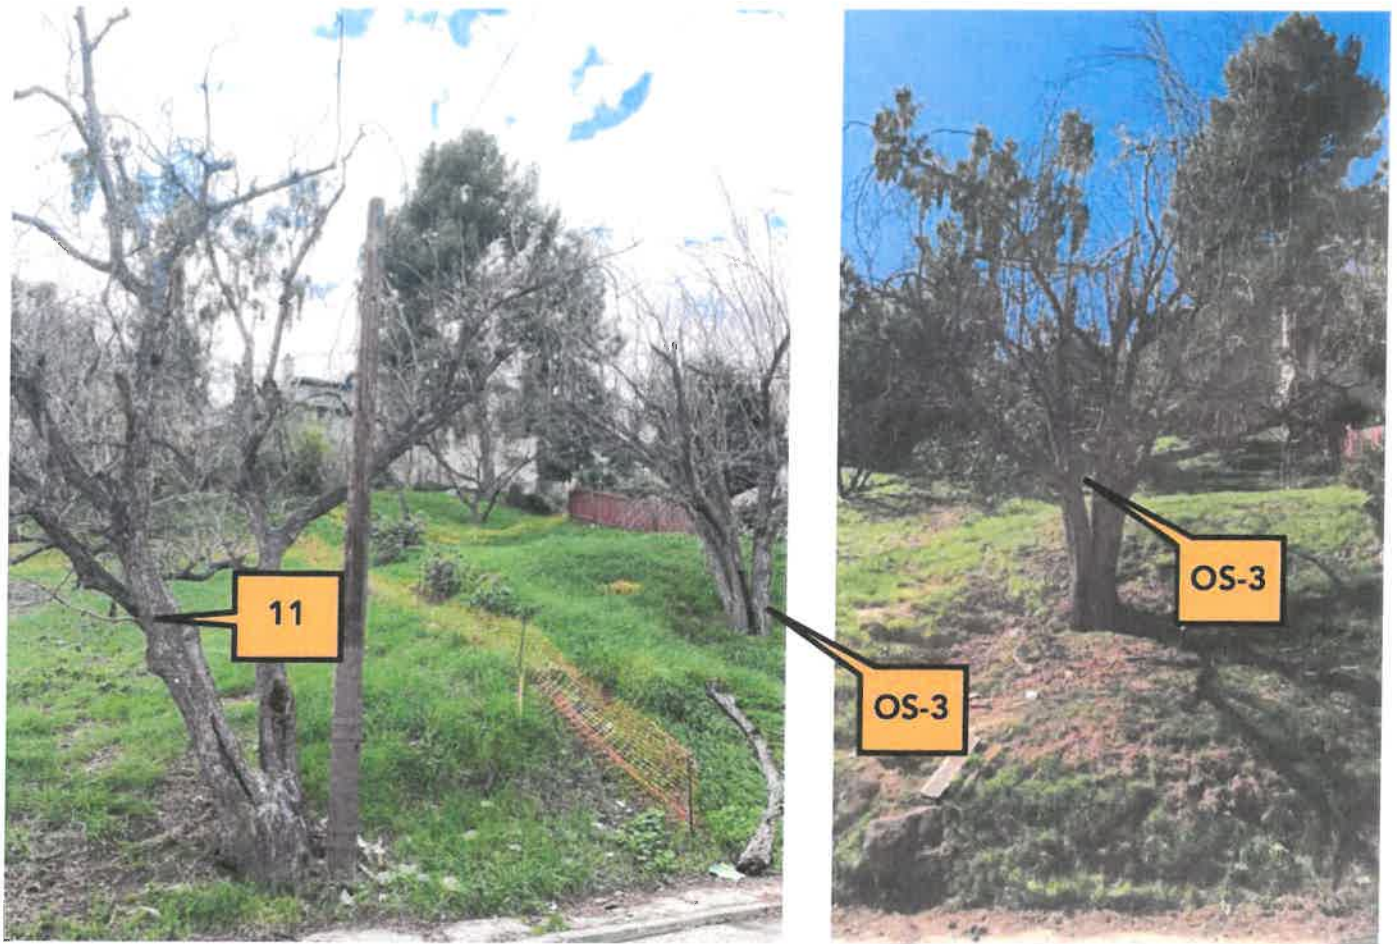
**PHOTO 7** - Shows Black Walnut #11 and off-site black walnut tree #OS-3.

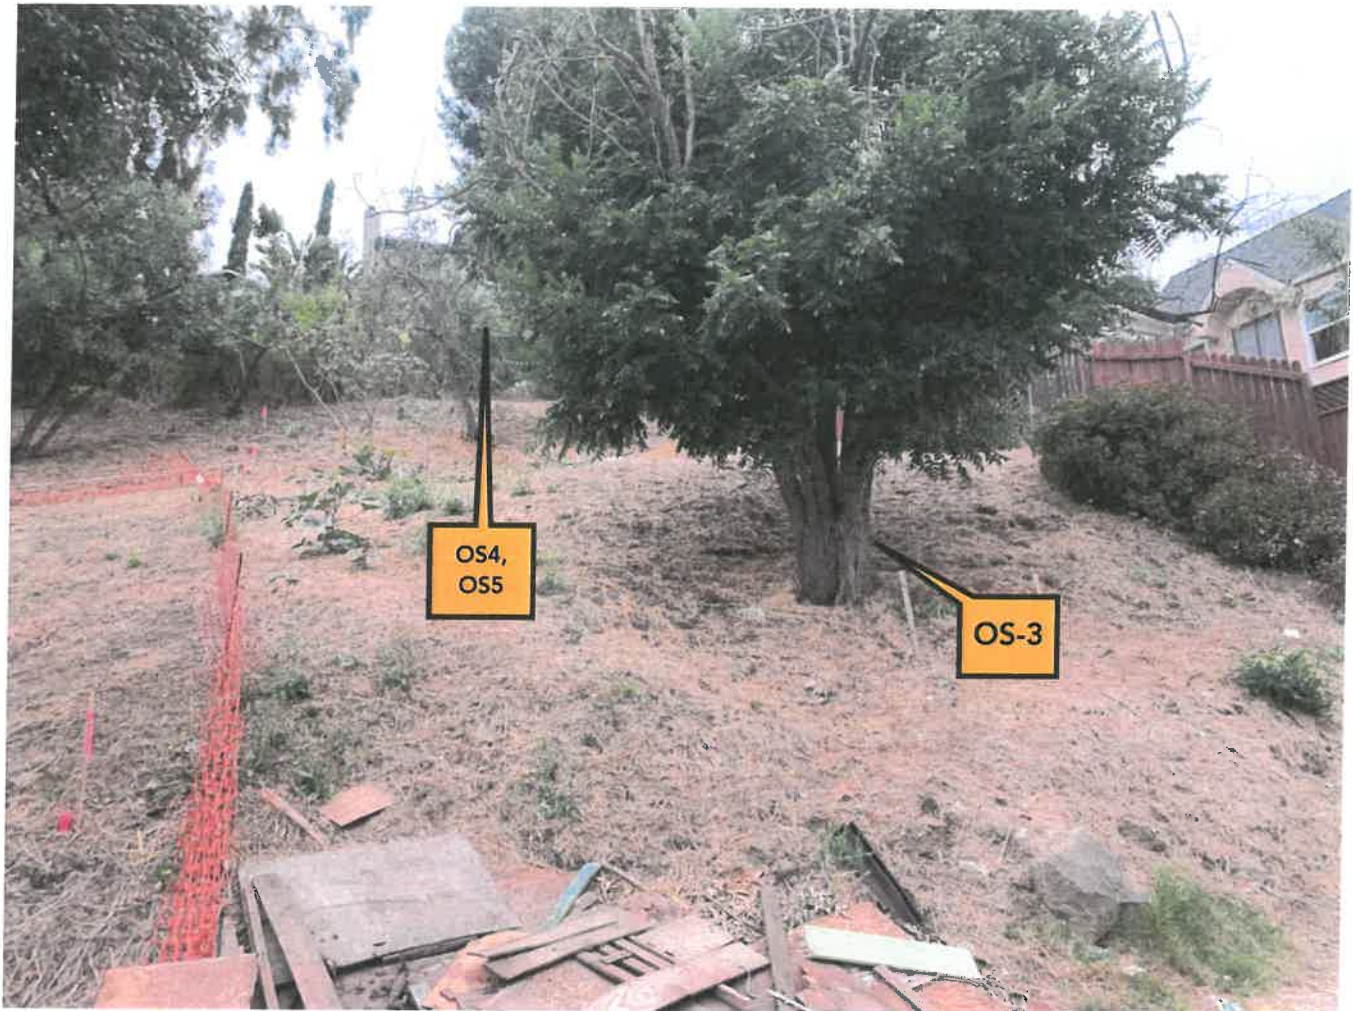
**PHOTO 8** - Shows protective fencing for off site protected trees OS3, OS4, and OS5.
