ORTEGA PARK MURAL EVALUATION REPORT
JULY 13, 2021

Prepared by:
Site & Studio Conservation, LLC.
Kiernan Graves
Evelynn Bird
Abigail Rodriguez
Magdalena Solano

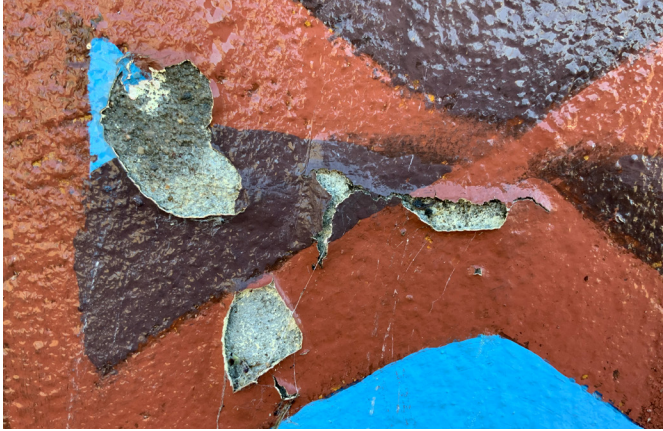
Overall, the Ortega Park murals are in fairly good condition except the *Codex Cospi*. This mural exhibits widespread and severe condition issues such as salt activity leading to flaking paint (Figure 1) and structural cracking of the stucco layer. Other murals that exhibit similar structural cracking are the underwater scenes found inside the wall around the pool— particularly *Dolphins* (Figure 2) found on the opposite side of the *Codex Cospi* wall. *Campeños* has relatively minor vertical structural cracks that run almost the full height and divide the mural into thirds. This condition may affect the stability of stucco if these particular murals are relocated and more robust protection materials may be necessary, especially in the case of *Codex Cospi* and *Dolphins*.

Figure 1. Detail from *Codex Cospi* (2020), showing damage to painted surface from salt activity. This is found throughout most of the painted surface of this particular mural.

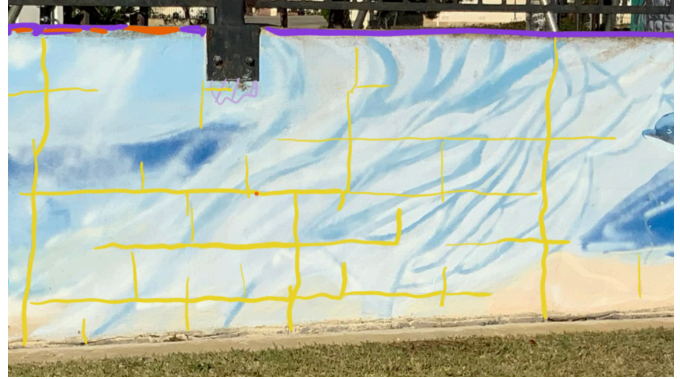
Figure 2. Example of the extensive cracking (drawn in yellow) in the shape of the CMUs found in *Dolphins* and *Codex Cospi*. This type and extent of cracking is what would make these murals extremely difficult to relocate without significant damage.

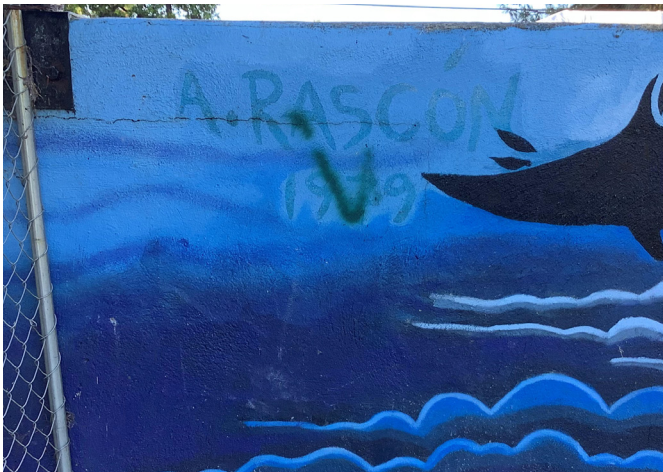
Figure 3. Example of the graffiti found on the murals currently. All incidences are done with the same green paint.

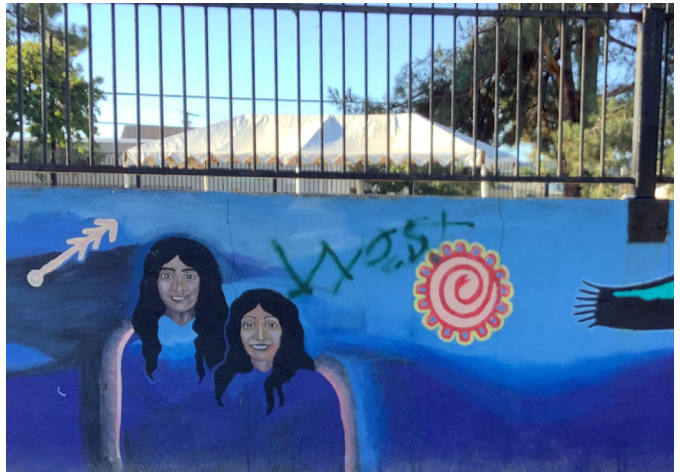
Figure 4. Example of the graffiti found on the murals currently. All incidences are done with the same green paint.

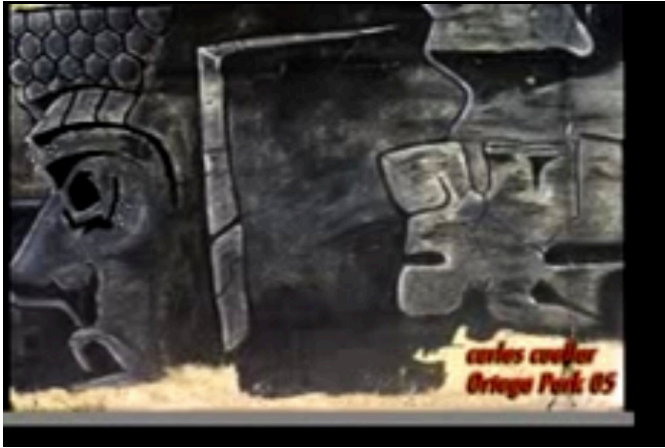
Figure 11. *Underwater Atlantes/Toltecas* before restoration, note the very muted and monotone palette. (Image is taken from a video put together with archive images by Cuellar.)

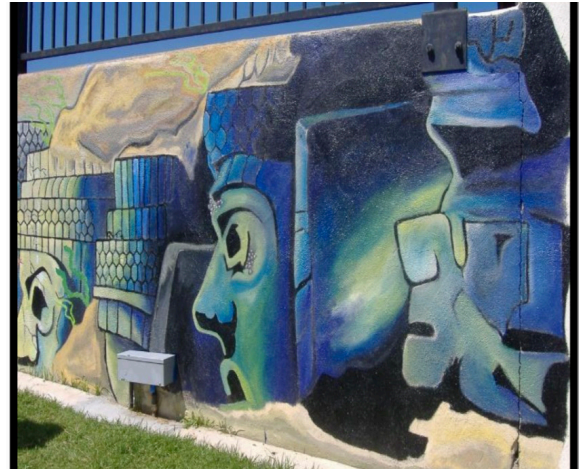
Figure 12. *Underwater Atlantes/Toltecas* after restoration, note the much changed and vibrant palette though the lines and composition are the same. (Image from Venegas 2020.)

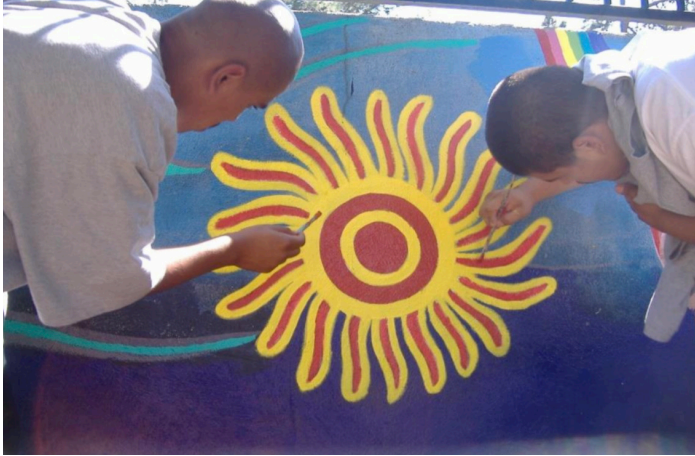
Figure 17. Detail from *Aztec Chumash Solstice* showing the restoration work during 2005
(Image from Venegas 2020)

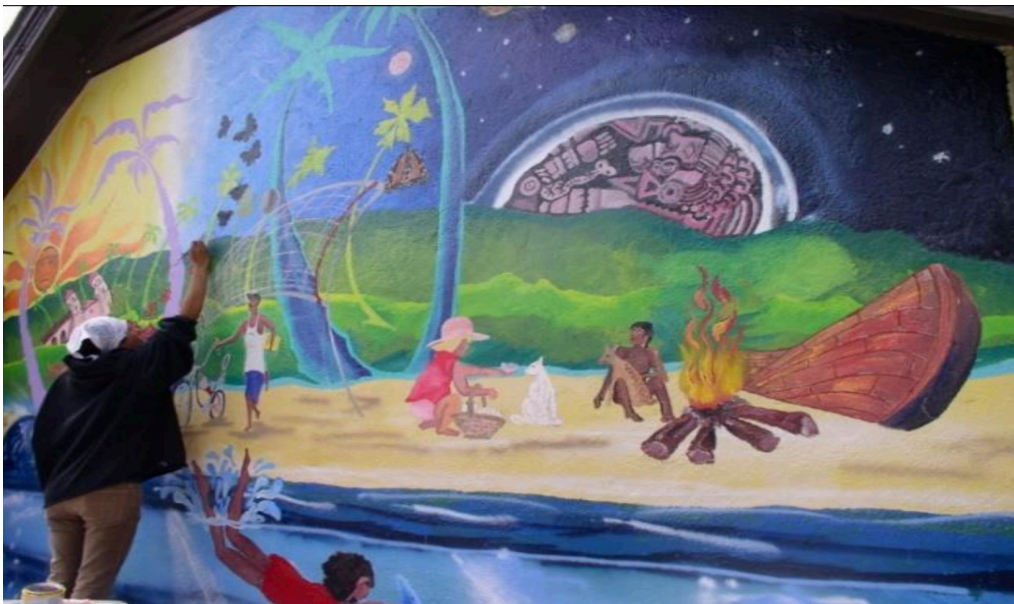
Figure 24. The painting of *La Playa* in 2005, notice the fading of the colors between the original and the current image.
(Image from Venegas 2020)
